# INITIAL STRUCTURAL INTEGRITY ASSESSMENT REPORT (SIAR)

Factory Name: **Unicorn Sweaters Ltd**  
Address: **Gorat, Navana Village, Ashulia, Savar, Dhaka-1341  
Savar Bangladesh**  
Assessor: **Shaheedullah**  
Date: **10 Jan 2018**

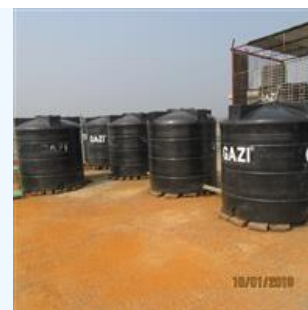
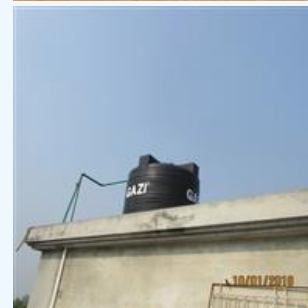
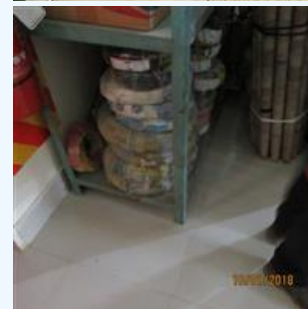
Question:	Are all non-structural elements suspended from, attached to, or resting atop the structure adequately anchored and braced to resist earthquake forces?
Priority Level:	Medium
Non-Compliance Level:	2
Description:	8-plastic water tanks of 2000 liter capacity each and 1 of 5000 liter capacity have been noticed over the roof of building#2 and 1 plastic water tank of 2000 liter capacity has been noticed over the roof of building#3 without seismic anchorage. Steel racks without seismic anchorage have been noticed in 1st floor of building#3.
Source of Findings:	Visual Assessment: Visual inspection.
Suggested Plan of Action:	Plastic water tanks, and steel racks shall be adequately anchored to resist earthquake forces.
Suggested Deadline Date:	15 Mar 2018
Standard:	Alliance Standards Part 8 Section 8.18 Seismic Bracing of Key Non-Structural Elements and 2006 BNBC Part 6
