# K-Tex Industrial Co. Ltd

Plot No.76, Road-5, Block-k Rupnagar Industrial Area, Sector-2, Mirpur, Dhaka-1216  
(23°48'42"N, 90°21'27"E)  
7<sup>th</sup> February 2015

# Observations

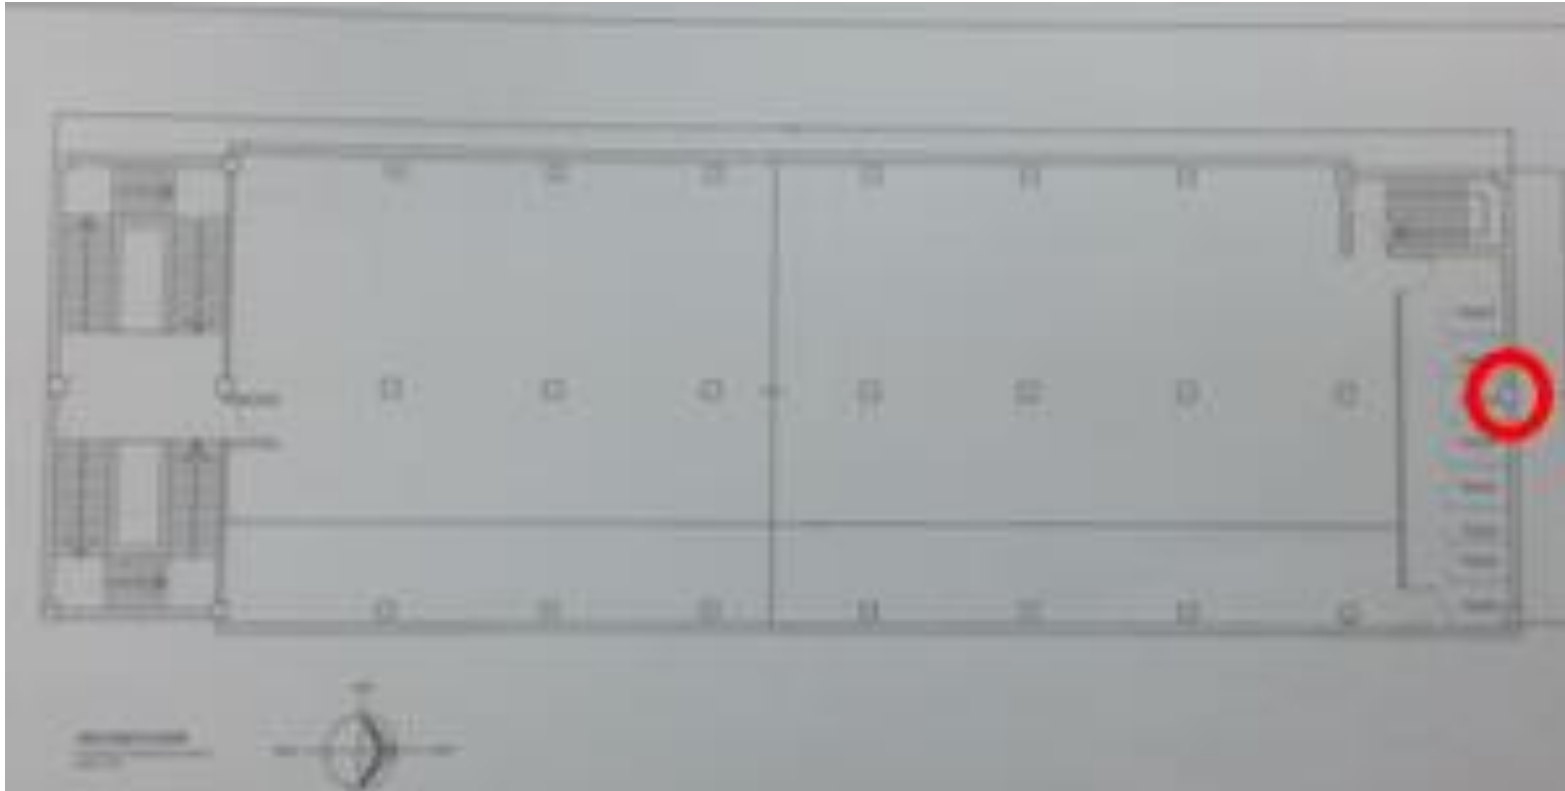
## Heavily-loaded column in toilet area

**Column in toilet area appears to be loaded in excess of normal stress limits**

**ITEM 1:** Columns at ground floor level appear to be stressed in excess of normal design limits

| Item No. | Observation | Recommended Action Plan | Recommended Timeline |
|---|---|---|---|
| 1 | Columns at ground floor level appear to be stressed in excess of normal design limits | Building Engineer to review design, loads and columns stresses in area identified in full report. | 6-weeks |
| 2 | Columns at ground floor level appear to be stressed in excess of normal design limits | Verify insitu concrete strengths (using min. 4 no. 100mm dia. Cores) and existing reinforcement for all columns. | 6-weeks |
| 3 | Columns at ground floor level appear to be stressed in excess of normal design limits | Produce and actively manage a loading plan for all floor plates within the factory giving consideration to floor capacity and column capacity. | 6-weeks |
| 4 | Columns at ground floor level appear to be stressed in excess of normal design limits | Building Engineer to confirm that column strengths and reinforcement surveys show the columns as adequate for loading as shown in loading plans. | 6-months |
| 5 | Columns at ground floor level appear to be stressed in excess of normal design limits | Implement load management plan | 6-months |

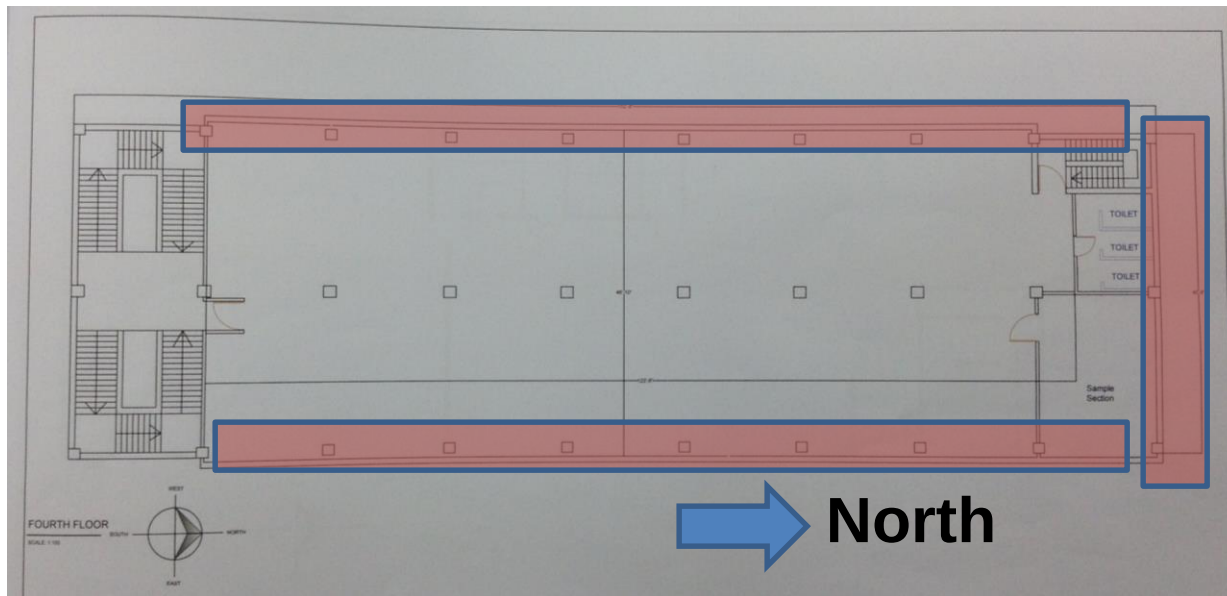
Cantilever not mentioned in the drawing

**ITEM 2:** Differences between drawings and as-built structure

| Item No. | Observation | Recommended Action Plan | Recommended Timeline |
|---|---|---|---|
| 6 | Differences between drawings and as-built structure:<br>* Cantilevered suspended floor on sides and rear<br>* Wall layout on floors<br>* Rooftop water tank locations | Building Engineer to survey as-constructed building | 6-weeks |
| 7 | Differences between drawings and as-built structure:<br>* Cantilevered suspended floor on sides and rear<br>* Wall layout on floors<br>* Rooftop water tank locations | Amend structural drawings to reflect as-constructed floor plates | 6-weeks |
| 8 | Differences between drawings and as-built structure:<br>* Cantilevered suspended floor on sides and rear<br>* Wall layout on floors<br>* Rooftop water tank locations | Update loading plan (ref. Item 1) as required. | 6-months |

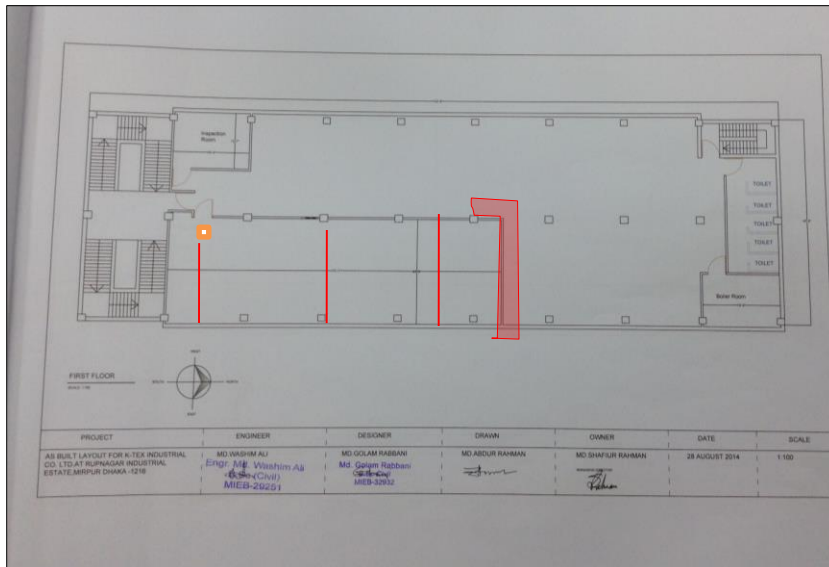
First floor plan

Wall layout missing

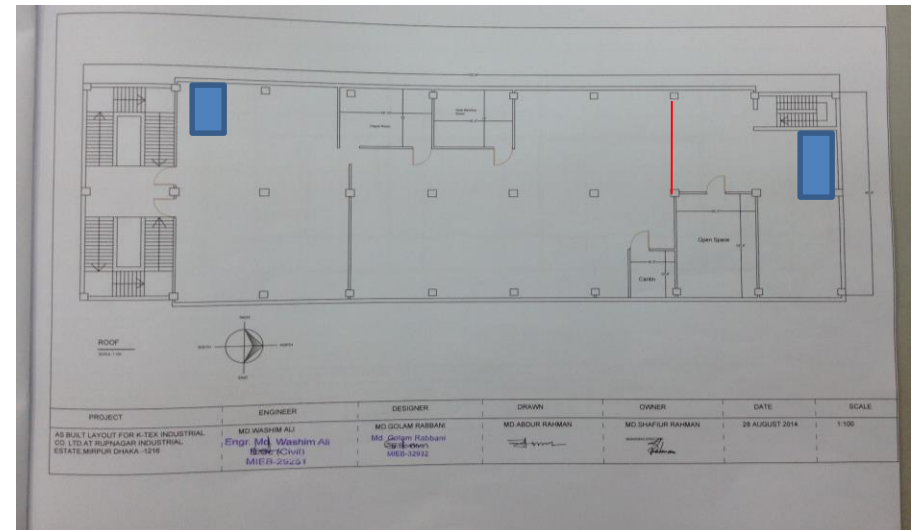
Roof plan

Water tank positions are missing from the drawing

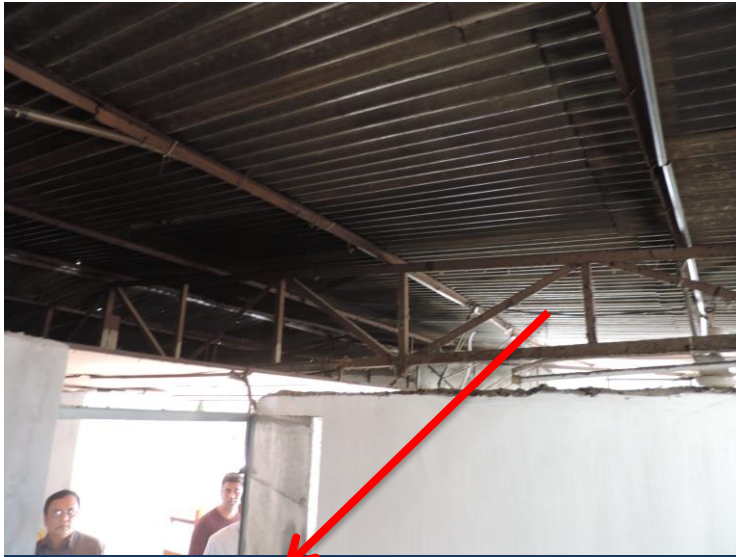
**Non-engineered and poorly-constructed lightweight roofs to dining area and stair cores**

**Poorly-constructed and non-engineered structure at roof top**

**ITEM 3:** Non-engineered and poorly-constructed lightweight roofs to dining area and stair cores

| Item No. | Observation | Recommended Action Plan | Recommended Timeline |
|---|---|---|---|
| 9 | Non-engineered and poorly-constructed lightweight roofs to dining area and stair cores | Building Engineer to review the structure to the dining room and the stair core roofs. | 6-weeks |
| 10 | Non-engineered and poorly-constructed lightweight roofs to dining area and stair cores | Building Engineer to review the structure to the dining room and the stair core roofs. Structure to be replaced or altered on the basis of the engineering review. | 6-months |

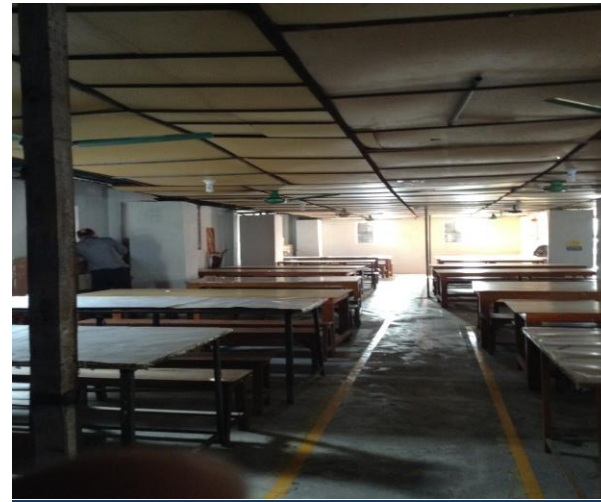
**Non-engineered structure at roof top**

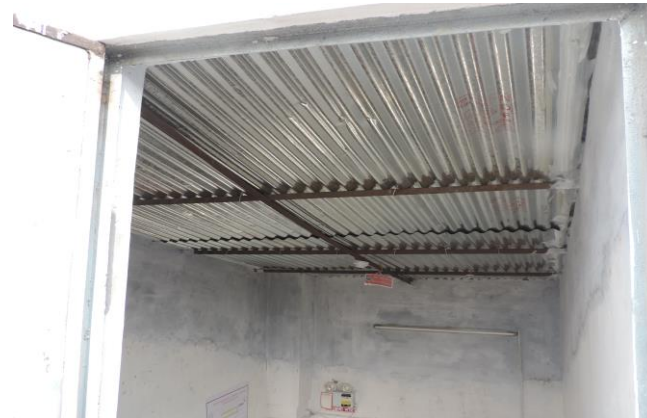
**Non-engineered structure over the stair core**

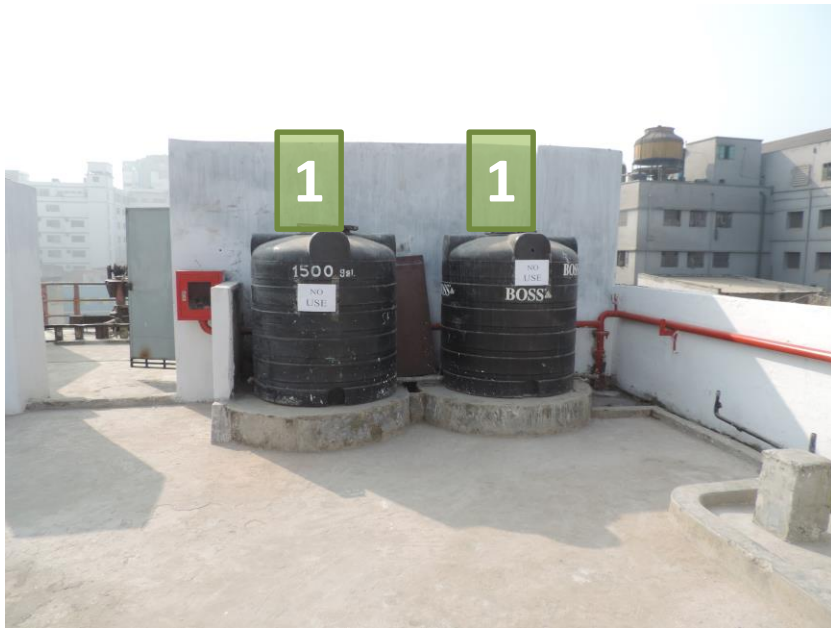
**Water tanks on roof at rear, empty at  
time of inspection**

Water tanks were empty at the time of inspection.

**1** 1500 litres each

**ITEM 4:** Water tanks noted on roof at rear, empty at time of inspection

| Item No. | Observation | Recommended Action Plan | Recommended Timeline |
|---|---|---|---|
| 11 | Water tanks noted on roof at rear, empty at time of inspection | Keep water tanks empty (as on the day of the inspection) | 6-weeks |
| 12 | Water tanks noted on roof at rear, empty at time of inspection | Keep water tanks empty | 6-months |
| 13 | Water tanks noted on roof at rear, empty at time of inspection | Remove tanks | 6-months |

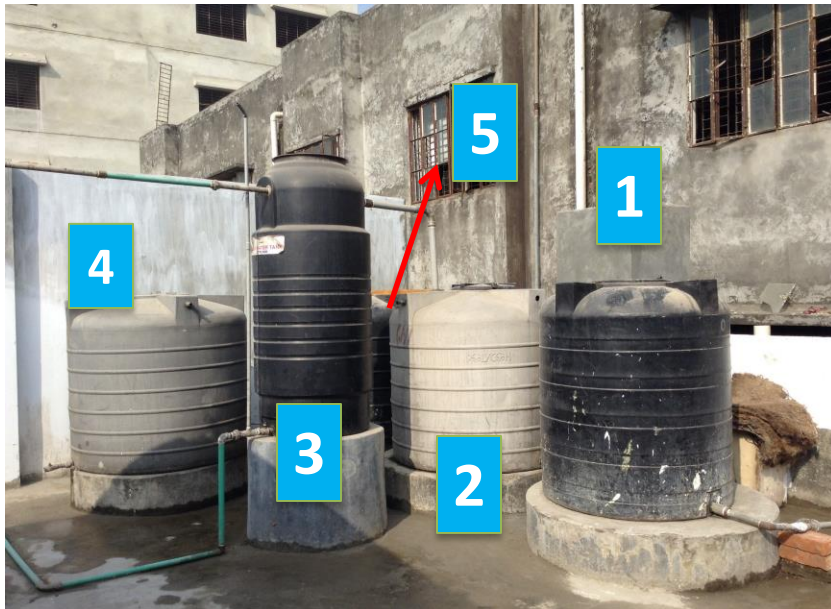
Water tanks on the rear side (Empty)

**1** 1000 litres **4** 1500 litres

**2** 1500 litres **5** 1500 litres

**3** 500 litres

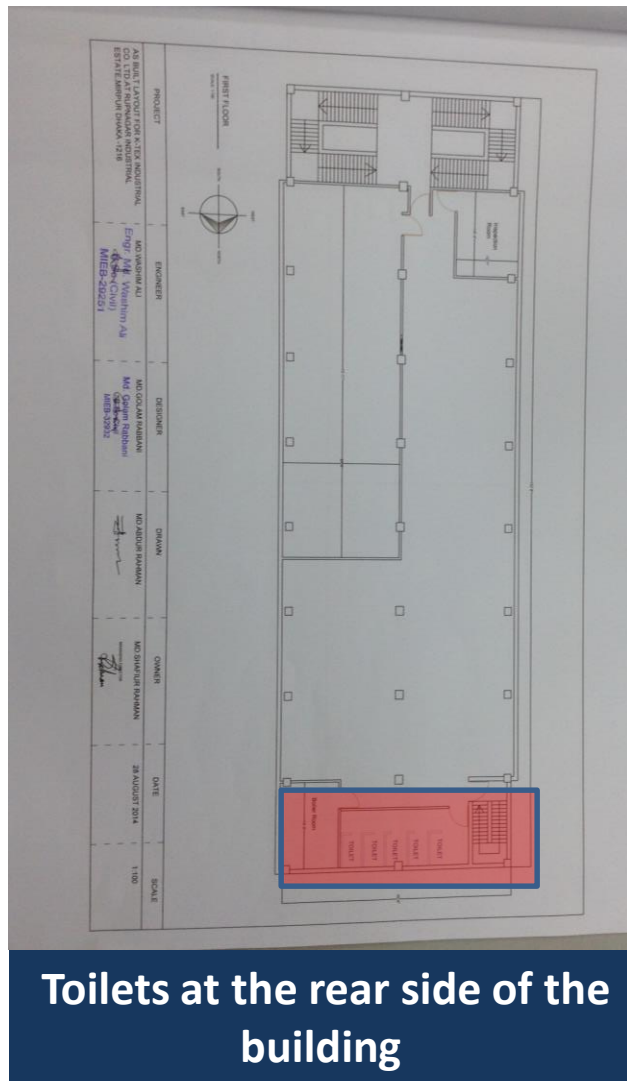
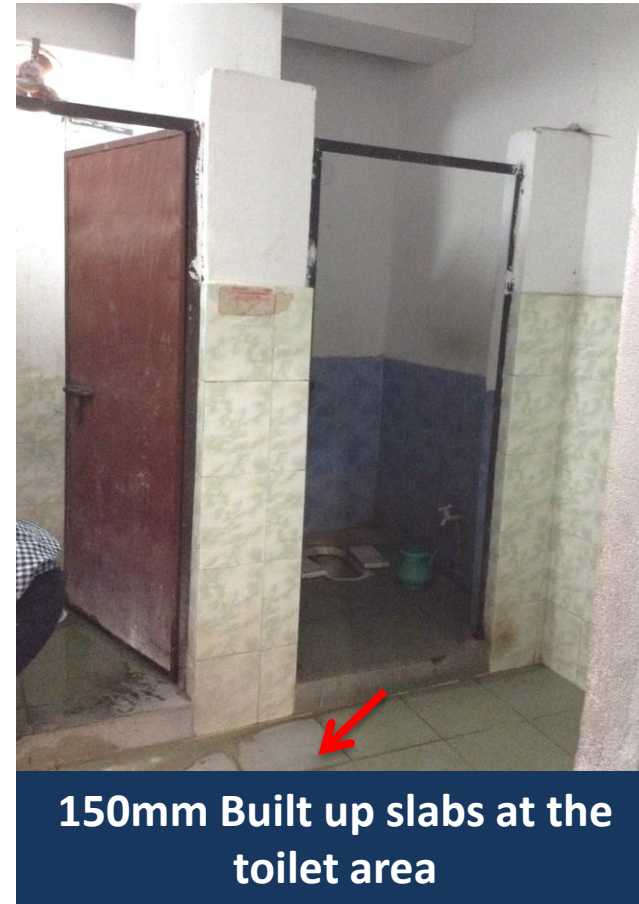
**Heavily-loaded cantilever slab due to  
build-up in toilet area in rear of the  
building**

**ITEM 5:** Heavily-loaded cantilever slab due to build-up in toilet area in rear of the building

| Item No. | Observation | Recommended Action Plan | Recommended Timeline |
|---|---|---|---|
| 14 | Heavily-loaded cantilever slab due to build-up in toilet area in rear of the building | Building Engineer to review the loading on the cantilever slab in the toilet area | 6-weeks |
| 15 | Heavily-loaded cantilever slab due to build-up in toilet area in rear of the building | Carry out any remedial works arising from the engineering review | 6-months |

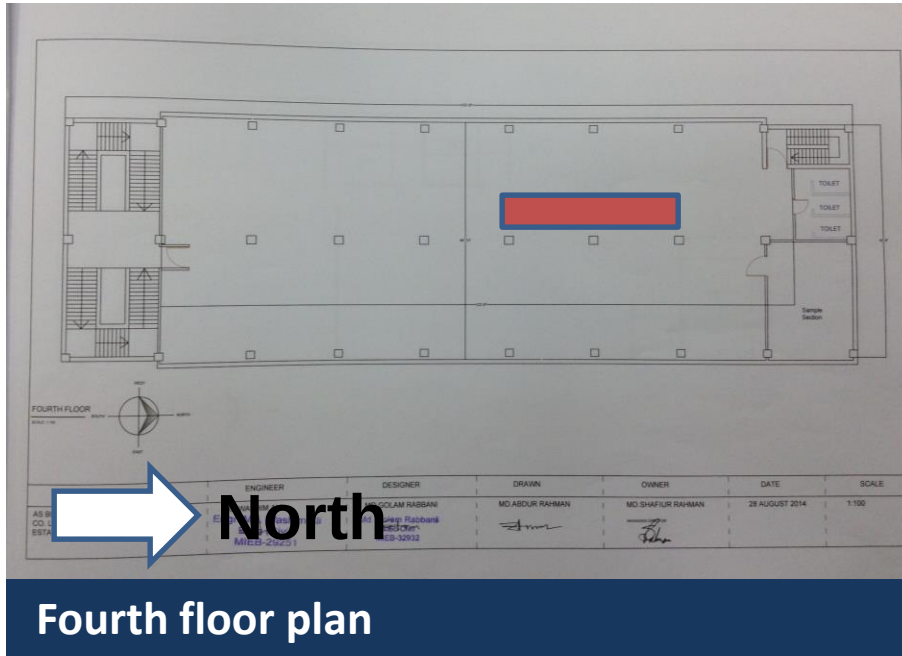
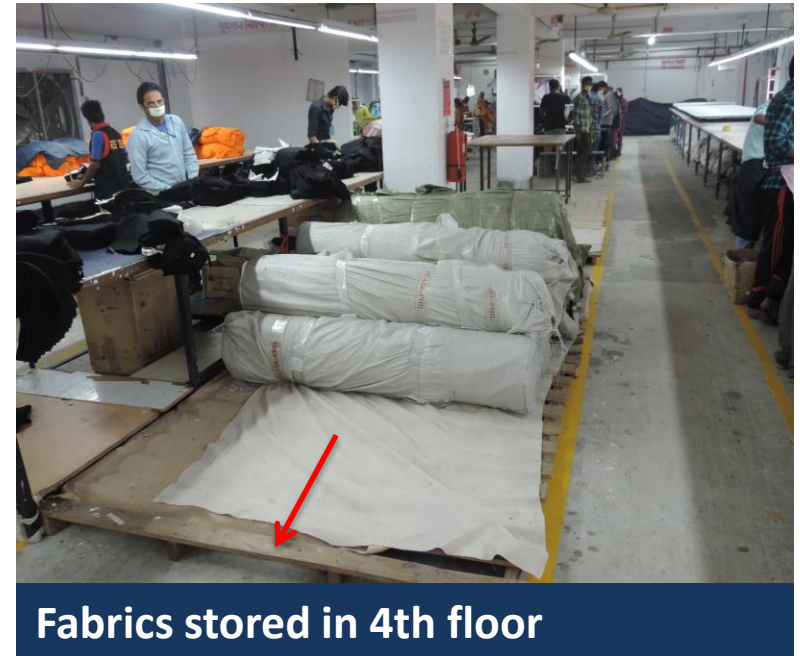
# Storage of fabric on 4<sup>th</sup> floor

**ITEM 6:** Storage of fabric on 4<sup>th</sup> floor

| Item No. | Observation | Recommended Action Plan | Recommended Timeline |
|---|---|---|---|
| 16 | Storage of fabric on 4th floor | Continue to restrict loading on floors to 2kPa. | 6-months |

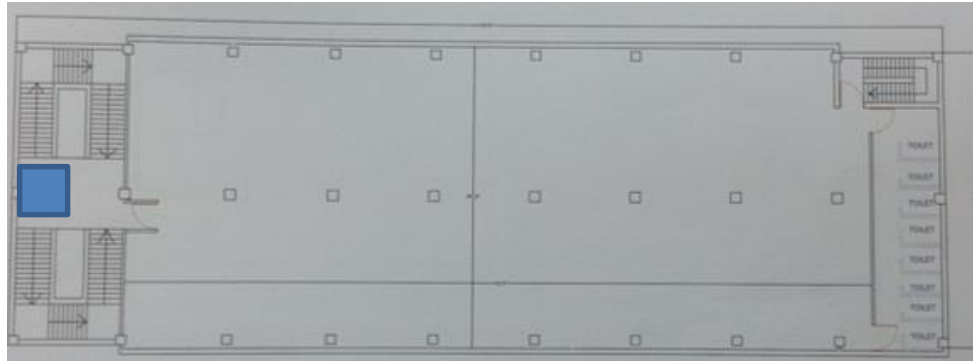
**Hoist position on the roof**

**ITEM 7:** Poorly-fixed hoist on the roof

| Item No. | Observation | Recommended Action Plan | Recommended Timeline |
|---|---|---|---|
| 17 | Poorly-fixed hoist on the roof | Hoist to be removed from the roof | 6-months |

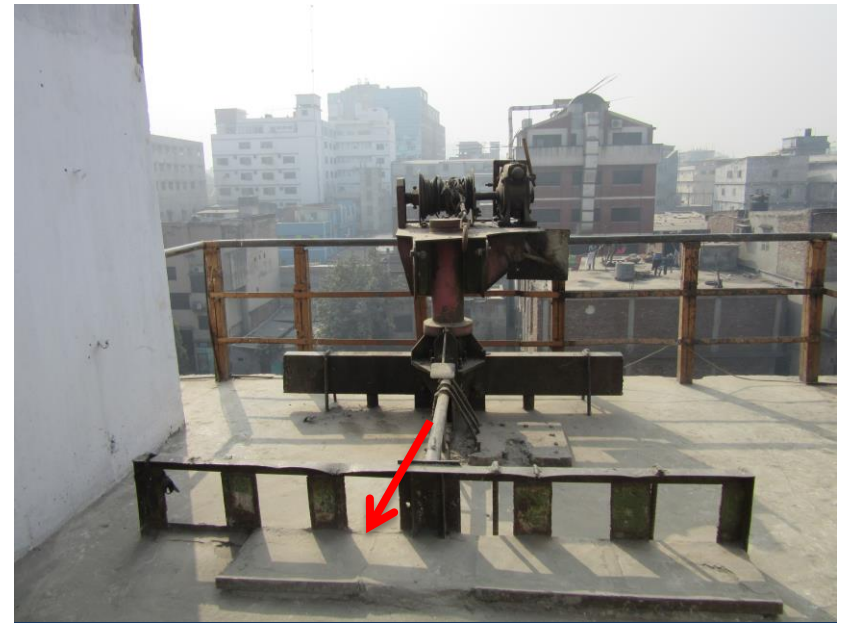
**Hoist on the front side of the roof**
