Mahadi Fashion pvt Ltd.

Bashugaon, Pubail, Gazipur Sadar, Gazipur -1721.

8th February 2015

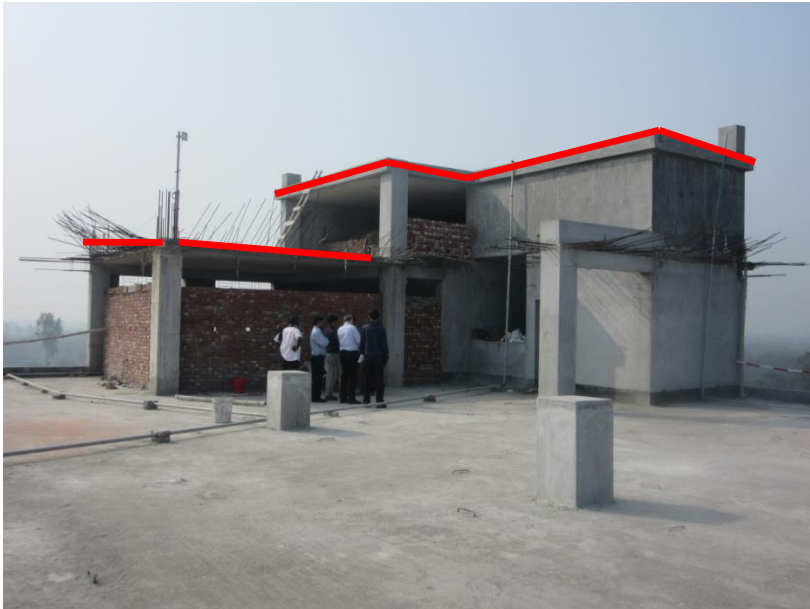
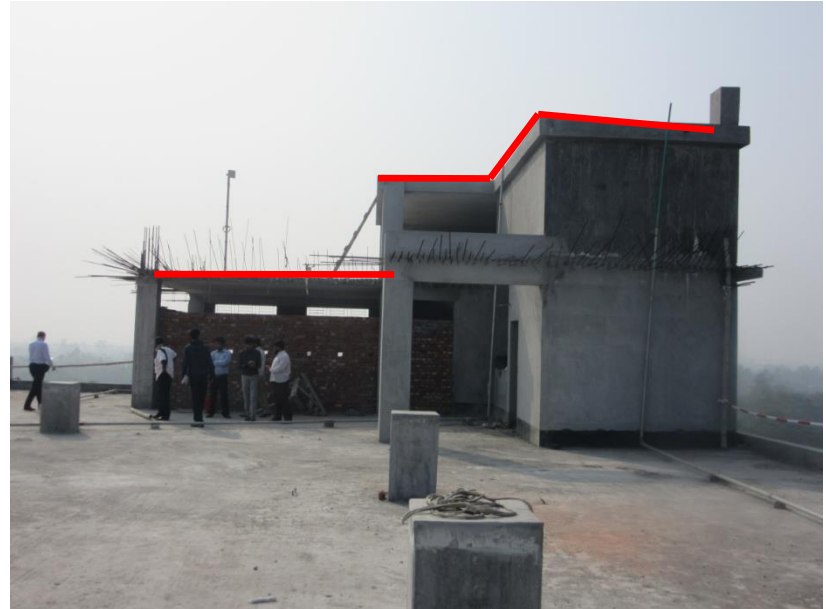
Lack of edge protection on the roof

No edge protection was provided on the roof (marked with red line)

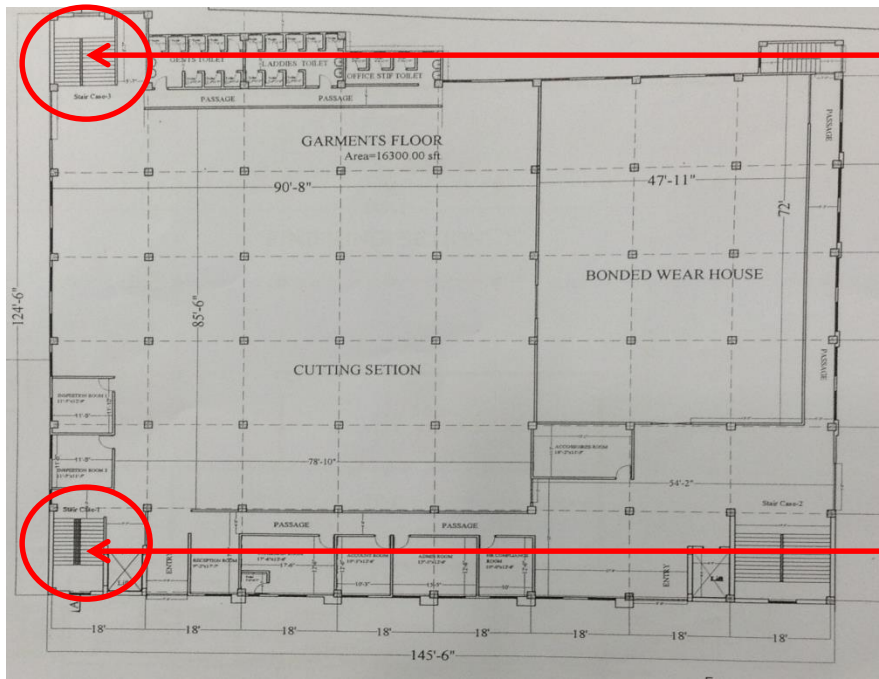
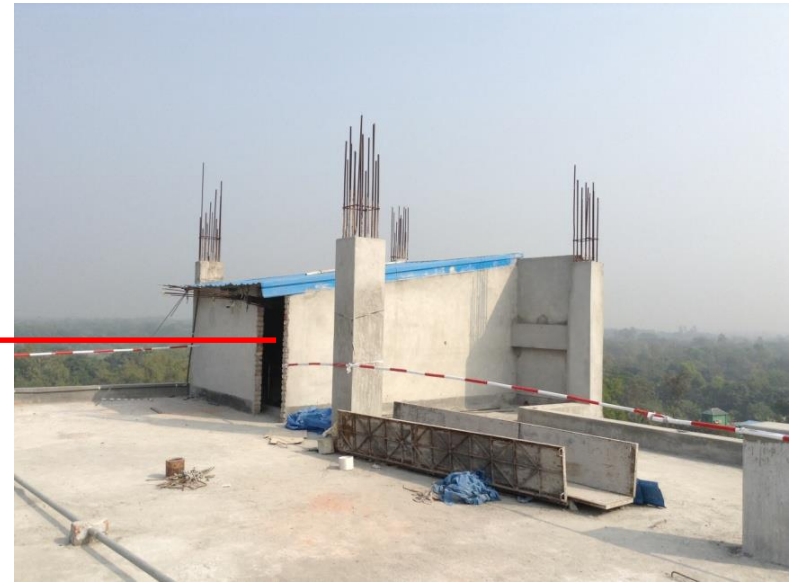
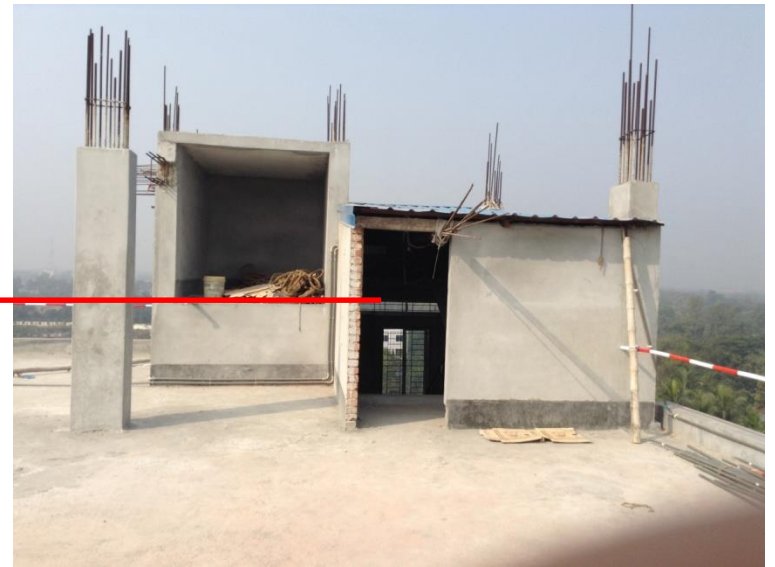
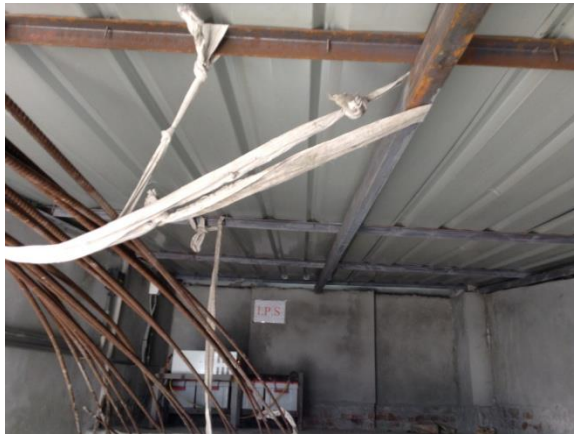
Apparently non engineered roof structures in main building

Roof over stairways appear non engineered.

ITEM 2: Apparently Non engineered Roof structures.

Item No.	Observation	Recommended Action Plan	Recommended Timeline
1	Discrepancy between site observation and information on drawing	Factory Engineer to prepare a set of “as-constructed” drawings to reflect the actual column dimensions and water tank location.	6-months
2	Apparently Non engineered Roof structures.	Building engineer to check the capacity of the lightweight roof structures and make any necessary alterations.	6-months

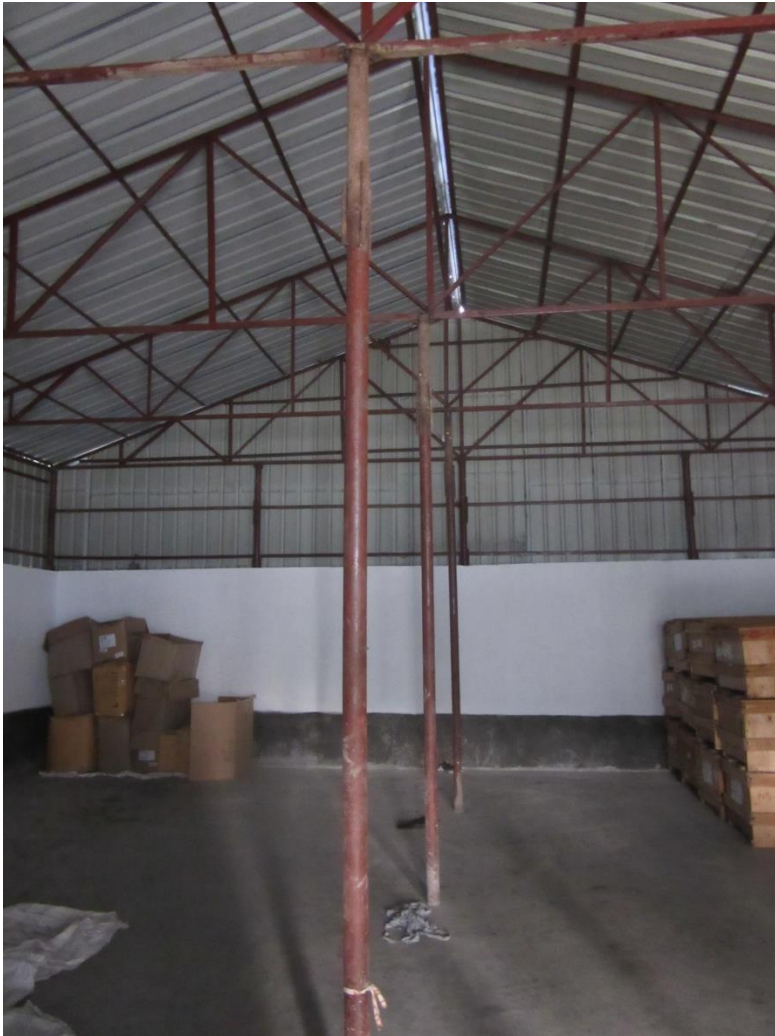
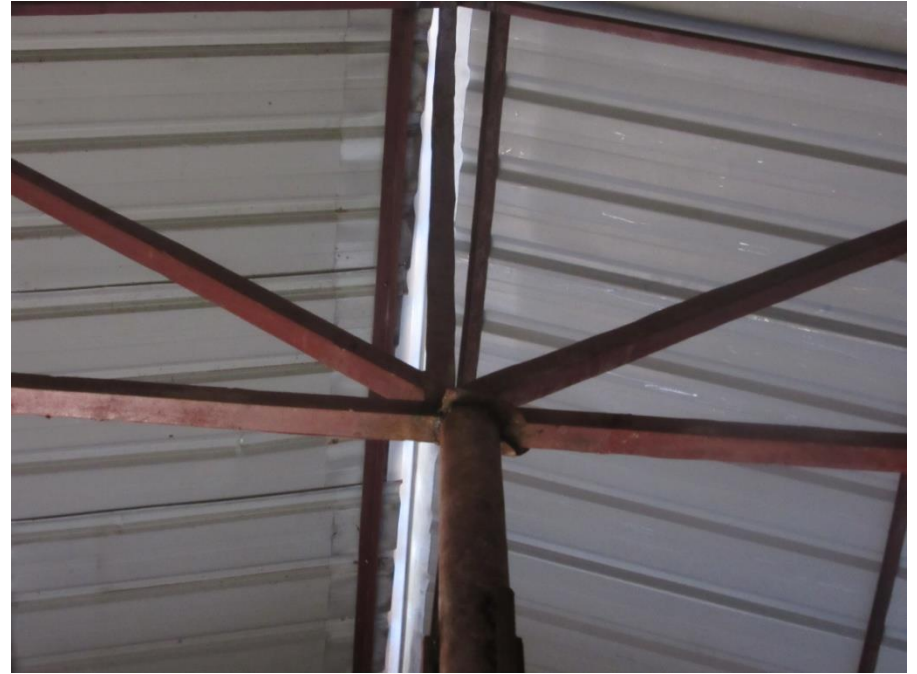
Apparently non engineered structure in Accessories Store Building

Apparent lack of bracing in walls and roof.

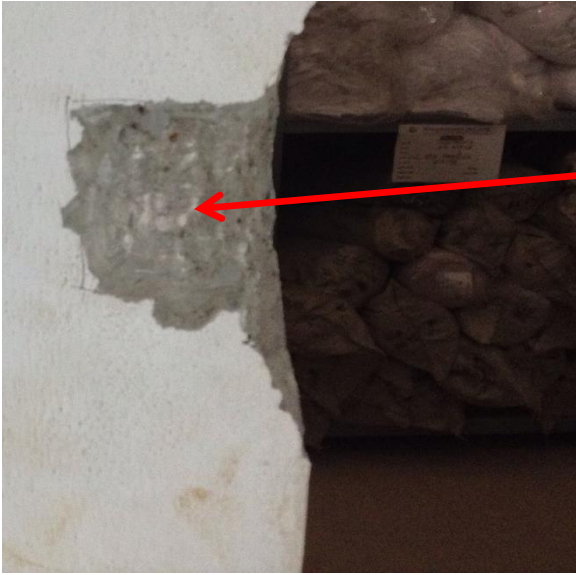
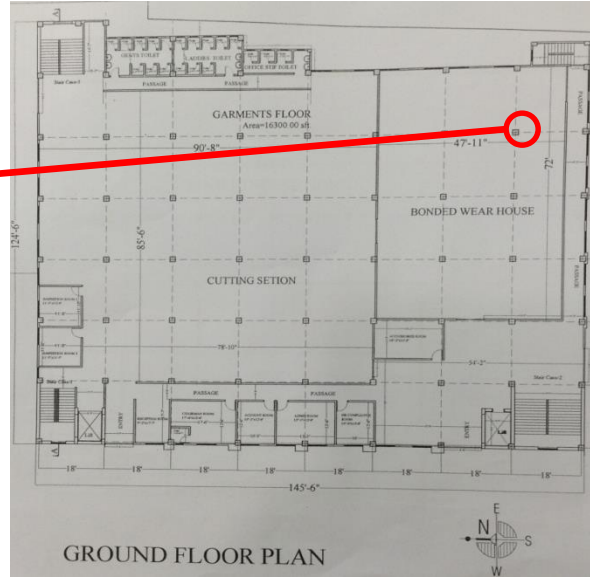
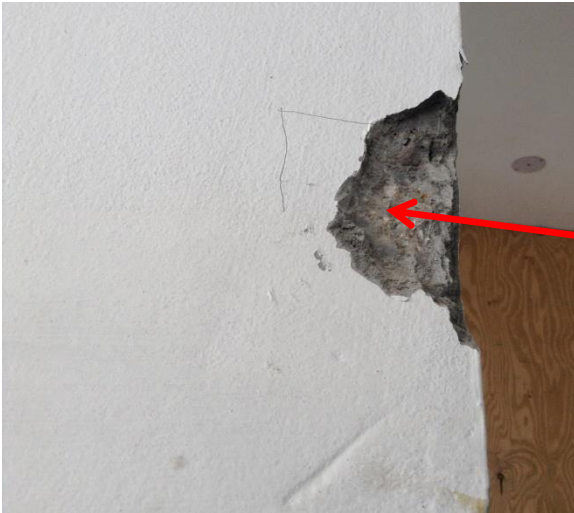
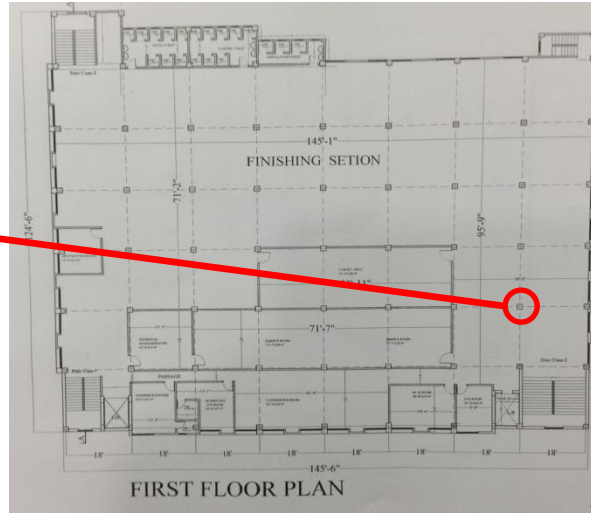
Column testing

Stone chips were observed in the two columns tested at Ground Floor and 1st floor.

Reinforcing bars were scanned at a number of column locations and found to agree with the column schedule in the drawings.
