# Crystal Martin Apparel Bangladesh Ltd.

203 Habirbari, Seedstore, Valuka, Mymensingh  
(24.340163 N, 90.376863 E)

10<sup>th</sup> February 2015

# Observations

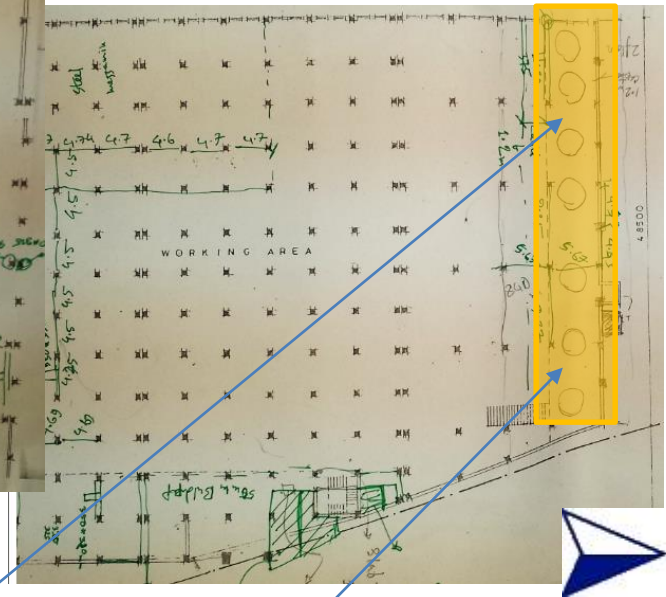
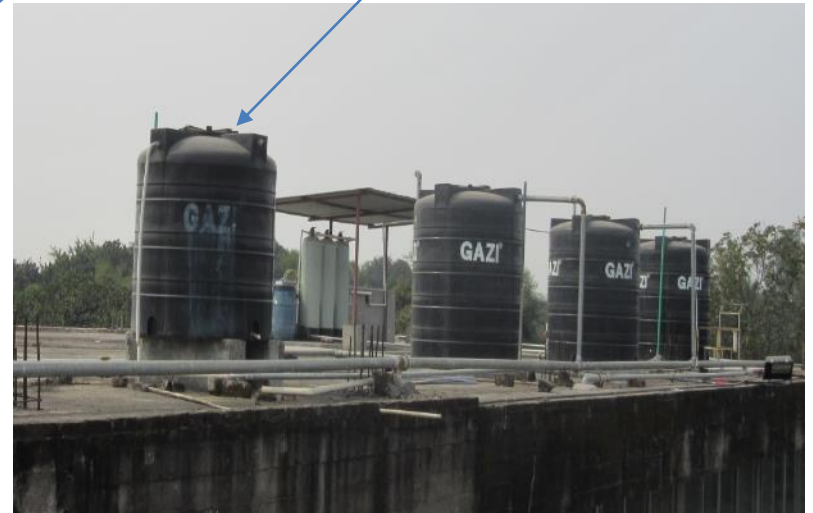
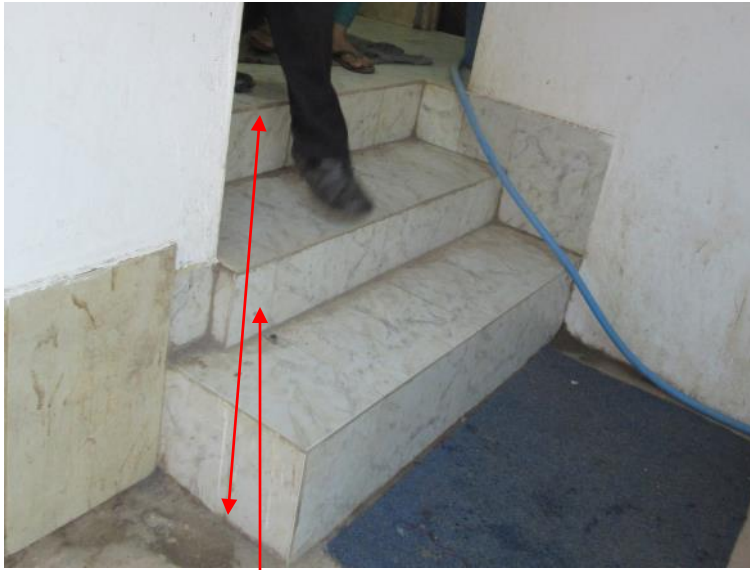
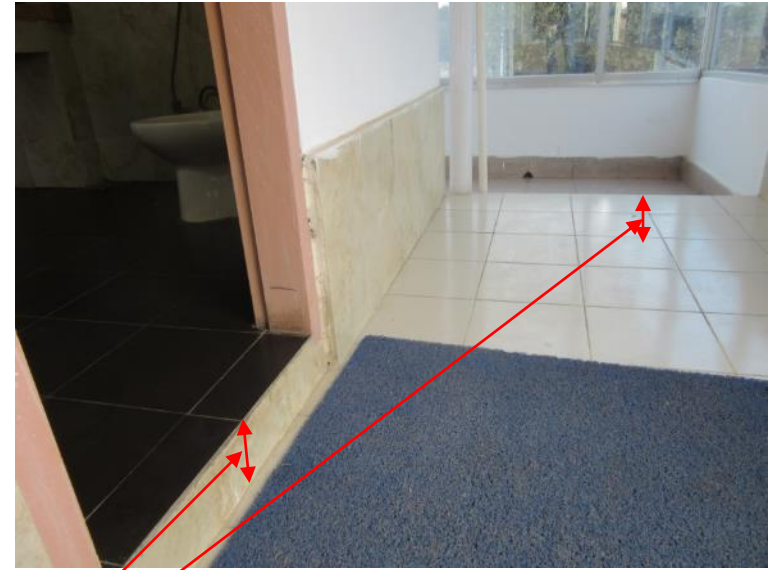
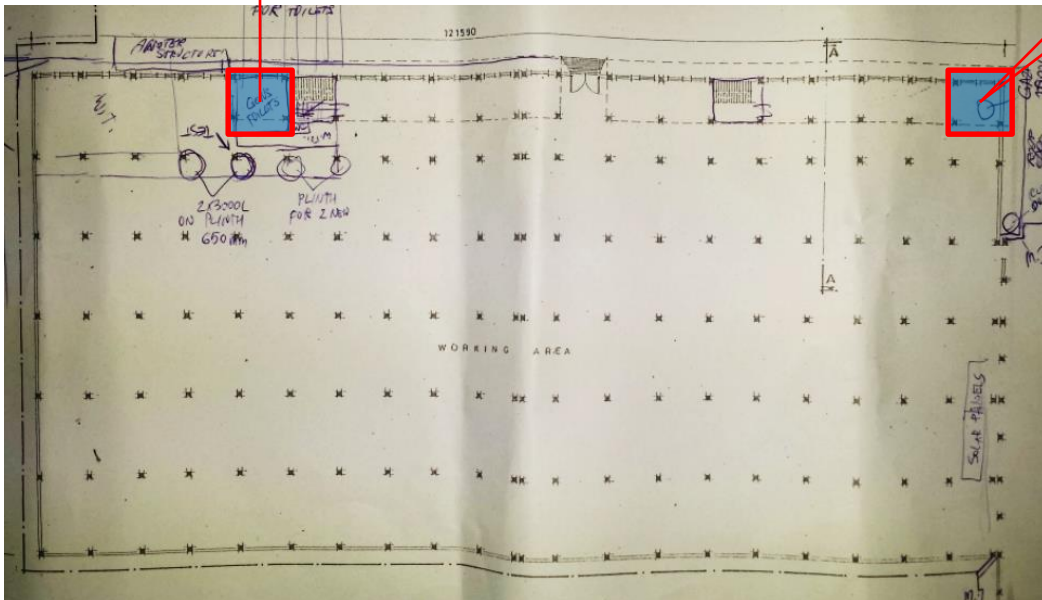
# Heavy loads on the roof in Building 1

| Item No. | Observation | Recommended Action Plan | Recommended Timeline |
|---|---|---|---|
| 1 | Heavy loads on the roof in Building 1 | Building Engineer to review roof slab design in relation to GAZI tanks' arrangement. | 6-months |

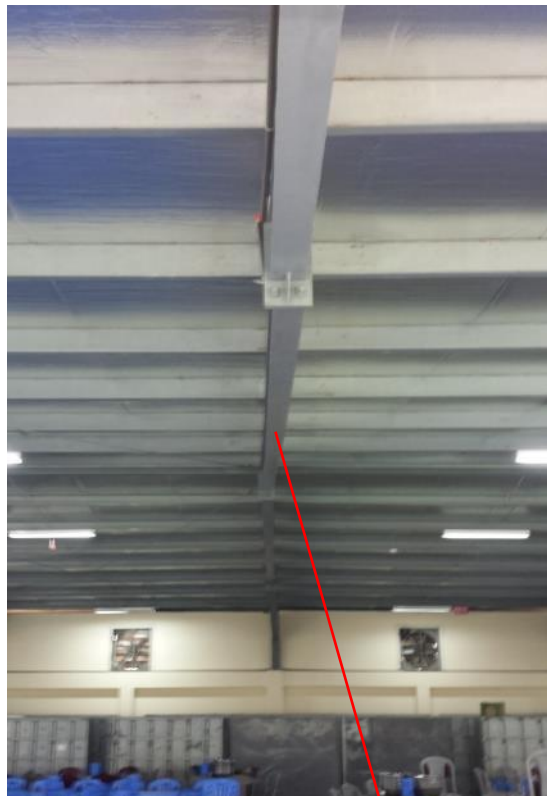
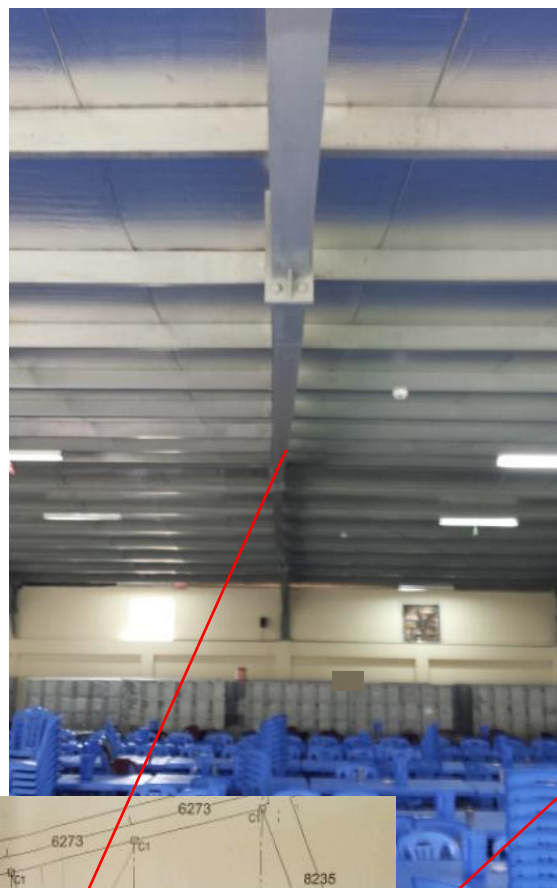
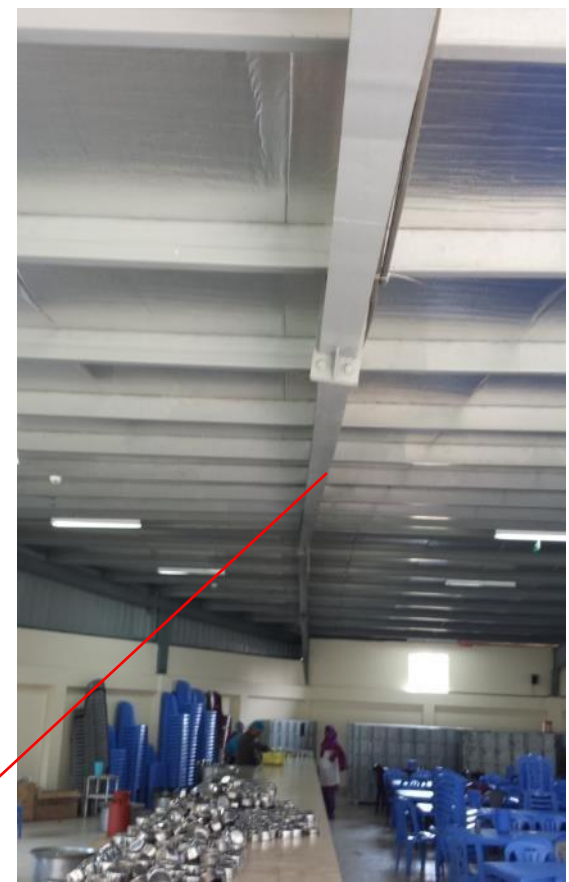
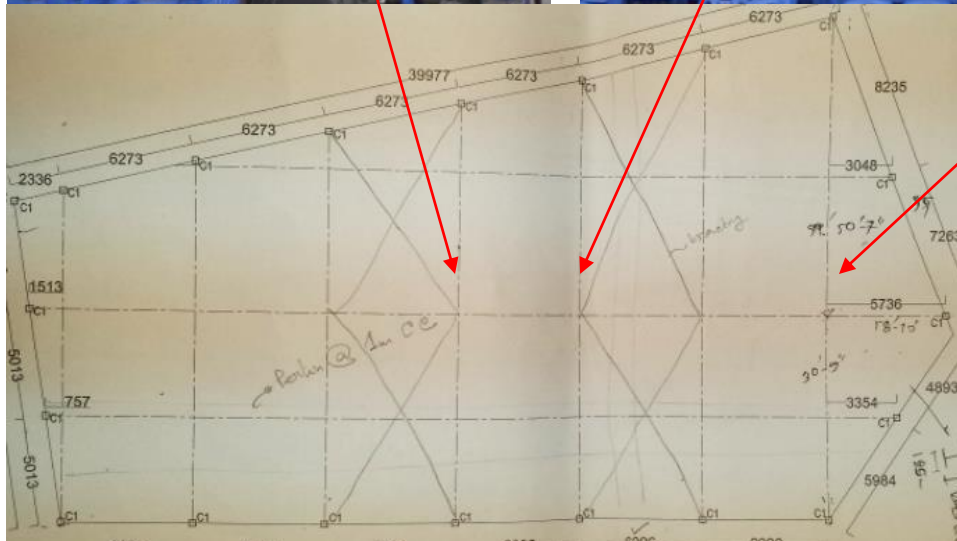
# Issues with the steel roof members in Building 2

**Twisting of the roof beams  
observed in Building 2**

| Item No. | Observation | Recommended Action Plan | Recommended Timeline |
|---|---|---|---|
| 2 | Issues with the steel roof members in Building 2 | Building Engineer to review roof design in reference to observed deformation of the roof beams, holes in web and poor connection details | 6-months |

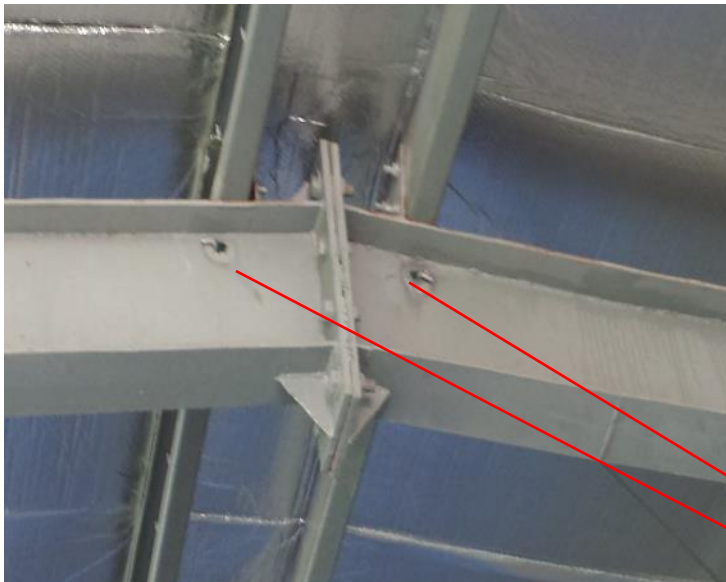
Holes observed in the web of the roof beams

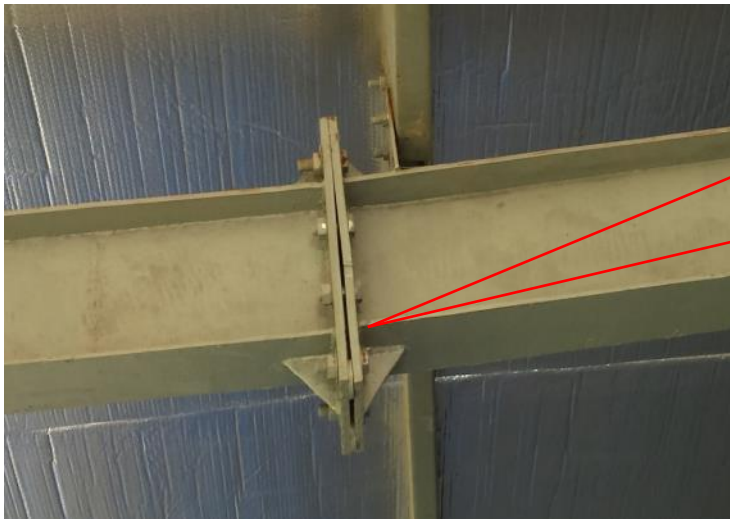
Non-engineered joint construction

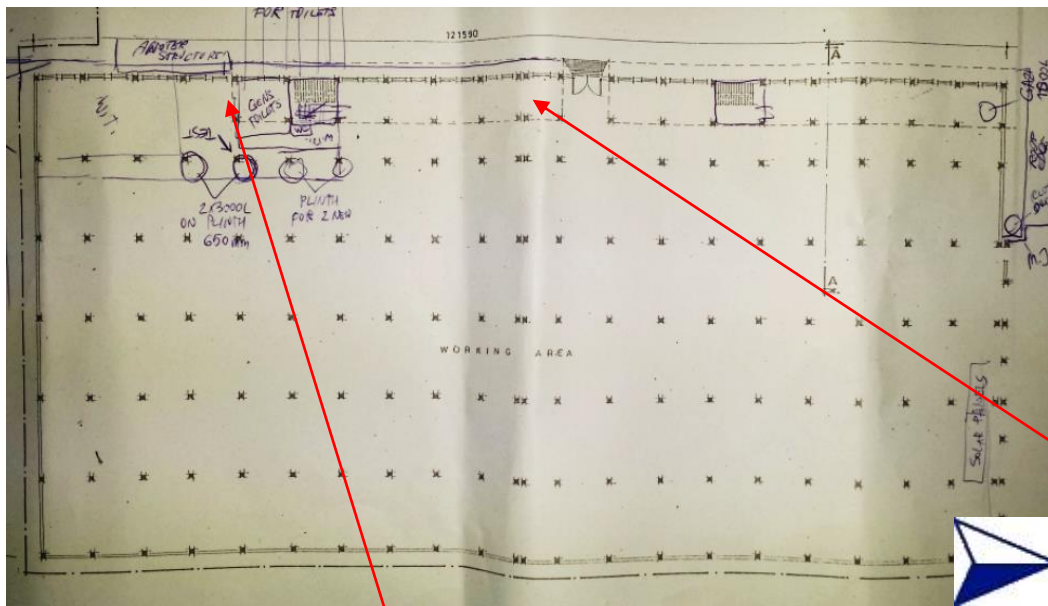
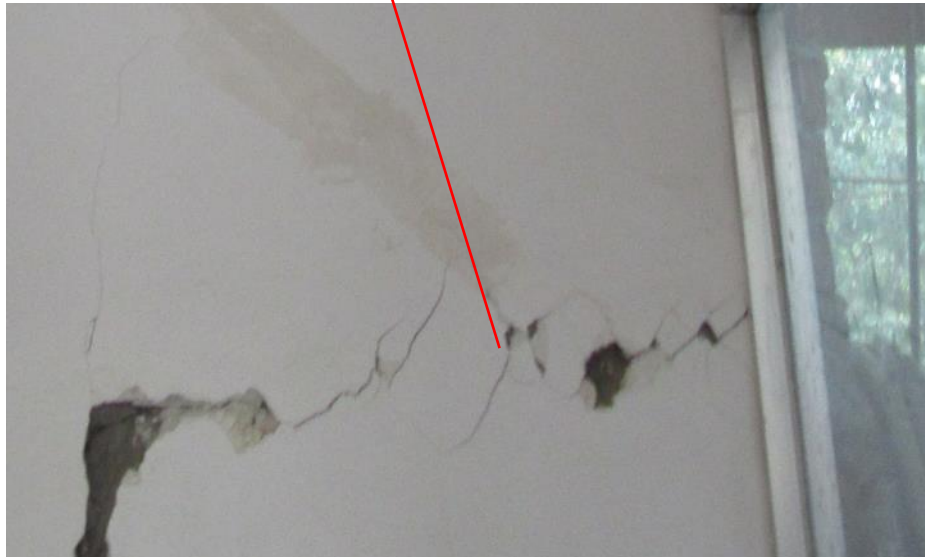
**Damages observed in wall, probably caused by construction works in the neighbouring building**

| Item No. | Observation | Recommended Action Plan | Recommended Timeline |
|---|---|---|---|
| 3 | Wall damage, and gaps in Movement Joints | Building Engineer to assess detailing of movement joints and cause of wall damage. | 6-months |
| 4 | Wall damage, and gaps in Movement Joints | Carry out any remedial works arising from assessment. | 6-months |

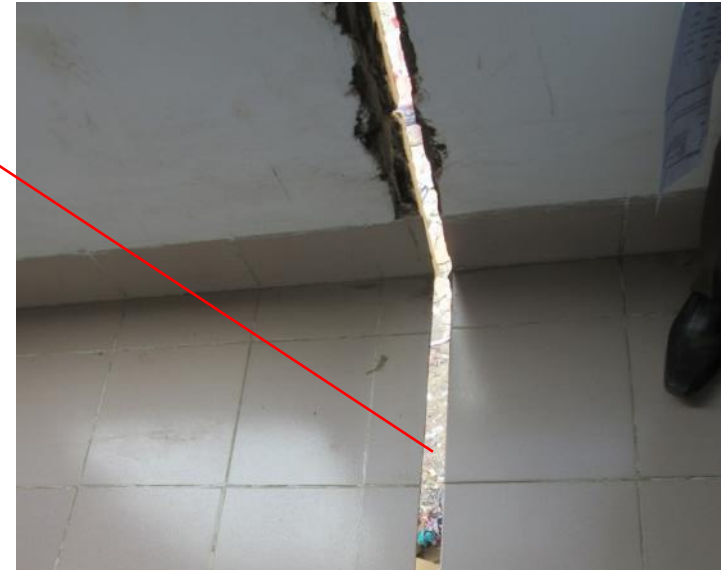
**Building Movement Joint gap, not properly maintained**

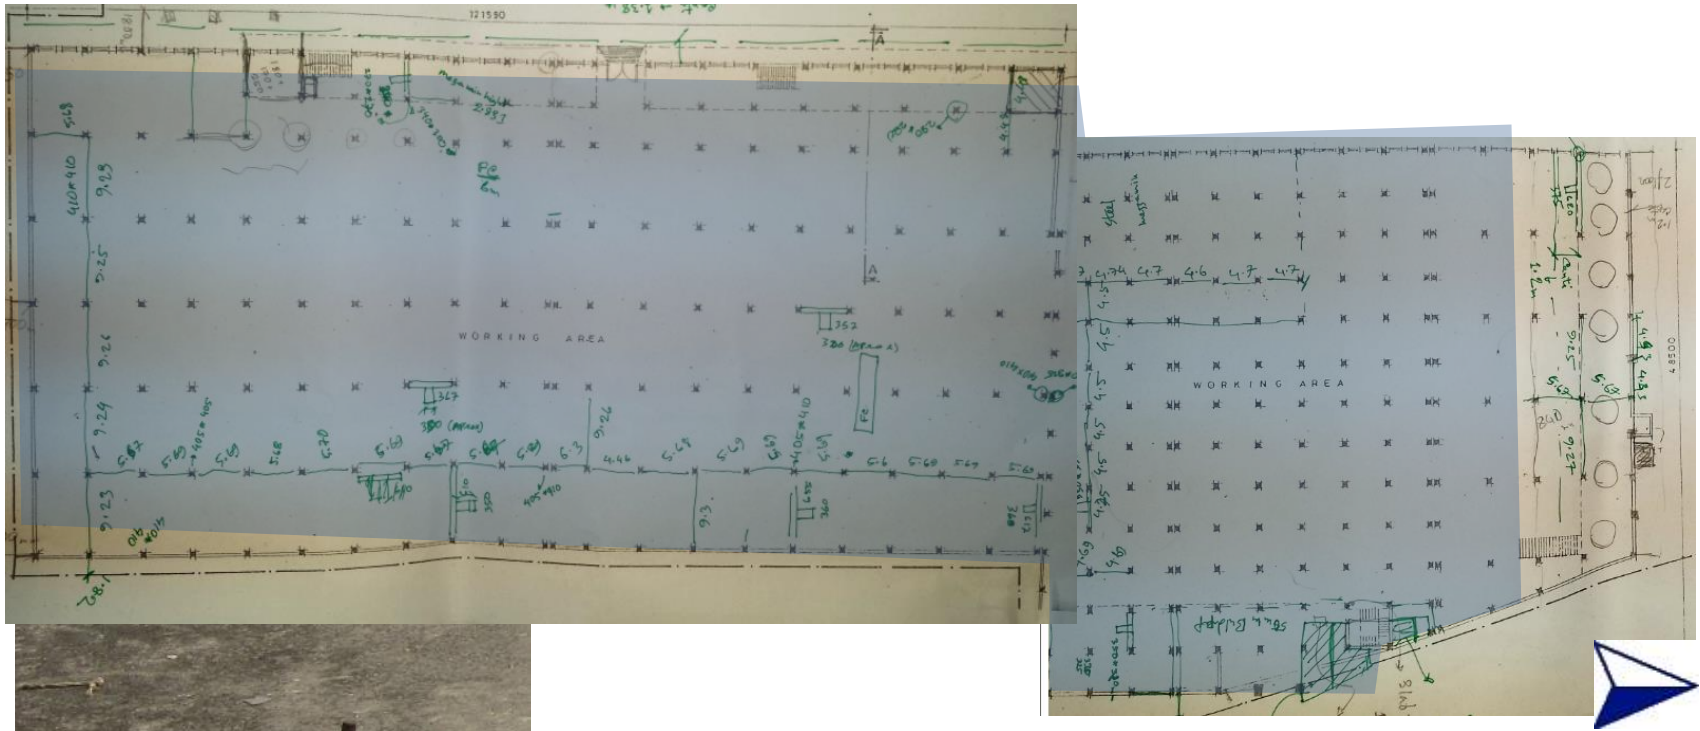
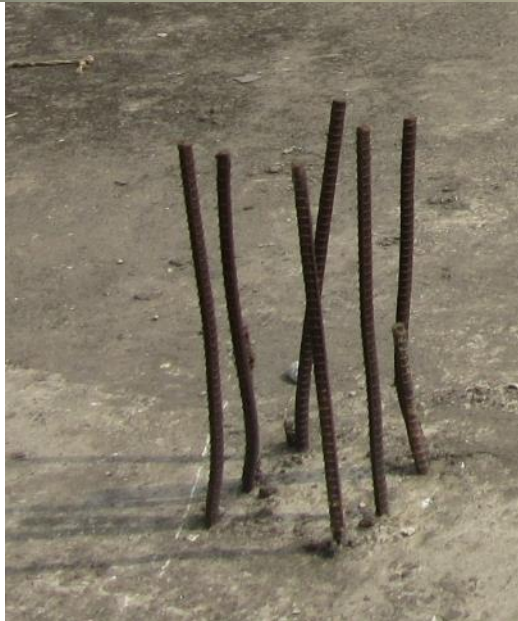
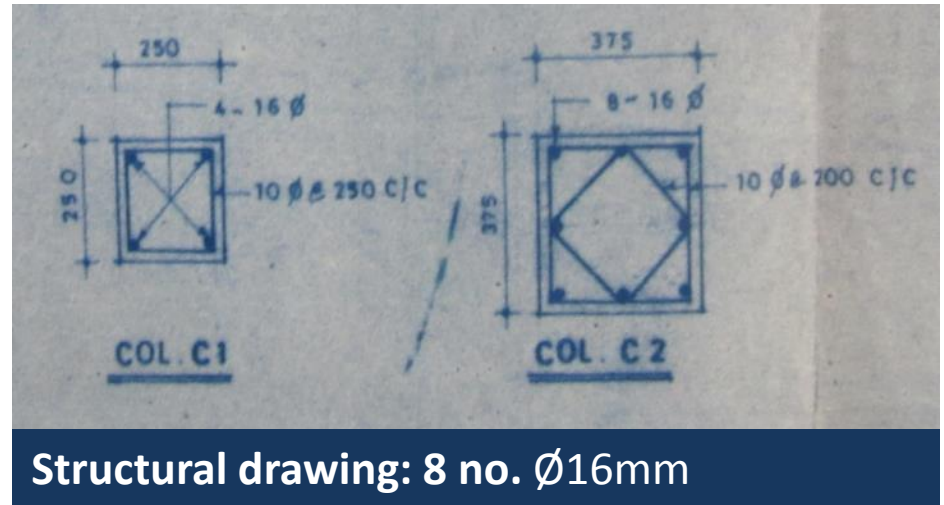
# **Discrepancies between “as-built” drawings and on-site observations**

Structural drawing: 8 no.  $\varnothing 16\text{mm}$

Rebar found on site 6 no.  $\varnothing 16\text{mm}$

| Item No. | Observation | Recommended Action Plan | Recommended Timeline |
|---|---|---|---|
| 5 | Discrepancies between "as-built" drawings and on-site observations | Building Engineer to provide accurate as-built documentation based on the actual buildings. | 6-months |
