FIRE SAFETY INSPECTION REPORT

**AJAX SWEATER LTD.
ZIRABO BAZAR, ASHULIA, EPZ ROAD, SAVAR,
DHAKA**

ACCORD
on Fire and Building Safety in Bangladesh

May 6, 2014

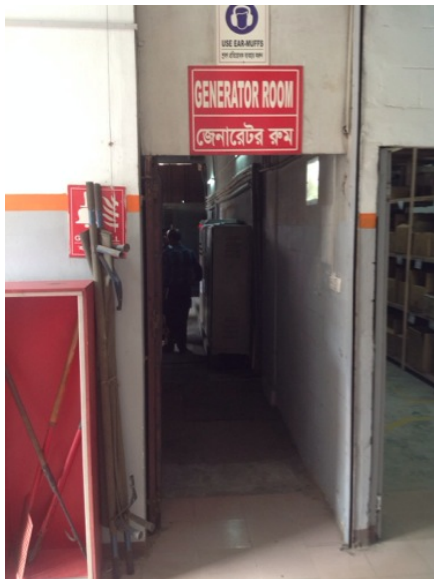
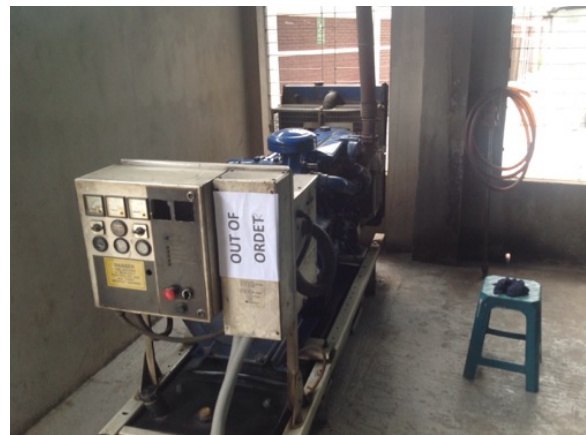
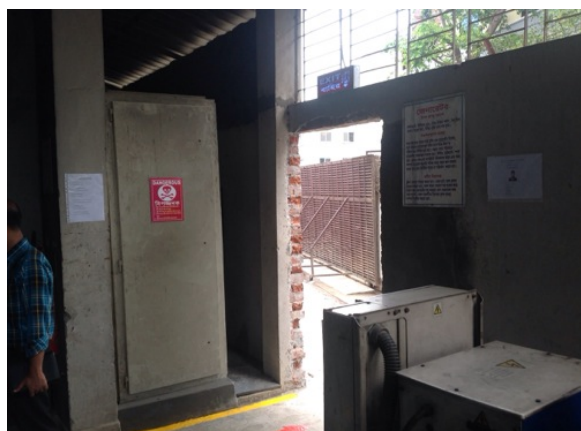
No.	Category	Finding	Recommendation	Remediation Timeframe
F-1	Fire Rated Construction	The transformer, generator, and substation room is not separated by fire-rated construction, it has openings and no door by the generator. It is located on the ground floor in the east exit discharge.	Separate the boiler room by a minimum 2-hr fire-rated construction. Seal and/or protected all openings to maintain the required fire separations.	Within 3 months

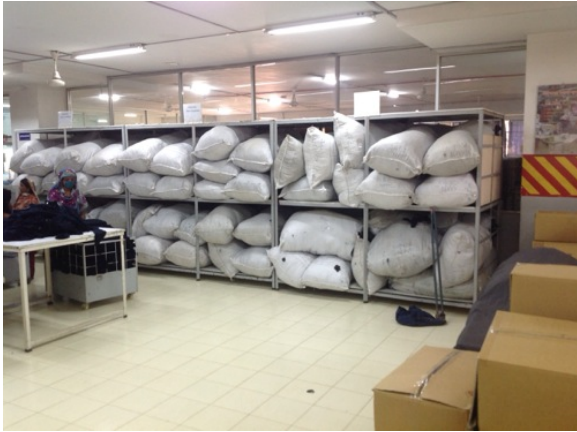
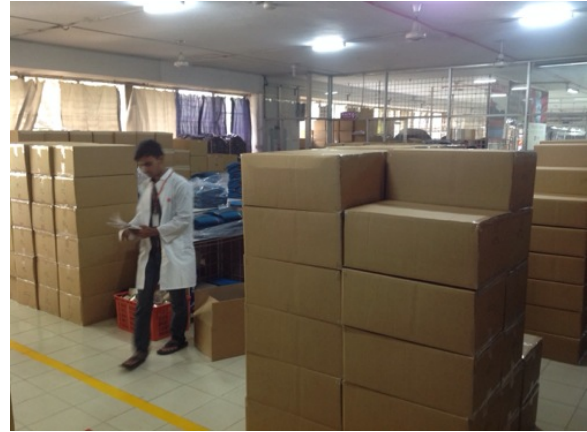
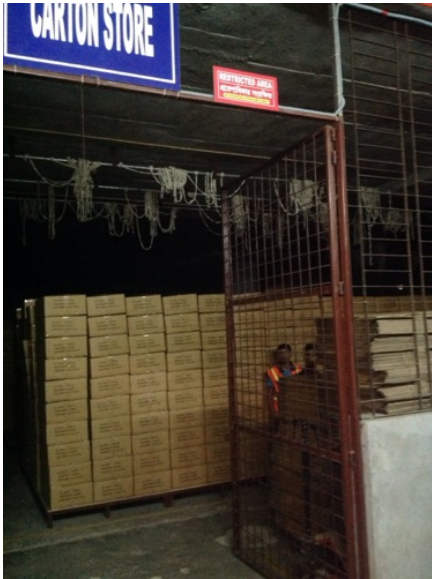
F-2	Fire Rated Construction	Areas used for storage are not separated by fire-rated construction. This applies to the dedicated storage on the ground and first floors southeast side of the first floor where open storage is on the factory floor.	Provide dedicated storage rooms separated by minimum 1-hr fire-rated construction on the ground floor. on the first floor where separate storage rooms may not be feasible, provide defined storage areas and limit the storage arrangement as follows: Maximum height of 2.4m and maximum area of 23m ² . If sprinkler protected: maximum height of 3.66m and maximum area of 93m ²	Within 3 months
-----	-------------------------	---	---	-----------------

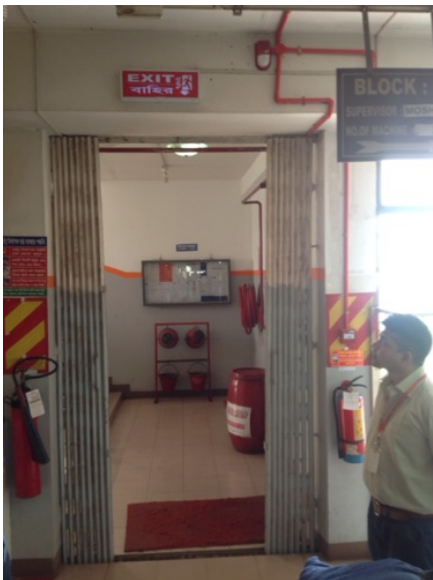
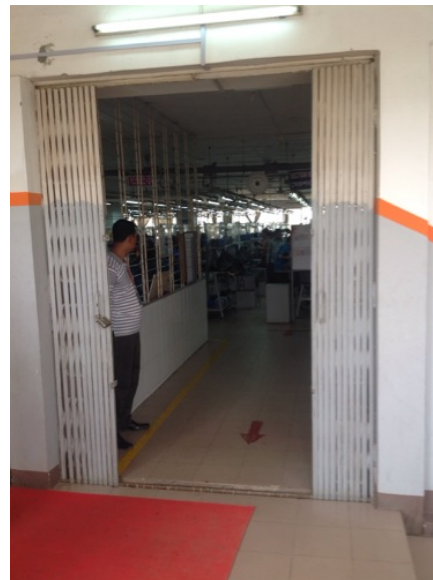
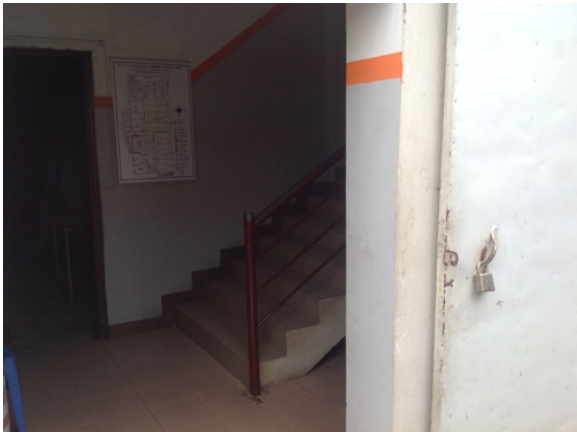
F-3	Fire Rated Construction	The exit stairs are not separated from work areas, other spaces on each floor by fire-rated construction.	Provide minimum 1.5-hr fire rated doors and seal all unprotected openings to separate the exit stairs from work areas and other building spaces on all floor levels. Ensure that the fire doors are self-closing and positive latching and that they are provided with fire exit (panic) hardware where serving production floors.	Within 3 months
			If fire doors are required to be held open for functional reasons, provide automatic-closing devices tied to the fire alarm system.

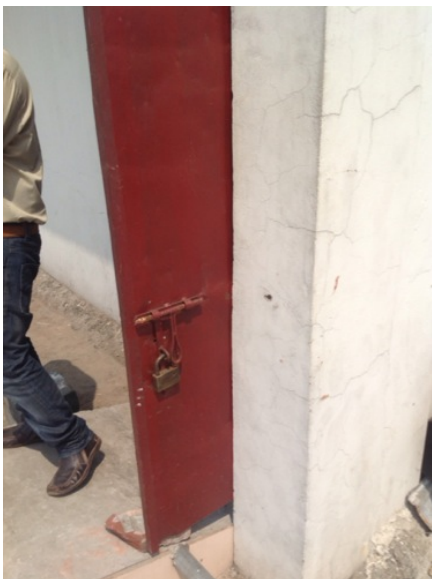
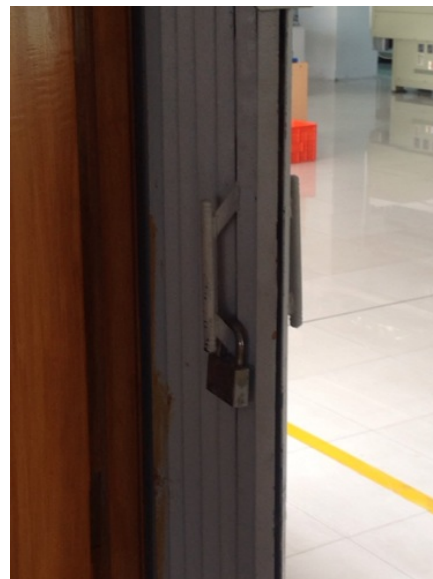
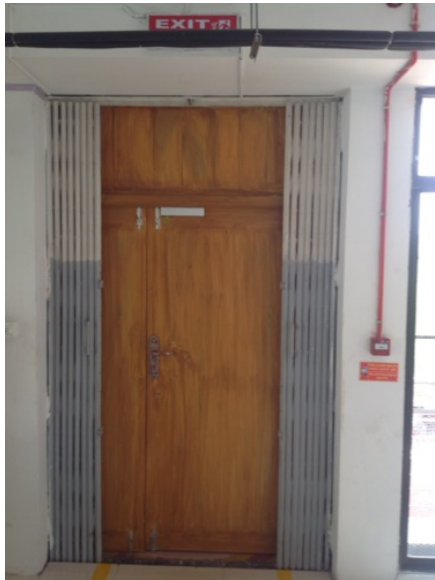
F-4 Egress

Egress doors / gates with locking features are provided at building exits, exit stairs, along egress routes, exit discharge.

These locking features can be found on all exits, on all floors throughout the factory.

Remove locking features from all egress doors / gates.

If locks are required for security reasons, utilize special door locking features complying with NFPA 101.

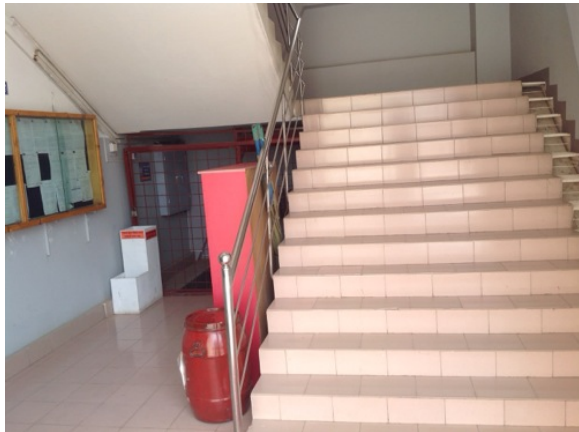
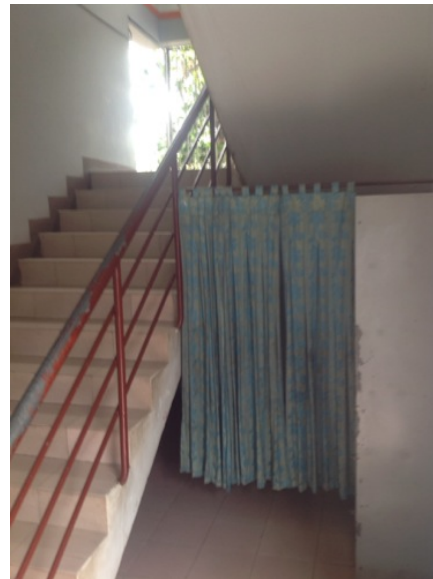
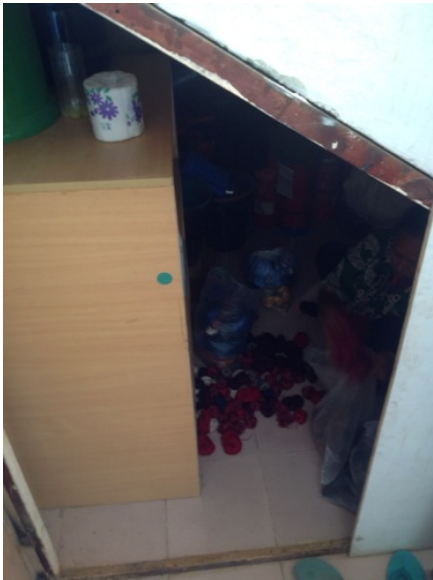
F-5 Egress

Storage was located in the exit stair on the ground floor exit discharge on the northwest, southwest, east exits.

Remove all storage from exit stairs and egress paths.

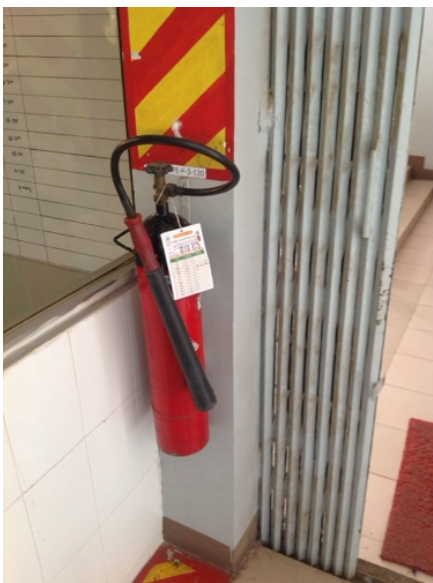
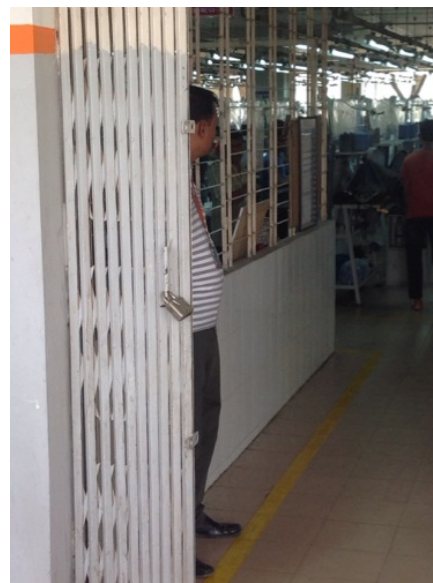
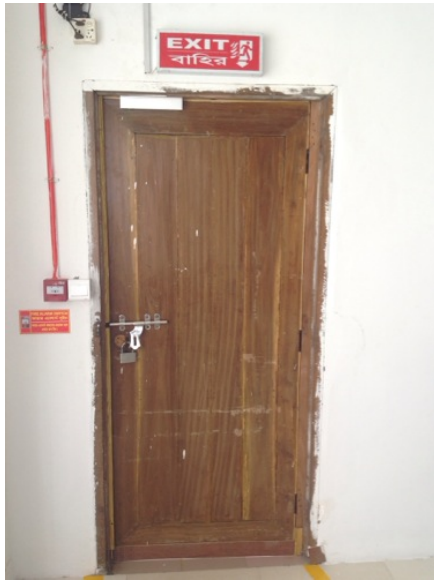
F-6	Egress	Egress doors / gates with locking features are provided at building exits, exit stairs, along egress routes, exit discharge throughout the facility.	Remove locking features from all egress doors / gates. If locks are required for security reasons, utilize special door locking features complying with NFPA 101.	Immediate
-----	--------	--	--	-----------

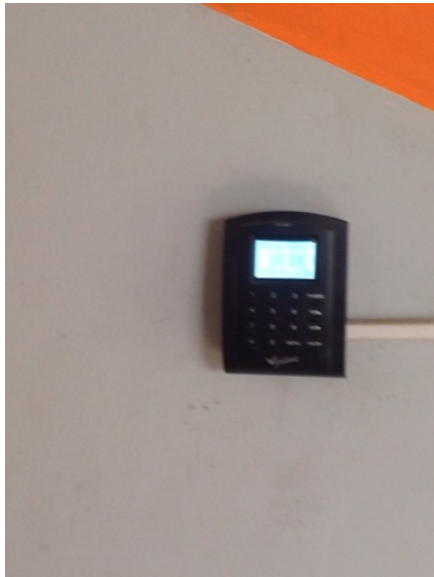
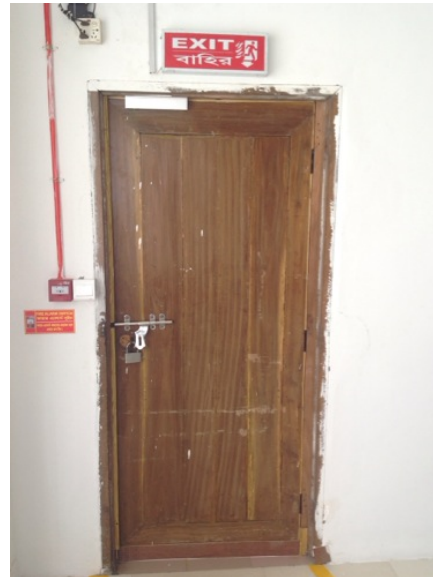
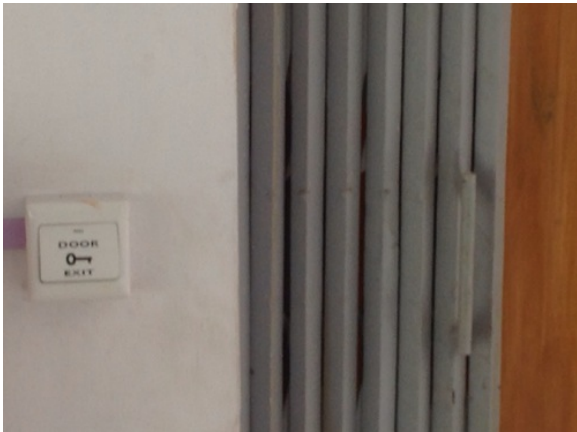
F-7	Egress	The east exit (exit #2) requires a key or pass code to open,	Remove locking device.	Immediate
-----	--------	--	------------------------	-----------

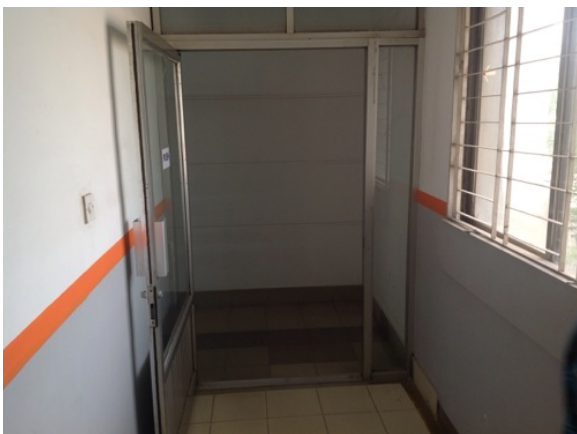
F-8	Egress	Exit stair door / egress door serving 50 or more occupants does not swing in the direction of egress travel at the first floor east exit.	Modify the egress door to swing in the direction of egress travel.	Within 3 months
-----	--------	---	--	-----------------
