# **FIRE SAFETY INSPECTION REPORT**

## **ARRIVAL FASHION LIMITED**

**ACCORD**  
on Fire and Building Safety in Bangladesh

August 26, 2014

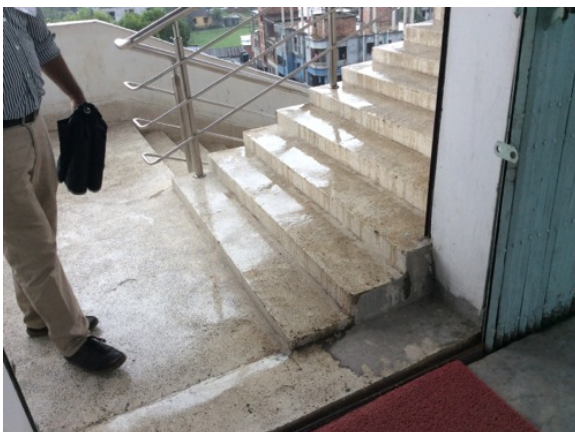
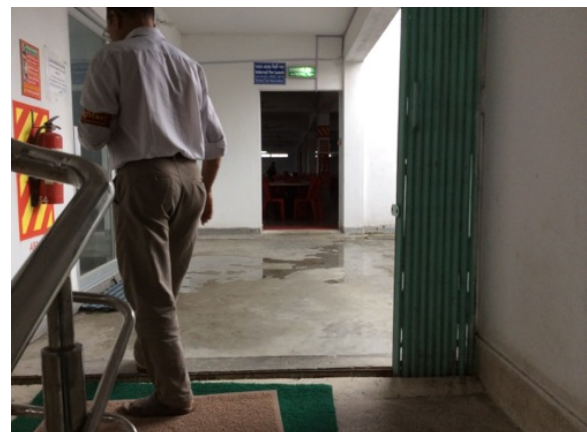
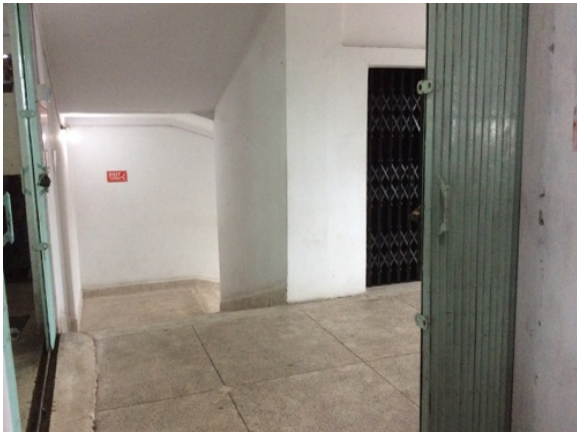
| No. | Category | Finding | Recommendation | Remediation Timeframe |
|---|---|---|---|---|
| F-1 | Fire Rated Construction | The exit stairs are not separated from work areas and other spaces on each floor by fire-rated construction. | <p>Provide minimum 1.5-hr fire rated doors and seal all unprotected openings to separate the exit stairs from work areas and other building spaces on all floor levels. Ensure that the fire doors are self-closing and positive latching and that they are provided with fire exit (panic) hardware where serving production floors.</p> <p>If fire doors are required to be held open for functional reasons, provide automatic-closing devices tied to the fire alarm system.</p> | Within 3 months |

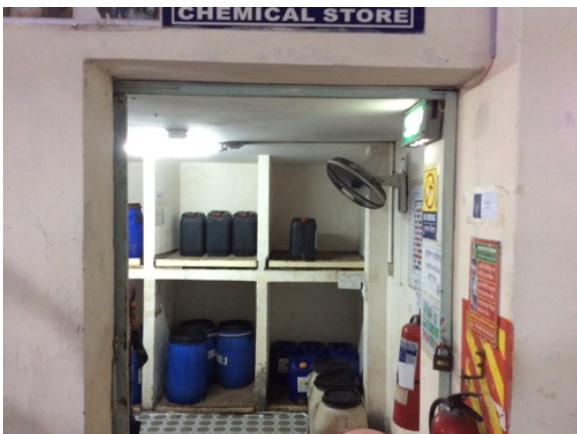
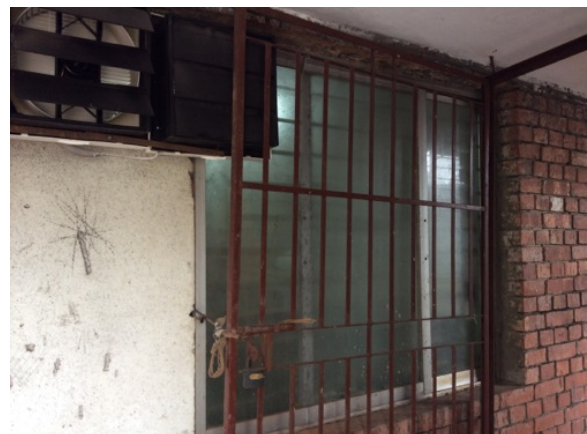
| F-2 | Fire Rated Construction | Hazardous materials and flammable liquid storage area is not separated by fire-rated construction due to openings and non-rated doors. | Separate the hazardous materials and flammable liquid storage room by a minimum 2-hr fire-rated construction. Seal and protect all openings to maintain the required fire separations. | Within 3 months |

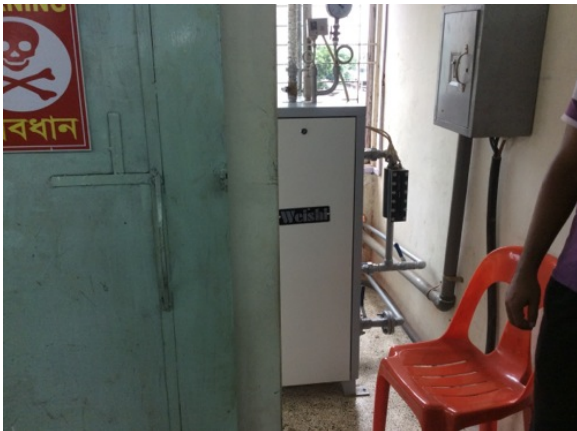
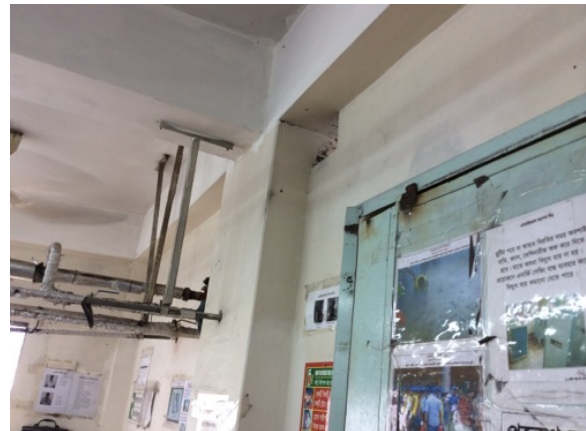
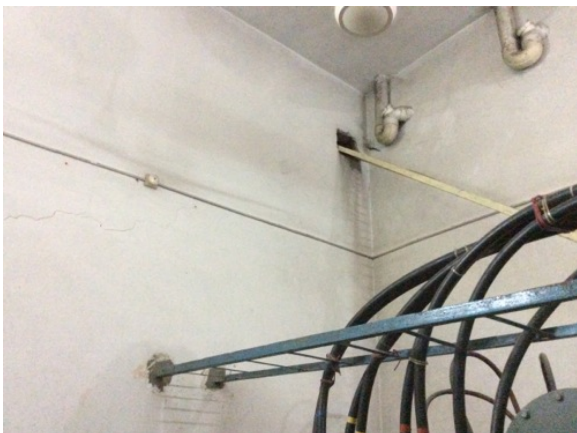
| F-3 | Fire Rated Construction | The boiler and transformer rooms are not separated by fire-rated construction due to openings, non-rated doors and penetrations on the ground and first floor. | Separate the boiler rooms by a minimum 1-hr fire-rated construction. Separate the transformer room by a minimum 2-hr fire-rated construction. Seal and protect all openings to maintain the required fire separations. | Within 3 months |

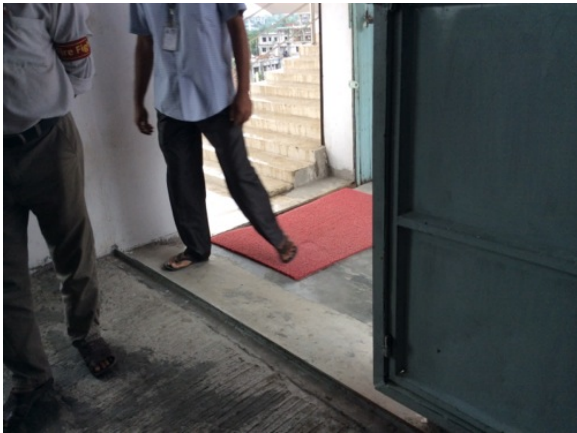
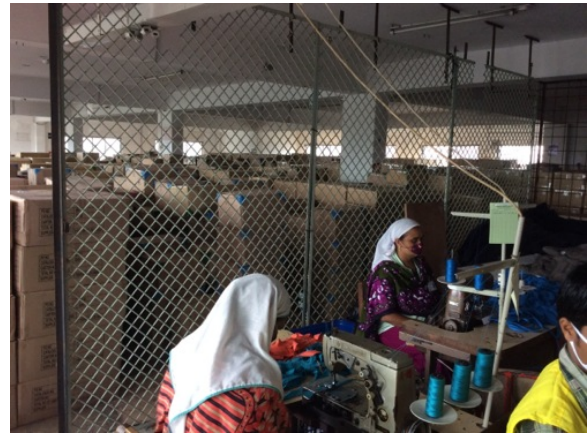
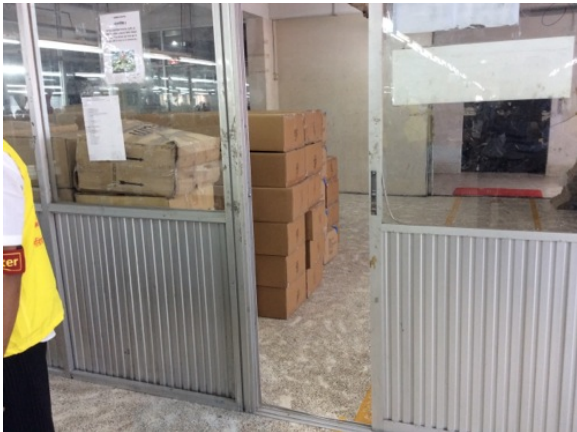
| F-4 | Fire Rated Construction | Storerooms used for combustible storages are not separated by fire-rated construction on the ground, first, third and fifth floors. | Provide dedicated storage rooms separated by minimum 1-hr fire-rated construction. | Within 3 months |

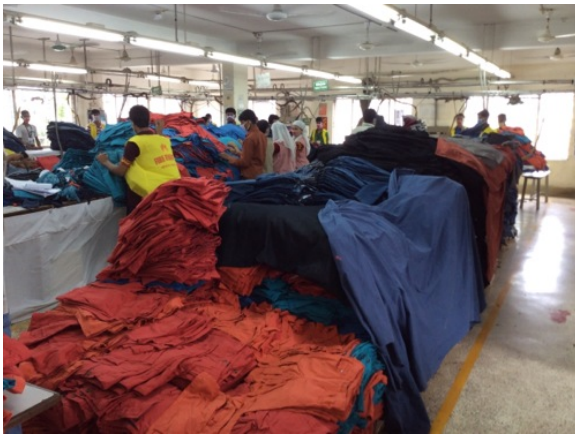
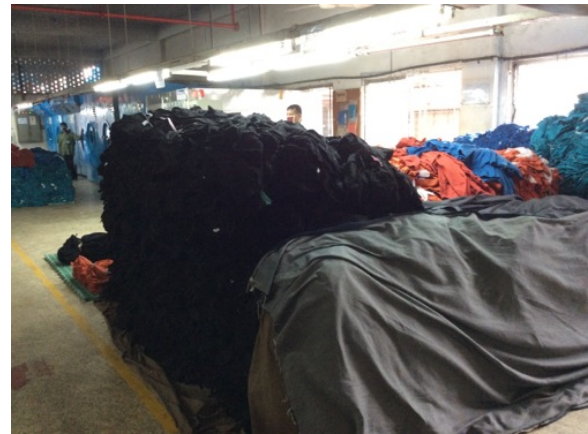
| F-5 | Fire Rated Construction | Areas used for combustible storages are open to the factory floors on the ground and first floors. | Provide defined storage areas and limit the storage arrangement as follows:<br>- Maximum height of 2.4m and maximum area of 23m <sup>2</sup><br>- Separate areas of unenclosed combustible storage by a minimum clear distance of 3m. | Within 3 months |

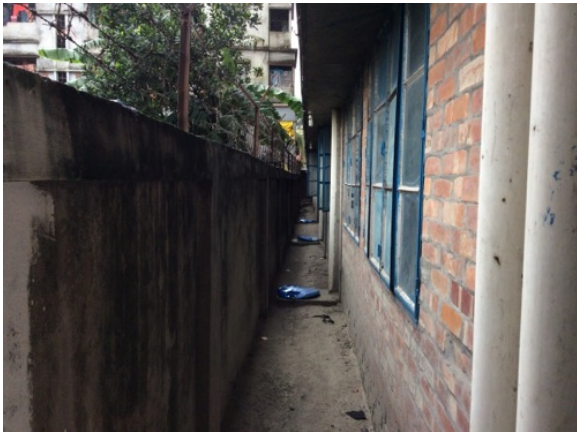
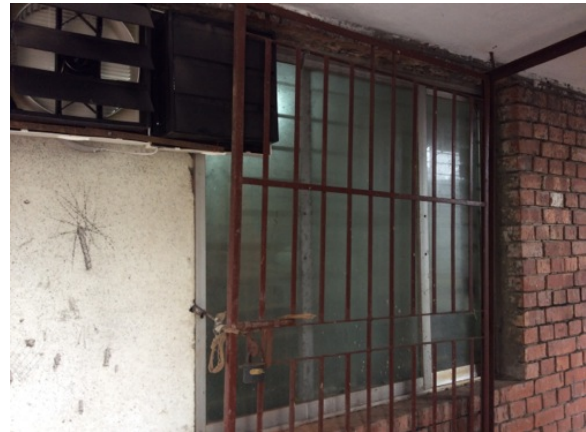
| F-6 | Fire Rated Construction | The exit discharge path serving East and West exit is less than 10 ft wide and is not separated from the building interior. | Seal all penetrations and openings to the interior of the building along the discharge path, up to a height of 10 ft., to provide a minimum 1-hr fire separation. | Within 6 months |

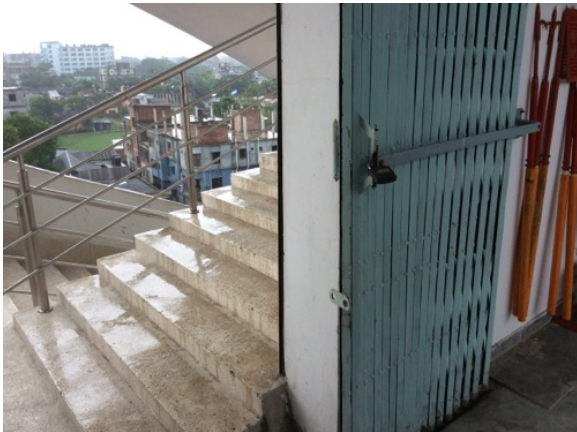
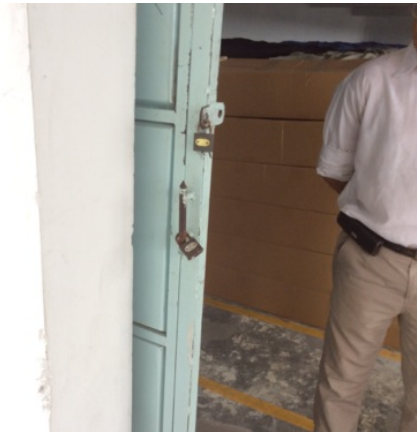
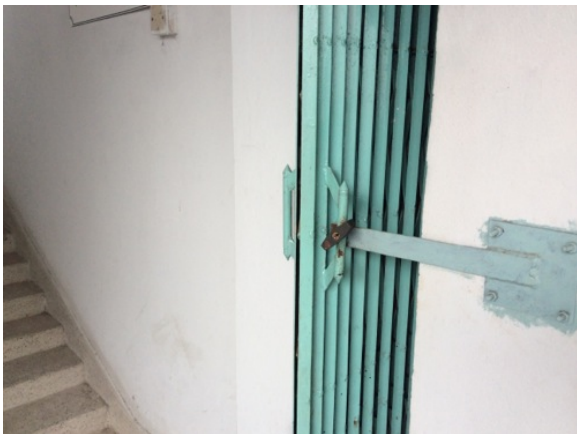
| F-8 | Egress | Egress doors and gates with locking features (padlocks) are provided at building exits, exit stairs, along egress routes and exit discharge. All gates and doors were not open and unlocked during the inspection. | Remove locking features from all egress doors and gates.<br><br>If locks are required for security reasons, utilize special door locking features complying with NFPA 101. | Immediate |

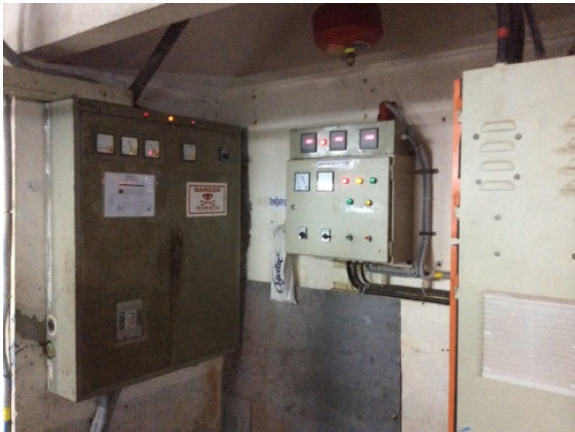
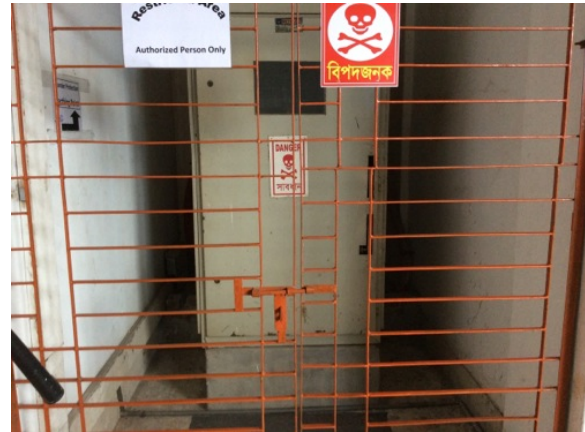
| F-9 | Egress | Storage was located in the North and West exit stairs on the ground floor. | Remove all storage from exit stairs and egress paths. | Immediate |

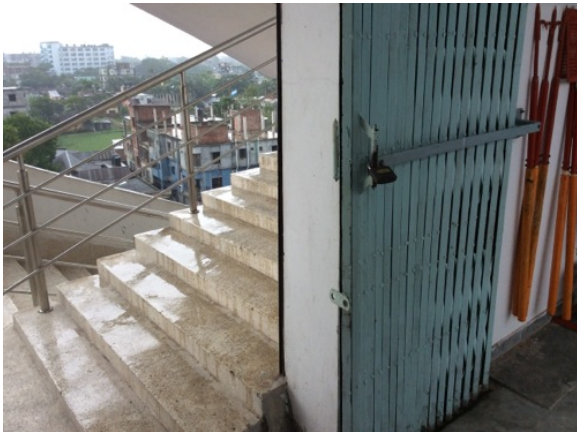
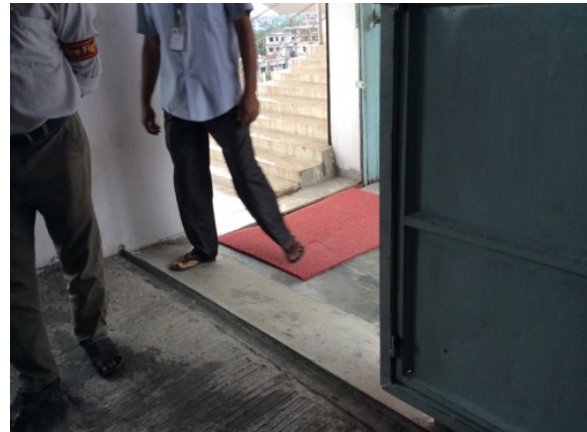
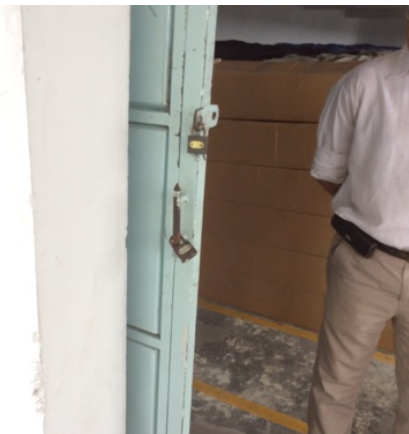
| F-11 | Egress | Collapsible gates and sliding doors are provided at building exits, exit stairs, along egress routes and exit discharge. | <p>Replace all gates and sliding doors along the means of egress with side-hinged, swinging egress doors.</p> <p>If locks are required for security reasons, utilize special door locking features complying with NFPA 101.</p> | Within 1 month |

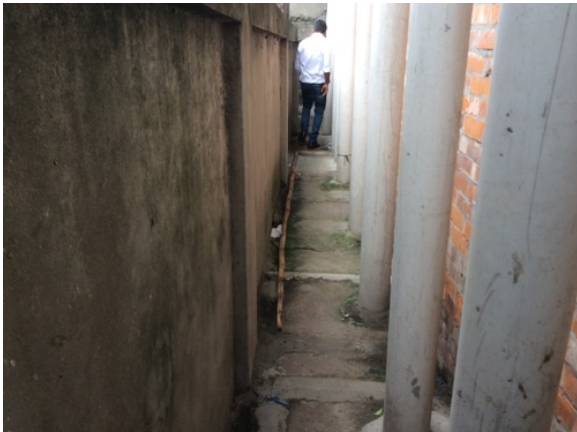
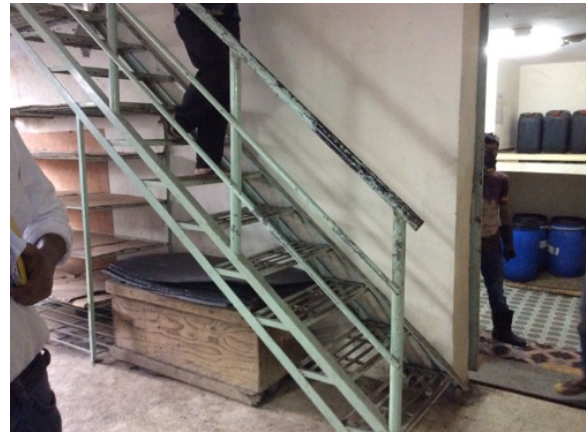
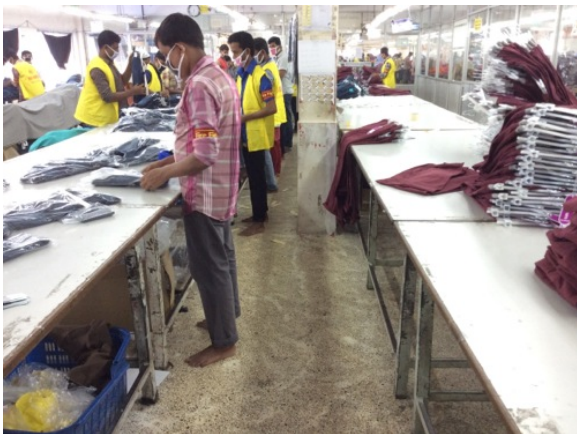
| F-12 | Egress | The width of egress aisles is less than 36-in. on the first floor. The width of exit stair from the mezzanine floor is less than 36-in. The width of exterior discharge path from the West exit is less than 36-in. | Provide minimum aisle widths, stair widths and discharge path widths of 36-in. | Within 3 months |

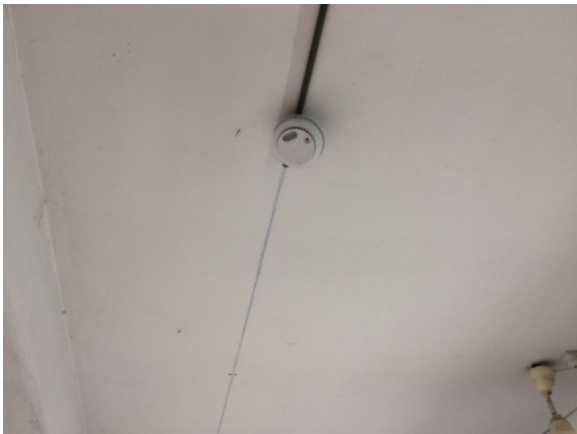
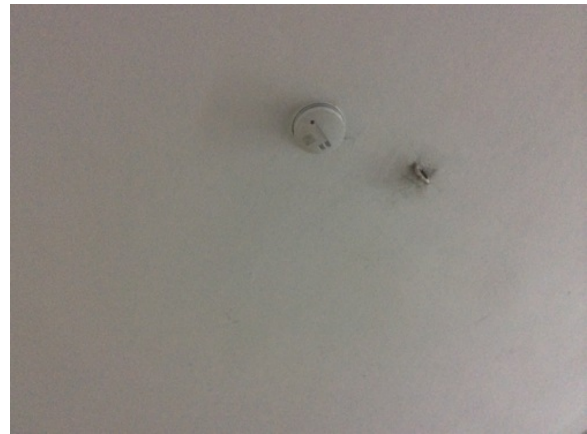
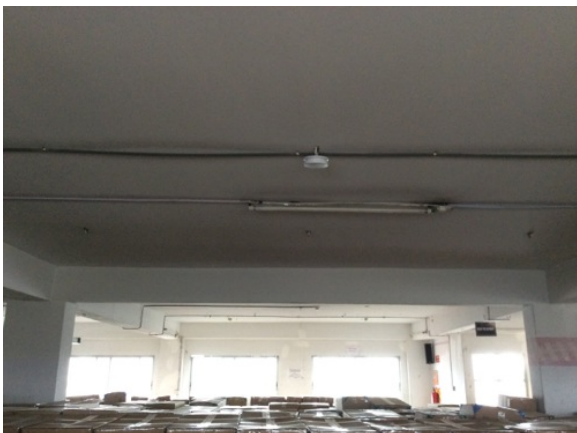
| F-15 | Fire Protection | The building is equipped with single-station smoke alarms. Smoke alarm activation sounds only a local alarm and does not provide automatic fire alarm notification of occupants. | Remove single-station smoke alarms. | Within 6 months |

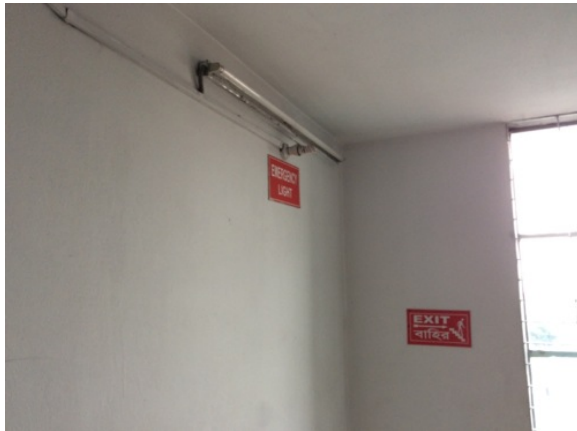
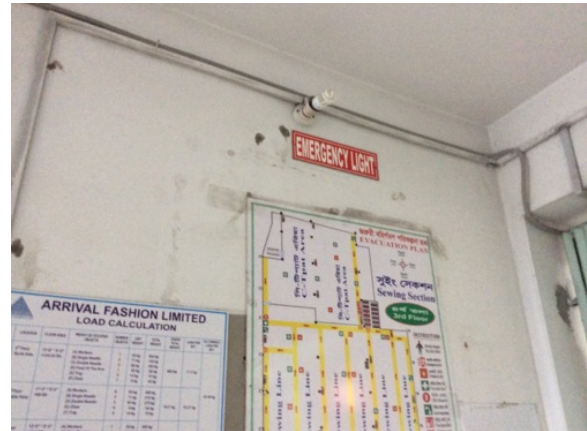
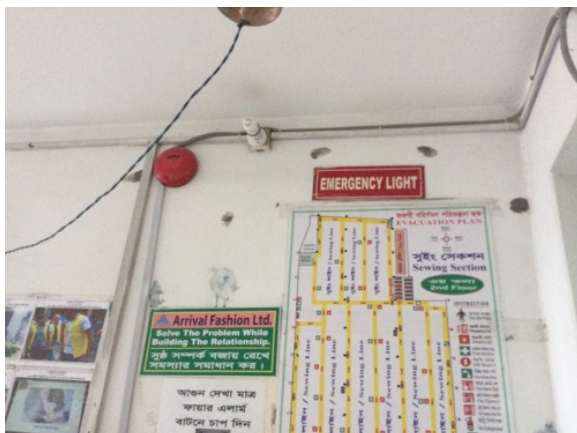
| F-16 | Egress Lighting | Emergency lighting did not function in test mode (burned out) in the North exit stair and on the factory floors. | Regularly test the emergency lighting system on each floor and replace and repair lights as needed. | Within 1 month |
