# Siji Garment Co Ltd.

S.A Plot -47, Kewa,Sreepur, Gazipur

# Observations

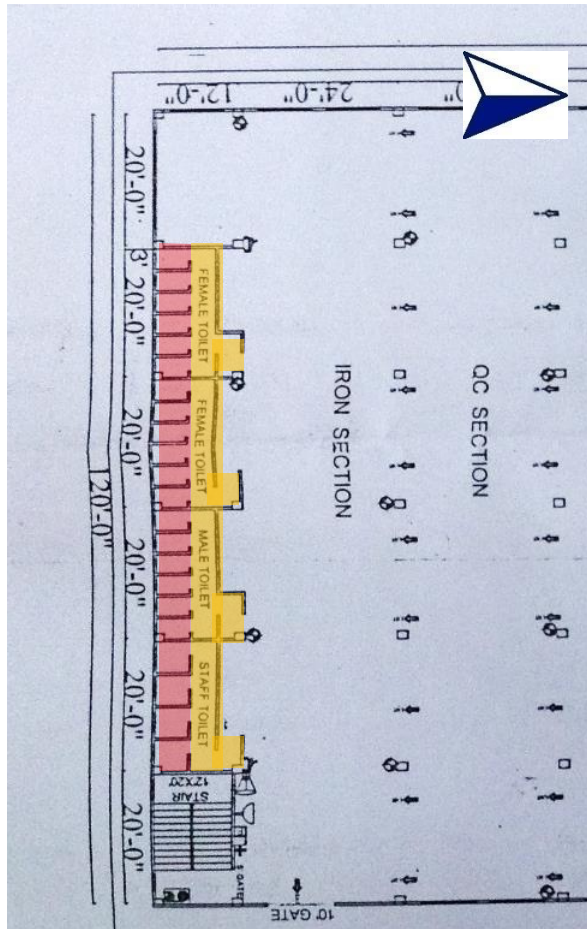
**Very heavy column loads when building height increased from present**

| Item No. | Observation | Recommended Action Plan | Recommended Timeline |
|---|---|---|---|
| 1 | Very large loads on columns of Building 1 & 3 after additional floor construction | Factory Engineer to review design , loads and all column stresses and confirm in situ concrete strength by taking 4 No 100mm cores if extension to proceed. | 6-weeks |
| 2 | Very large loads on columns of Building 1 & 3 after additional floor construction | Upward extension should be put on hold until the completion of the engineering review | 6-weeks |
| 3 | Very large loads on columns of Building 1 & 3 after additional floor construction | Carry out the recommendations of the review. | 6-months |

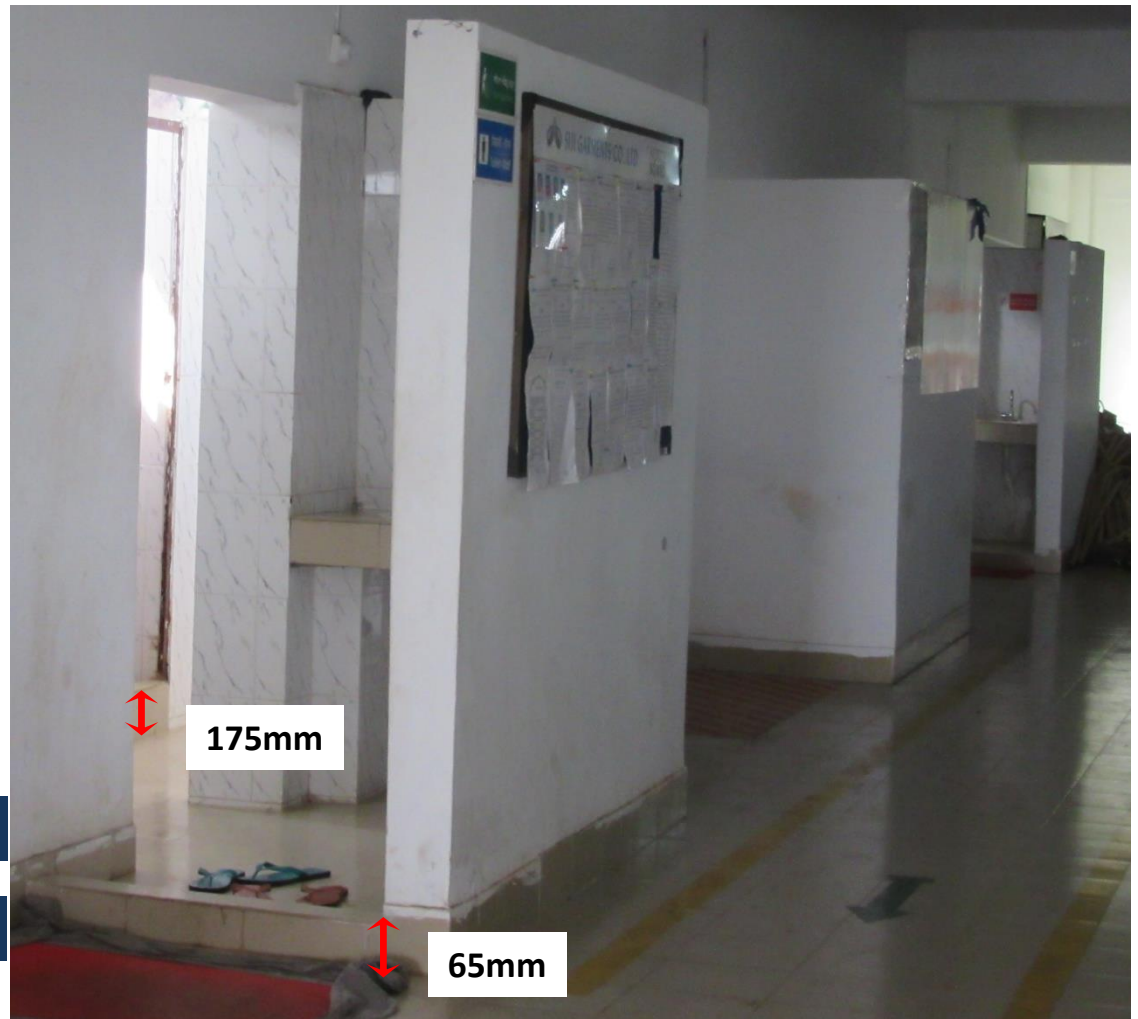
**Build-ups in toilets' corridors 65mm**

**Build-ups in toilets' 230mm (total)**

**175mm + 65mm build ups observed in the toilet area.**

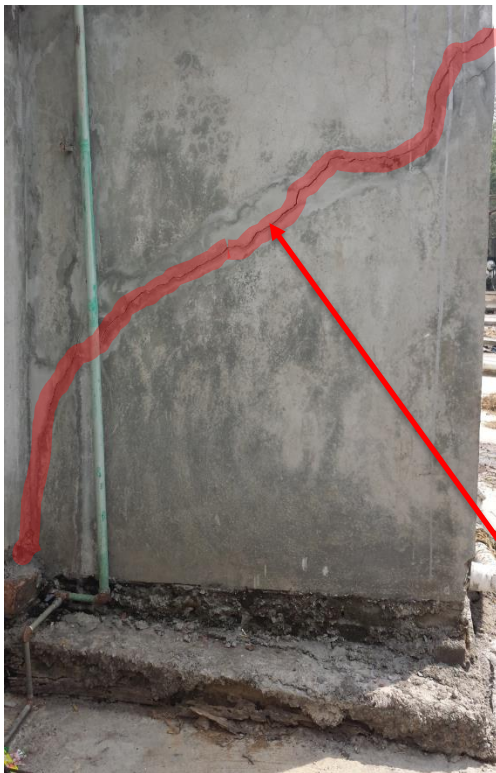
Crack observed in the external brick wall of the toilet area at Ground Floor.

| Item No. | Observation | Recommended Action Plan | Recommended Timeline |
|---|---|---|---|
| 4 | Cracks in the masonry wall in the toilet zone Building 1 | Factory Engineer to investigate cracks in ground floor toilet masonry wall and review effectiveness of wall foundations. | 6-weeks |
| 5 | Cracks in the masonry wall in the toilet zone Building 1 | Carry out remedial works | 6-months |

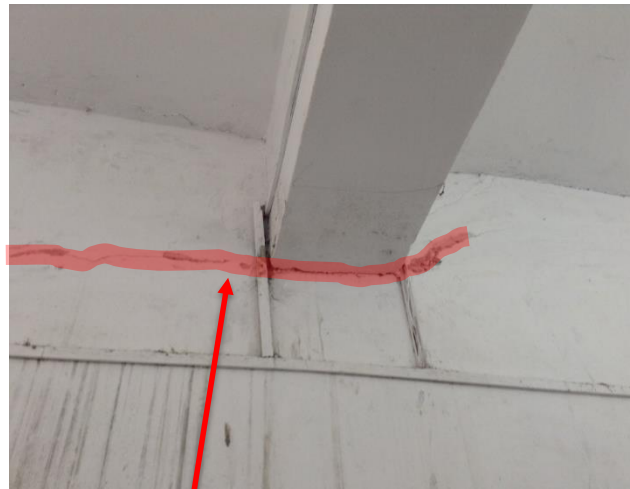
Crack on the partitions are observed in the toilet area .

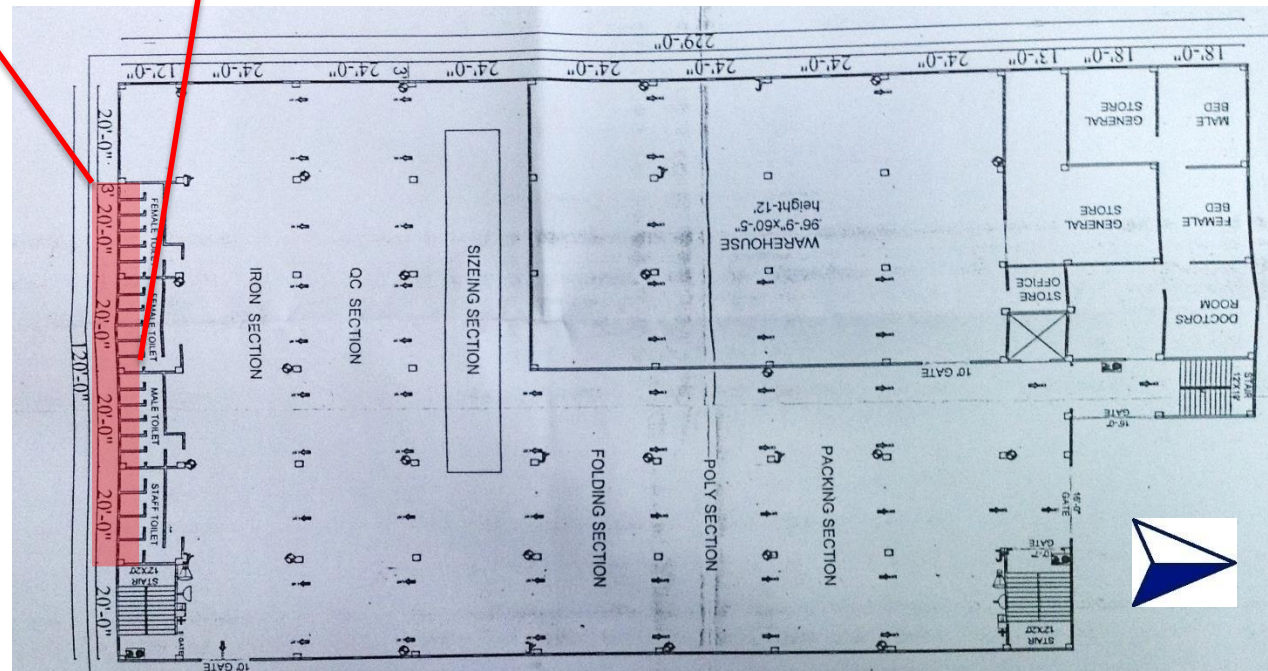
Toilet area appears to be on own footings at ground floor

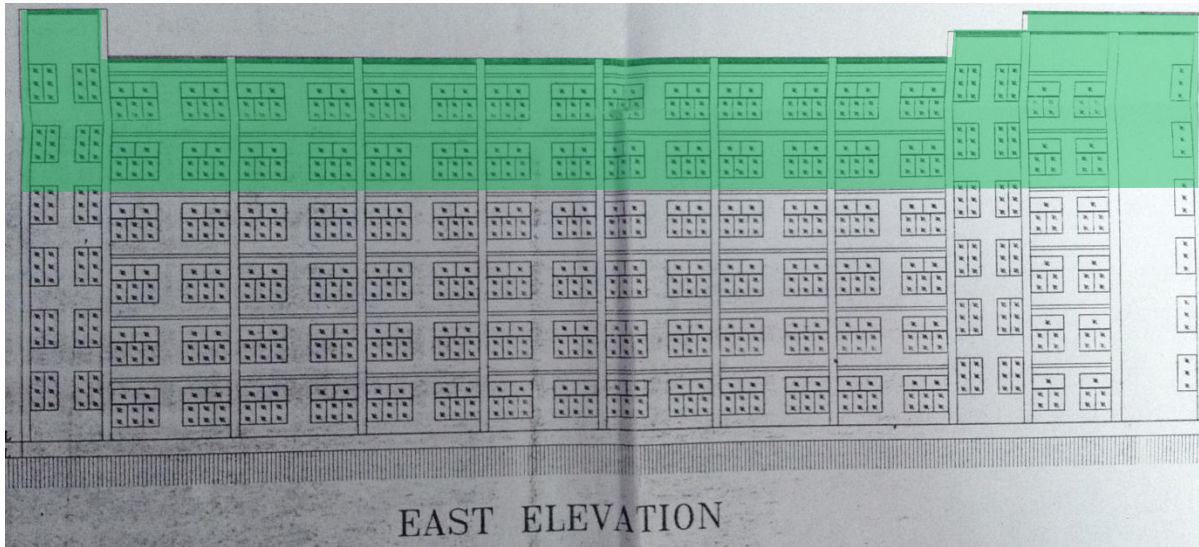
**Floors to be built**

**The permit drawing shows 6-storey structure for the Main Building**

**Discrepancies between two permit drawings.**

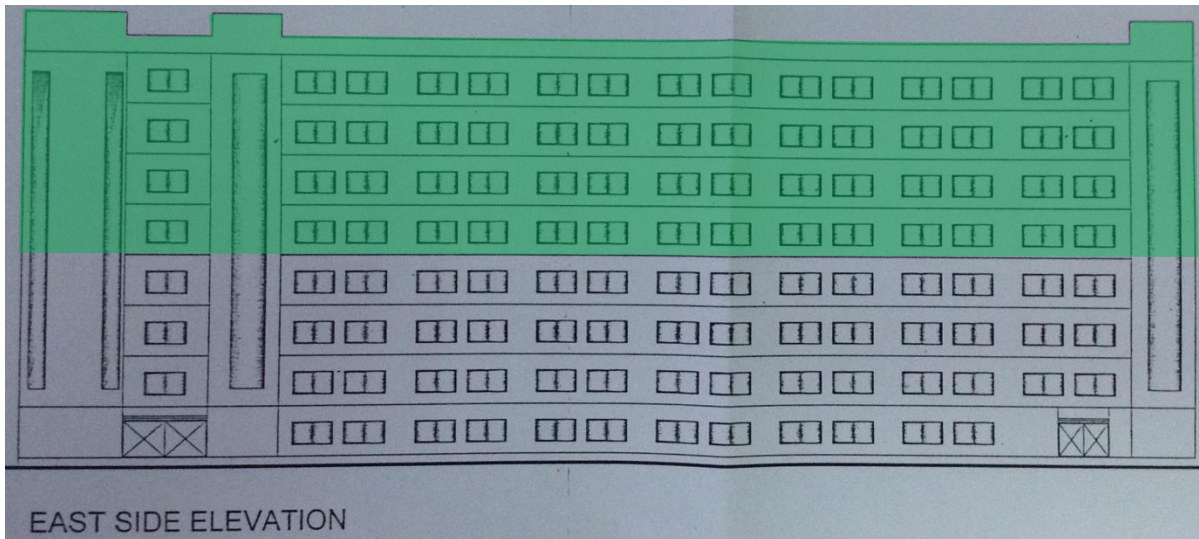
**The industrial permit drawing shows 8-storey structure for the Main Building**

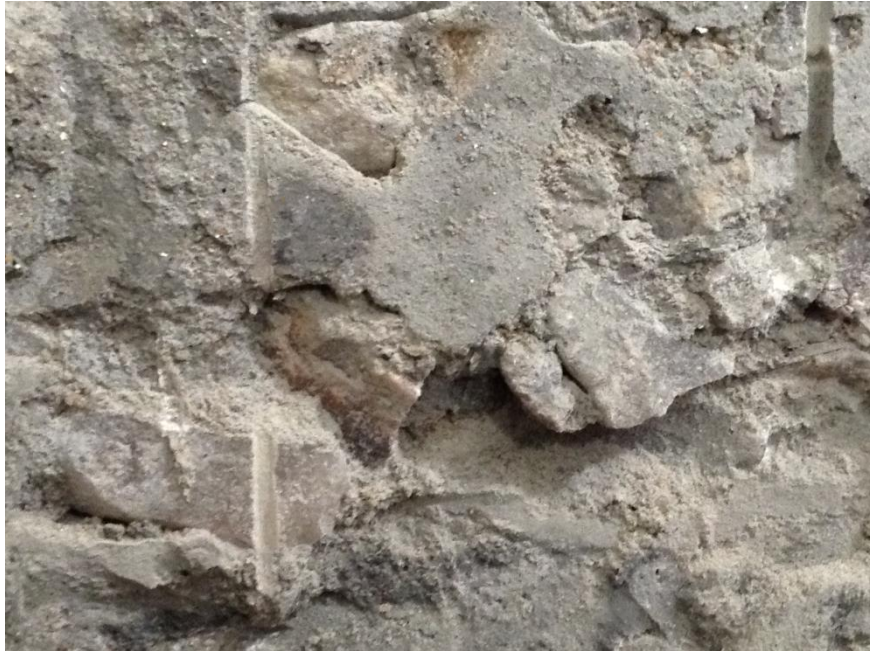
**Stone aggregate in Building 1**

**Two types of aggregate observed.**

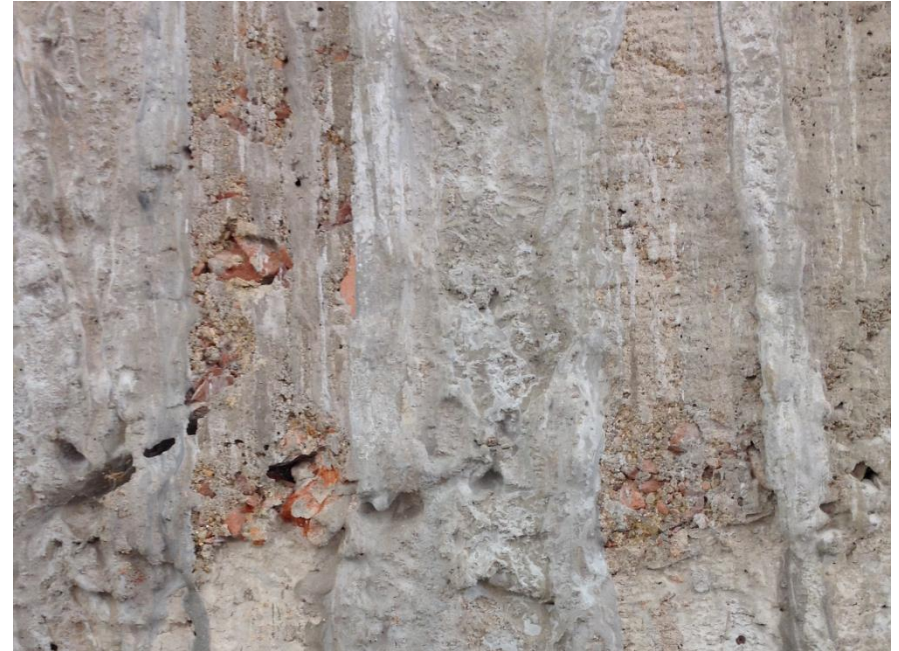
**Brick aggregate present in the Buildings No2 & No 3**
