# Shamser Knit Fashion Ltd.

Sreepur, Ganakbari, Ashulia, Savar, Dhaka.

11 February 2015

# Observations

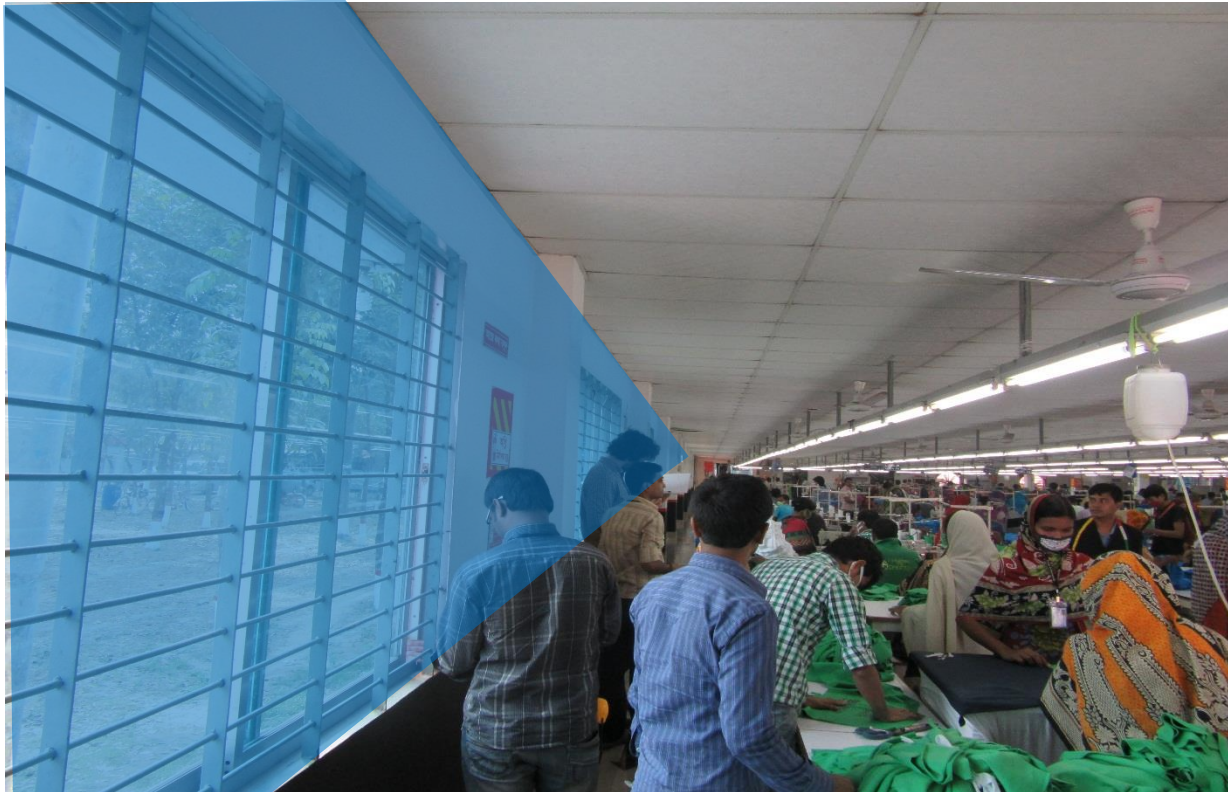
**Lateral bracing system is reliant on the  
external brick walls**

Lateral bracing system is observed

**ITEM 1:** Lateral bracing system is reliant on the external brick walls and the RC columns cantilevering.

| Item No. | Observation | Recommended Action Plan | Recommended Timeline |
|---|---|---|---|
| 1 | Building 1 Lateral bracing system is reliant on the external brick walls and the RC columns cantilevering | The Engineer to carry out a review of the existing building structure and its lateral support system in particular the brick walls and columns to resist the lateral load. | 6-weeks |
| 2 | Building 1 Lateral bracing system is reliant on the external brick walls and the RC columns cantilevering | Carry out any remedial actions from review | 6-months |

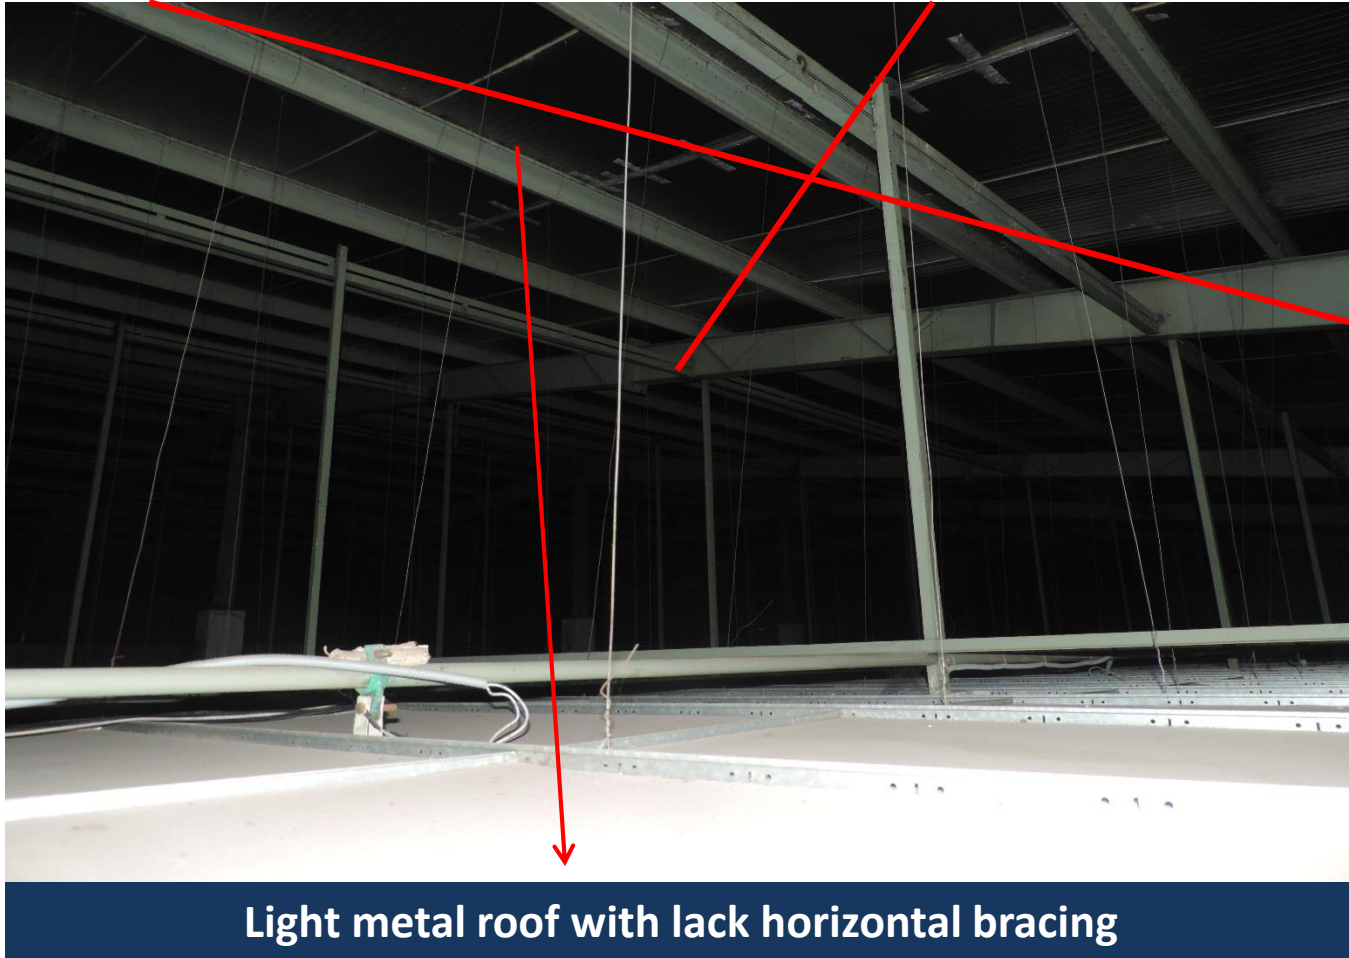
**Roof steel structure appears light and lacks horizontal bracing**

Light metal roof with lack horizontal bracing

**ITEM 2:** Roof steel structure appears light and lacks horizontal bracing

| Item No. | Observation | Recommended Action Plan | Recommended Timeline |
|---|---|---|---|
| 3 | Building 1 Roof steel structure appears light and lacks horizontal bracing | The Engineer to carry out a review of the roof structure, in particular the lateral stability of the portal frame | 6-weeks |
| 4 | Building 1 Roof steel structure appears light and lacks horizontal bracing | Carry out any remedial actions from the above review | 6-months |

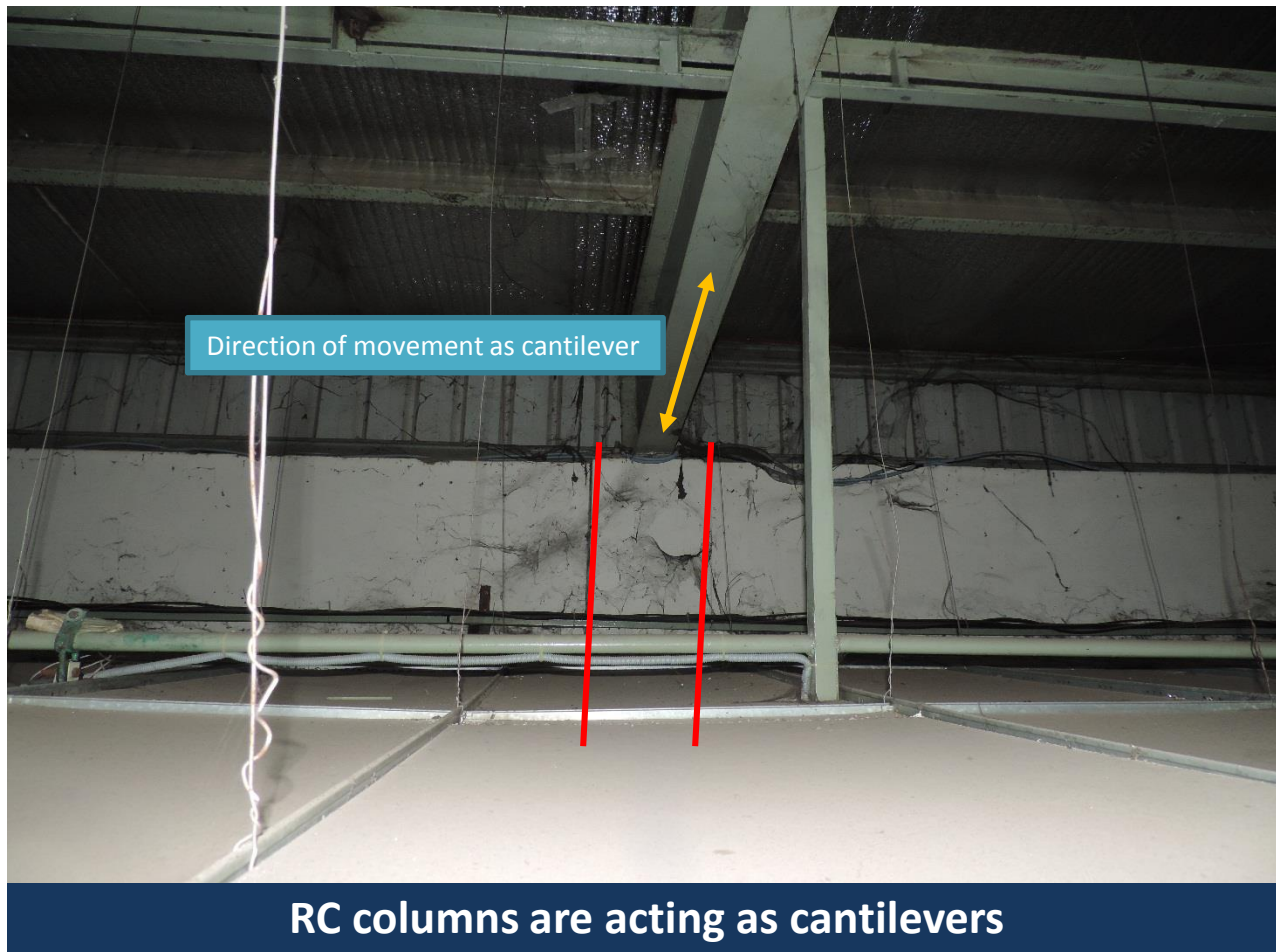
**RC columns supporting roof appear to be  
acting as cantilevers**

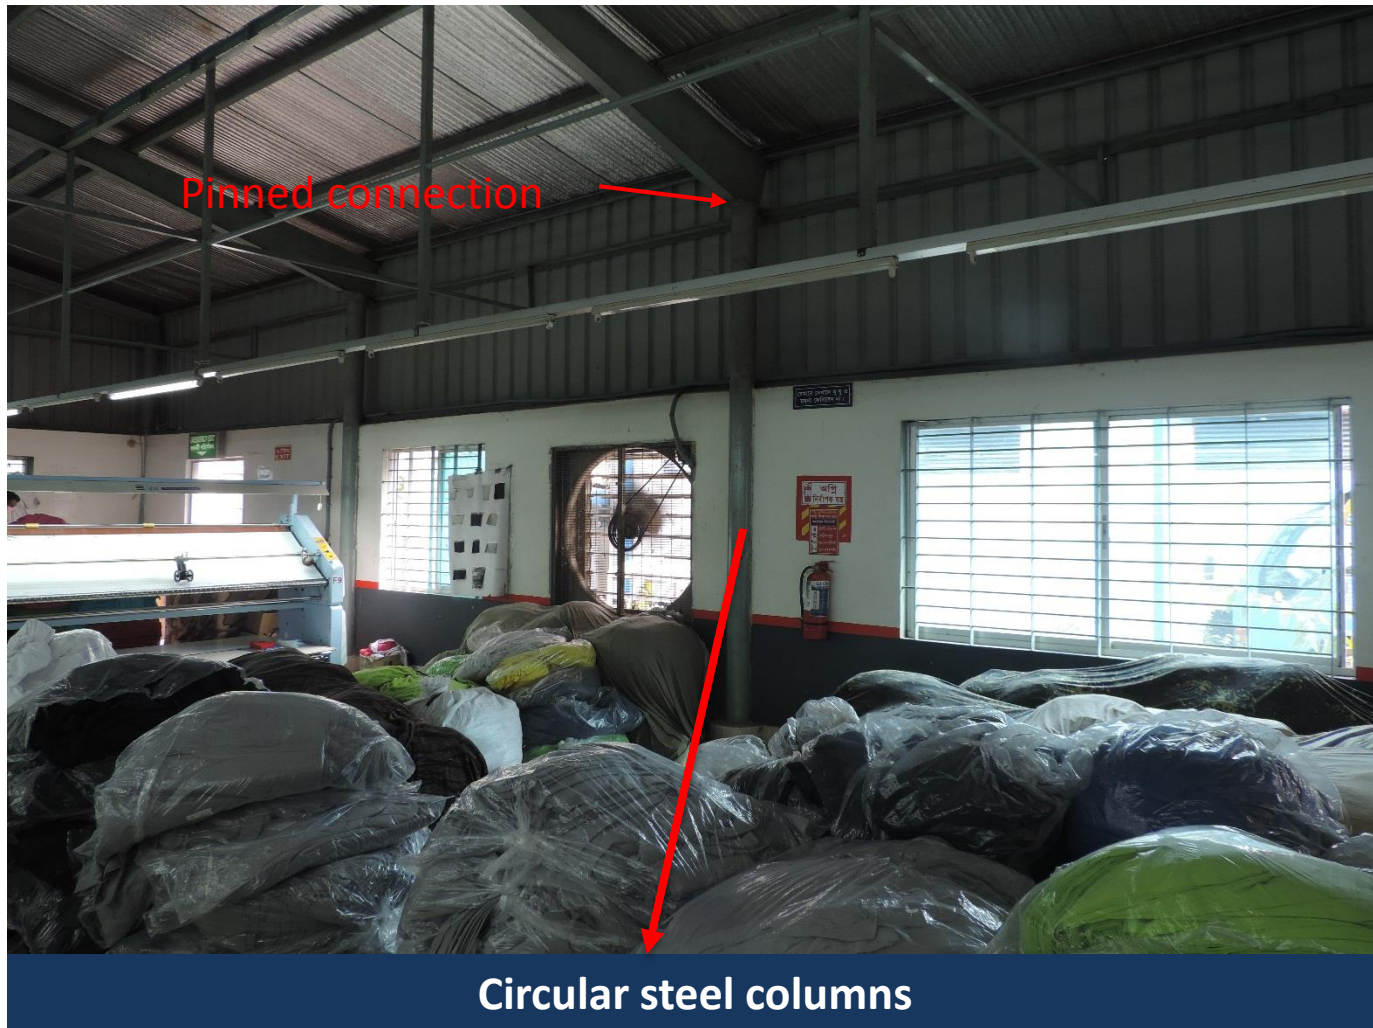
**Steel frame appears not to act as a  
portal frame**

**ITEM 1:** Steel frame appears not to act as a portal frame

| Item No. | Observation | Recommended Action Plan | Recommended Timeline |
|---|---|---|---|
| 6 | Building 2 Steel frame appears not to act as a portal frame | The engineer to review the structural system of the frame. In particular the circular column connections to the beams. The frame appears to be non-engineered. | 6-weeks |
| 7 | Building 2 Steel frame appears not to act as a portal frame | Carry out any remedial actions form the engineers review above. | 6-months |

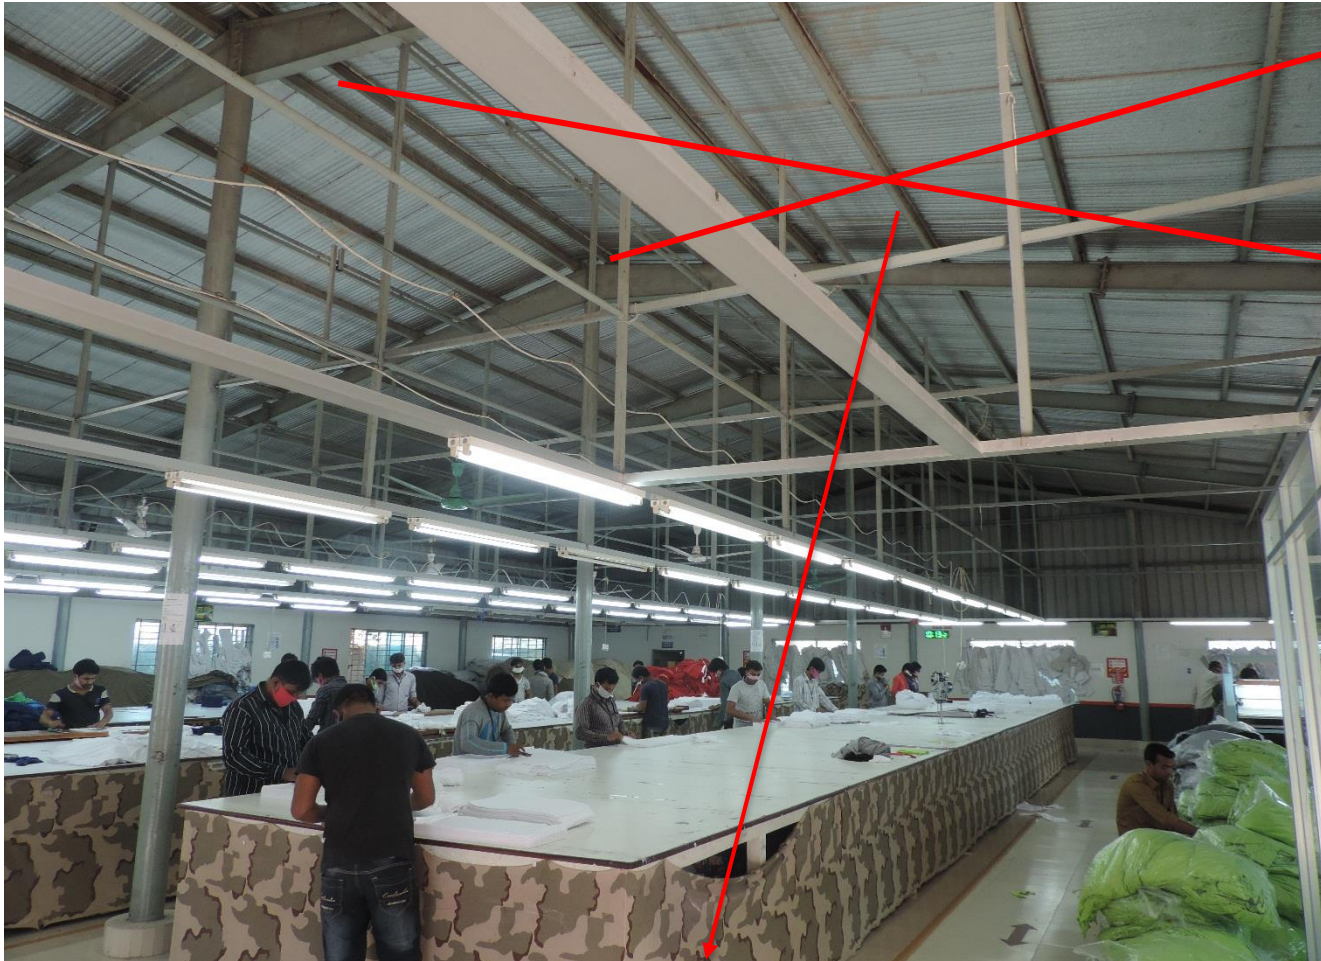
# Lack of roof bracing

No bracing was observed in roof

| Item No. | Observation | Recommended Action Plan | Recommended Timeline |
|---|---|---|---|
| 8 | Building 2 The lateral bracing system appear to be reliant on external walls which show cracking. No lateral roof bracing observed | The engineer to review the structural system of the frame. In particular the circular column connections to the beams. The frame appears to be non-engineered as does the roof structure. | 6-weeks |
| 9 | Building 2 The lateral bracing system appear to be reliant on external walls which show cracking. No lateral roof bracing observed | Carry out any remedial actions form the engineers review above. | 6-months |

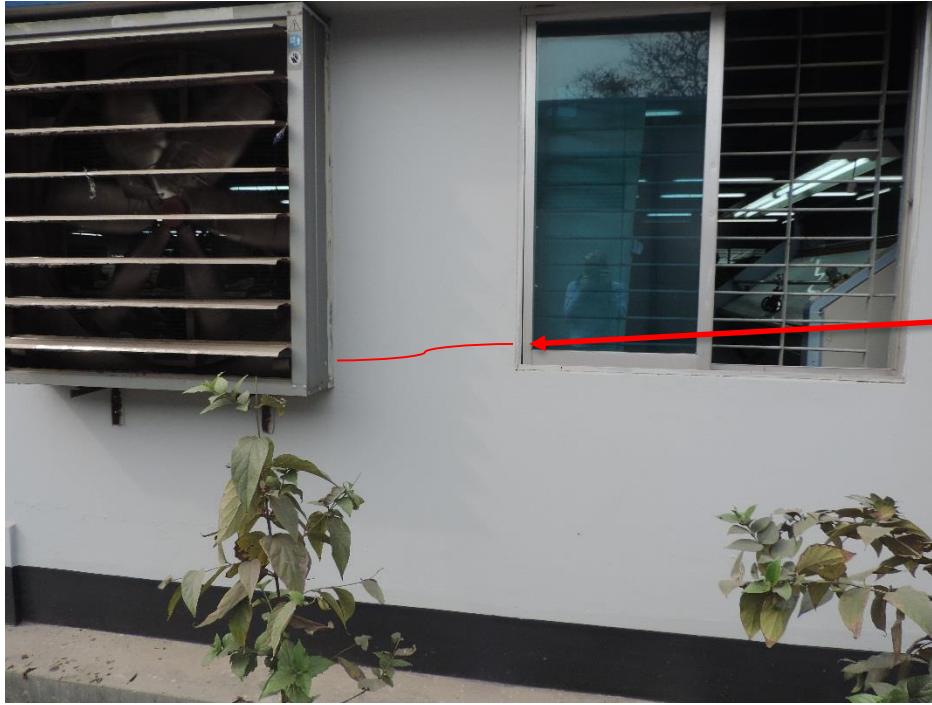
**Lateral bracing system appear to be reliant on external walls which show cracking**

**ITEM 2** The lateral bracing system appear to be reliant on external walls which show cracking. No lateral roof bracing observed

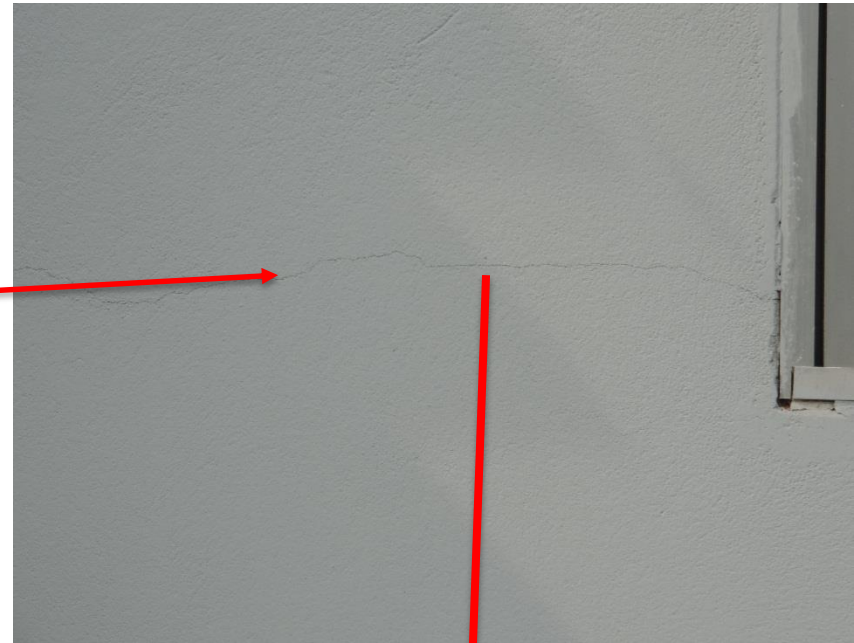
**Horizontal crack is observed on the side wall**

**Cracks observed on the wall**

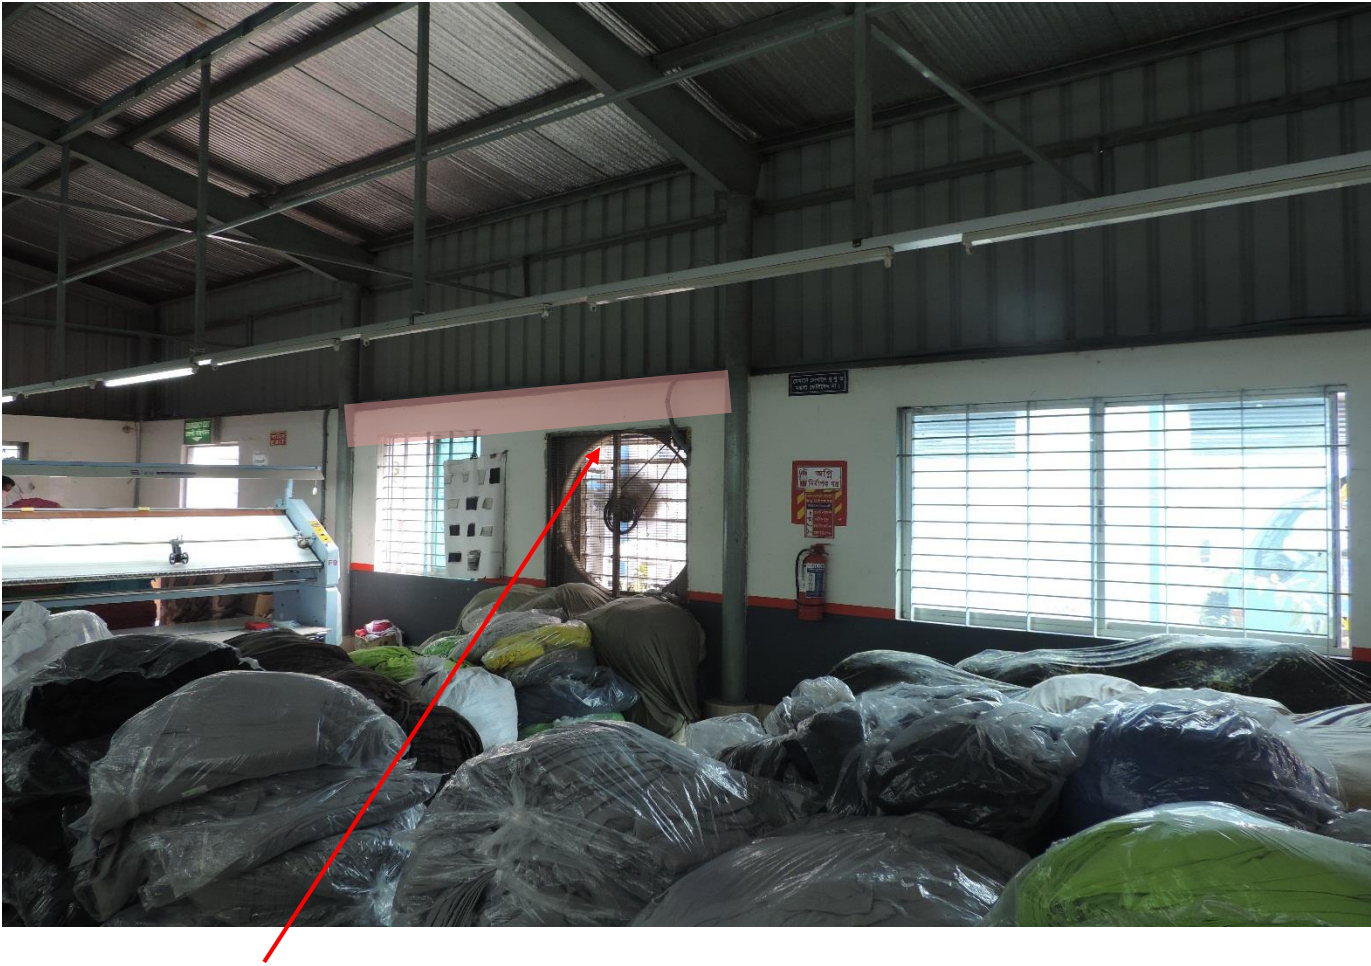
**Wall panels have no head restraint**

**No head restraint on wall**

**ITEM 3:** Wall panels have no head restraint.

| Item No. | Observation | Recommended Action Plan | Recommended Timeline |
|---|---|---|---|
| 10 | Building 2 Wall panels have no head restraint | Engineer to review the wall panels and their ability to span between columns | 6-weeks |
| 11 | Building 2 Wall panels have no head restraint | Carry out any remedial actions form the engineers review above. | 6-months |

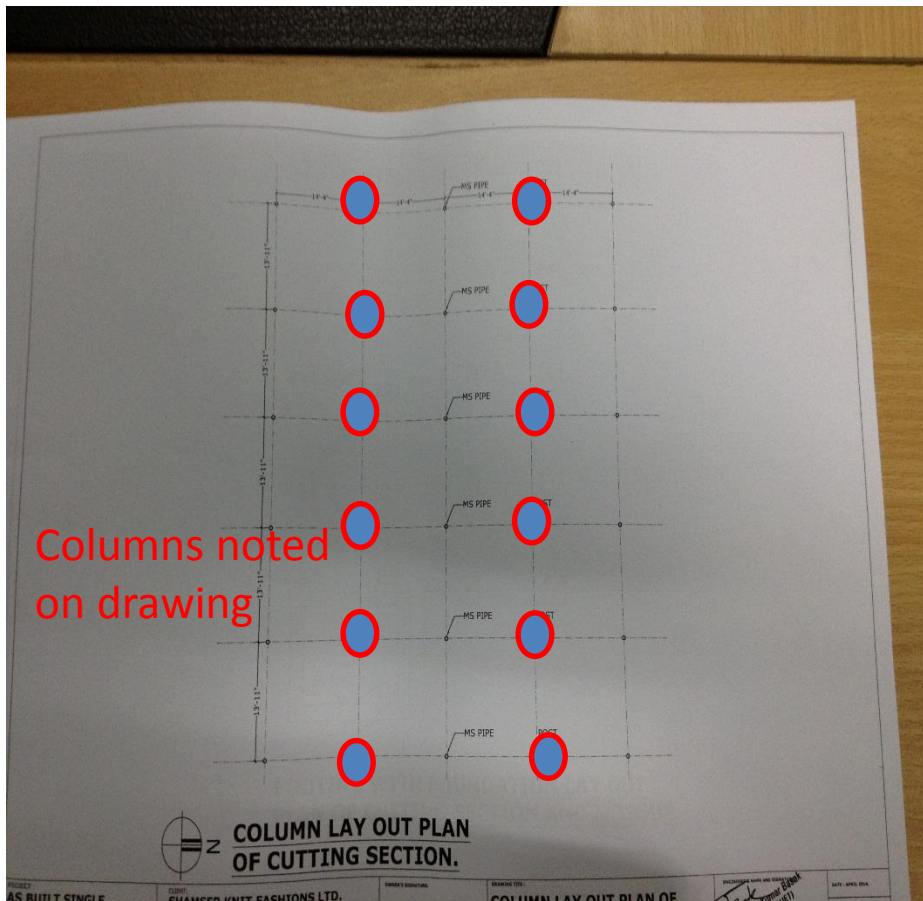
**Structural drawing of column layout plan**

**Columns shown in the structural drawing that do not exist on site**

| Item No. | Observation | Recommended Action Plan | Recommended Timeline |
|---|---|---|---|
| 12 | Building 2 Structural drawings is not consistent with the as-built structure | The engineer to update the drawings to reflect the as built structure. | 6-months |

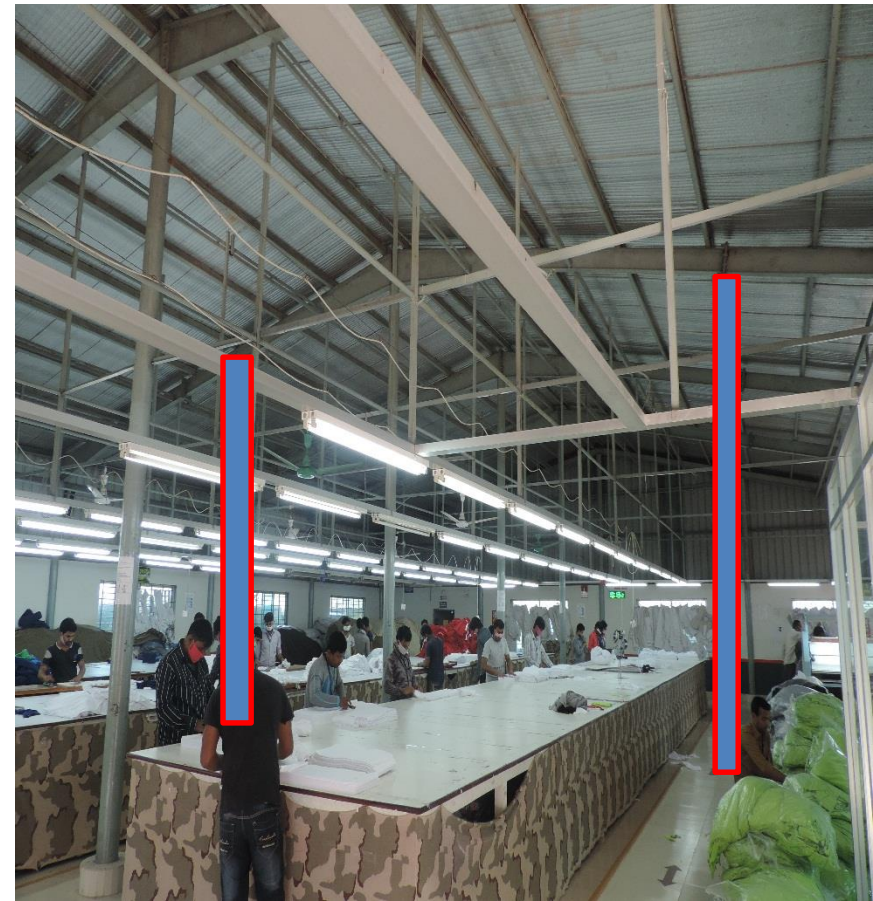
**No column was found during inspection**

**ITEM 4:** Structural drawings is not consistent with the as-built structure

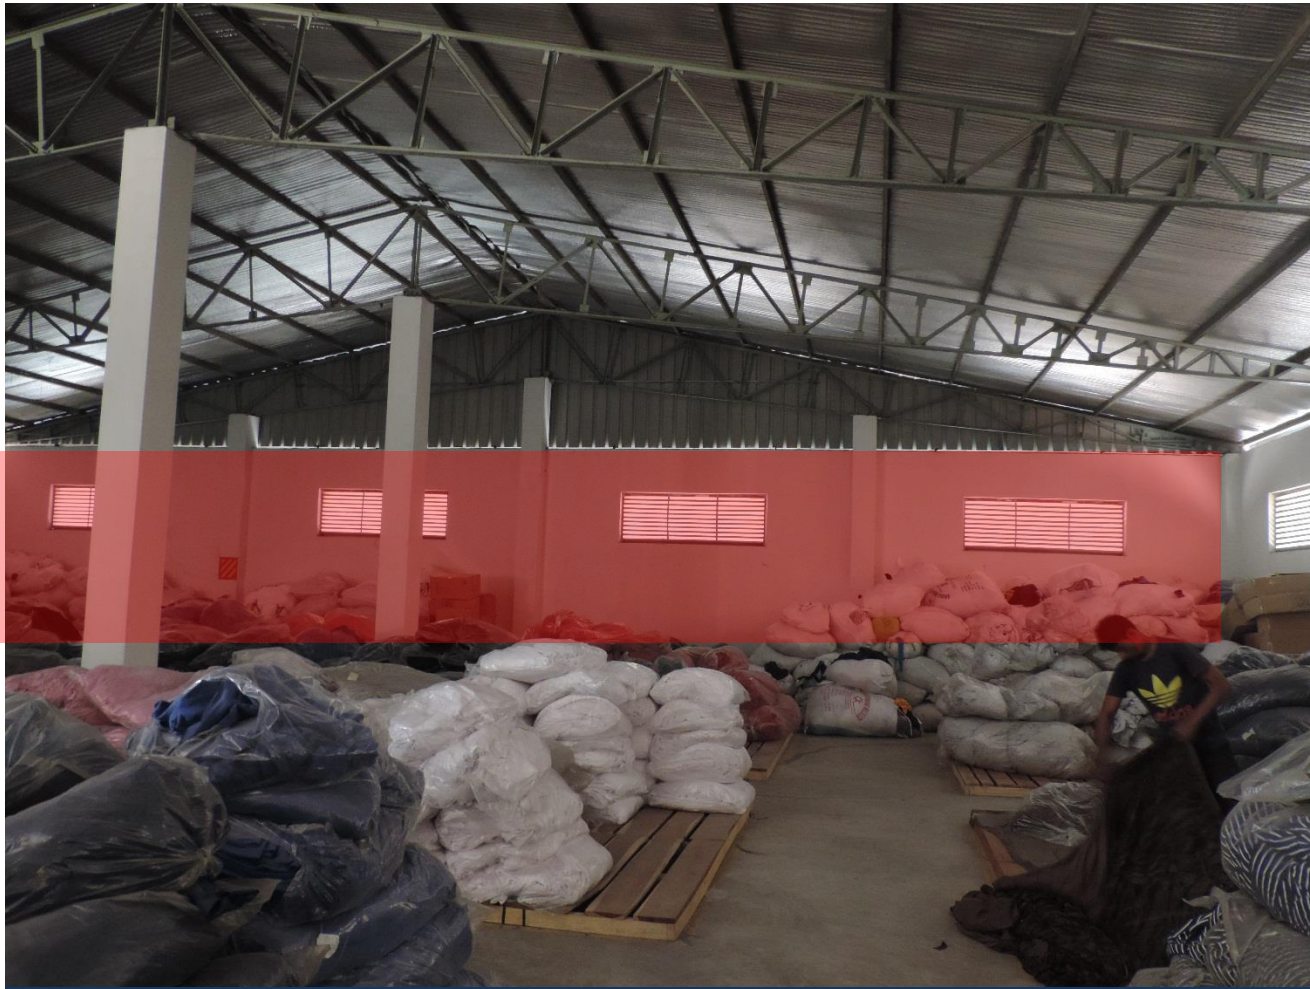
**Lateral bracing system for structure would appear to be currently reliant on the external brick walls**

**Lateral forces currently resisted by external walls**

**ITEM 1:** Lateral bracing system for structure would appear to be currently reliant on the external brick walls. There is also lack of bracing at roof level particularly at the head of the columns

| Item No. | Observation | Recommended Action Plan | Recommended Timeline |
|---|---|---|---|
| 13 | Building 3: Lateral bracing system for structure would appear to be currently reliant on the external brick walls. There is also lack of bracing at roof level particularly at the head of the columns | Engineer to review the structural system of the building, in particular to review the buildings ability to resist horizontal loading. | 6-weeks |
| 14 | Building 3: Lateral bracing system for structure would appear to be currently reliant on the external brick walls. There is also lack of bracing at roof level particularly at the head of the columns | Carry out remedial works as directed by the engineering review | 6-months |

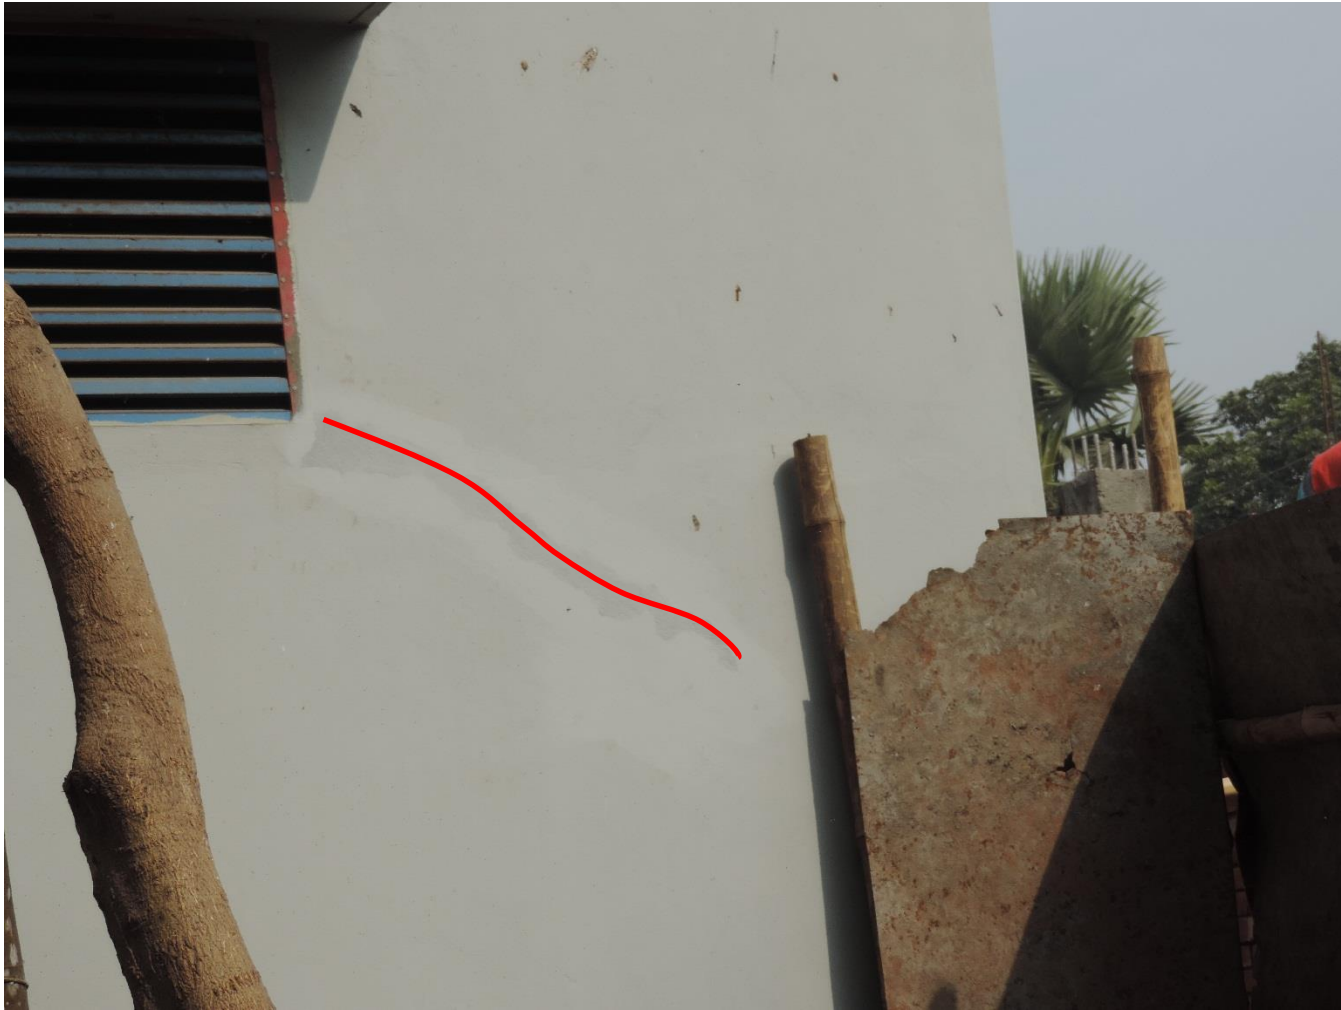
# Cracking in external gable wall

Crack is observed in external wall

**ITEM 2:** Cracking in external gable wall

| Item No. | Observation | Recommended Action Plan | Recommended Timeline |
|---|---|---|---|
| 15 | Building 3: Cracking in external gable wall | Engineer to review the cracking in the gable walls. | 6-weeks |
| 16 | Building 3: Cracking in external gable wall | Carry out remedial works as directed by the engineering review | 6-months |

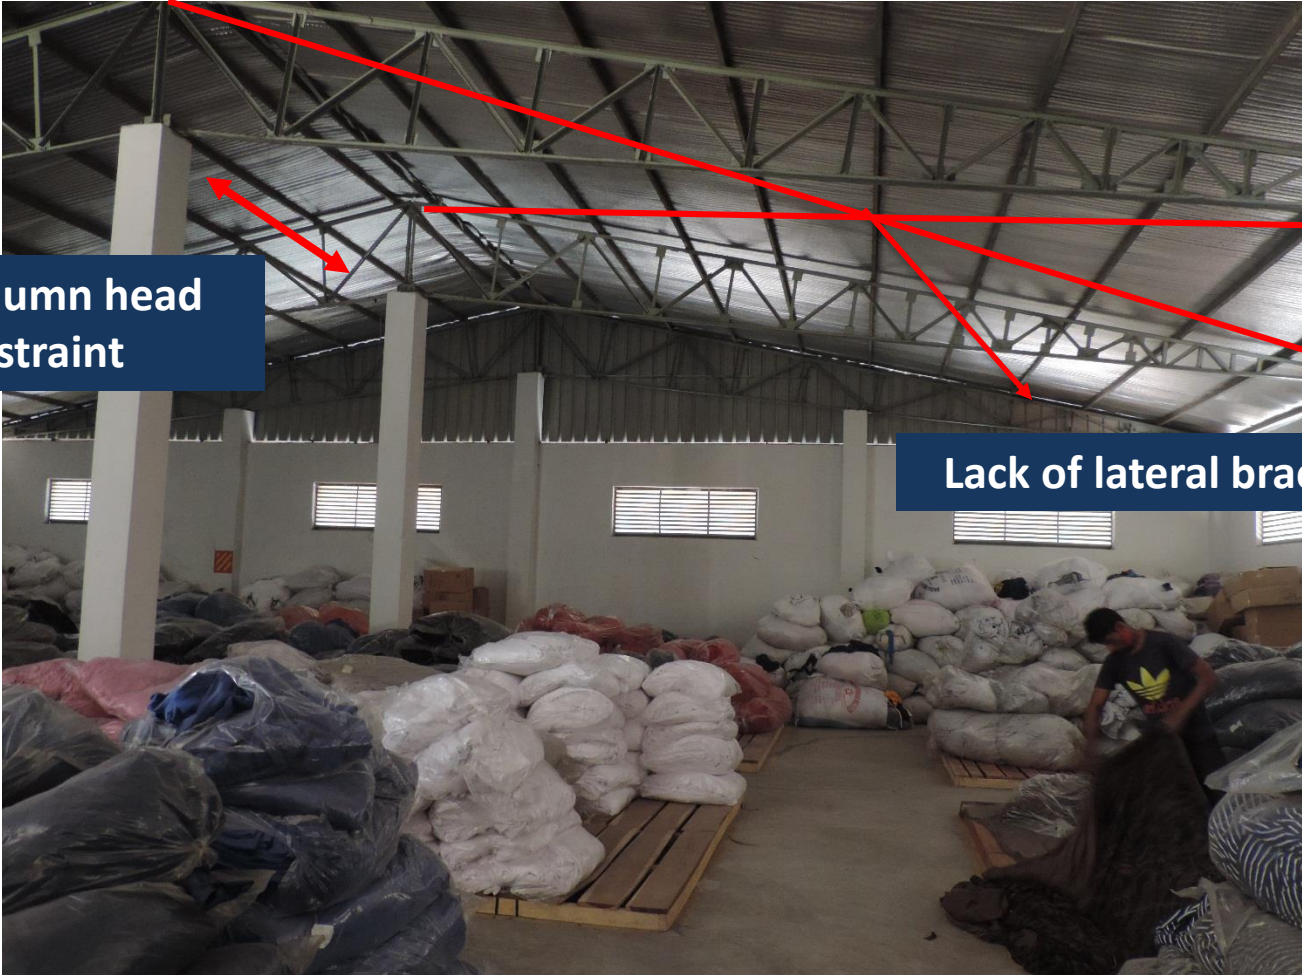
**Lack of roof lateral bracing including head restraint to top of internal columns**

No column head restraint

Lack of lateral bracing

Lack of lateral bracing and no head restraint

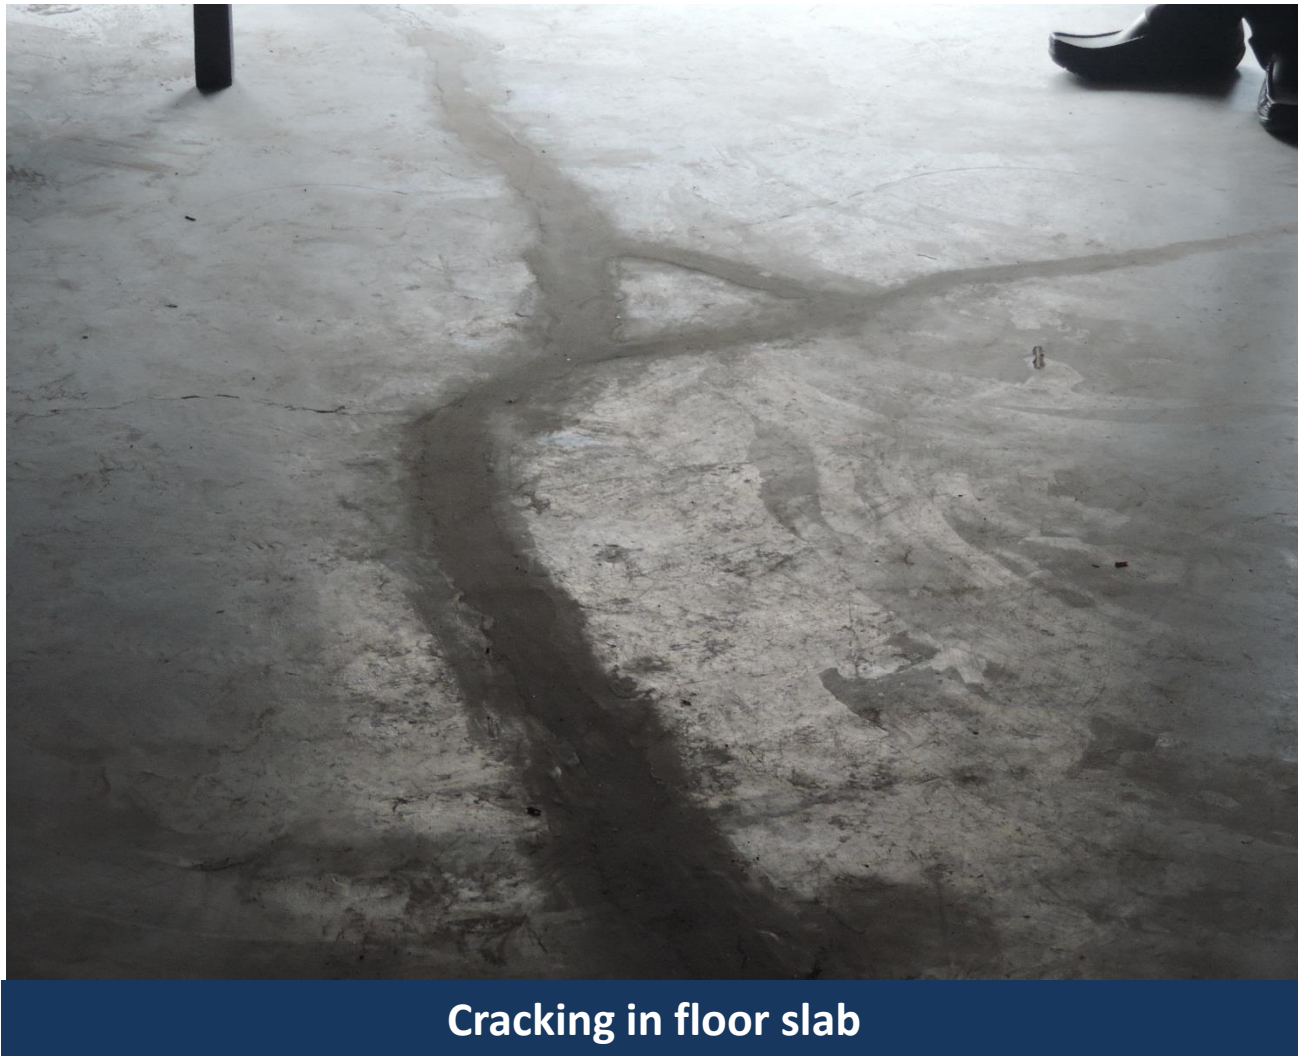
# Cracking in floor

**ITEM 3:** Cracking in floor slab

| Item No. | Observation | Recommended Action Plan | Recommended Timeline |
|---|---|---|---|
| 17 | Building 3: Cracking in floor slab | Engineer to review the cracking in the floor slab. Possible settlement cracks. | 6-weeks |
| 18 | Building 3: Cracking in floor slab | Carry out remedial works as directed by the engineering review | 6-months |

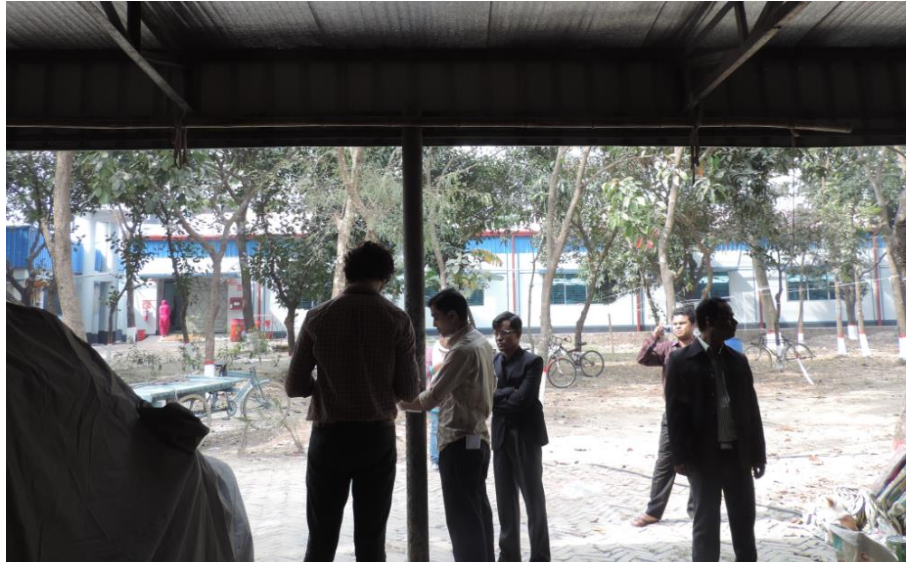
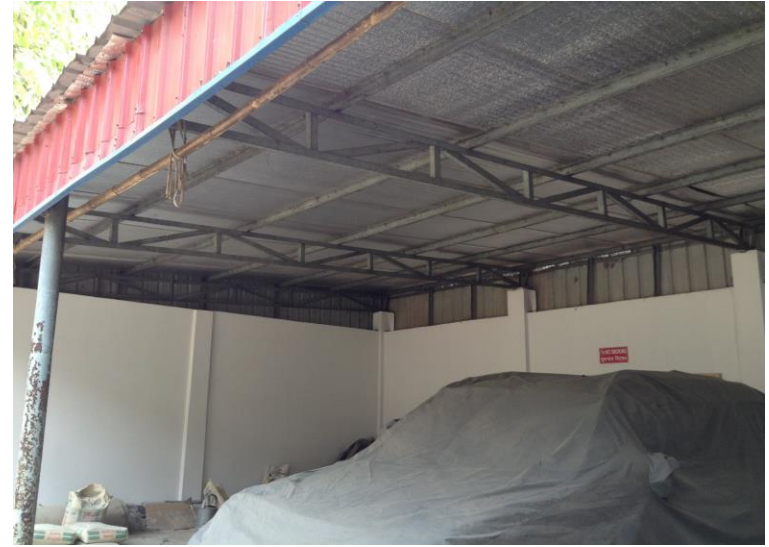
# Non-engineered roof structure

Non engineered roof structure to garage

**ITEM 1:** Non- engineered roof structure

| Item No. | Observation | Recommended Action Plan | Recommended Timeline |
|---|---|---|---|
| 19 | Building 4: Non- engineered roof structure | Engineer to review the roof structure. | 6-weeks |
| 20 | Building 4: Non- engineered roof structure | Carry out remedial works as directed by the engineering review | 6-months |

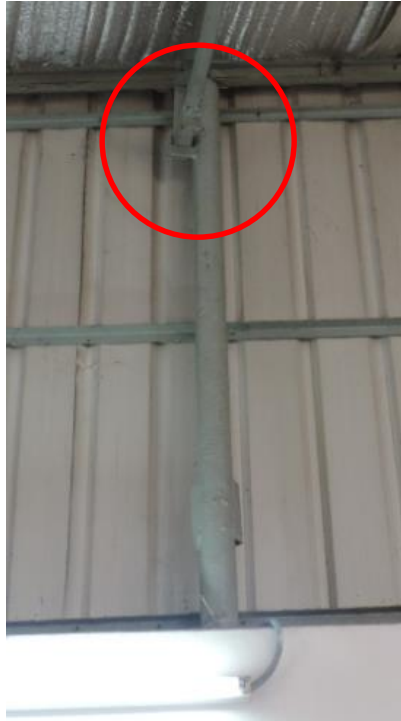
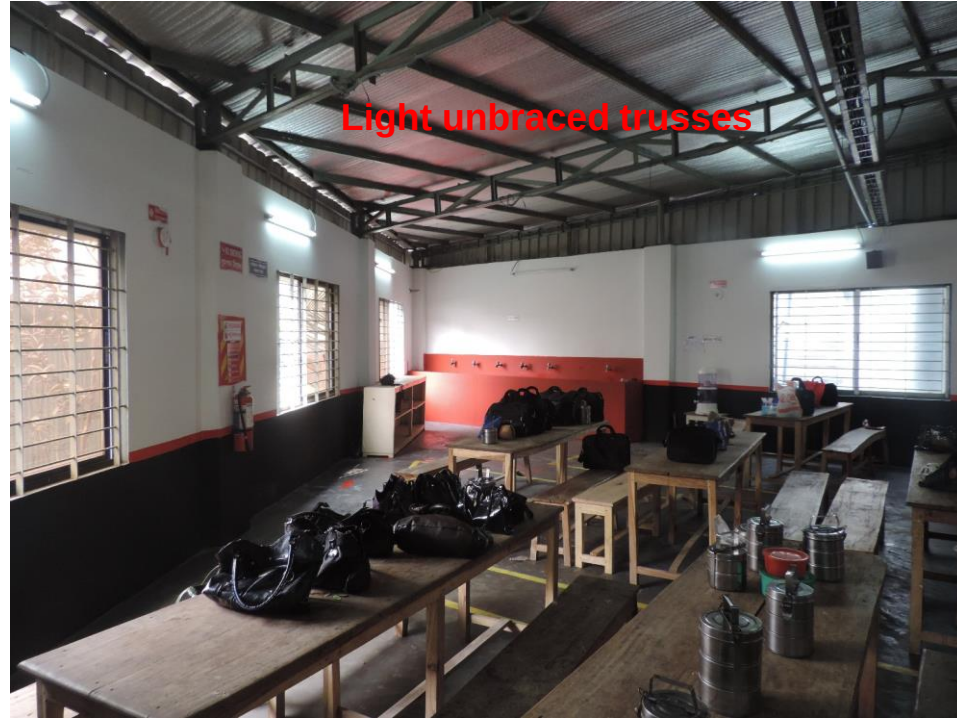
# **Non-engineered roof structure with poor steel to steel connections observed**

**Non engineered roof structure to Dining and generator building 5**

**ITEM 1:** Non- engineered roof structure with poor steel to steel connections observed

| Item No. | Observation | Recommended Action Plan | Recommended Timeline |
|---|---|---|---|
| 21 | Building 5: Non- engineered roof structure with poor steel to steel connections observed | The engineer to review the roof structure. | 6-weeks |
| 22 | Building 5: Non- engineered roof structure with poor steel to steel connections observed | Carry out remedial works as directed by the engineering review | 6-months |

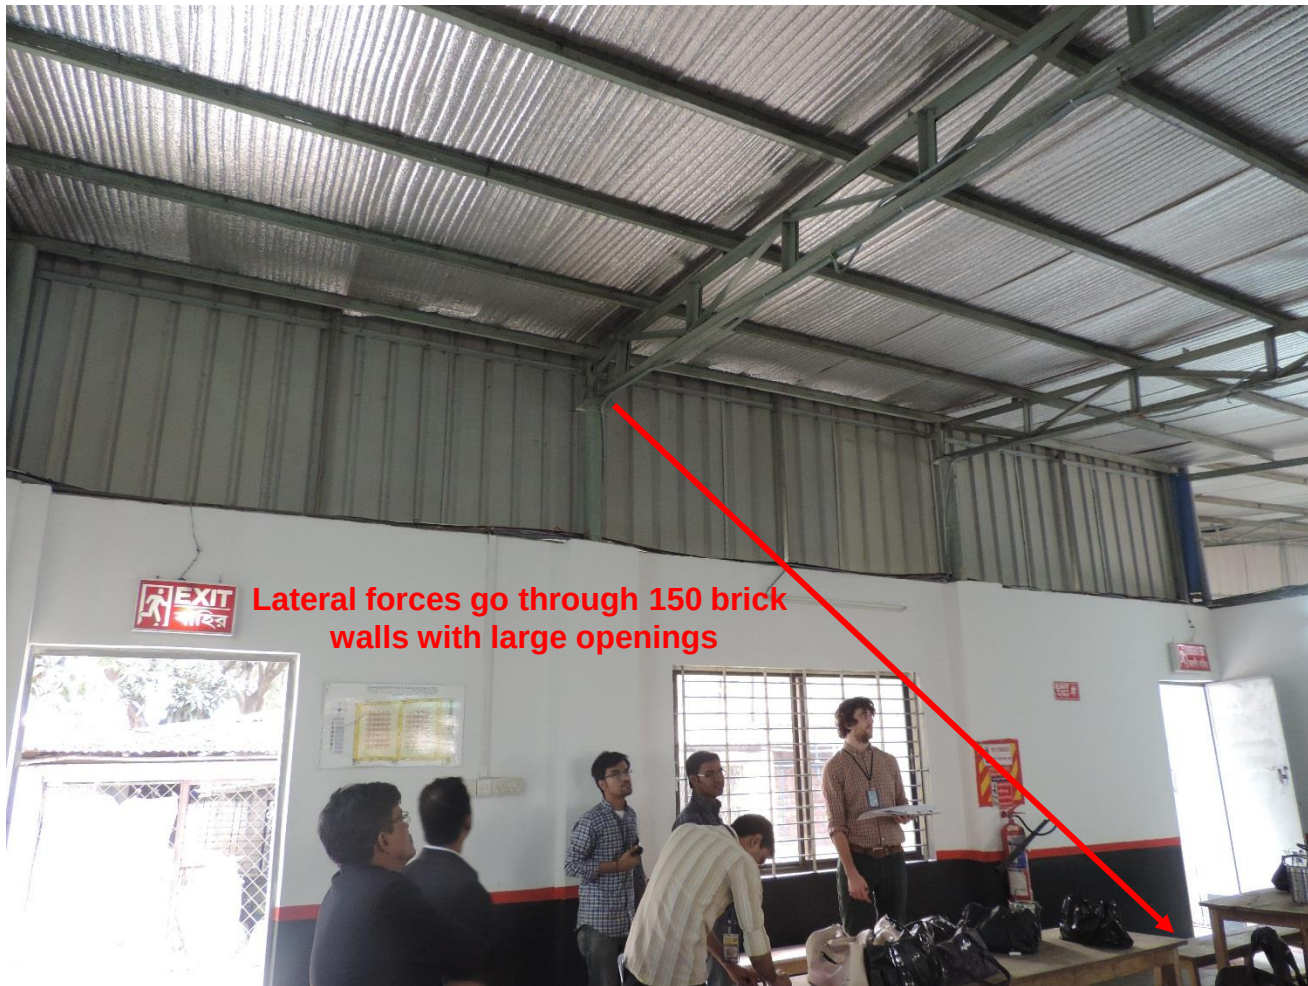
**Lateral bracing system reliant on external wall and cantilever columns.**

**Lateral bracing system reliant on external walls**

**ITEM 2:** Lateral bracing system reliant on external wall and cantilever columns.

| Item No. | Observation | Recommended Action Plan | Recommended Timeline |
|---|---|---|---|
| 23 | Building 5: Lateral bracing system reliant on external wall and cantilever columns | The engineer to review how the structure resist lateral load | 6-weeks |
| 24 | Building 5: Lateral bracing system reliant on external wall and cantilever columns | Carry out remedial works as directed by the engineering review | 6-months |
