# South End Sweater Co Ltd.

House 70, Block D, Road Mokom Ali Sarker, Ward 03, Turag, Dhaka - 1230.

14<sup>th</sup> February 2015

# Observations

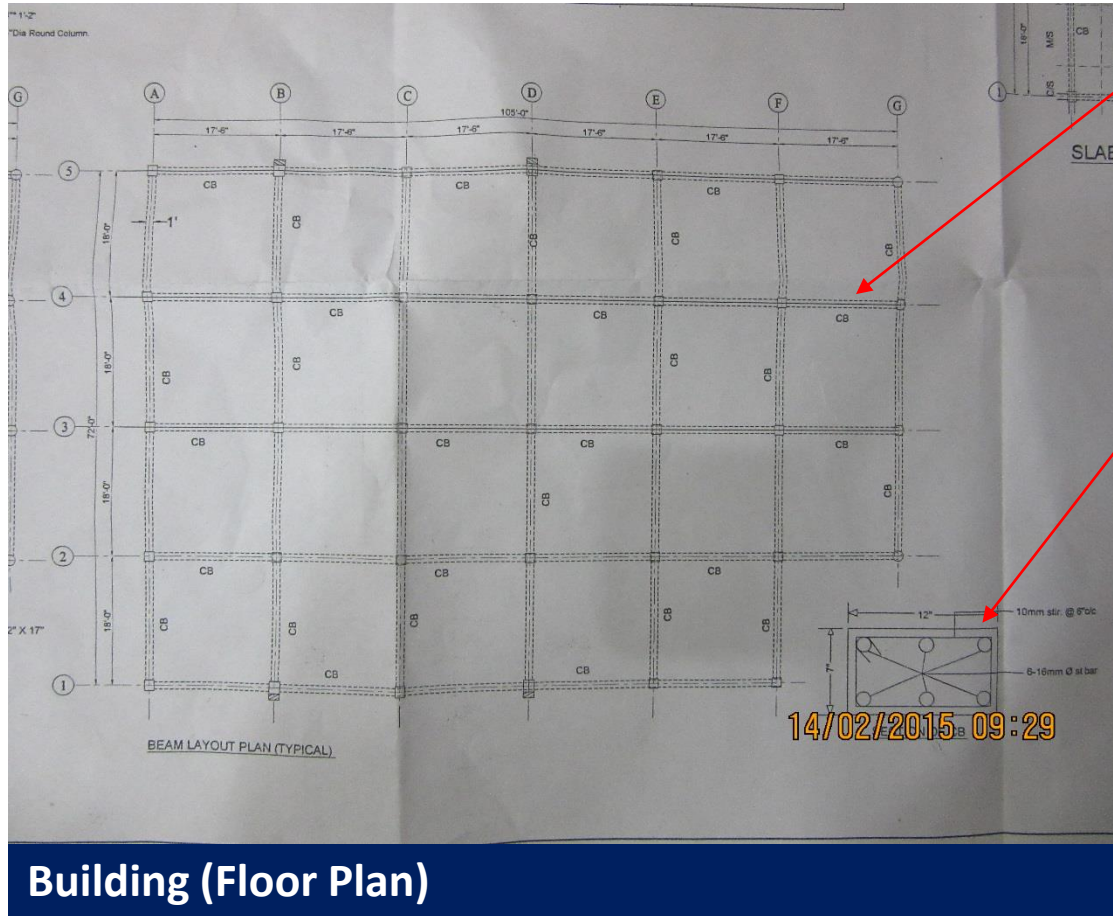
# **Discrepancy in slab reinforcement between drawings and site**

**Concealed beams (CB):**  
Drawing shows concealed R.C. beam reinforcement (contained in depth of slab) in column strips.

Contractor opened small area of slab at 3<sup>rd</sup> floor level and there was no evidence of CB rebar.

| Item No. | Observation | Recommended Action Plan | Recommended Timeline |
|---|---|---|---|
| 3 | Discrepancies in reinforcement between drawings and site | Factory engineer to verify presence of reinforcement shown in "CD" column strips in suspended slabs. Verify adequacy of design if "CD" reinforcement is not present throughout all suspended floor plates | 6-weeks |
| 4 | Discrepancies in reinforcement between drawings and site | Carry out remedial action as required by factory engineer | 6-months |

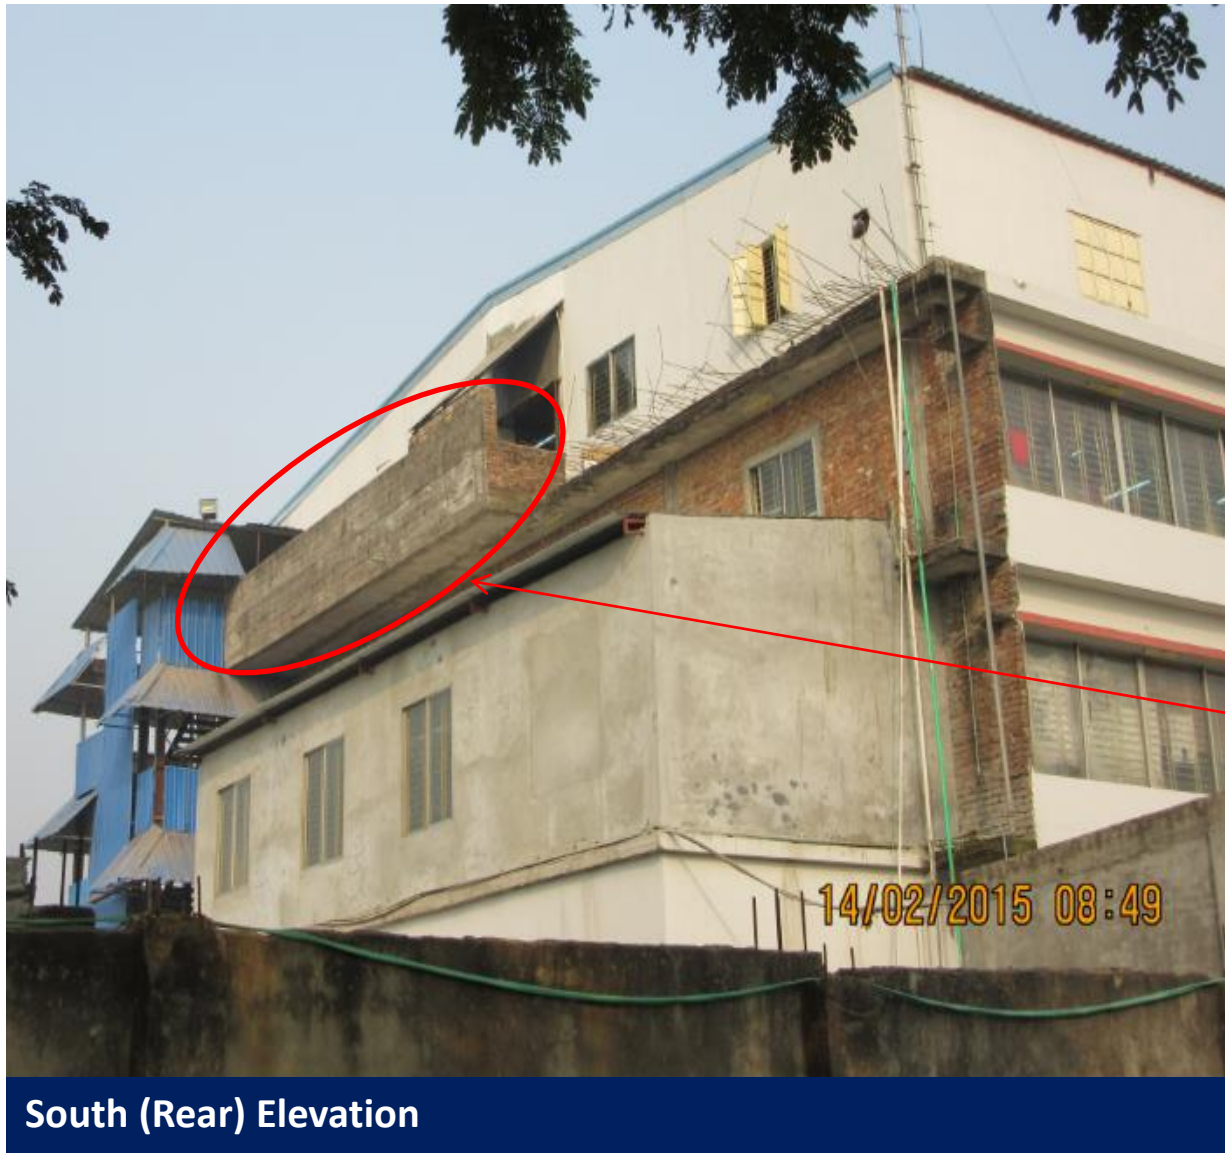
**Cantilevered Slab at 3<sup>rd</sup>  
floor level**

**Cantilevered walkway south of main  
building at 3rd floor level not on drawings**

| Item No. | Observation | Recommended Action Plan | Recommended Timeline |
|---|---|---|---|
| 5 | Cantilevered walkway south of main building at 3rd floor level not on drawings | Factory engineer to review cantilevered slab to south of building B1 at Level 3 and check its structural adequacy. | 6-weeks |
| 6 | Cantilevered walkway south of main building at 3rd floor level not on drawings | Carry out remedial works as required | 6-months |
| 7 | Cantilevered walkway south of main building at 3rd floor level not on drawings | Update as "built drawings" | 6-months |

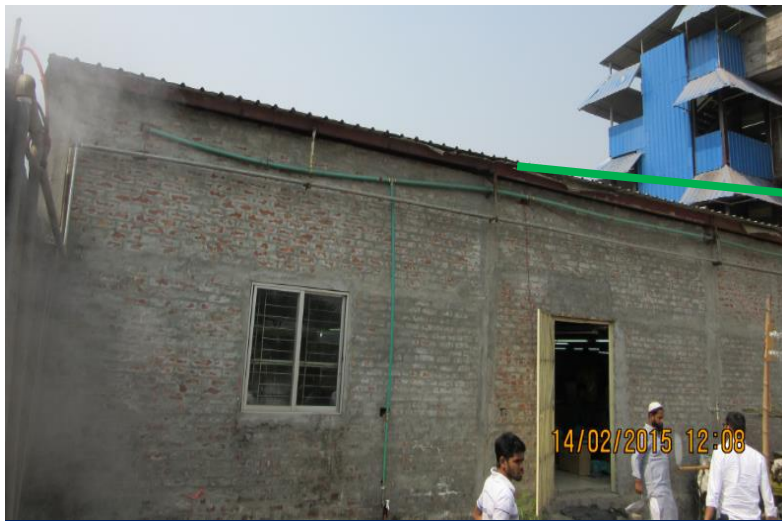
East Elevation Building B 2

# **Apparently non-engineered roof structure in Shed 1 Building B 2**

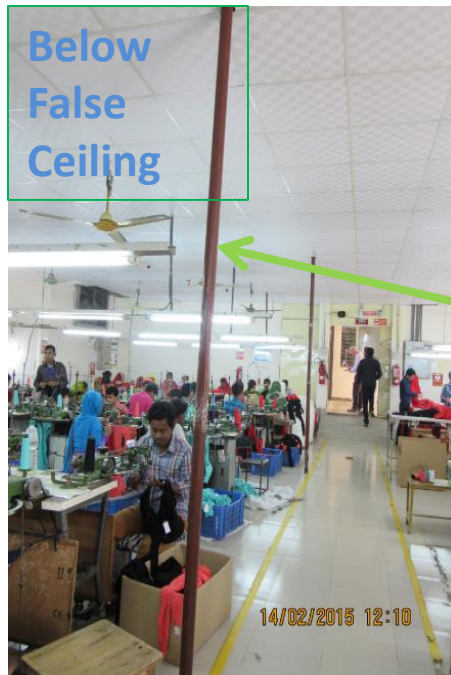
Below  
False  
Ceiling

60mm Circular Hollow Section  
support.  
Support not under nodal  
point on truss.

| Item No. | Observation | Recommended Action Plan | Recommended Timeline |
|---|---|---|---|
| 8 | Apparently non-engineered roof structure in Shed 1 Building B2 | Factory engineer to check that 60mm diameter Circular Hollow Section (CHS) columns have sufficient capacity to support roof. | 6-weeks |
| 9 | Apparently non-engineered roof structure in Shed 1 Building B2 | Engineer to confirm roof truss bottom boom has capacity to support CHS bending and shear stresses. | 6-weeks |
| 10 | Apparently non-engineered roof structure in Shed 1 Building B2 | Carry out remedial actions as required | 6-months |

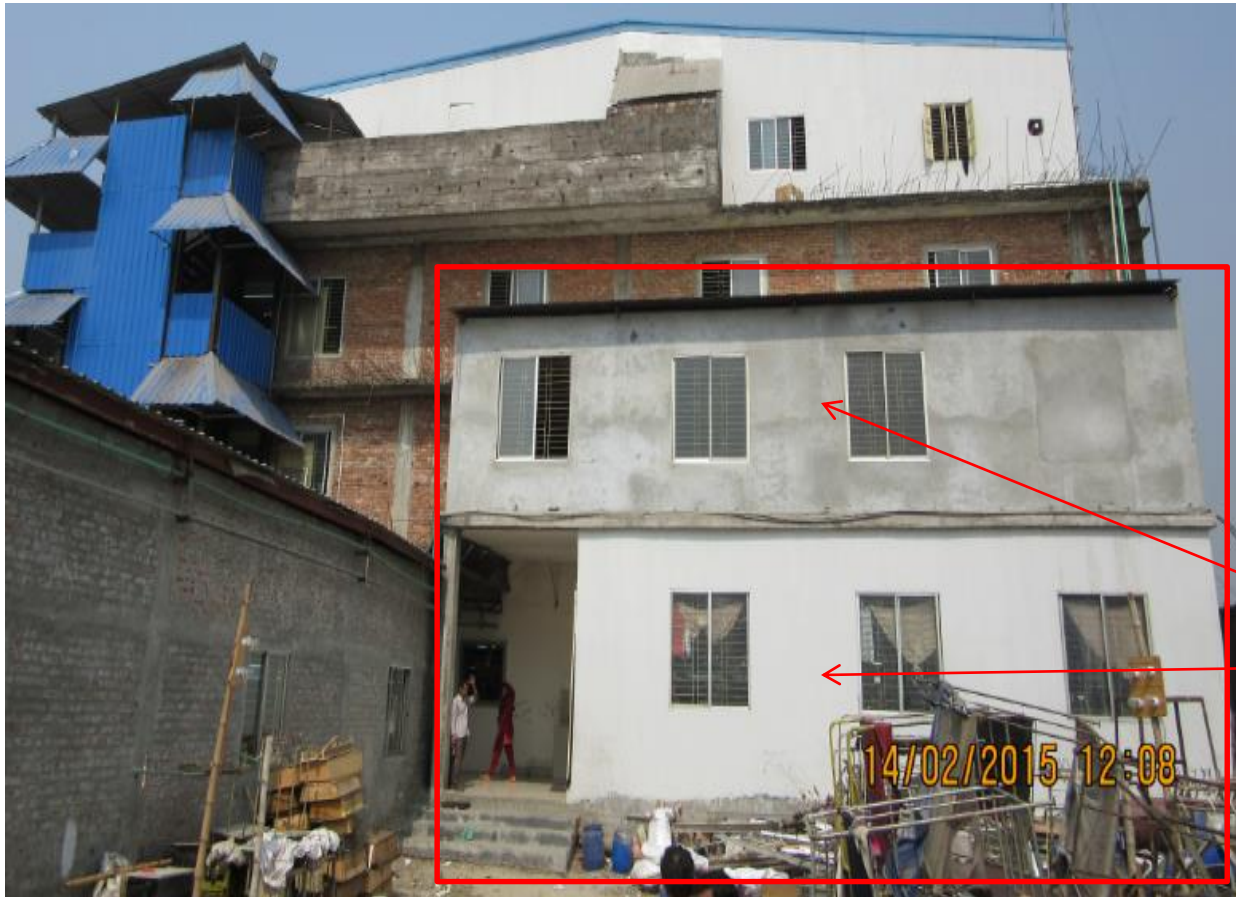
South (Rear) Elevation

No permit has been received for this two storey extension at the rear of the building B1

| Item No. | Observation | Recommended Action Plan | Recommended Timeline |
|---|---|---|---|
| 11 | Permit Approval for two Extension to South of Main Building still required | Owner liaise with local authority to establish status of Building Permit for Two Story Extension to South of Main Building | 6-months |

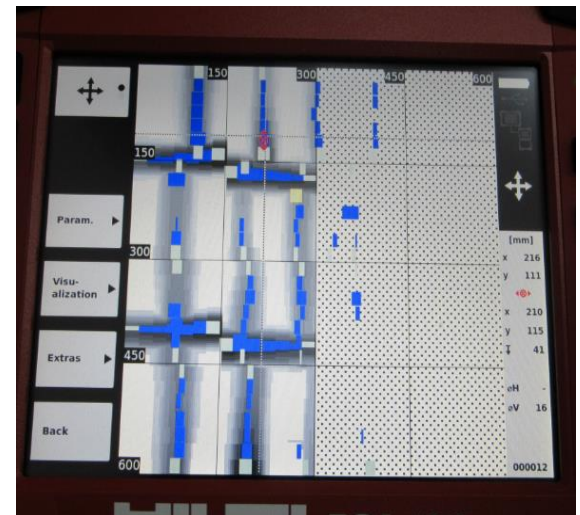
Reinforcement scan agrees with drawing information and reinforcement at the tested column
