# Rizvi fashions Ltd.

Anwar Jang Road, 1 No. Kalma Bazar, Savar  
(23.87805944N, 90.28969194E)

15<sup>th</sup> February 2015

# Observations

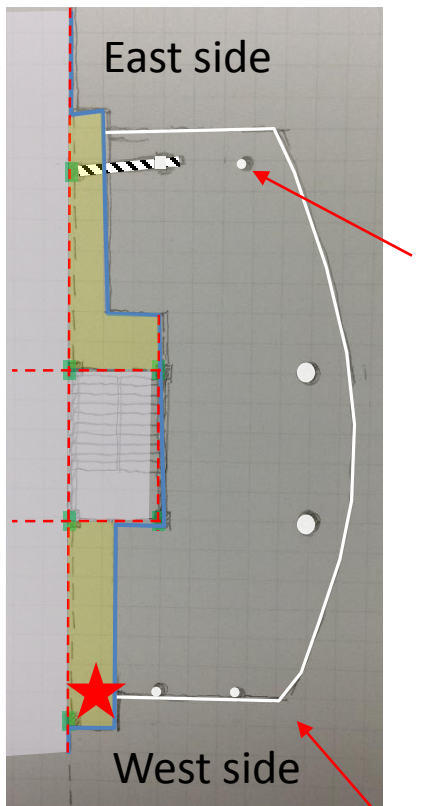
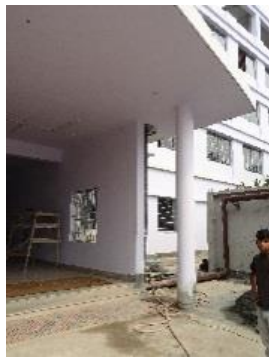
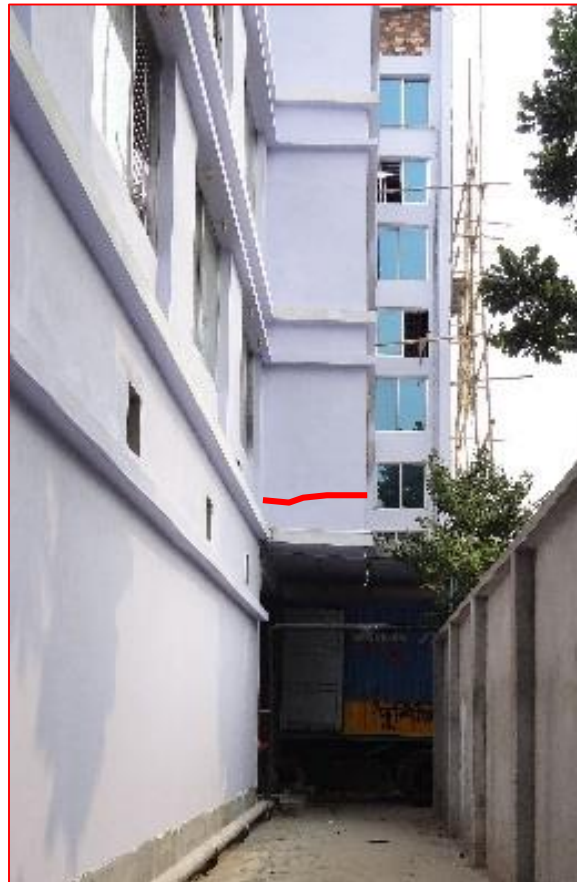
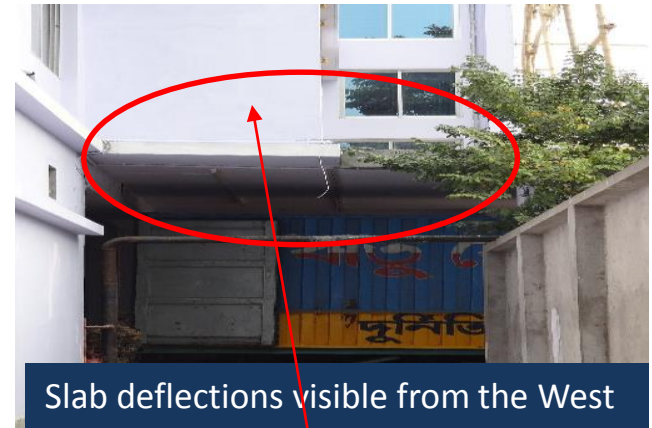
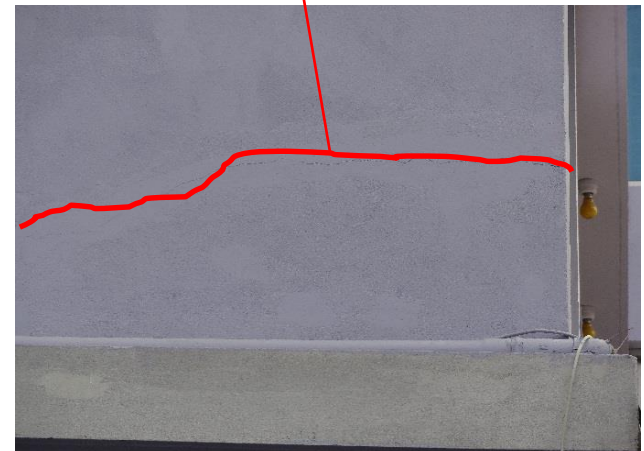
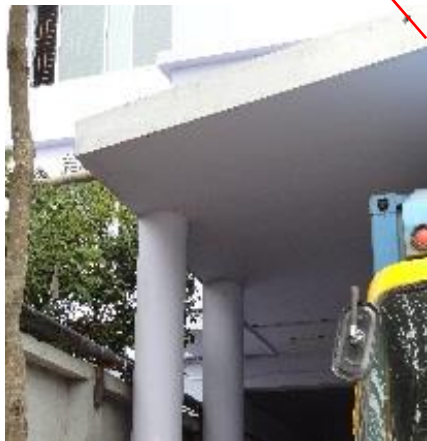
# **Cracking above 1<sup>st</sup> Floor on the cantilever part and the entrance porch**

Possible deflection of first floor cantilever / canopy slab due to following works , causing cracking in supported external brickwork wall (red star).

| Item No. | Observation | Recommended Action Plan | Recommended Timeline |
|---|---|---|---|
| 1 | Cracking to 1st floor level on the cantilever part and the entrance porch | An Engineering Assessment of the cantilever parts on the main entrance porch (east and west sides) of the Factory Building to be carried out. | 6-weeks |
| 2 | Cracking to 1st floor level on the cantilever part and the entrance porch | Factory Engineer to review design, loads and slab stresses in the entering porch and cantilevers using a model based design check to loading set out in BNBC-2006. | 6-weeks |
| 3 | Cracking to 1st floor level on the cantilever part and the entrance porch | Do not load the zones of the cantilever until the end of the Engineering Assessment. | 6-weeks |
| 4 | Cracking to 1st floor level on the cantilever part and the entrance porch | Make structural alterations as advised by Engineer. Sections of plaster finish to be removed to investigate if cracks penetrate the building structure. Building Engineer to review further if cracks are found to penetrate into building structure. | 6-months |
| 5 | Cracking to 1st floor level on the cantilever part and the entrance porch | Carry out repair remedial works as required. | 6-months |
| 6 | Cracking to 1st floor level on the cantilever part and the entrance porch | Continue to monitor for cracking on an on-going basis. | 6-months |

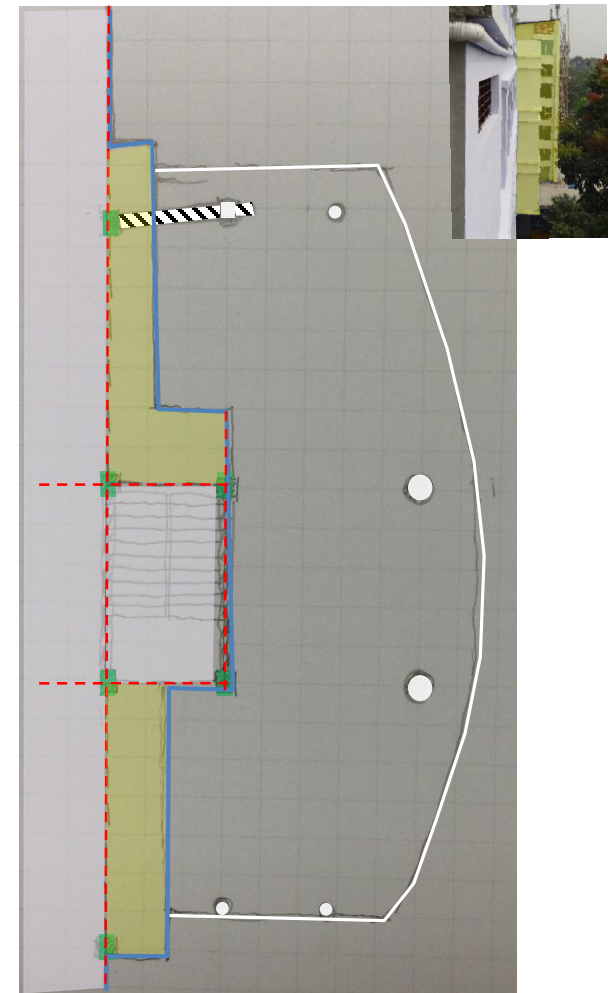
As-constructed

Canopy size and spans are reduced compared with design. However the canopy has been constructed at a flat slab with no beams.

| Item No. | Observation | Recommended Action Plan | Recommended Timeline |
|---|---|---|---|
| 7 | Discrepancies between structural drawings and the as-constructed arrangement of the factory | Building engineer to survey as constructed building. Updated drawings to be prepared showing the correct as constructed layout. | 6-months |

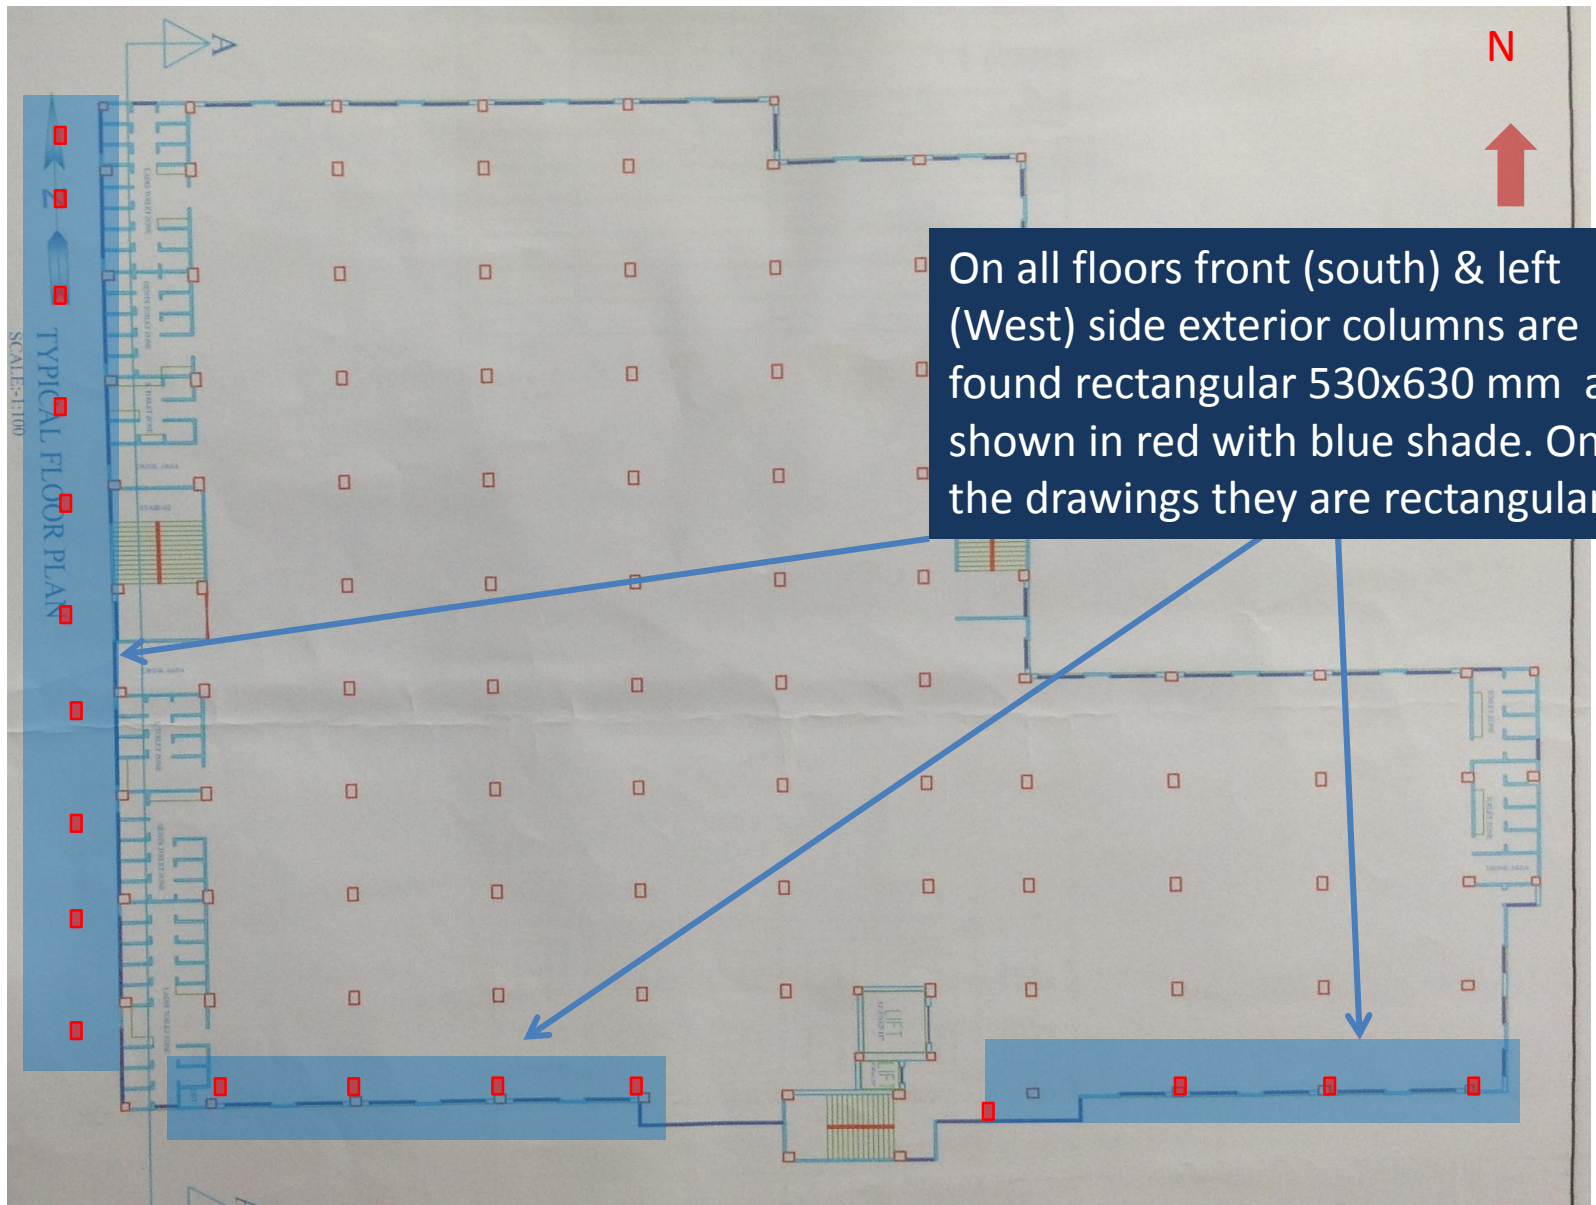
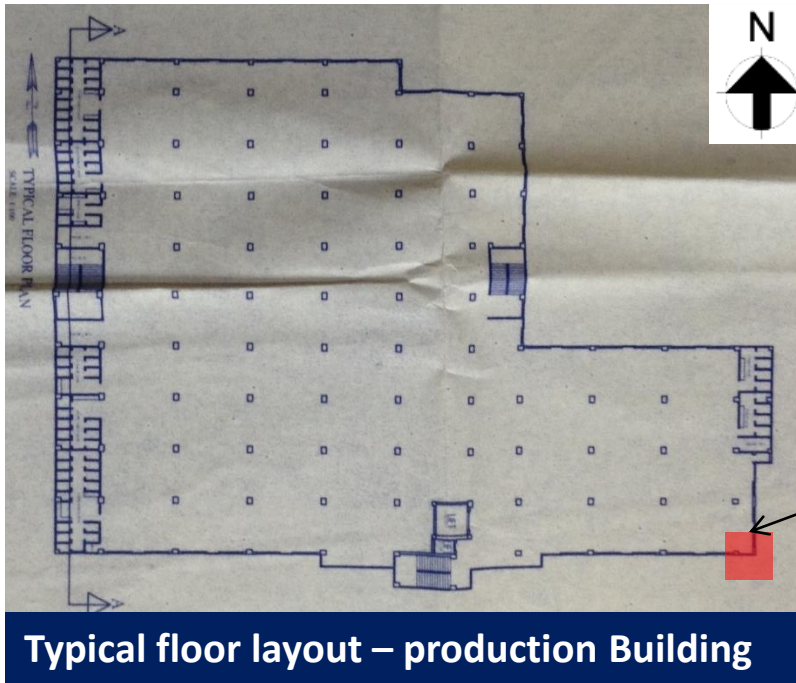
# Hairline cracking in the cantilever part

**Hairline cracking in the cantilever part.**

| Item No. | Observation | Recommended Action Plan | Recommended Timeline |
|---|---|---|---|
| 8 | Hairline cracking in the cantilevers | Sections of plaster finish to be removed to investigate if cracks penetrate the building structure. Building Engineer to review further if cracks are found to penetrate into building structure. | 6-months |
| 9 | Hairline cracking in the cantilevers | Carry out repair remedial works as required. | 6-months |
| 10 | Hairline cracking in the cantilevers | Continue to monitor for cracking on an on-going basis | 6-months |

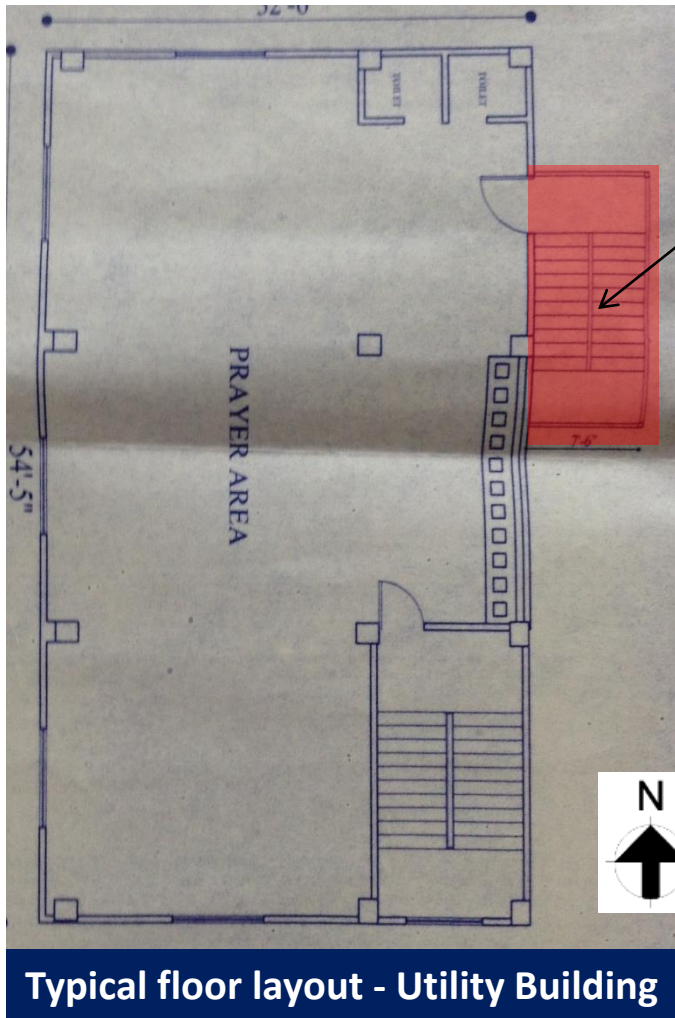
Typical floor layout - Utility Building

The evacuation stairs are not yet constructed, but they have plan to build it. This structure looks like a non engineering steel structure and there are no existing connection details.

| Item No. | Observation | Recommended Action Plan | Recommended Timeline |
|---|---|---|---|
| 11 | Apparently non engineered stair case structures | Before construction the Building Engineer to check the capacity of the lightweight stairs and make any necessary alterations. The connections to the Utility building must also be precise. | 6-months |
