Sirajgonj Fashions Ltd.

101/01/A, Barabagh, Mirpur-2, Dhaka – 1216, Mirpur, Dhaka, Bangladesh.
(23.803278N, 90.364693E)

18th February 2015

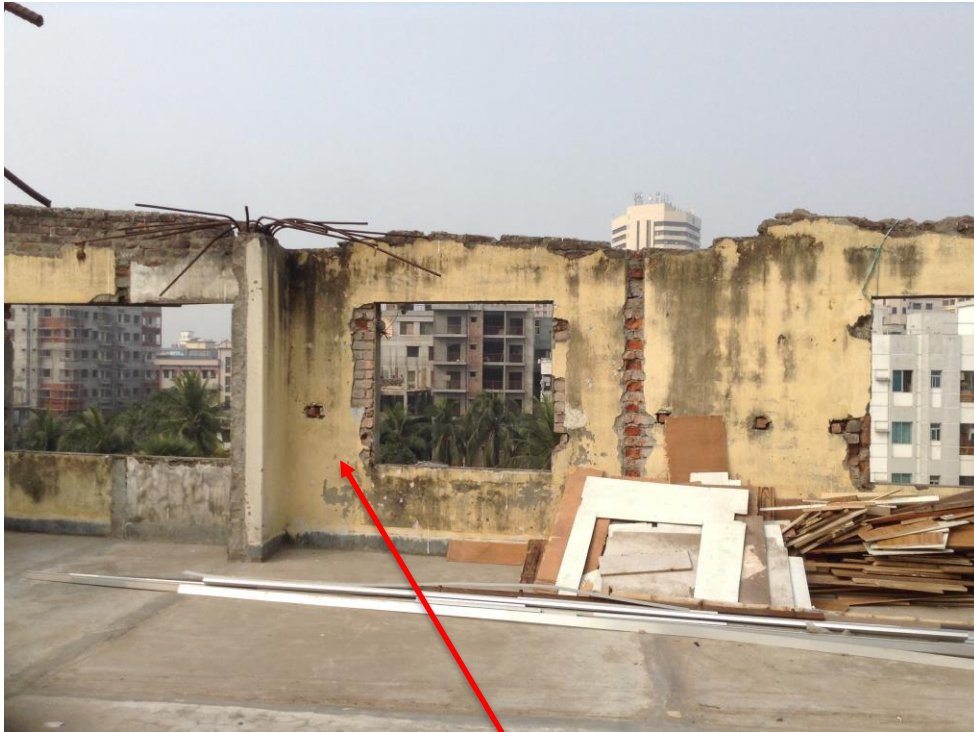
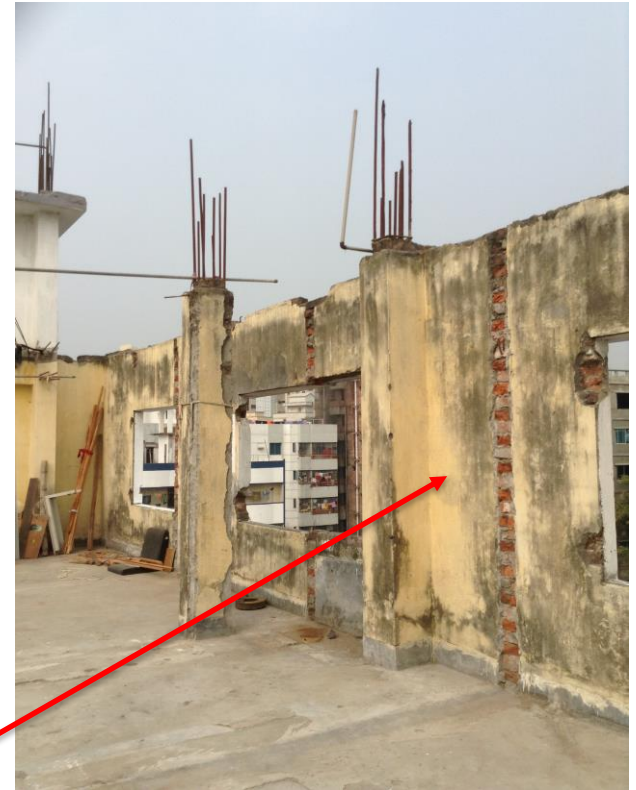
Unbraced brick walls at 5th floor level

Unbraced perimeter brick walls at 5th floor level

Item No.	Observation	Recommended Action Plan	Recommended Timeline
1	Unbraced perimeter walls at 5th floor level	Factory Engineer to check brick wall stability and devise appropriate action.	6-weeks
2	Unbraced perimeter walls at 5th floor level	Implement recommended actions	6-weeks
3	High Punching Shear Stress	Factory Engineer to review design, loads and slab stresses in area identified above. In situ concrete strength to be verified by taking 4 No 100 dia cores.	6-weeks
4	High Punching Shear Stress	Factory Engineer propose & implement remedial actions as appropriate	6-weeks
5	High Punching Shear Stress	Actively manage a loading plan for all floor plates within the factory giving consideration to floor capacity and column capacity.	6-months
6	Discrepancies between site observations and information on drawings	Factory Engineer to update the drawings to "as-constructed" status to reflect the actual column dimensions and alignments.	6-weeks

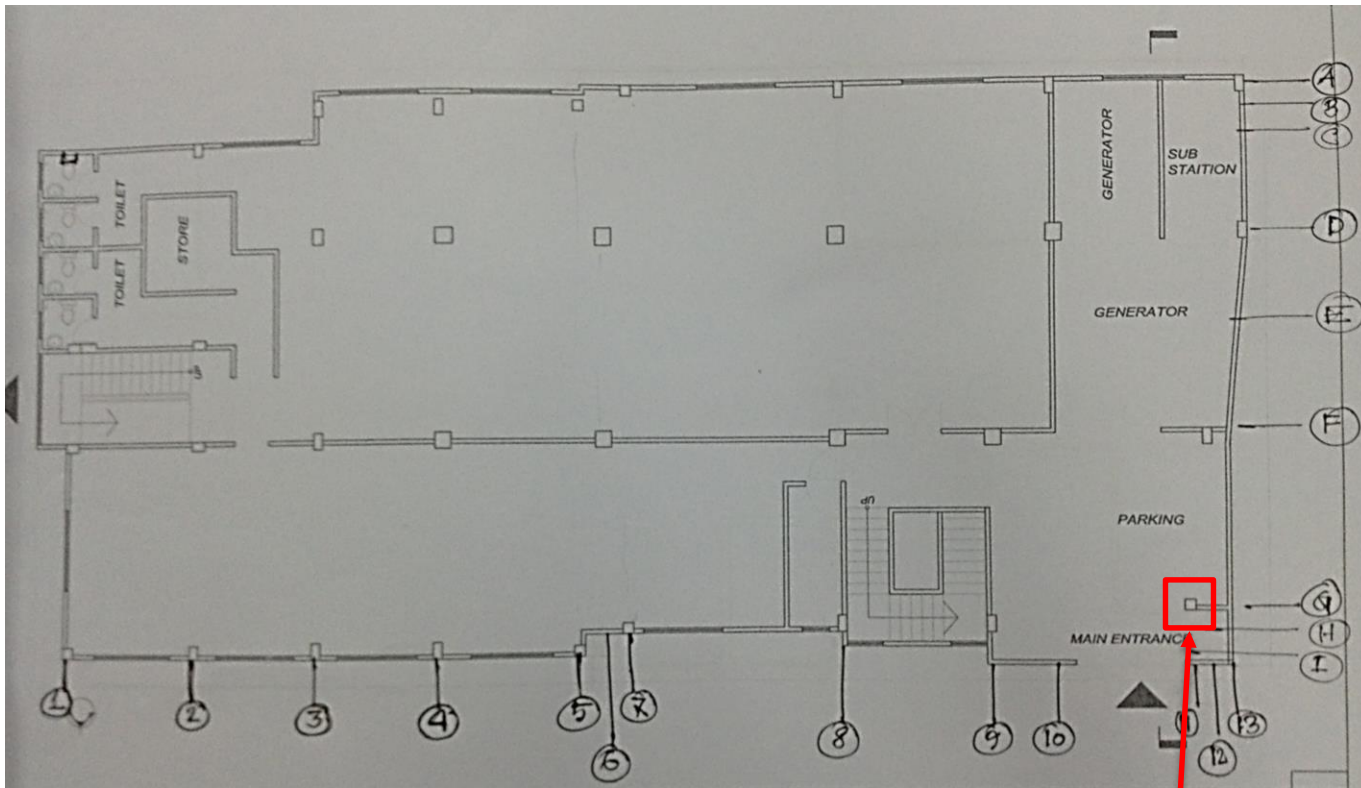
2nd Floor Plan

High Punching Shear Stress Level at Corner Column

High punching shear level at the column near toilet

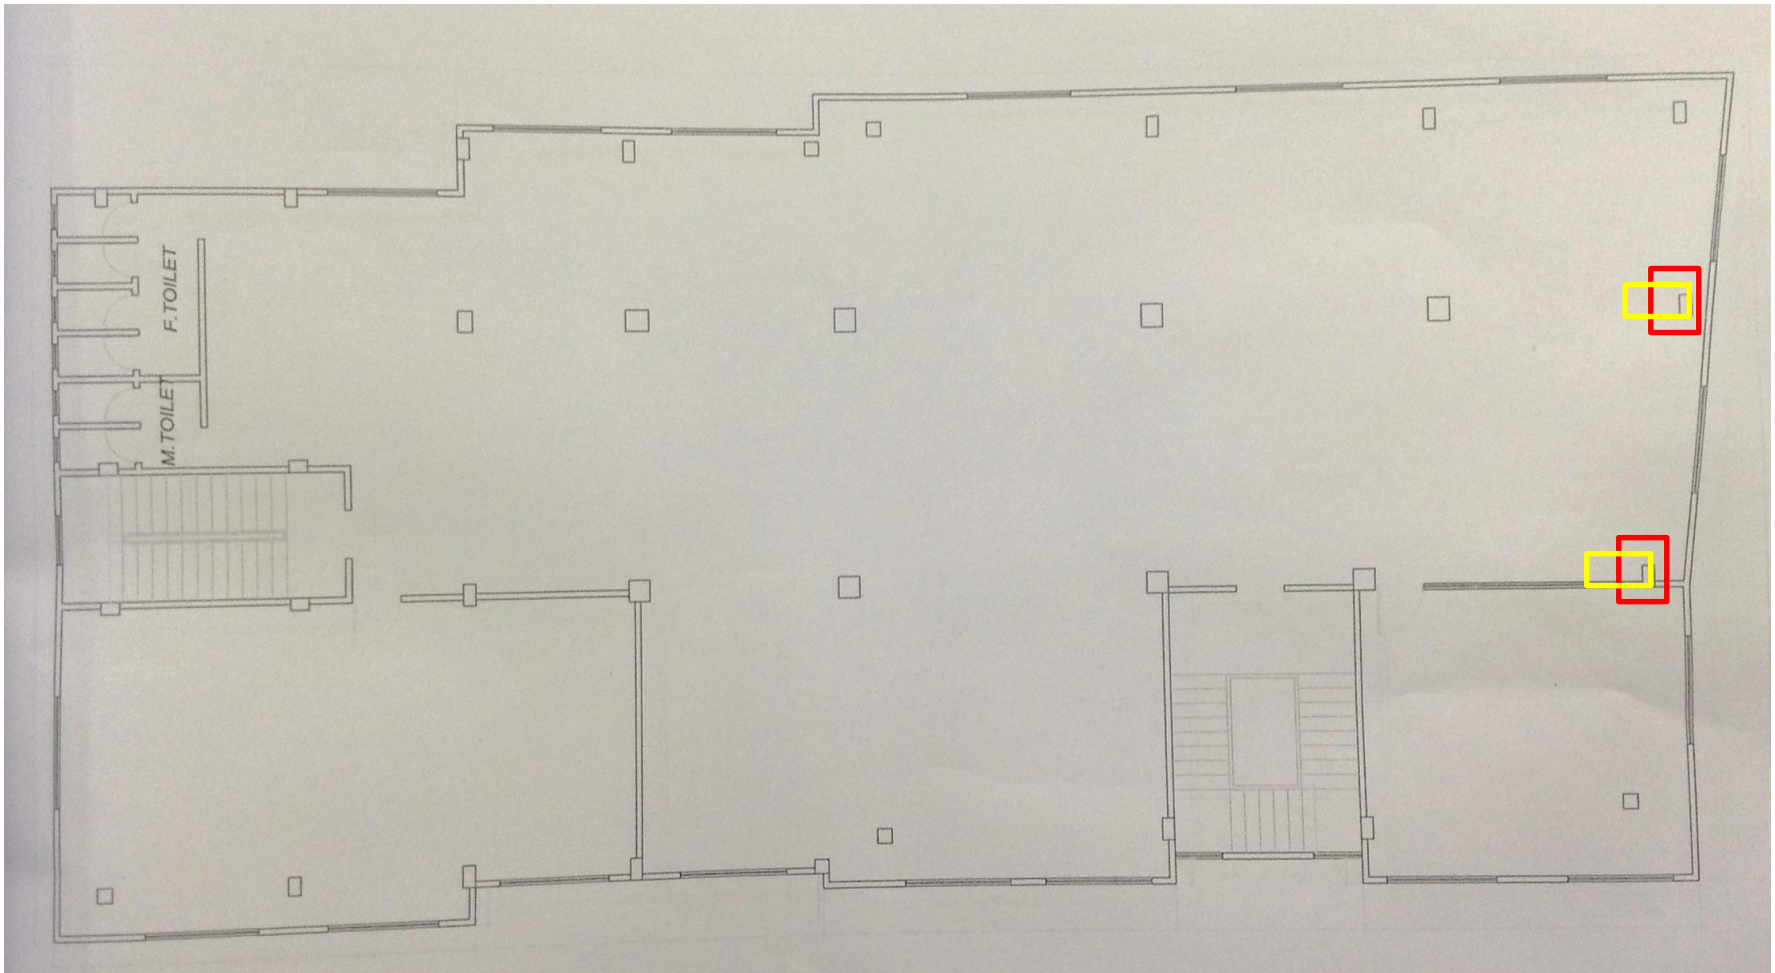
Discrepancies between site observations and information on drawings

Alignments of columns in drawings

Alignments alignment of columns observed on site

Most column dimensions are different on site from drawings.

7	Discrepancies between site observations and information on drawings	Column capacity checks to be undertaken if columns smaller than designed.	6-weeks
8	Apparently non-engineered Roof Structure	Factory engineer to check the capacity of the lightweight roof and make any necessary alterations.	6-months

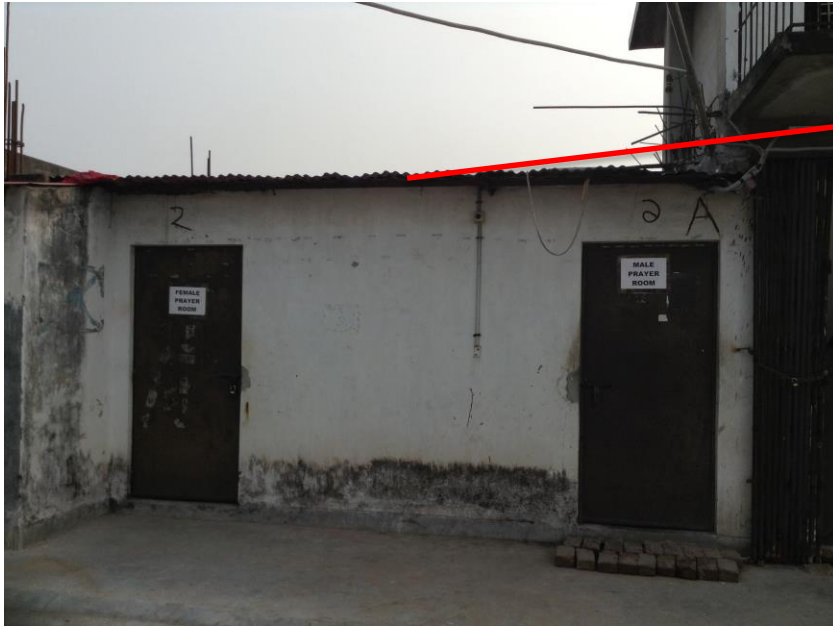
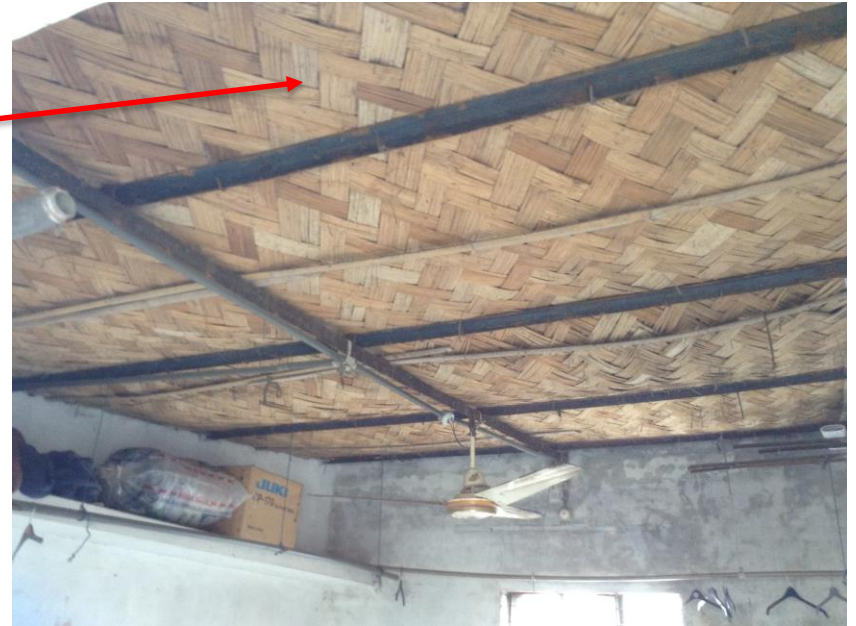
Apparently non engineered roof structures

Apparently non engineered roof structures used for prayer rooms
