Dekko Apparels Ltd. (10450)
Shamrin Tex Ltd (9187)
Agami Apparels Ltd

Plot #62, Kathgora, Amtola, Ashulia, Savar, Dhaka, Bangladesh

13.APRIL.2014

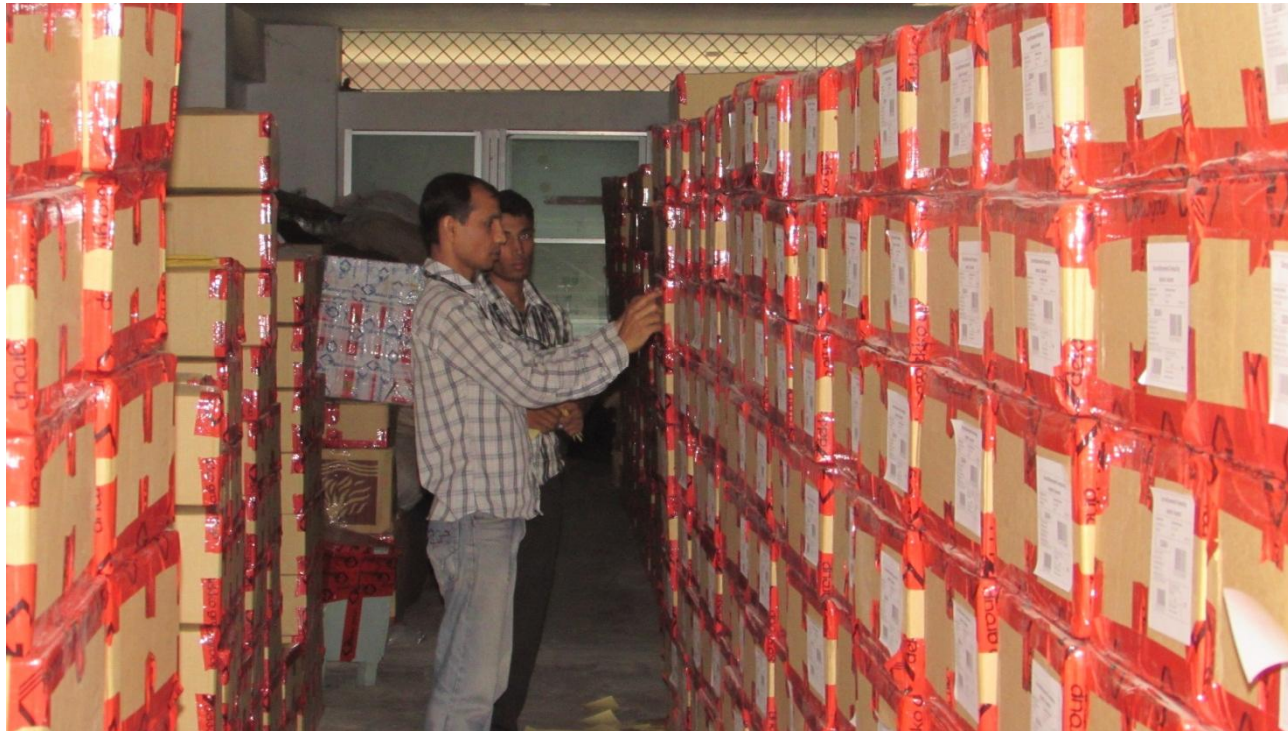
1st Priority 1 Concern

Excessive loading intensity in
storage areas

Each box of garment product is estimated to be approximately 9kg. As they are stacked 9 boxes high, the total weight is 81kg (0.795kN) per stack.

Based on a plan area of 0.3mx0.5m per stack, the equivalent live load per stack is estimated to be:

$$0.795\text{kN}/(0.3 \times 0.5)\text{m}^2 = 5.3\text{Kpa.}$$

The allowable live load is assumed to be a maximum of 3.0Kpa

- Immediately reduce the stacked height of product boxes to ensure total load does not exceed 3.0KPa.

- Develop floor loading plans. Mark the maximum allowable height of produce stacking to ensure full compliance.

- Maintain the loading plans and ensure that they are followed.

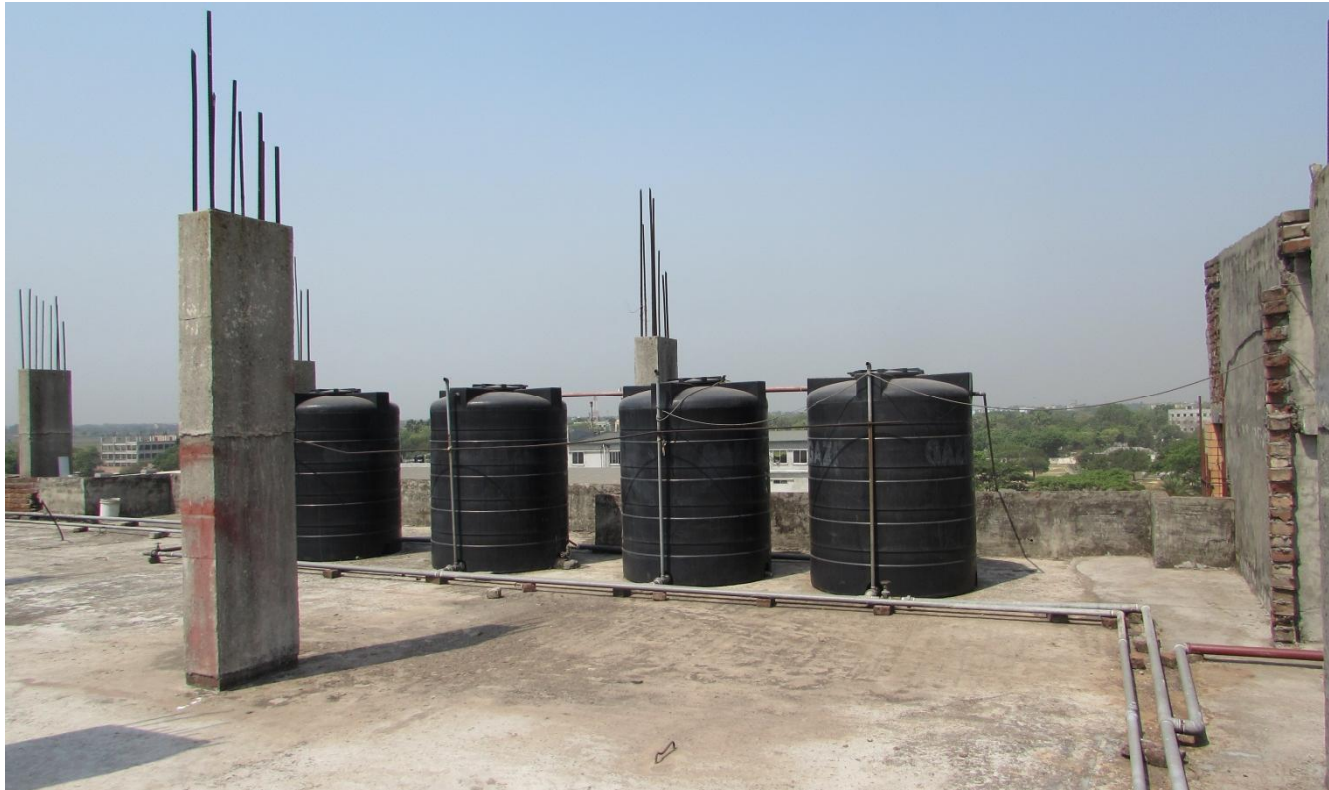
1st Priority 2 Concern

Each water tank is estimated to be approximately 3000kg, the total weight is 12 Ton (117.7 KN) per the area of $1.2 \times 6.0 \text{ m}^2$. This is a loading intensity of approx. 10kPa. The structure locally needs to be checked to make sure that it is capable of supporting this load. In the mean time the tanks should be spread out to minimise the intensity.

The four 3000 litre water tanks are placed too close together.

- Carry out design checks on the roof structure to check that they are able to support these high loads.

- Relocate and space the water tanks out on the roof level to avoid overloading for the supporting slab.

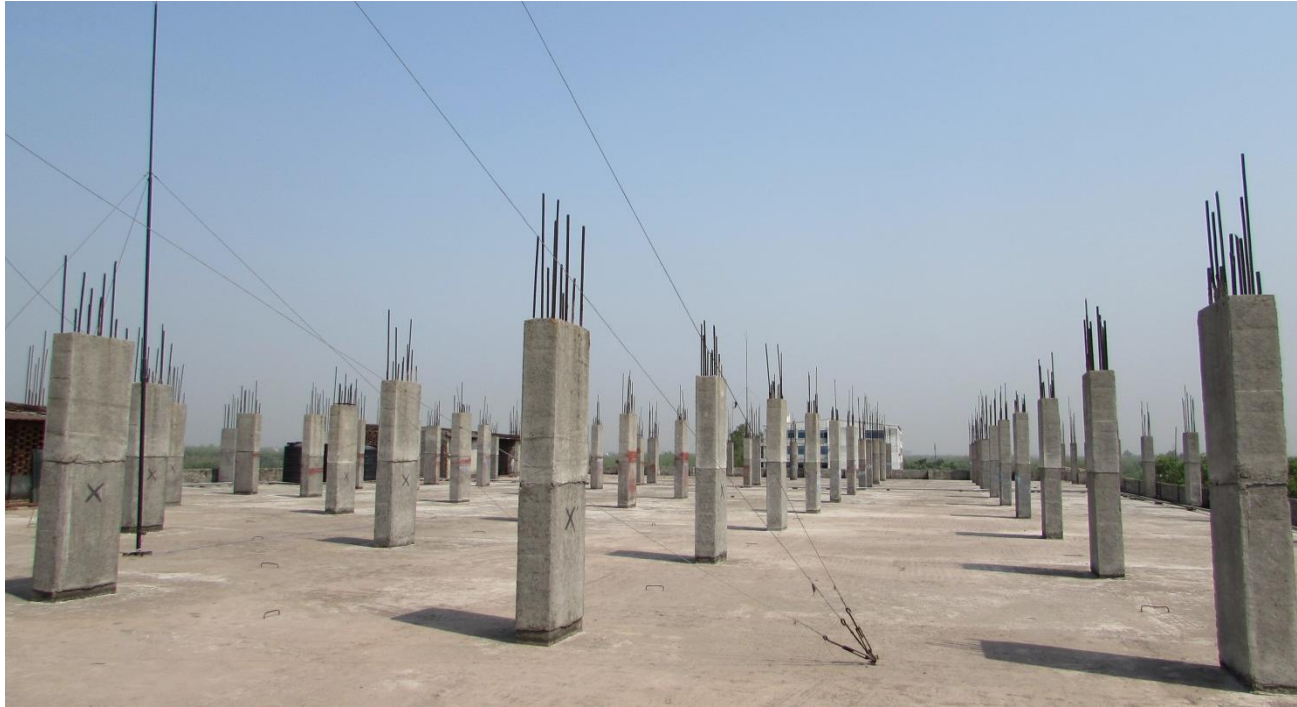
2nd Priority 2 Concern

Lack of proper waterproof layer

Waterproofing is not provided at the current roof level. In some locations the brick aggregate can be seen on the surface of the roof (5th floor). This poor construction has led to the water ingress seen on some of the lower levels. Water penetration will allow corrosion of the reinforcement and could possibly lead to future structural failure.

- Provide a proper waterproof layer on the existing roof level.
- Actions any recommendations resulting from the DEA.

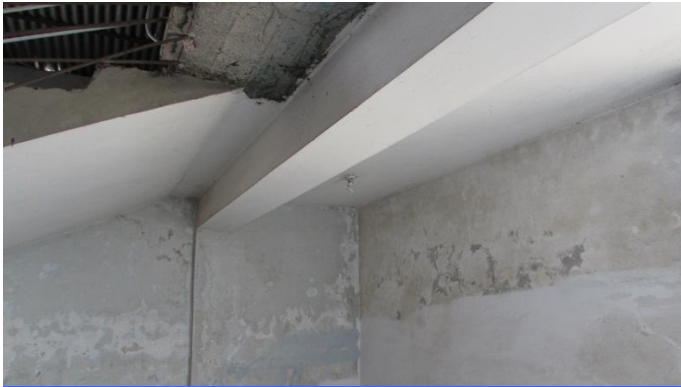
Water ingress on the stair wall

Water ingress

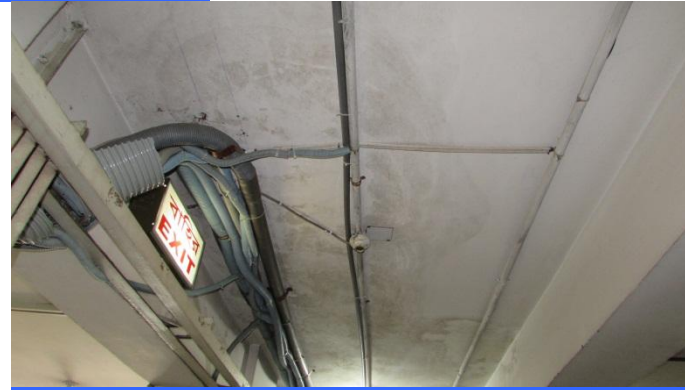
On the ceiling of the 4th floor level

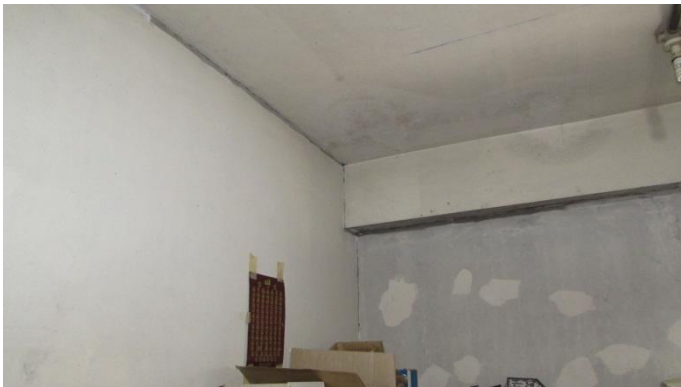
On ceiling of 4th floor

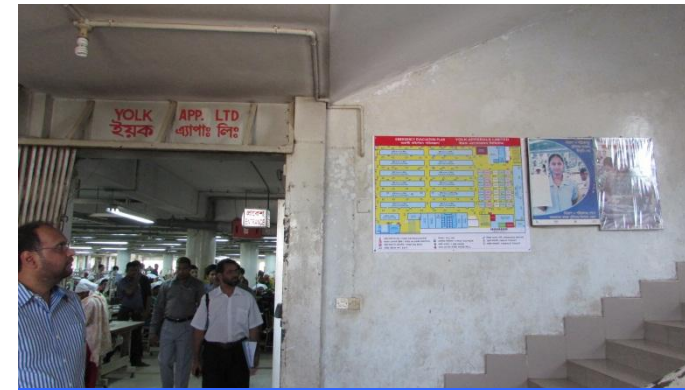
On a column / wall in a stair well

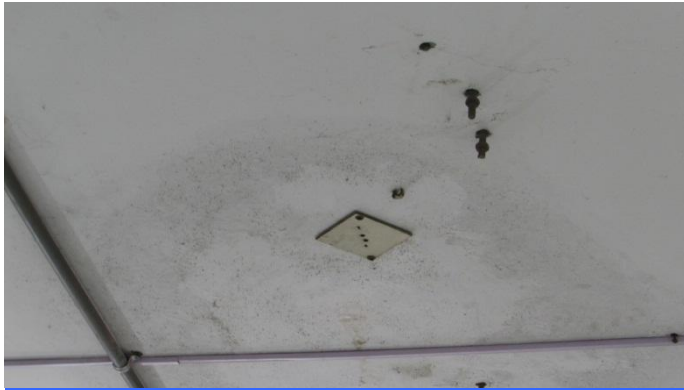
Cracks and water ingress on the ceiling of 4th floor level

Cracks on beams and slabs on various levels

- As part of the DEA, assess what has caused the cracking (part of the suggested Action 5.

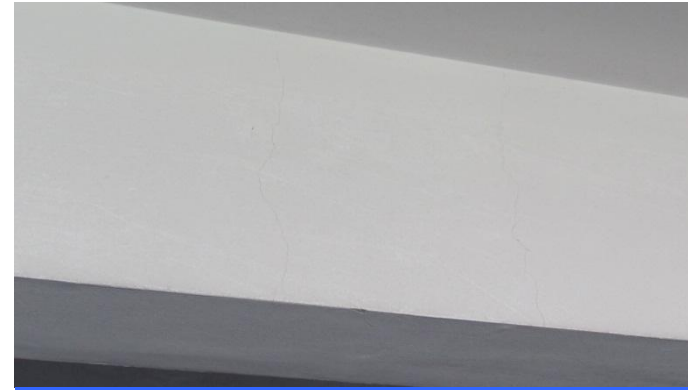
Cracks at the middle of a beam at 4th floor level (not clear in photo)

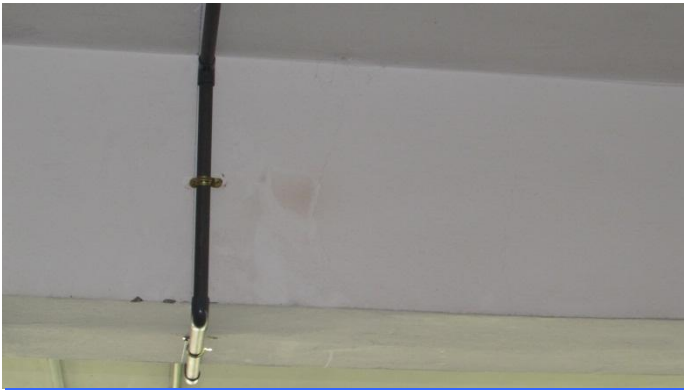
Cracks and water ingress on the beams of 4th floor level

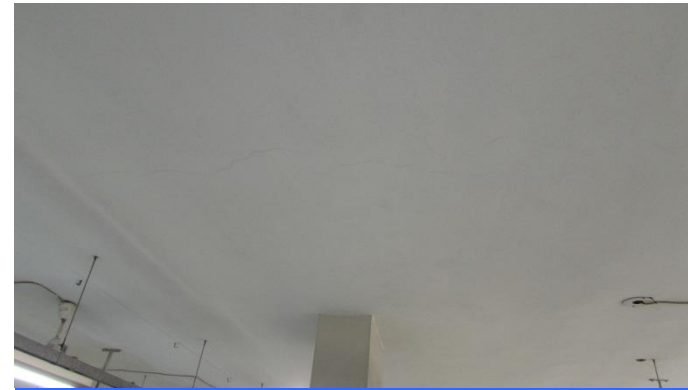
Cracks on the soffit of lower levels.

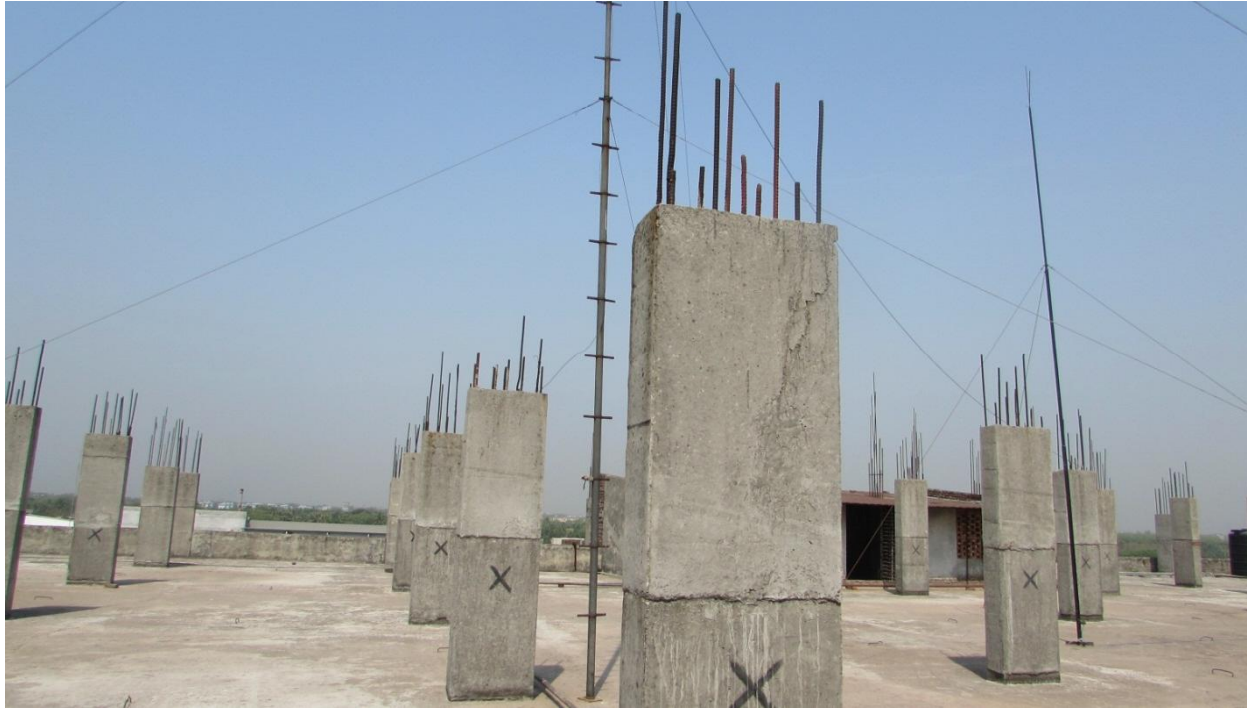
1st Priority 3 Concern

At the time of site investigation we were not provided with the full set of structural drawings. We were allowed to remove some concrete of a column at the ground floor level to determine re-bar diameter for. The columns surveyed are adequate with a reasonable loading assumption for the levels already built. However, adding one or more floors on the existing structure needs to be investigated as part of a Detailed Engineering Assessment before commenced.

With our preliminary calculation, the building will be rated as AMBER if 3 concrete stories would be built on top of the existing 5 story building as per drawing permit

It is intended to construct new levels above 5th floor level

- Carry out a Detailed Engineering Assessment to ensure that the existing structure is capable of supporting all planned extra levels.

- Cease construction at whatever level the Assessment determines the existing structure is capable of supporting.

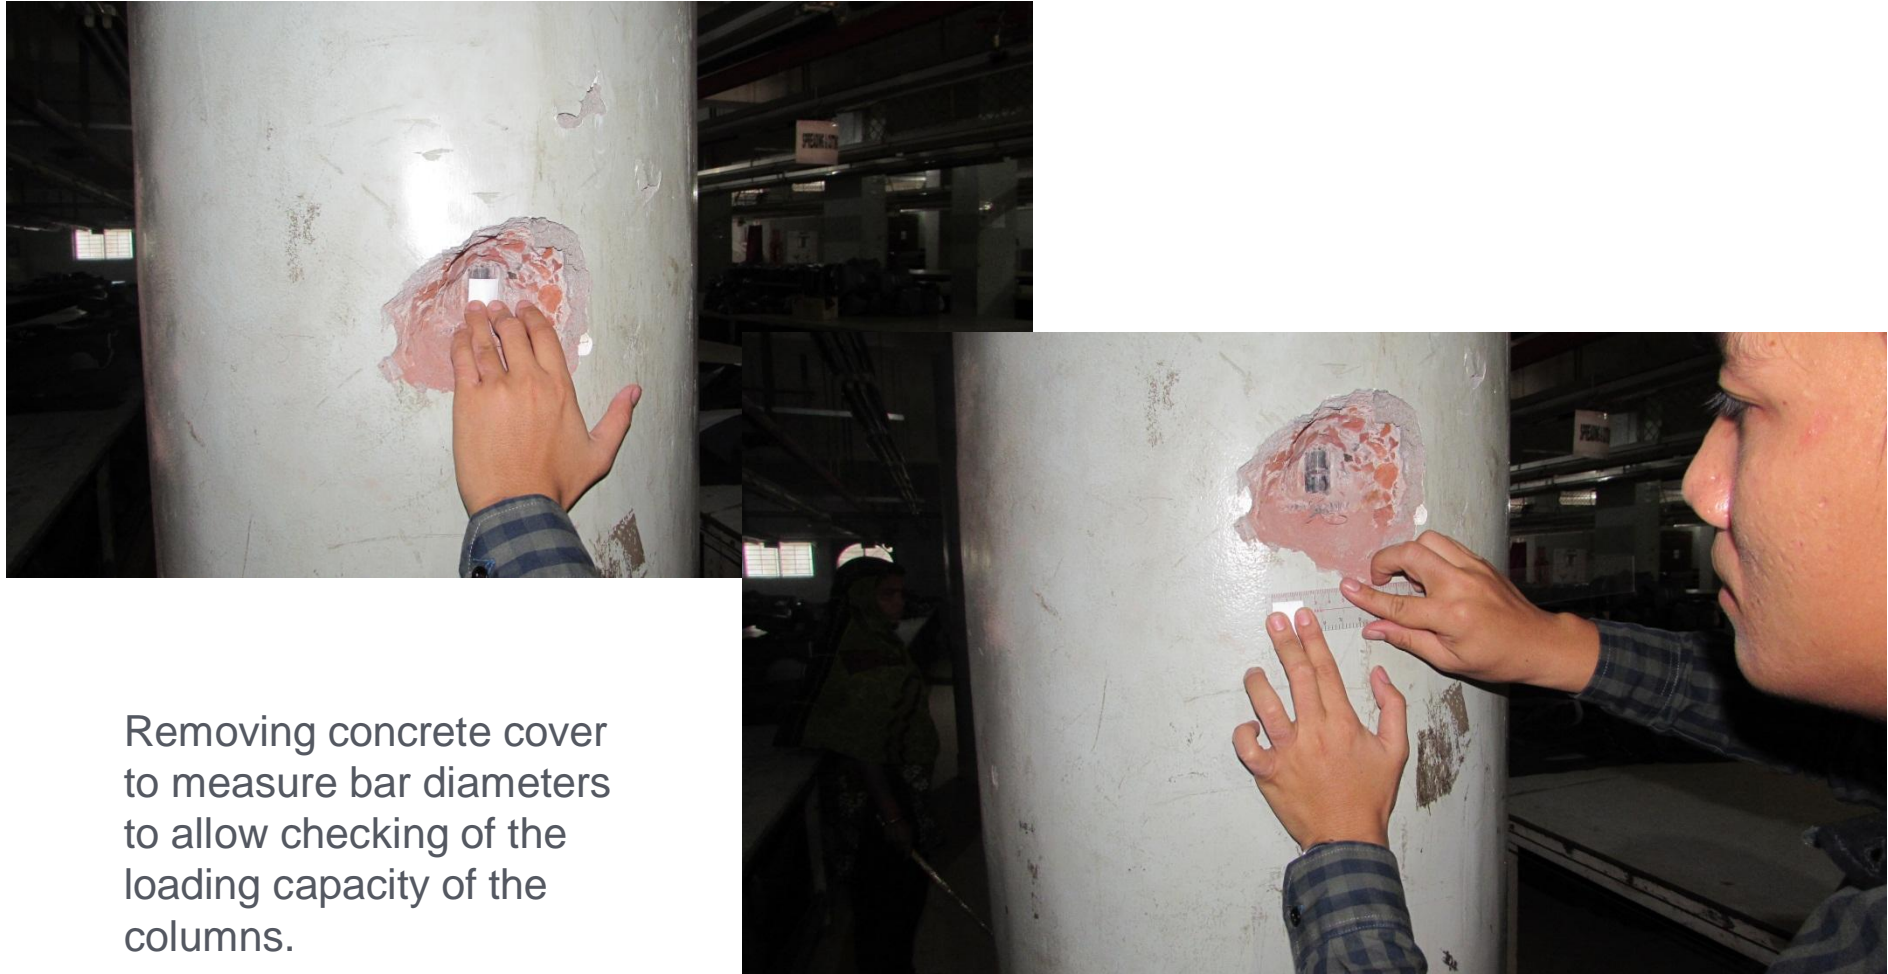
1st Priority 3 Concern (continued)

Removing concrete cover to measure bar diameters to allow checking of the loading capacity of the columns.

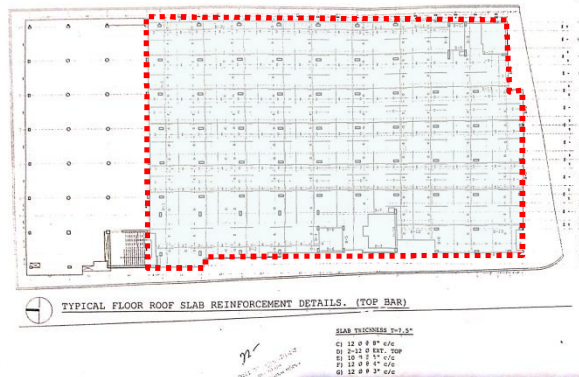
Slab design of
typical floor (top
bars)

Part of building has been
designed with flat slabs. All other
structural drawings are missing

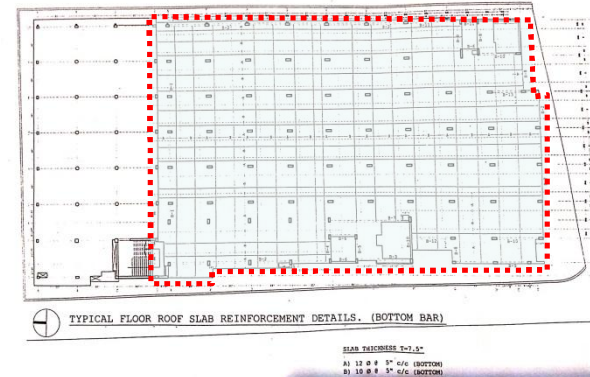
Slab design of
typical floor
(bottom bars)

The South side of building has flat slabs and concrete columns. No lateral stability system is evident. It is unclear what resists lateral loads.

A lack of lateral support system able to resist wind or earthquake loads. This should be investigated fully as part of a Detailed Engineering Assessment.

The set of structural drawings provided for the South side of the factory only covered the slab detailing. All other designs are missing.

- Assess the building's lateral stability capacity as part of the DEA.

- Provide any new forms of lateral structure that may be required as a result of the DEA.
