BHML Industries Ltd.

Kamarjuri, Natun Bazaar, National University, Gazipur

18 February 2015

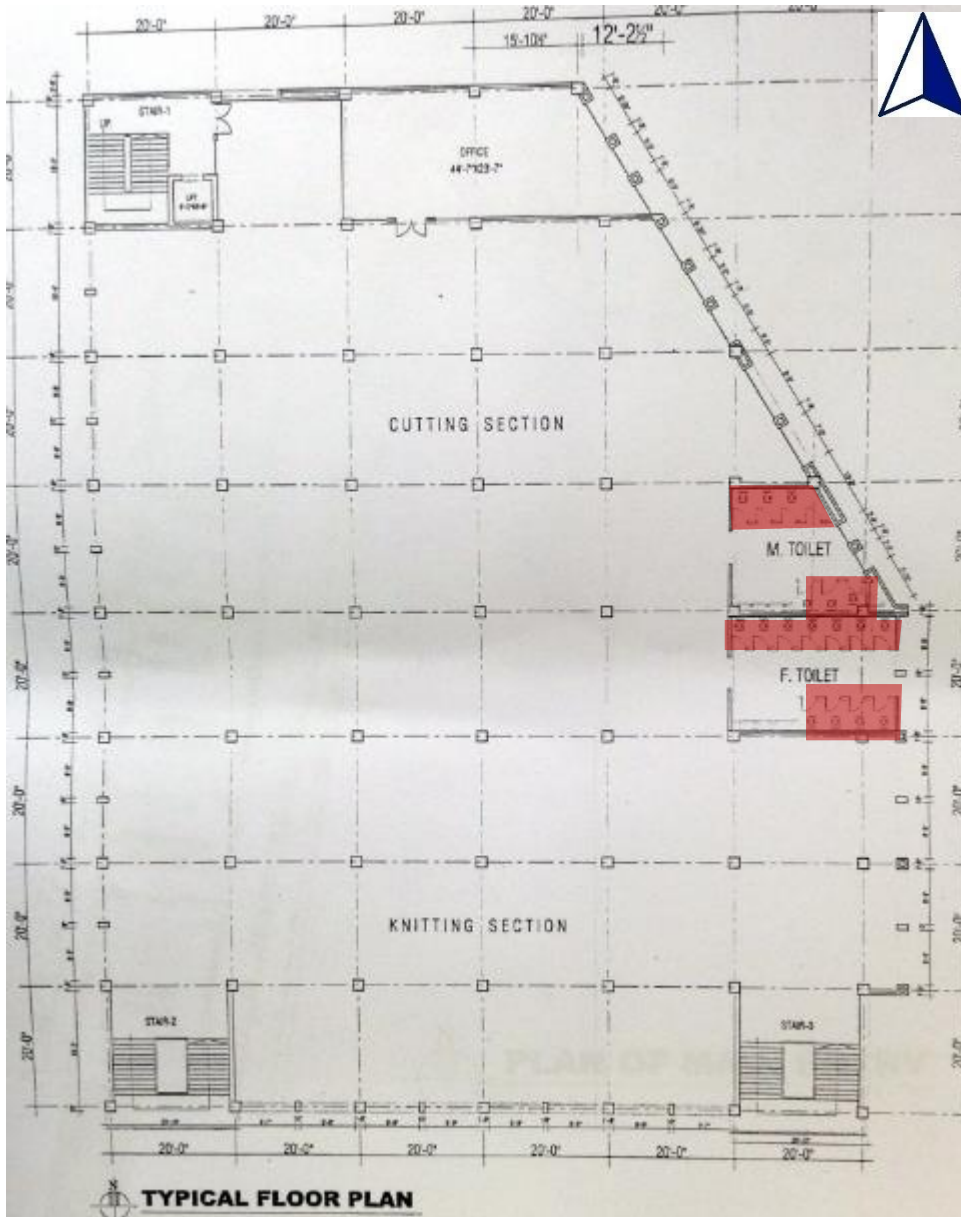
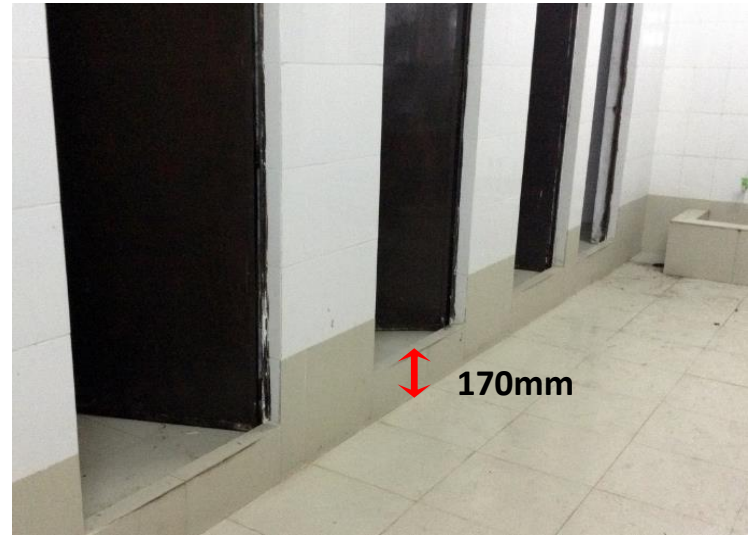
Heavy floor build up under toilets

Build-ups observed in the toilet area.

ITEM 1: High loads in the toilet columns after proposed extension to 6 storeys completed. (Loads satisfactory at present)

Item No.	Observation	Recommended Action Plan	Recommended Timeline
1	High loads on the columns in the toilet zone after completion of proposed extension to 6 storeys	Factory Engineer to review design , loads and all column stresses and confirm in situ concrete strength if extension to proceed.	6-weeks
2	High loads on the columns in the toilet zone after completion of proposed extension to 6 storeys	Upward extension should be put on hold until the completion of the engineering review	6-weeks
3	High loads on the columns in the toilet zone after completion of proposed extension to 6 storeys	Carry out the recommendations of the review.	6-months
4	Discrepancies between drawings and the as built site observations	Factory Engineer to up-date as-built drawings to reflect existing structure	6-months
5	Missing loading plans	Factory Engineer to make loading plans for each floor, based on the column, beam & slab capacity.	6-months

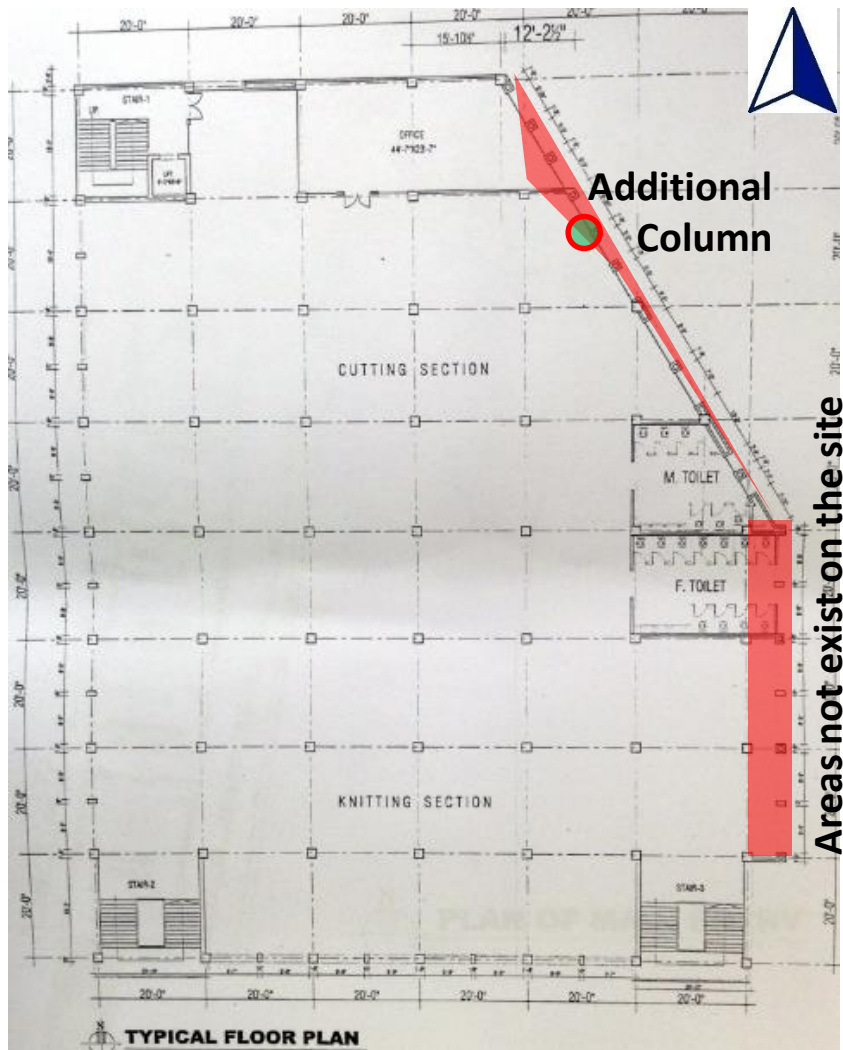
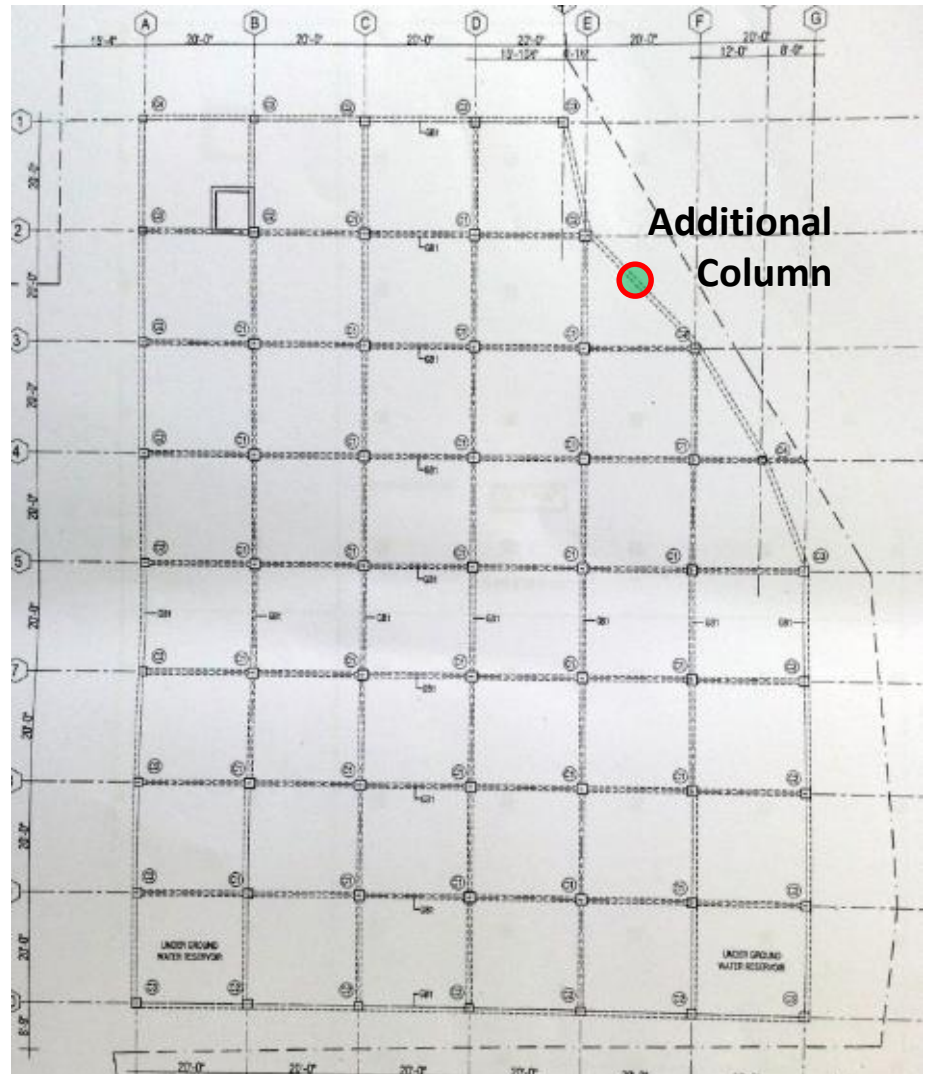
**Discrepancies of the as-built architectural and structural drawings.
Additional column presence on inspection, not shown on of the any drawings.**

ITEM 2: Discrepancies between as-built and the drawings

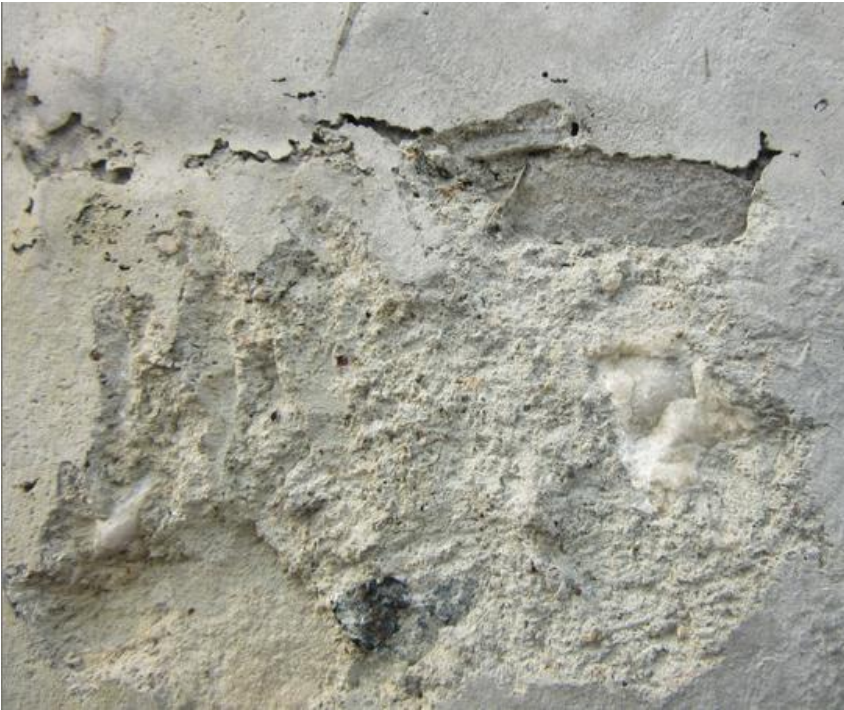
Stone aggregate in the Main Production Building B1

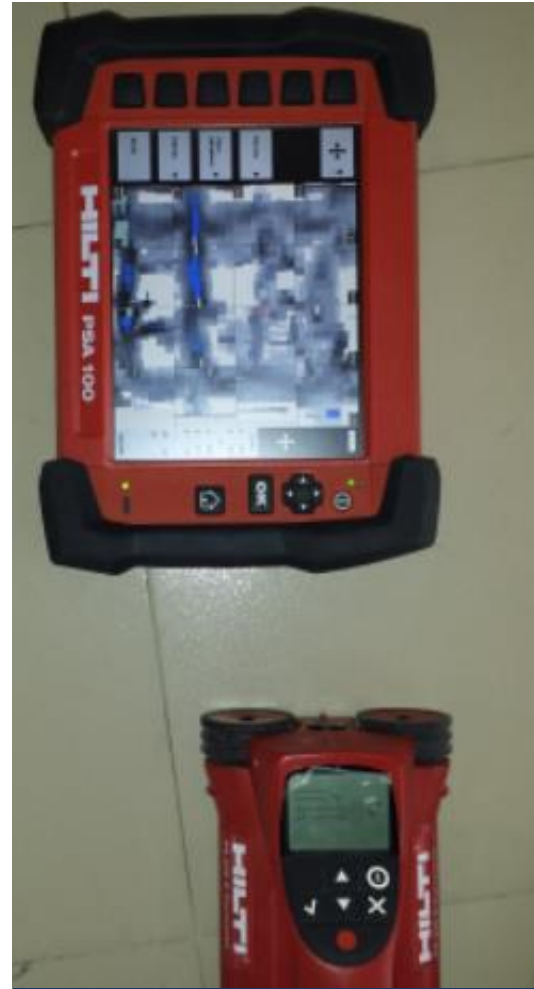
Reinforcement scanning
