Nipa Knitwear Company

Selina Tower-04: Islambag, Holan Road, Dhakhin khan, Dhaka-1230

18th February 2015

Observations

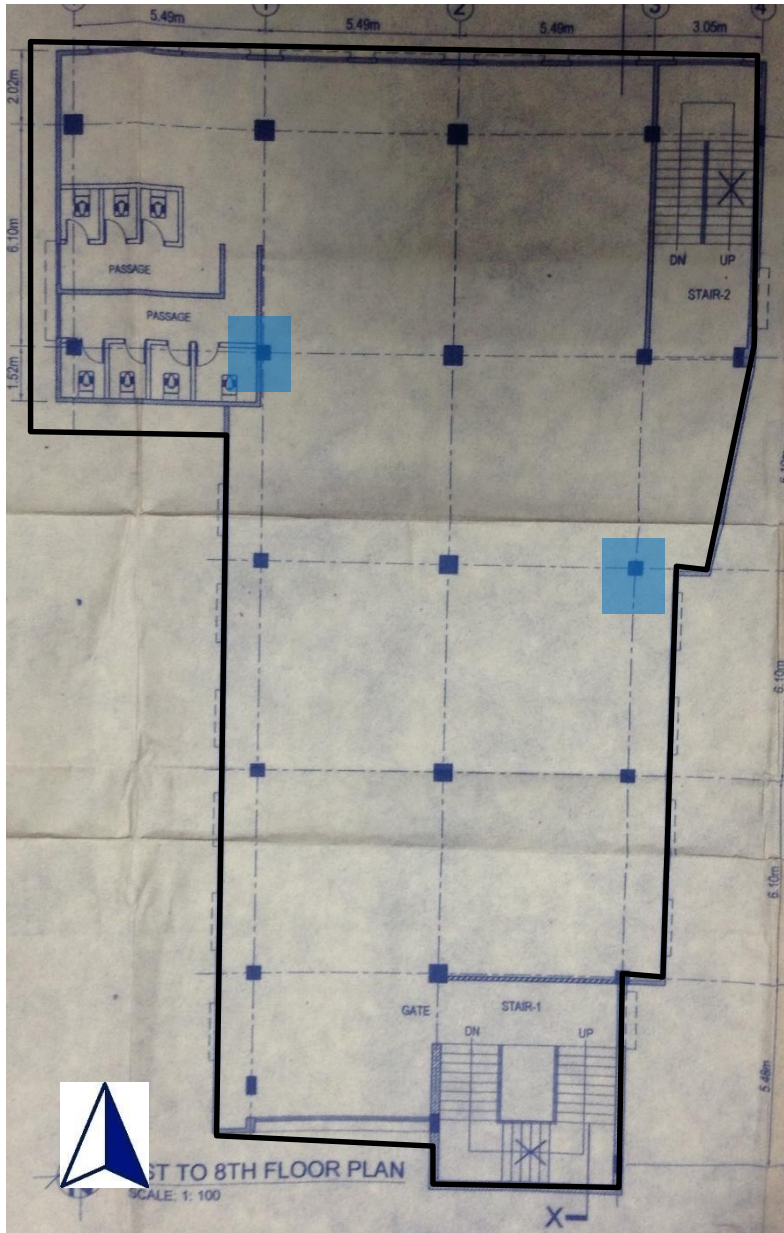
High stress levels in perimeter columns carrying cantilevers

Cursory calculation indicate that the working stress of some perimeter columns are at a high level mainly due to the load of the walls, some build-ups and the cantilever.

Item No.	Observation	Recommended Action Plan	Recommended Timeline
1	High stress levels in Perimeter Columns – Production Building	Maintain current use of the floors. Don't change use or increase occupation, either of which could increase loading.	Immediate - Now
2	High stress levels in Perimeter Columns – Production Building	Building Engineer to review design, loads and column stresses in the edge columns attracting loads from cantilevers.	Immediate - Now
3	High stress levels in Perimeter Columns – Production Building	Verify in-situ concrete stresses by 100mm dia. cores from min. 4 no. perimeter columns at basement level.	Immediate - Now
4	High stress levels in Perimeter Columns – Production Building	A Detail Engineering Assessment of the Production Building to be commenced, see attached Scope	Immediate - Now
5	High stress levels in Perimeter Columns – Production Building	Live load in cantilever/undocumented perimeter slab areas to be limited to 2.0kPa, pending outcome of Detail Engineering Assessment	Immediate - Now

6	High stress levels in Perimeter Columns – Production Building	Detail Engineering Assessment to be completed	6-weeks
7	High stress levels in Perimeter Columns – Production Building	Produce and actively manage a loading plan for all floor plates within the Building giving consideration to floor capacity and column capacity.	6-weeks
8	High stress levels in Perimeter Columns – Production Building	Actions identified in the Detail Engineering Assessment to be implemented.	6-months
9	High stress levels in Perimeter Columns – Production Building	Continue to implement the load management plan	6-months

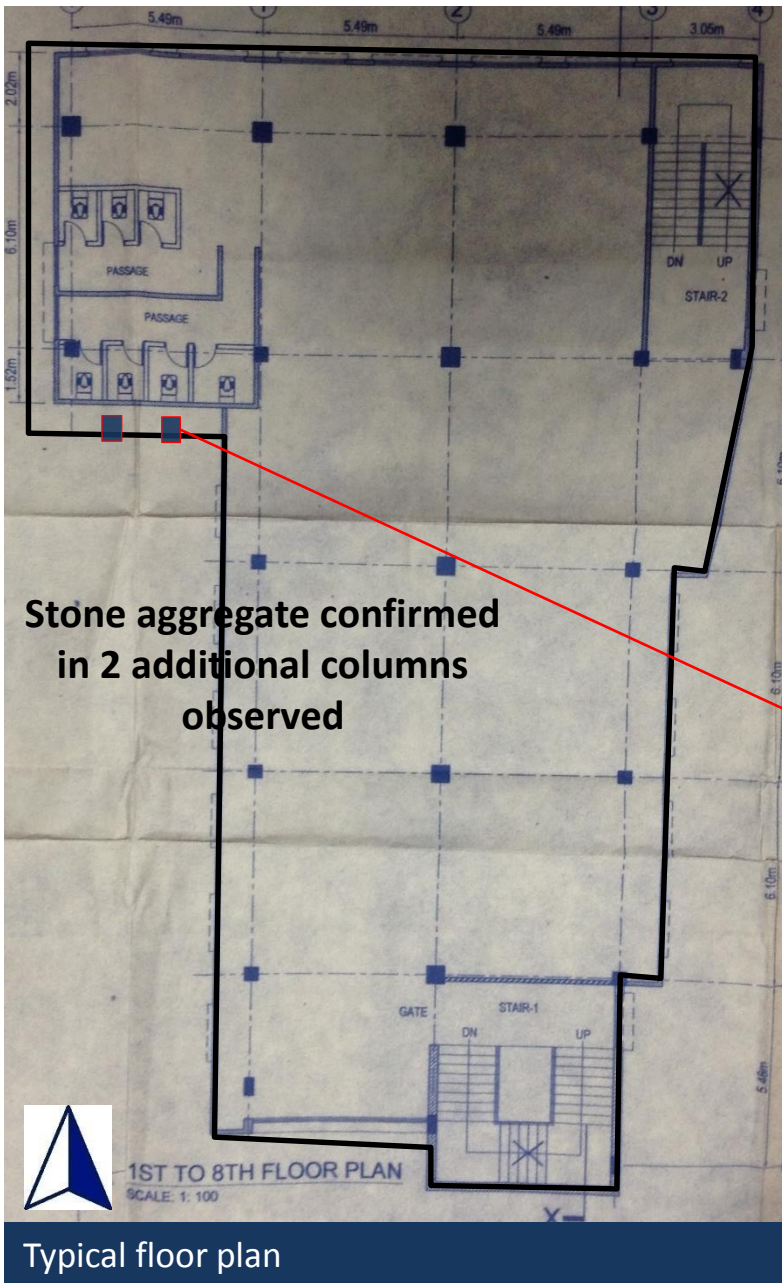
Discrepancies between the permit drawing and the as-built structure

Item No.	Observation	Recommended Action Plan	Recommended Timeline
10	Discrepancies between the permit drawings and the as-built structures – Production Building and Generator House	Building Engineer to commence update of the drawings to reflect the as-built structure and loading levels at all floor levels, including as built floor finishes thickness.	6-weeks
11	Discrepancies between the permit drawings and the as-built structures – Production Building and Generator House	Complete update of as-built drawings	6-months
12	Uncontrolled storage and heavy loading – Production Building and Generator House	Building Engineer to confirm design loading of slabs and take appropriate action by removing storage loads where required. This measure to be performed for the Production Building and the Generator House.	6-weeks
13	Uncontrolled storage and heavy loading – Production Building and Generator House	Building Engineer to design a loading plan for the building.	6-weeks

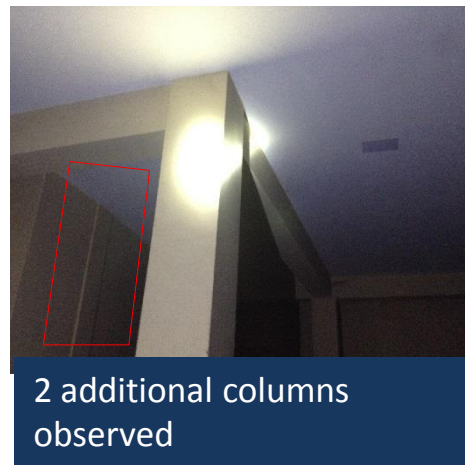
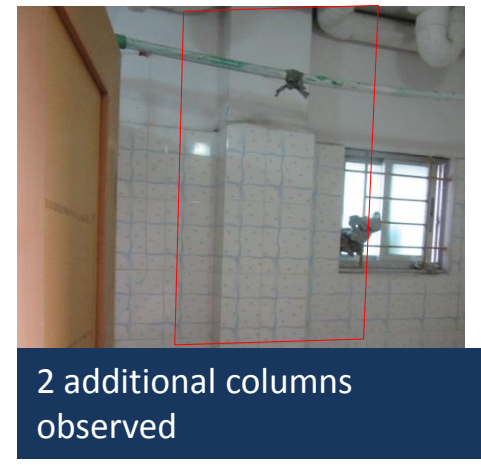
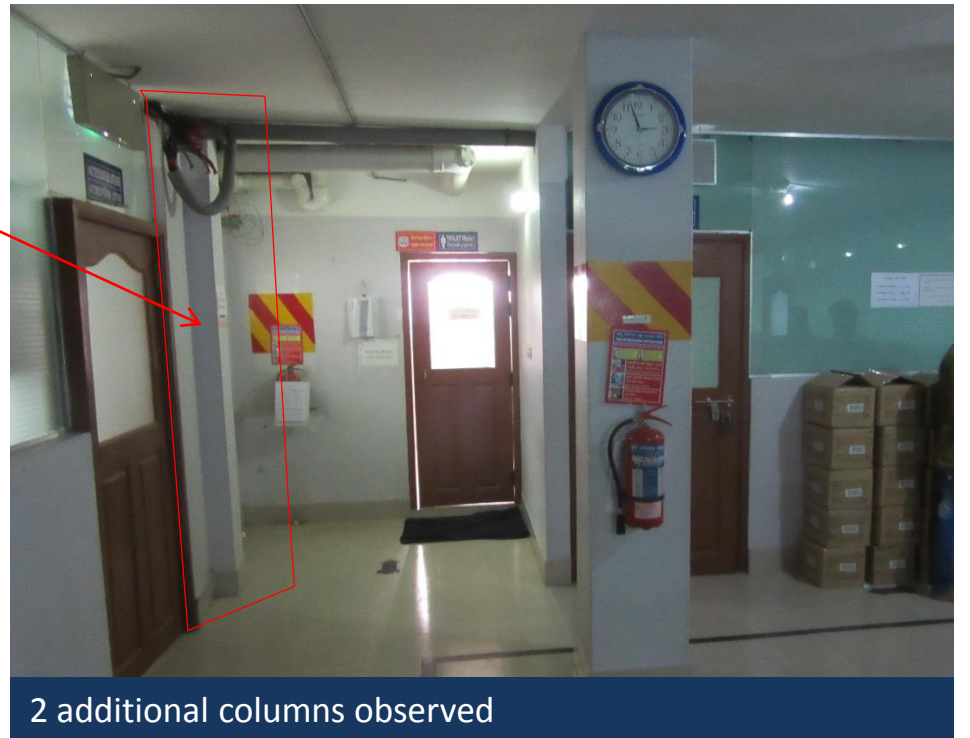
Stone aggregate confirmed
in 2 additional columns
observed

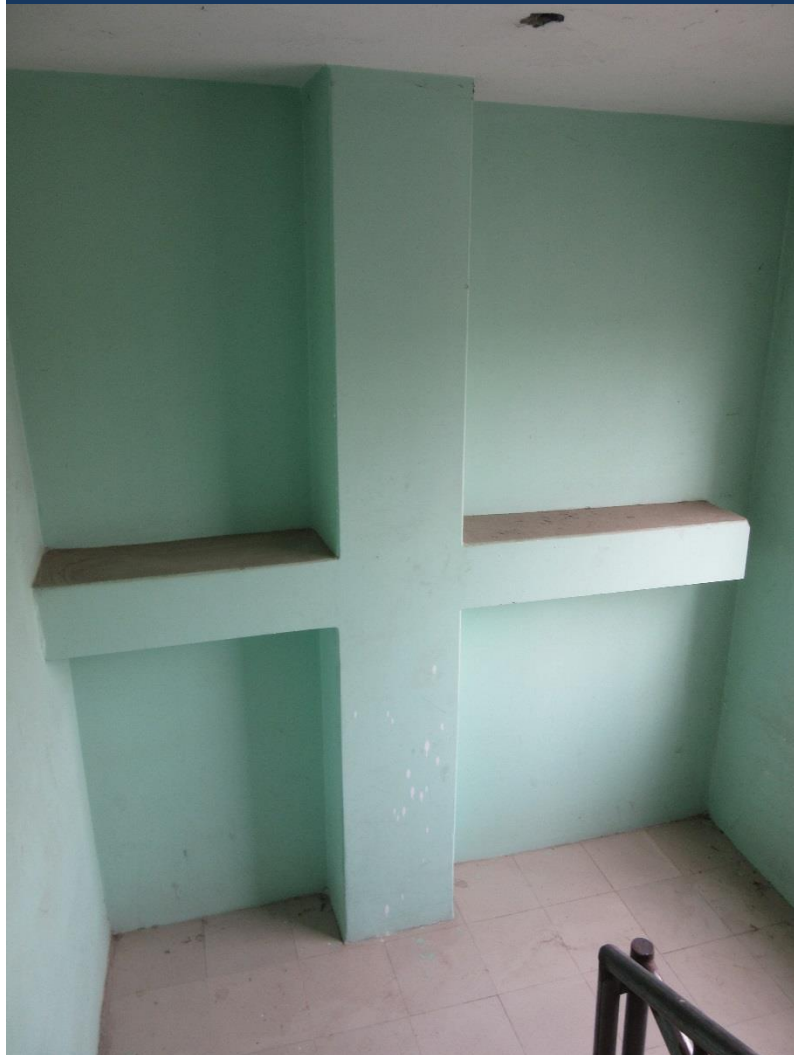
Structural elements which are not shown on the original design drawings

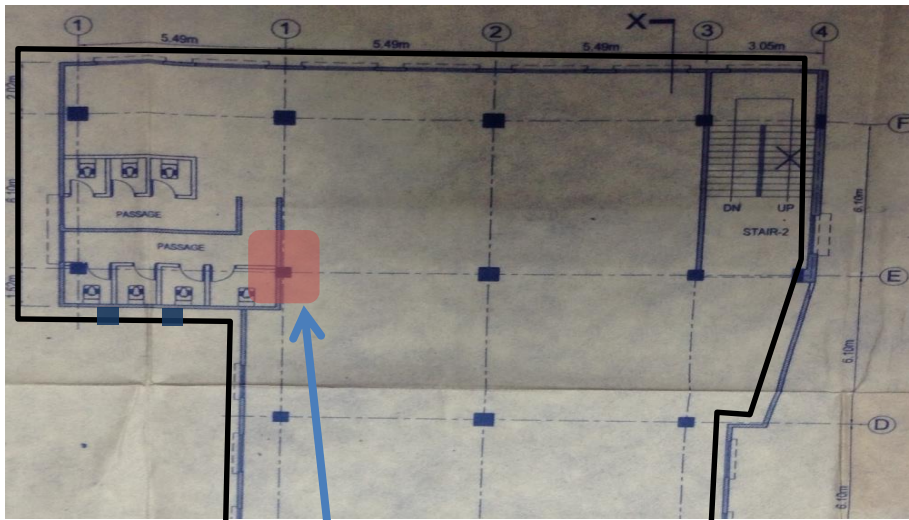
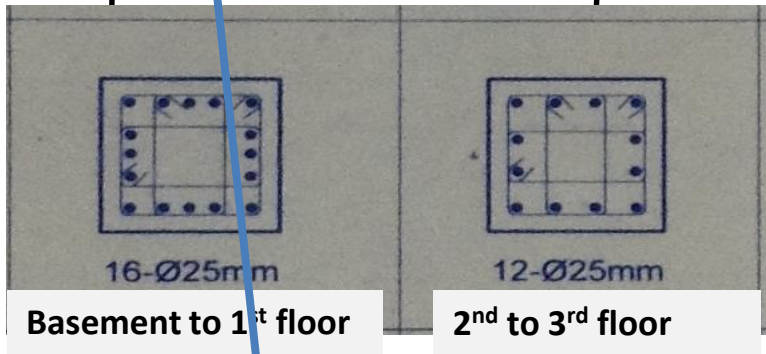
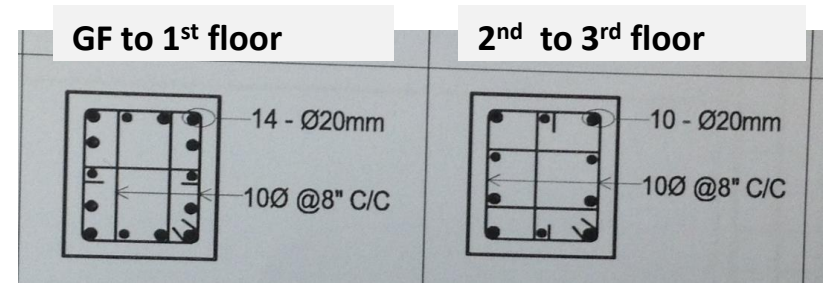
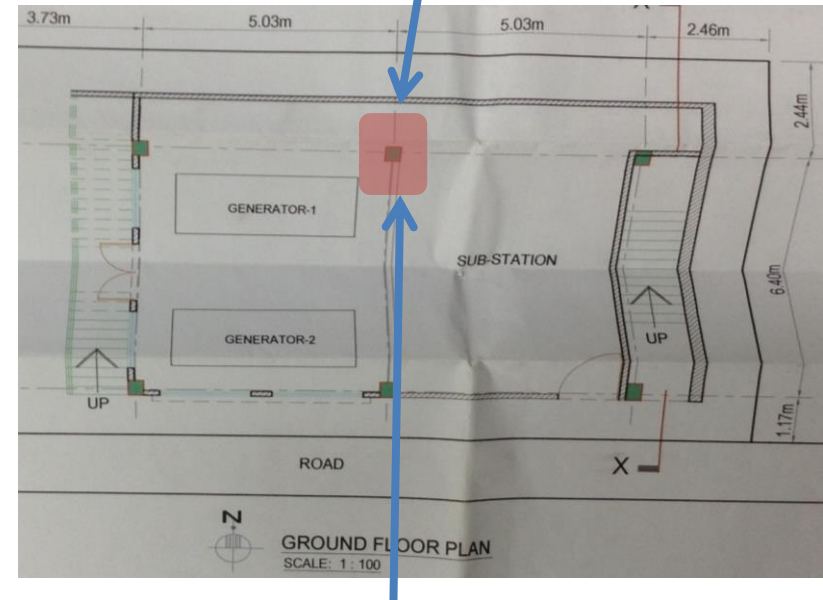
Column on the 4th floor

- Production Building Basement: 4 rebar bars were found on both sides for a total of 12 bars. However, structural drawing shows 16 bars at this level.

- Generator House 1st floor: 4 bars were found on each side for total of 12 bars. However, structural drawing shows 14 bars at GF level.

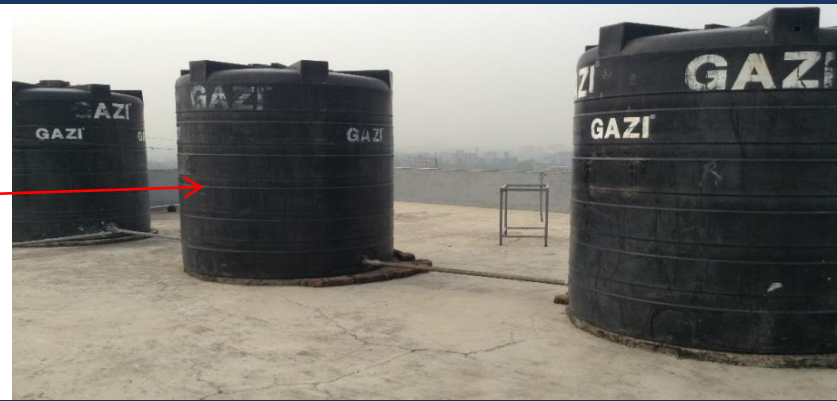
3 Water tanks on roof – 5000 litres each (total 1500 kN)

14	Uncontrolled storage and heavy loading – Production Building and Generator House	Spread the load of the roof water tanks on a bigger area.	6-weeks
15	Uncontrolled storage and heavy loading – Production Building and Generator House	Building Engineer to continue to implement loading plan.	6-months
16	Apparently non-engineered lightweight steel stair structures in Generator House	Building Engineer to assess adequacy of the lightweight steel stairs to withstand code vertical and wind loads, including connections to the Generator House.	6-months
17	Apparently non-engineered lightweight steel stair structures in Generator House	Carry out reconstruction or remedial works arising from the assessment.	6-months

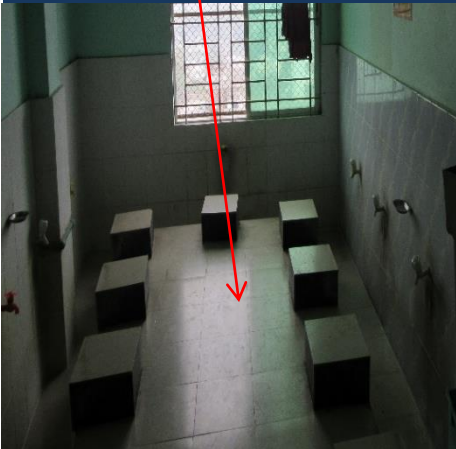
Build-ups 250mm

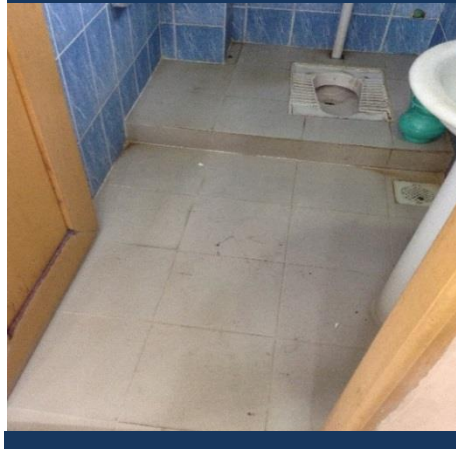
150 mm build up on every floor

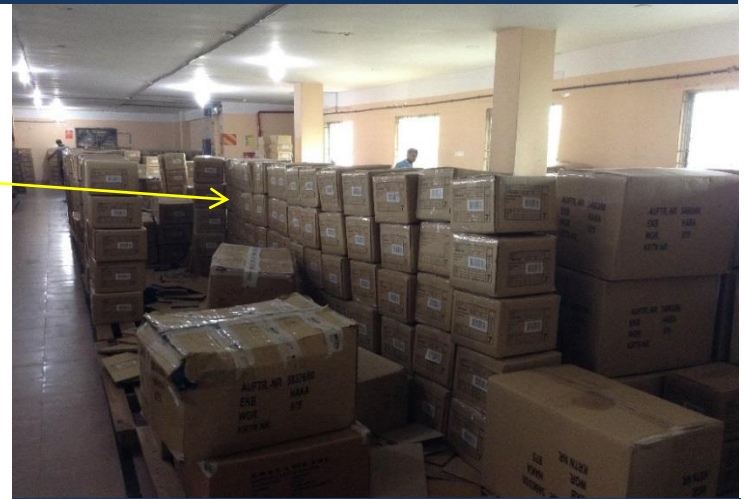
1.5m high boxes on entire 1st floor

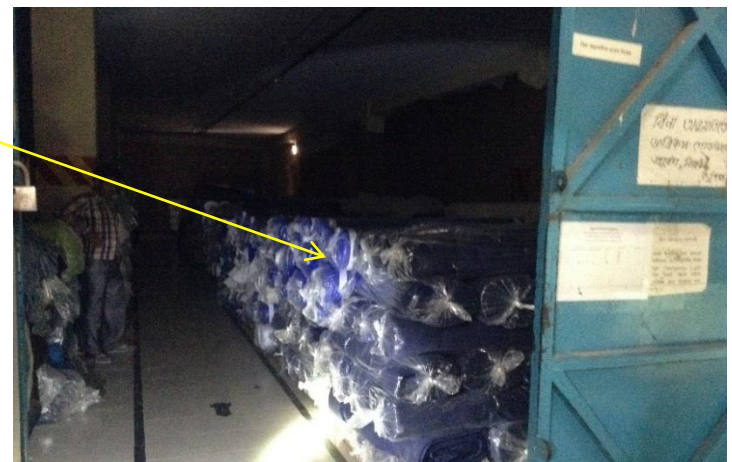
1.3m high fabric roll on entire ground floor

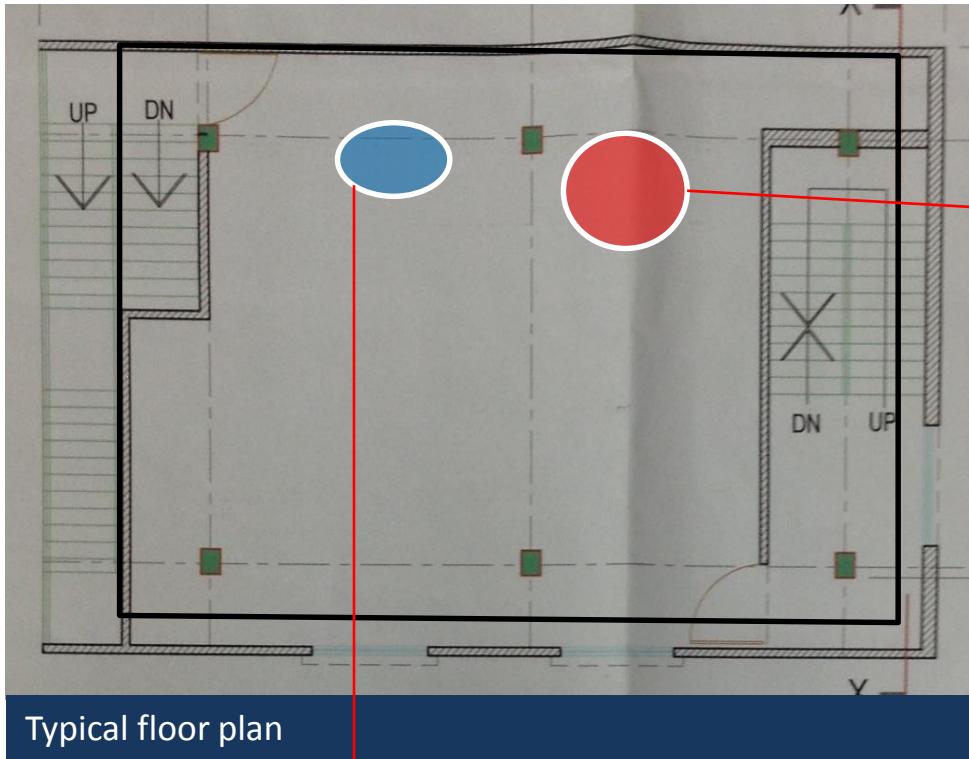
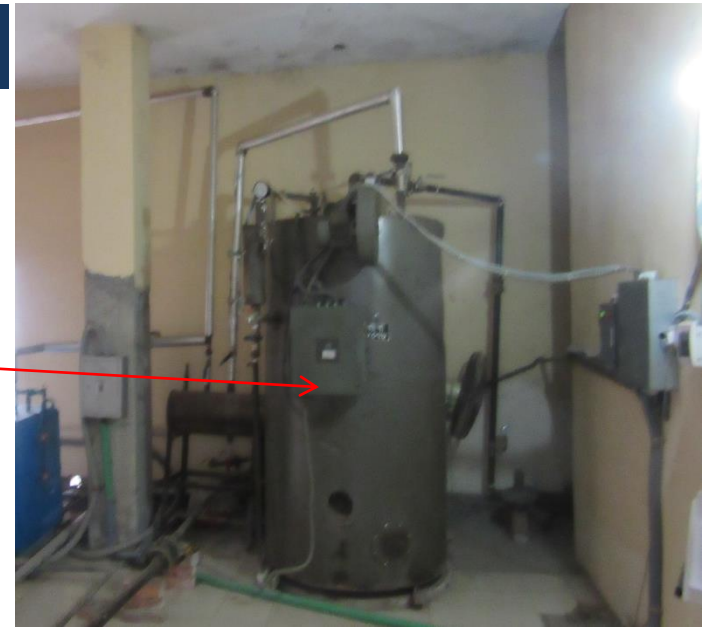
40-50KN boiler on 1st floor

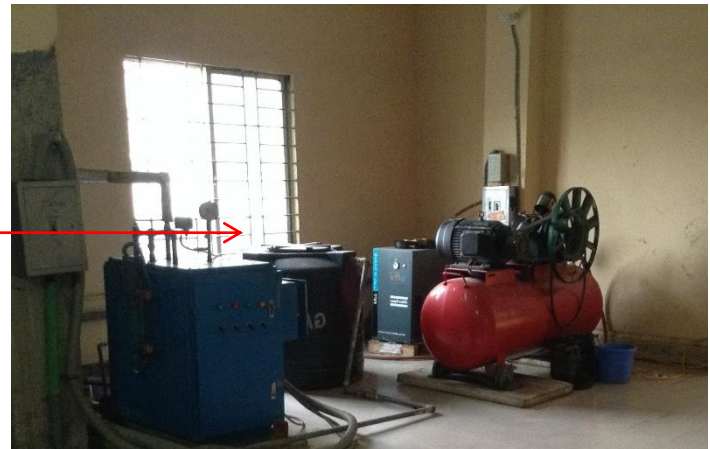
500L water tank on 1st floor

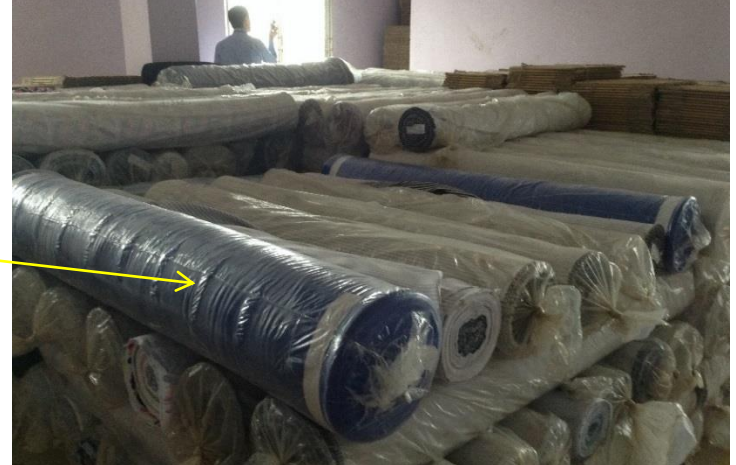
1.3m high fabric roll on 2nd and 3rd floor

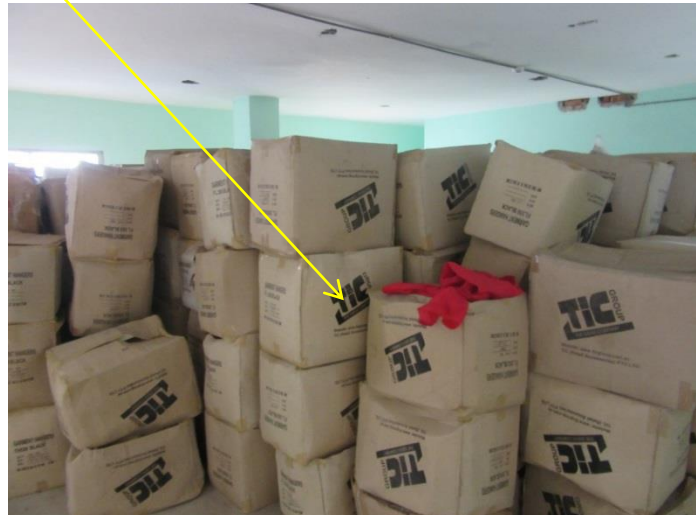
2m high lightweight storage on 4th and 5th floors

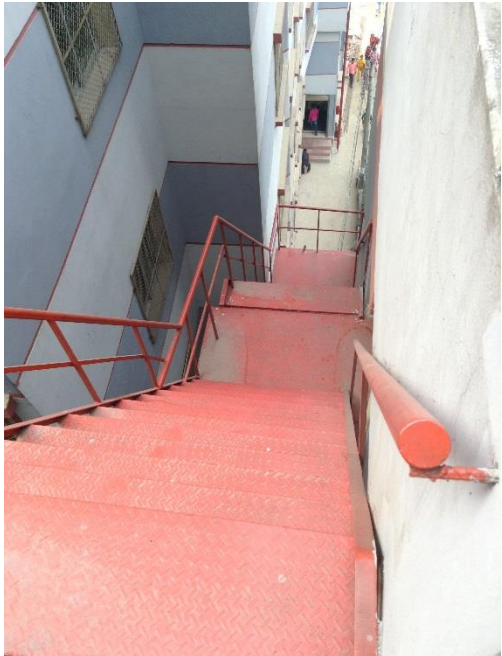
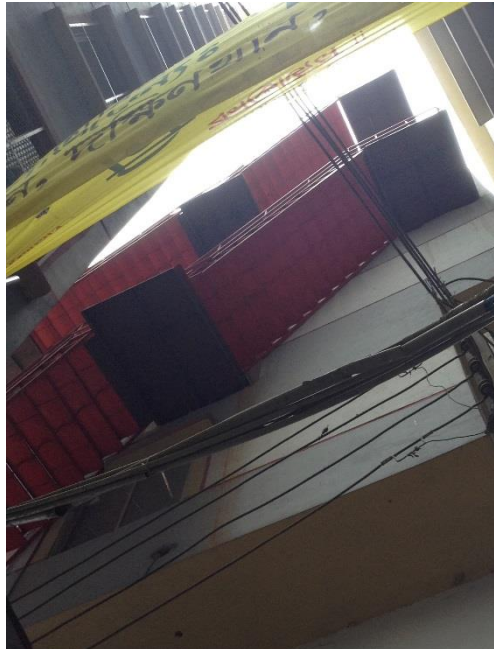
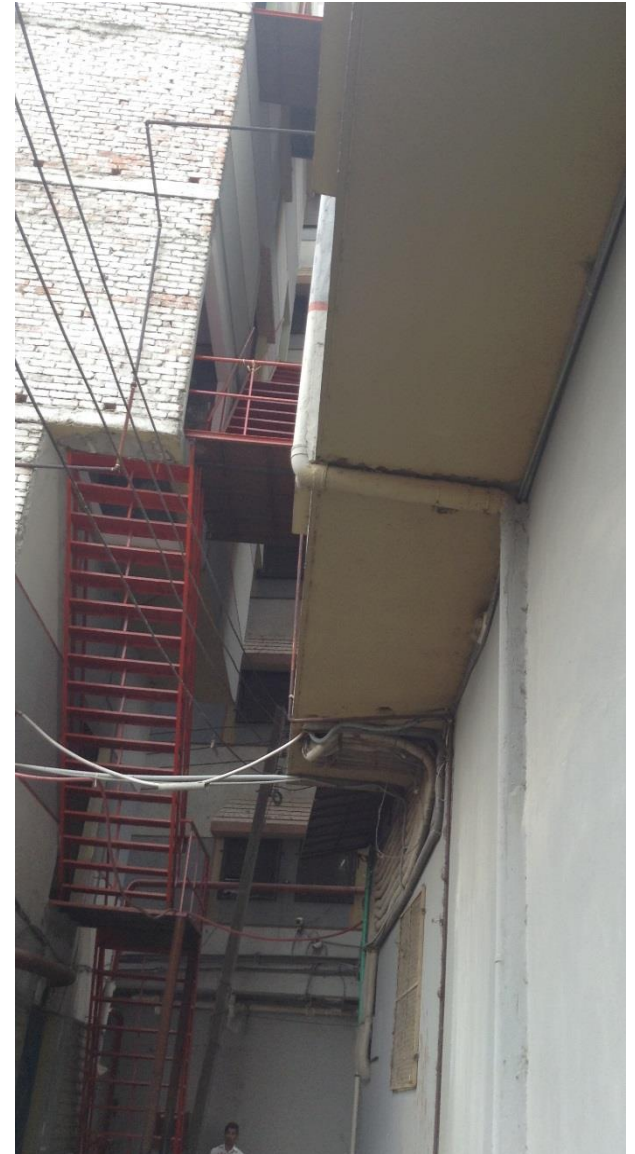
Apparently non-engineered lightweight steel stair structures

Non-engineered steel stair structure
