Chowgacha Fashions Ltd

Koir Para, Chowgacha, Jessore, Bangladesh
(23.255935N, 89.037443E)

22nd February 2015

Observations

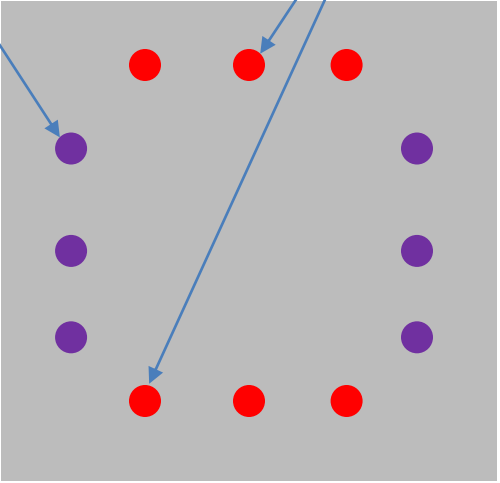
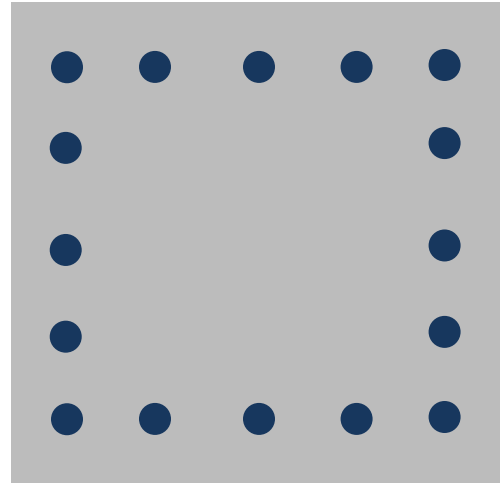
Actual reinforcement in Column C4 on gridline E/4 appears less than designed. – Ferroscan detected 3 bars on east and west face of column

**3 No. 20dia
(purple) bars
assumed**

**3 No. 20dia (red) bars found
on east and west face**

**12 No. 20dia used
for design check**

**16 No. 20dia shown
On drawings**

Item No.	Observation	Recommended Action Plan	Recommended Timeline
1	Reinforcement in Column C4 on gridline E/4 appears less than designed	Factory Engineer to clarify quantity of reinforcement in column C4 on gridline E/4 between Ground and 1st Floor.	6-weeks
2	Reinforcement in Column C4 on gridline E/4 appears less than designed	If less than 16 bars are found all other columns to be checked and calculations carried out to confirm adequacy of columns with reduced reinforcement.	6-weeks
3	Accessory Store (1st Floor) - Storage racking in this area.	Accessory Store (1st Floor) - Storage racking in this area to be checked for compliance with original design loads. Design load to be displayed in area.	6-weeks

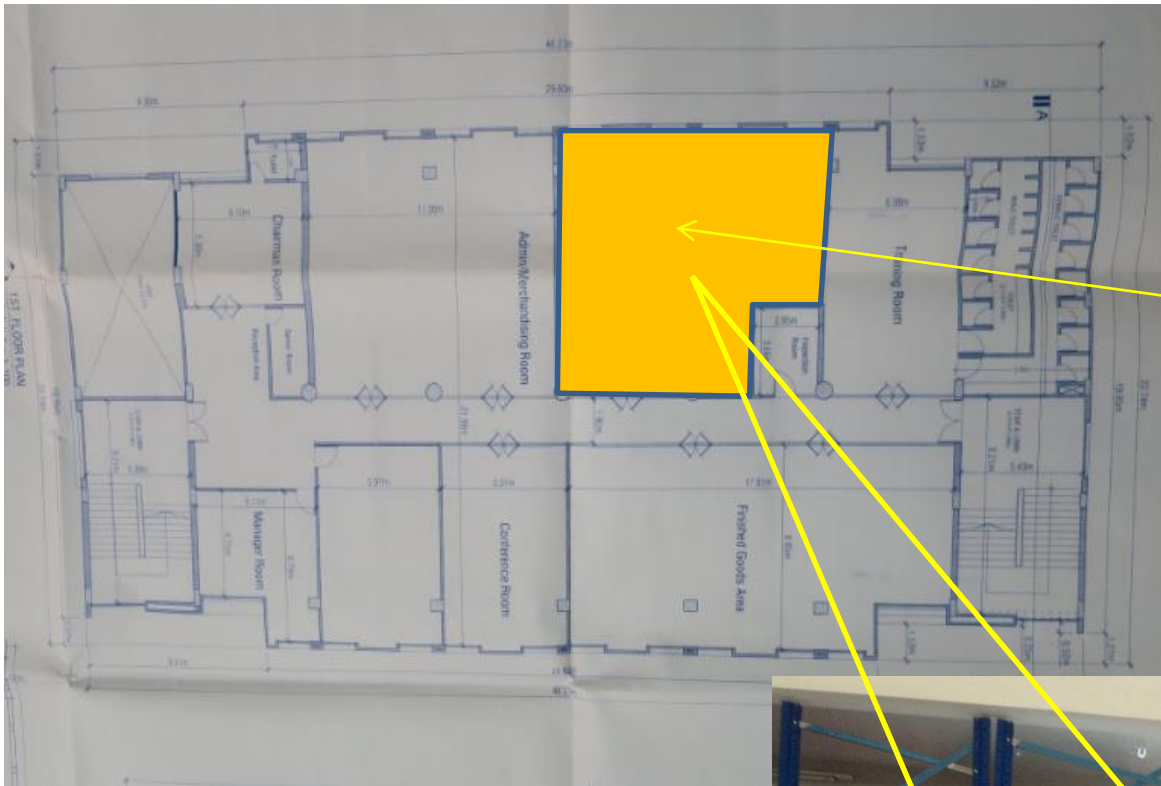
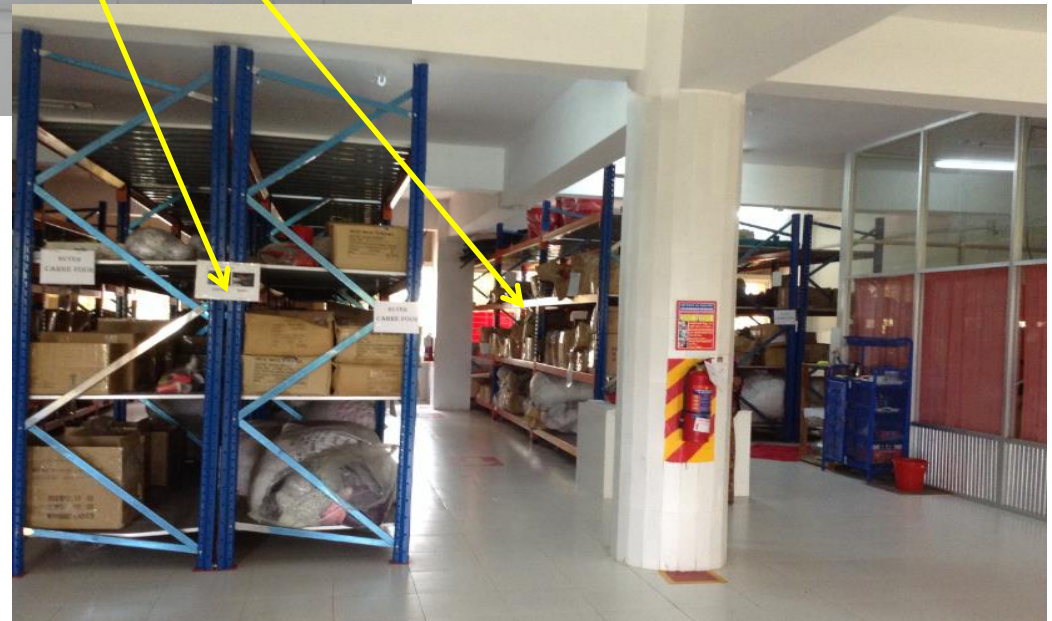
Accessories store: Storage racking in this area to be checked for compliance with original design loads

**Accessories store
Loading on the area
should be assessed
by engineer to
ensure compliance
with original design**
