# Denim Fashions Ltd.

RS-370, CS-727, Sataish, Tongi, Gazipur, 1712

22<sup>nd</sup> February 2015

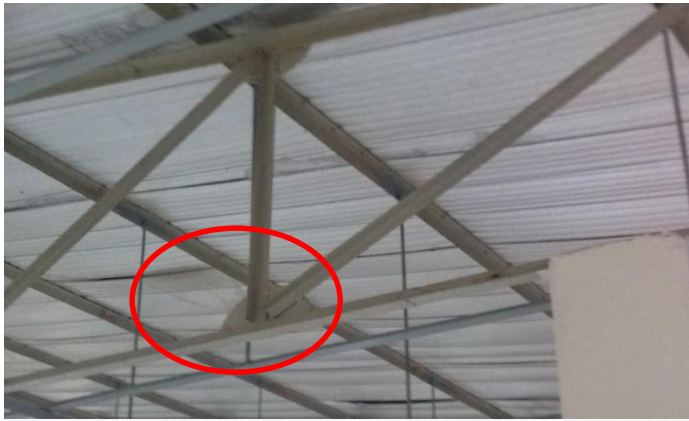
## **Roof steel trusses seem to be non-engineered**

Very poor welds between truss members

| Item No. | Observation | Recommended Action Plan | Recommended Timeline |
|---|---|---|---|
| 1 | Steel roof appears to be non-engineered | Factory Engineer to carry out an Engineering design check for the Building 1 roof. | Immediate - Now |
| 2 | Steel roof appears to be non-engineered | Engineering design check to be completed. | 6-weeks |
| 3 | Steel roof appears to be non-engineered | Make structural alterations as advised by Factory Engineer. | 6-weeks |

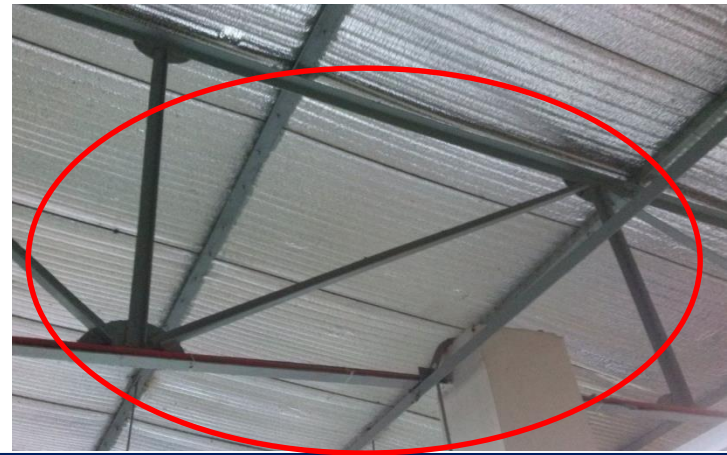
The sizes of structural members are very small (L-shapes L50 x 5 to L70 x 7)

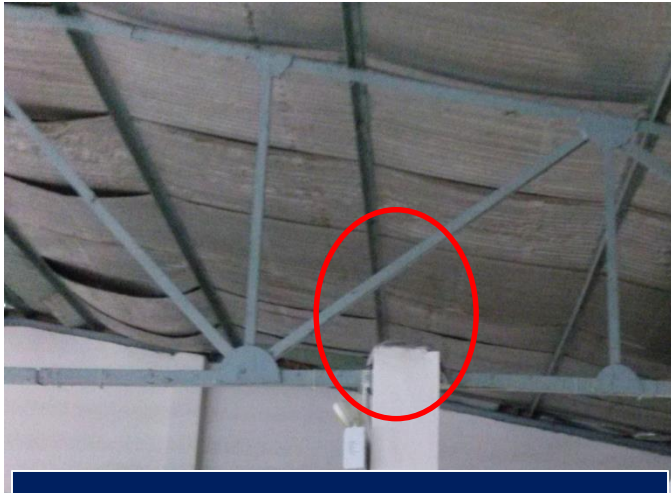
Supporting columns are NOT coincident with truss nodes

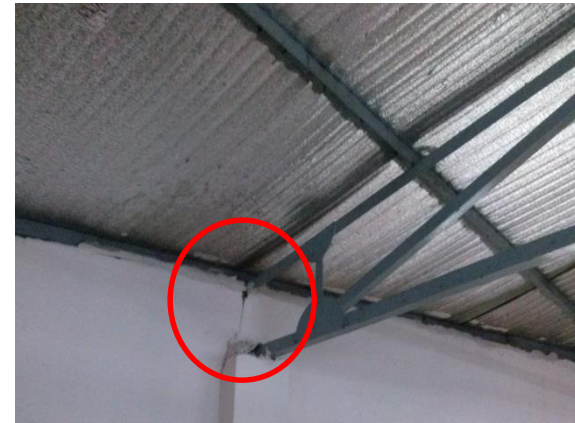
In general, no vertical truss members at bearing points

Roof steel trusses seemed to be non-engineered

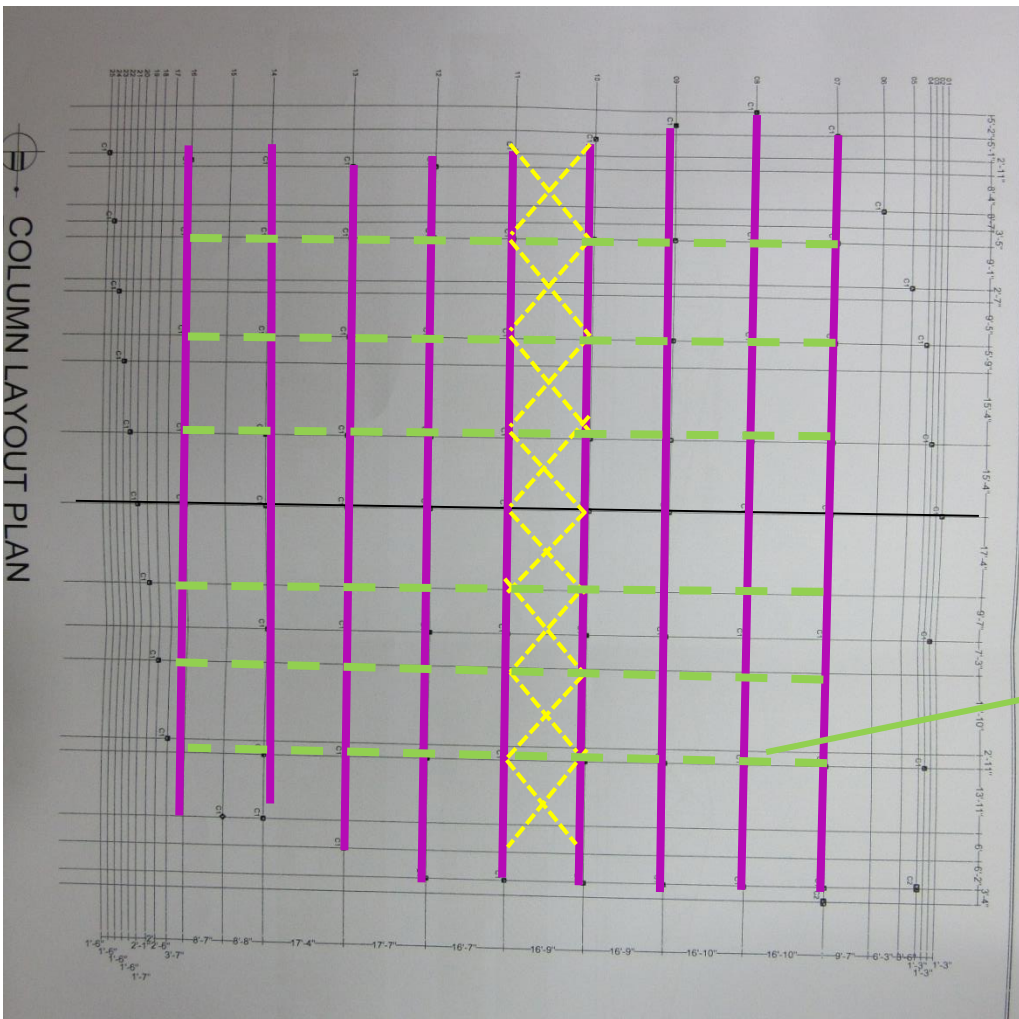
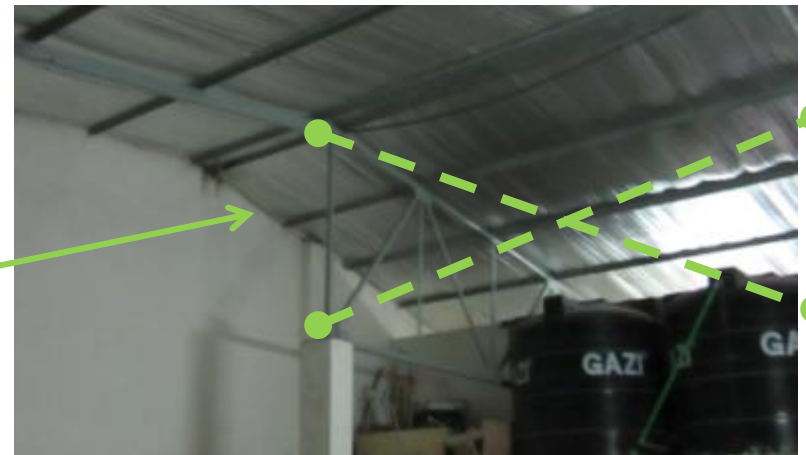
No horizontal bracing at roof level between steel trusses.  
No vertical bracing between trusses to protect them against overturning.

No stability bracing at roof level

| Item No. | Observation | Recommended Action Plan | Recommended Timeline |
|---|---|---|---|
| 4 | No stability bracing at roof level | Factory Engineer to review the stability of the steel roof structure with consideration of as-constructed joints, uplift forces, lateral loads and global stability. | Immediate - Now |
| 5 | No stability bracing at roof level | Factory Engineer to advise on any necessary alterations. | Immediate - Now |
| 6 | No stability bracing at roof level | Make structural alterations as advised by Factory Engineer. | 6-weeks |

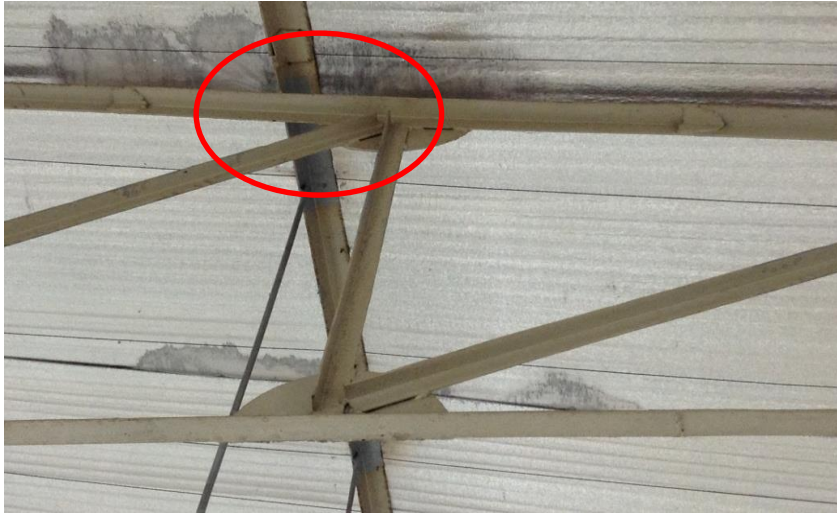
No structural connections observed between truss and purlins (critical for transfer of uplift and lateral loadings)

No structural connection between steel trusses and roof purlins

| Item No. | Observation | Recommended Action Plan | Recommended Timeline |
|---|---|---|---|
| 7 | No structural connections between steel trusses and purlins | Factory Engineer to review the design of the purlin connection to the trusses, with respect to the provision of engineered support points and withstanding uplift forces and lateral loads. | Immediate - Now |
| 8 | No structural connections between steel trusses and purlins | Factory Engineer to advise on any necessary alterations. | Immediate - Now |
| 9 | No structural connections between steel trusses and purlins | Make structural alterations as advised by Factory Engineer. | 6-weeks |

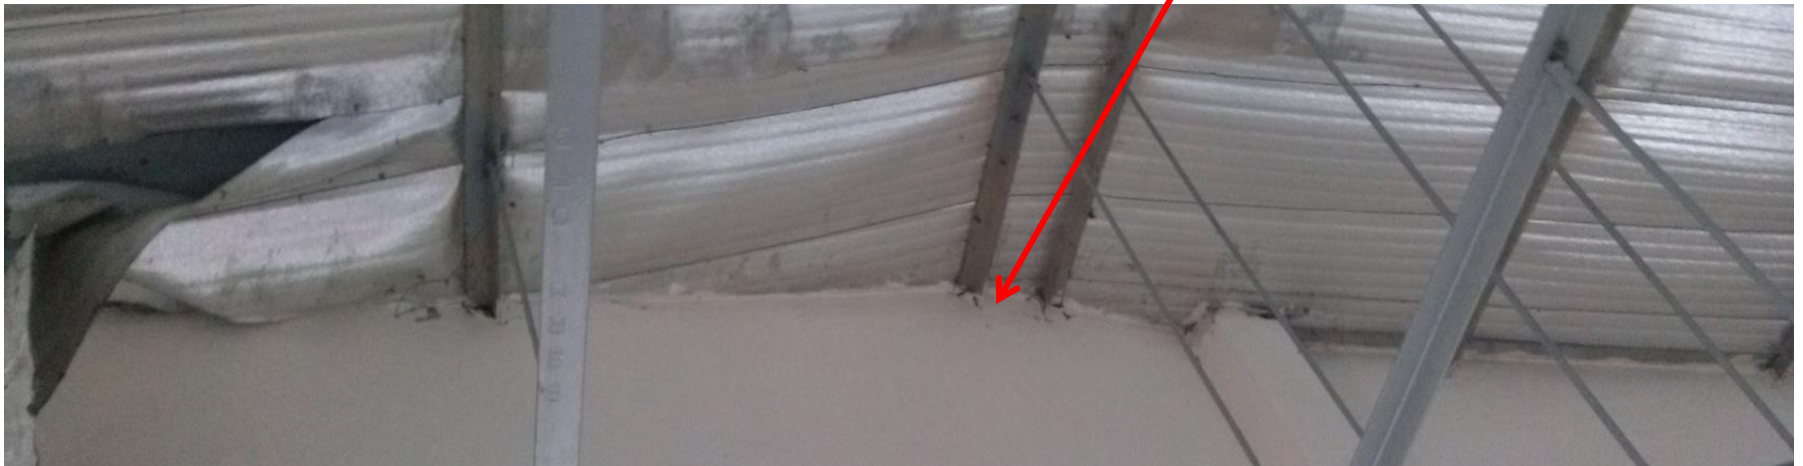
Non-engineered bearing and connection of purlins to outside walls

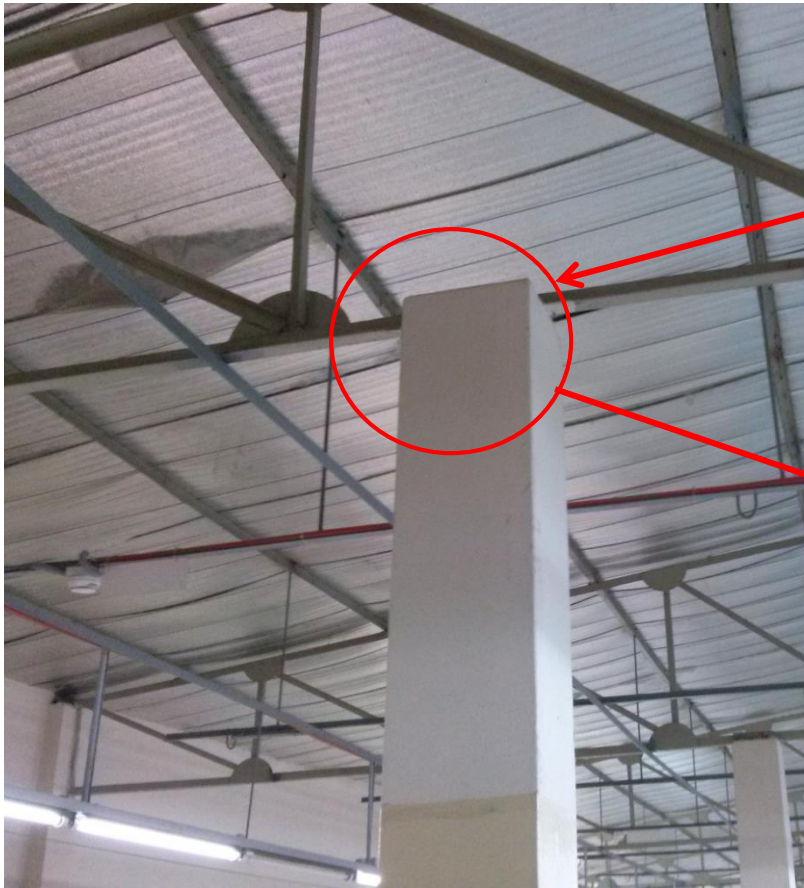
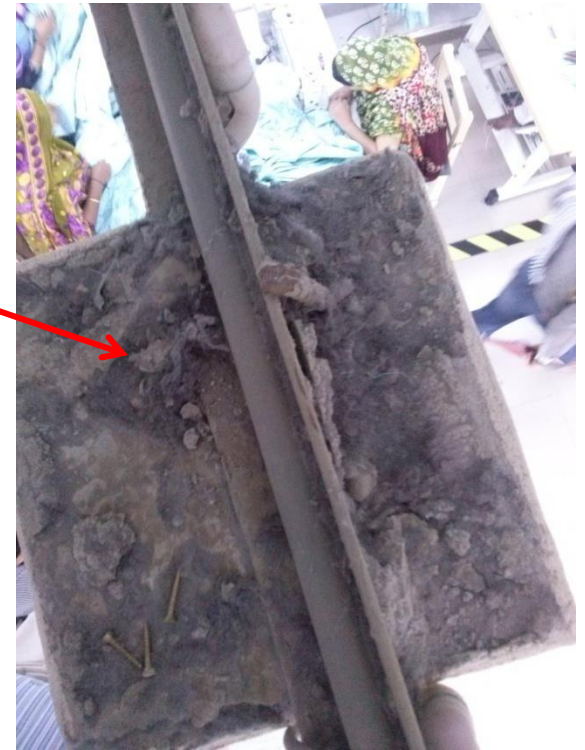
Non-engineered bearing of  
steel trusses on columns  
(critical for transfer of uplift  
and lateral loadings)

Bearing of trusses on columns seems to be non-engineered

| Item No. | Observation | Recommended Action Plan | Recommended Timeline |
|---|---|---|---|
| 10 | Bearing of trusses on columns seems to be non-engineered | Factory Engineer to review the bearing of the steel roof trusses on the columns, with respect to the provision of engineered support points and withstanding uplift forces and lateral loads. | 6-weeks |
| 11 | Bearing of trusses on columns seems to be non-engineered | Factory Engineer to advise on any necessary alterations to steelwork. | 6-weeks |
| 12 | Bearing of trusses on columns seems to be non-engineered | Factory Engineer to advise on any necessary alterations to steelwork. | 6-months |

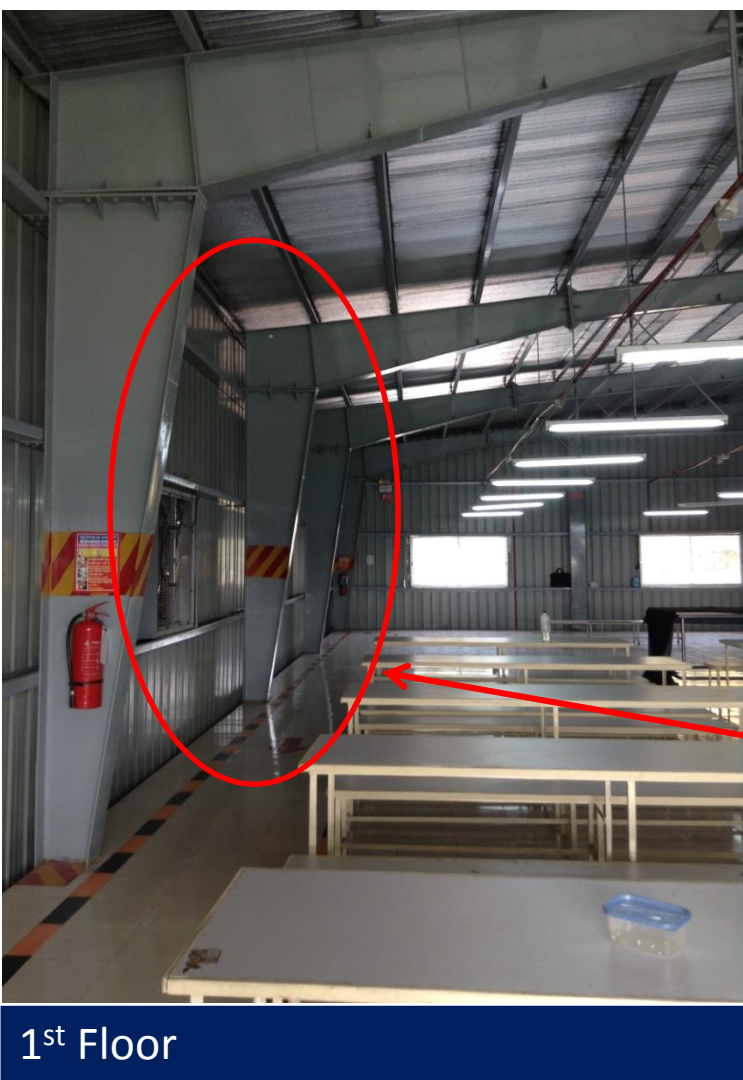
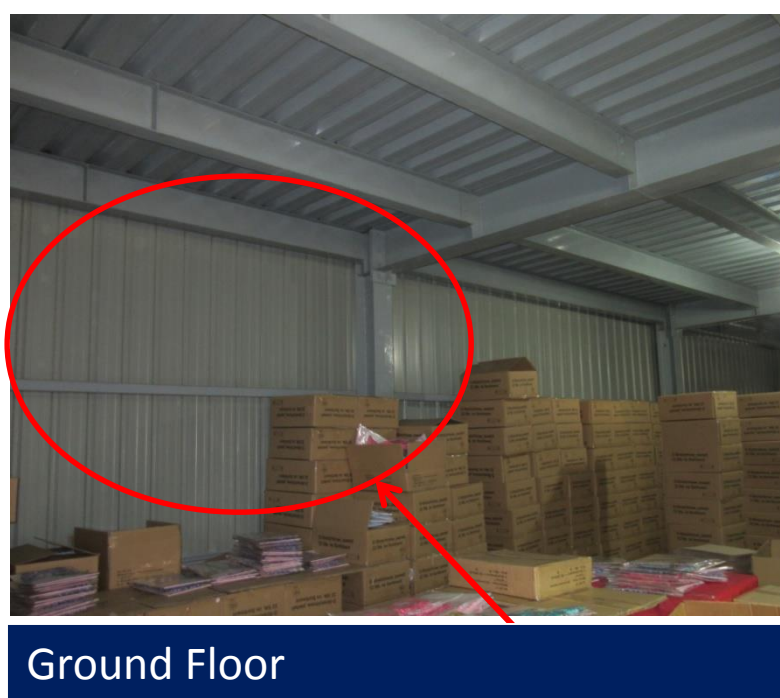
No vertical  
bracing

No vertical stability system in longitudinal direction

| Item No. | Observation | Recommended Action Plan | Recommended Timeline |
|---|---|---|---|
| 13 | No vertical stability system in longitudinal direction | Factory Engineer to investigate the stability of the building in the longitudinal direction, and advise on any necessary alterations. | 6-weeks |
| 14 | No vertical stability system in longitudinal direction | Carry out structural alterations as advised by Factory Engineer. | 6-weeks |

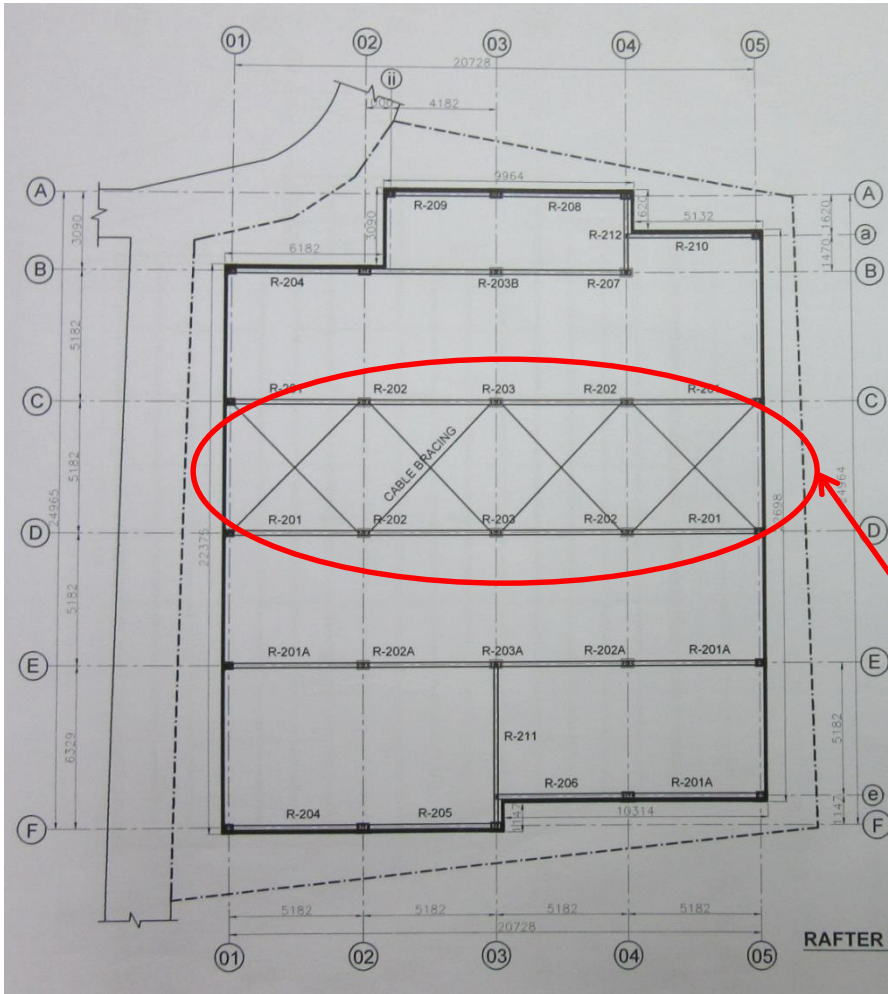
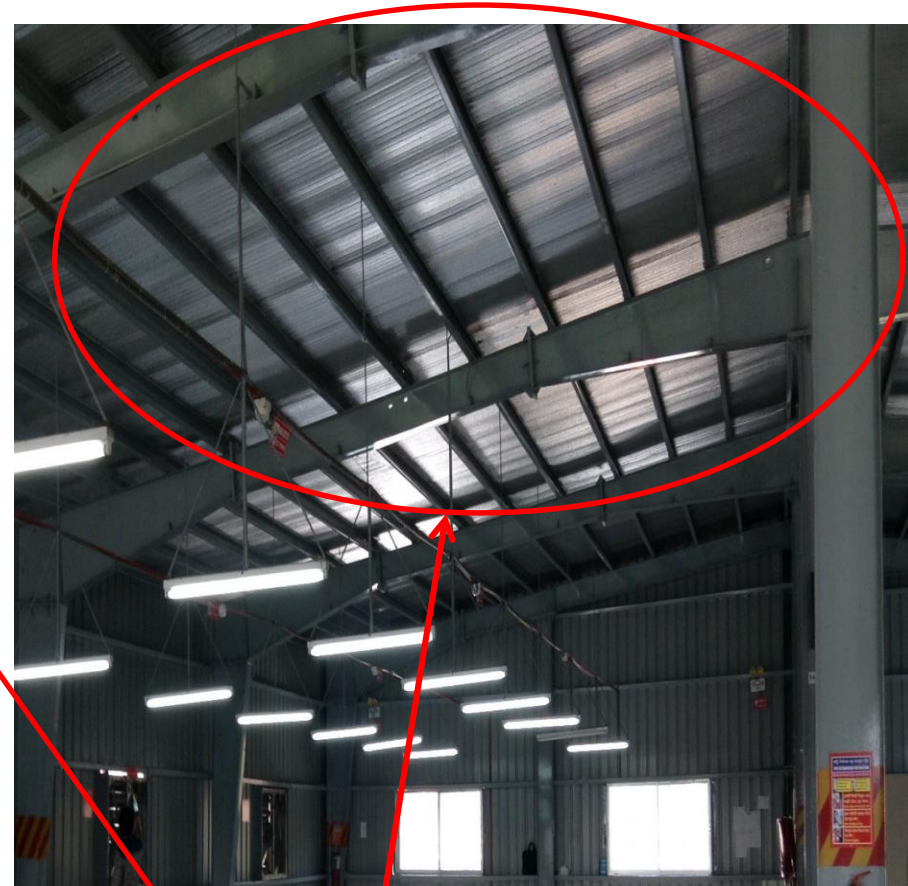
Bracing shown on drawing  
but missing from roof

Roof bracing is missing  
**Building 2**

| Item No. | Observation | Recommended Action Plan | Recommended Timeline |
|---|---|---|---|
| 15 | Roof bracing is missing | Factory Engineer to assess the lateral stability at roof level with respect to the transfer of lateral loads to the vertical structure. | 6-weeks |
| 16 | Roof bracing is missing | Factory Engineer to advise on any necessary alterations to the steelwork in order to achieve lateral stability. | 6-weeks |
| 17 | Roof bracing is missing | Carry out structural alterations as advised by Factory Engineer. | 6-weeks |

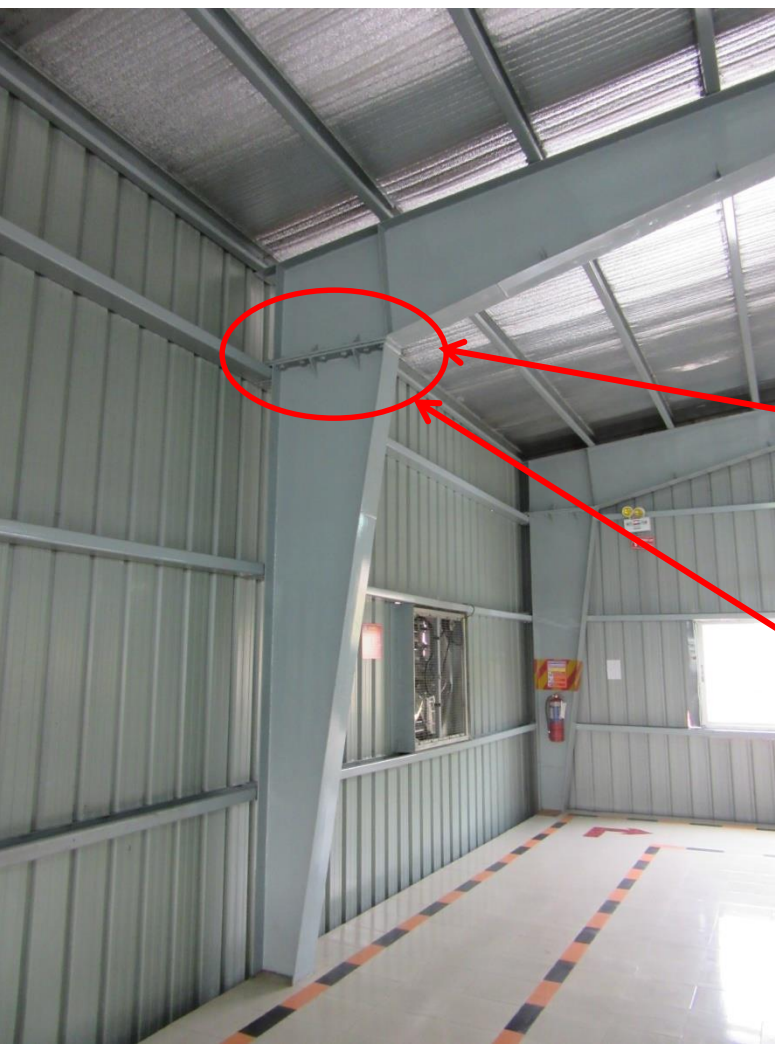
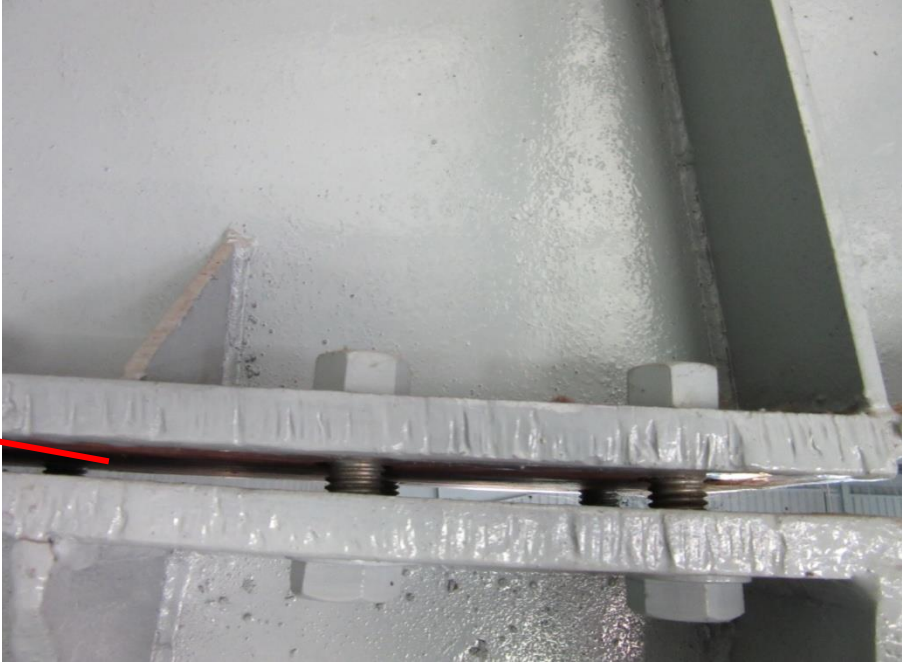
Semi-rigid connections

Semi-rigid connections at "rigid" moment frame corners

| Item No. | Observation | Recommended Action Plan | Recommended Timeline |
|---|---|---|---|
| 18 | Semi-rigid connections at "rigid" moment frame corners | Factory Engineer to assess the stability system in cross direction of the building, taking into consideration the as-built details at the moment frame connections. | 6-weeks |
| 19 | Semi-rigid connections at "rigid" moment frame corners | Factory Engineer to advise on any necessary alterations to the steelwork in order to achieve lateral stability. | 6-weeks |
| 20 | Semi-rigid connections at "rigid" moment frame corners | Carry out structural alterations as advised by Factory Engineer. | 6-weeks |
