Florence Fabrics Ltd

Bimile, Konabari, Gazipur-1346

24 February 2015

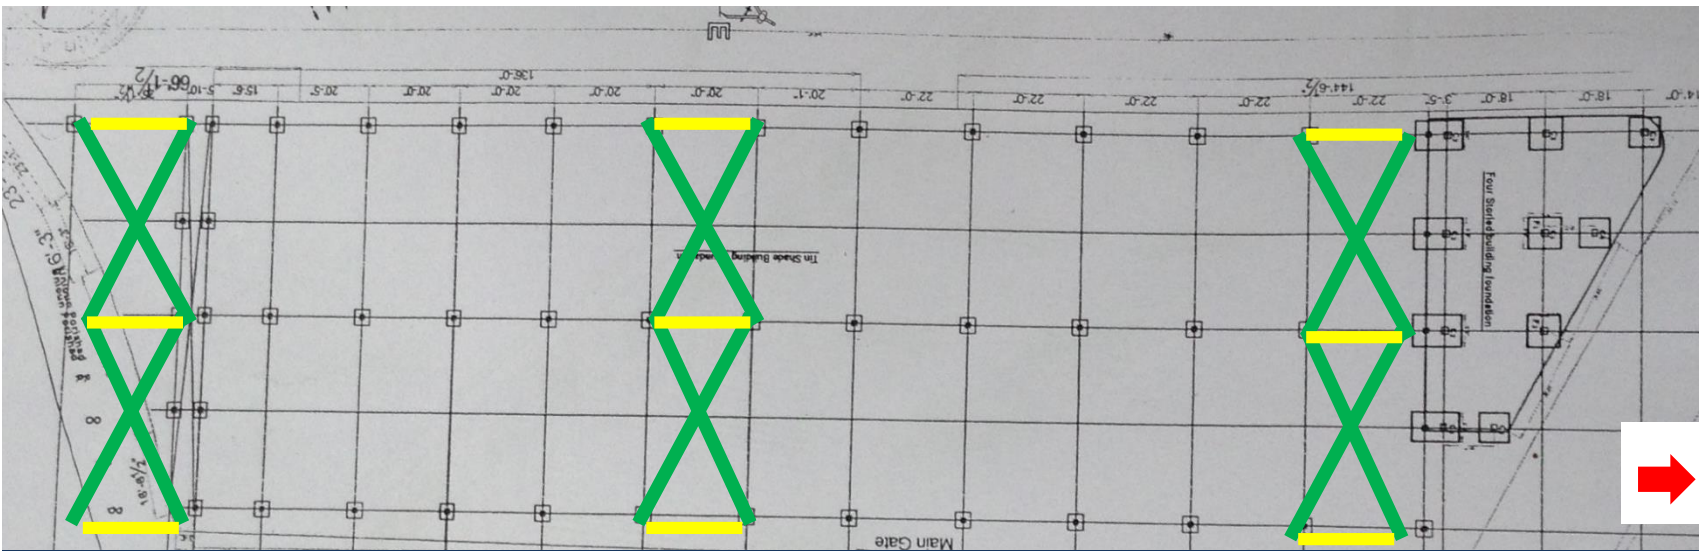
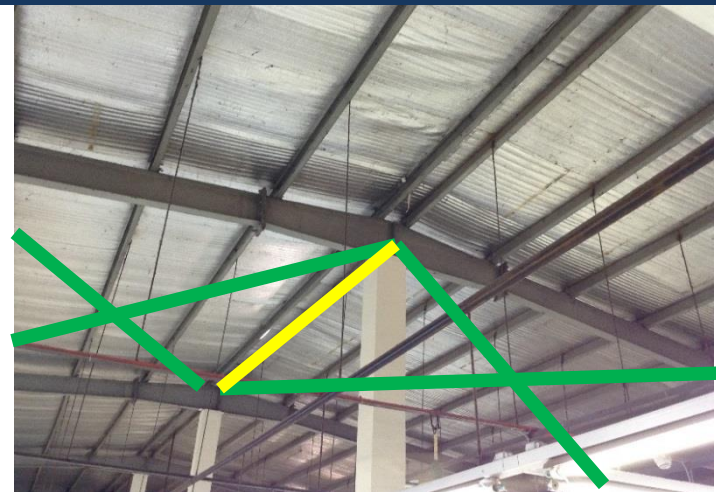
Possible lack of lateral bracing in the Production Building

The Production Building doesn't have any obvious lateral bracing. Connection to the Office Building structure to be investigated. The capacity of the concrete columns to provide lateral stability to be investigated.

A possible lateral bracing system is presented in green and yellow if required

Item No.	Observation	Recommended Action Plan	Recommended Timeline
1	Possible lack of lateral bracing for the steel roof frame of the Production building	The Engineer to investigate the lateral longitudinal bracing, and advise on any necessary alterations.	6-months
2	Possible lack of lateral bracing for the steel roof frame of the Production building	Make any structural alterations as advised by Factory Engineer.	6-months
3	Discrepancies between structural drawings and the as-constructed arrangement of the factory	Building engineer to survey as constructed building. Updated drawings to be prepared showing the correct as constructed layout.	6-months
4	Missing Connection bolts in the Roof steel frame of the Production building	Building Engineer to identify all the omissions and supervise remedial works to the lightweight steel roof to ensure structural adequacy under code vertical and horizontal loads.	6-months

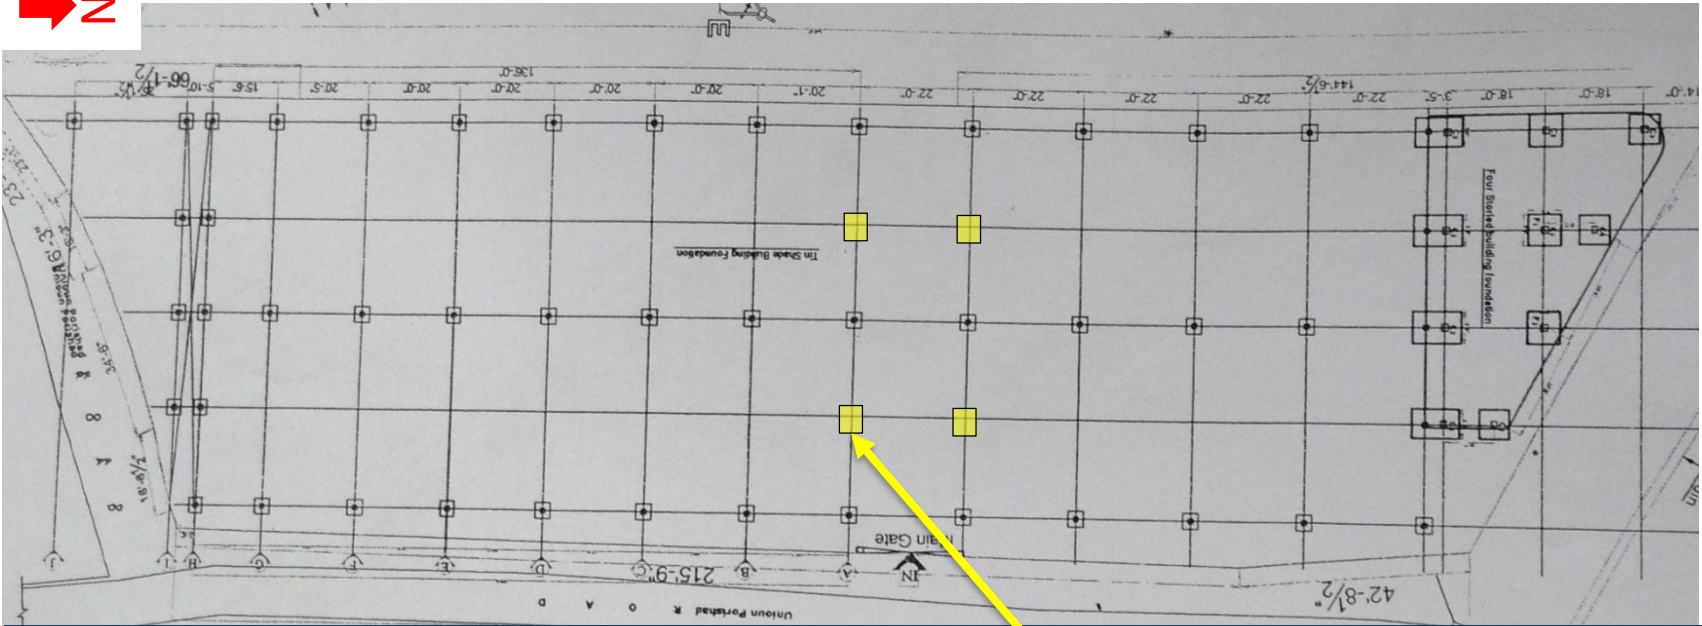
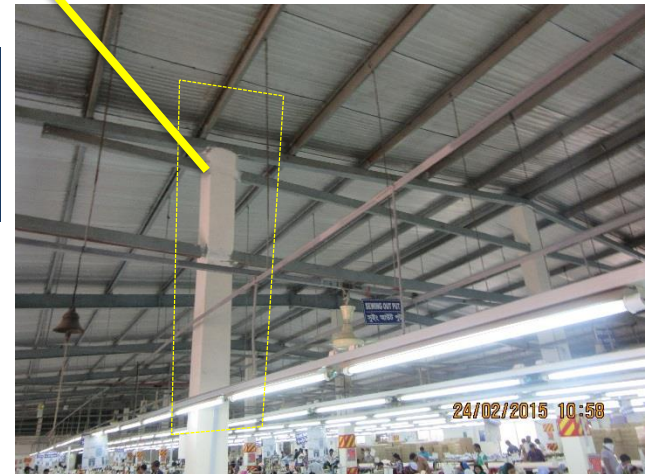
Production Building plan and the position of the additional columns

Discrepancies between Structural Drawings and As build status

Additional columns were found in the middle of the building but they are not shown on the Structural drawings.

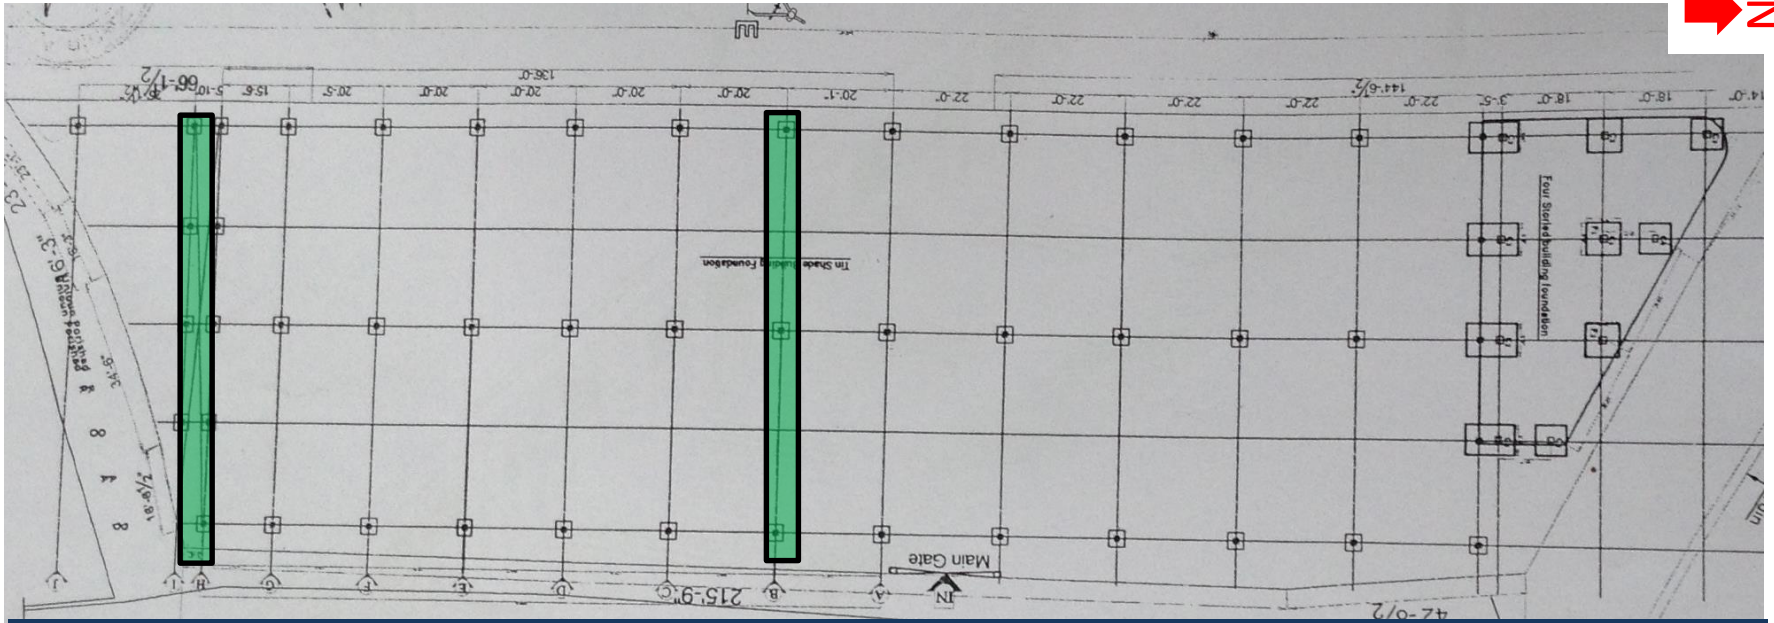
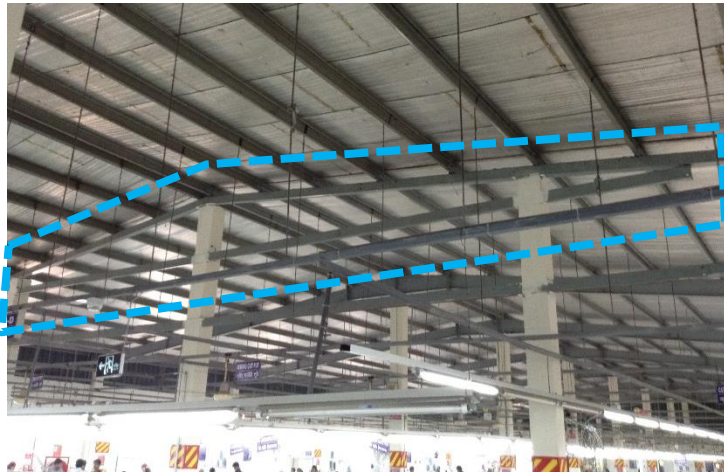
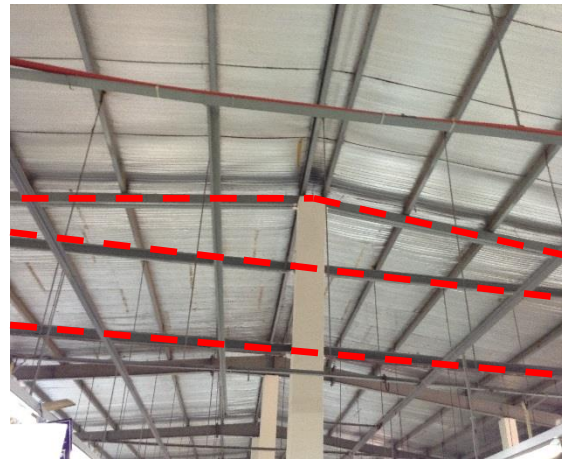
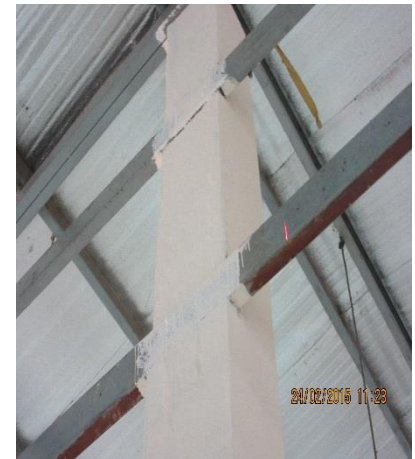
The steel roof frame in 2 grids has a different shape to the typical frame shape. This is not defined in the structural documentation.

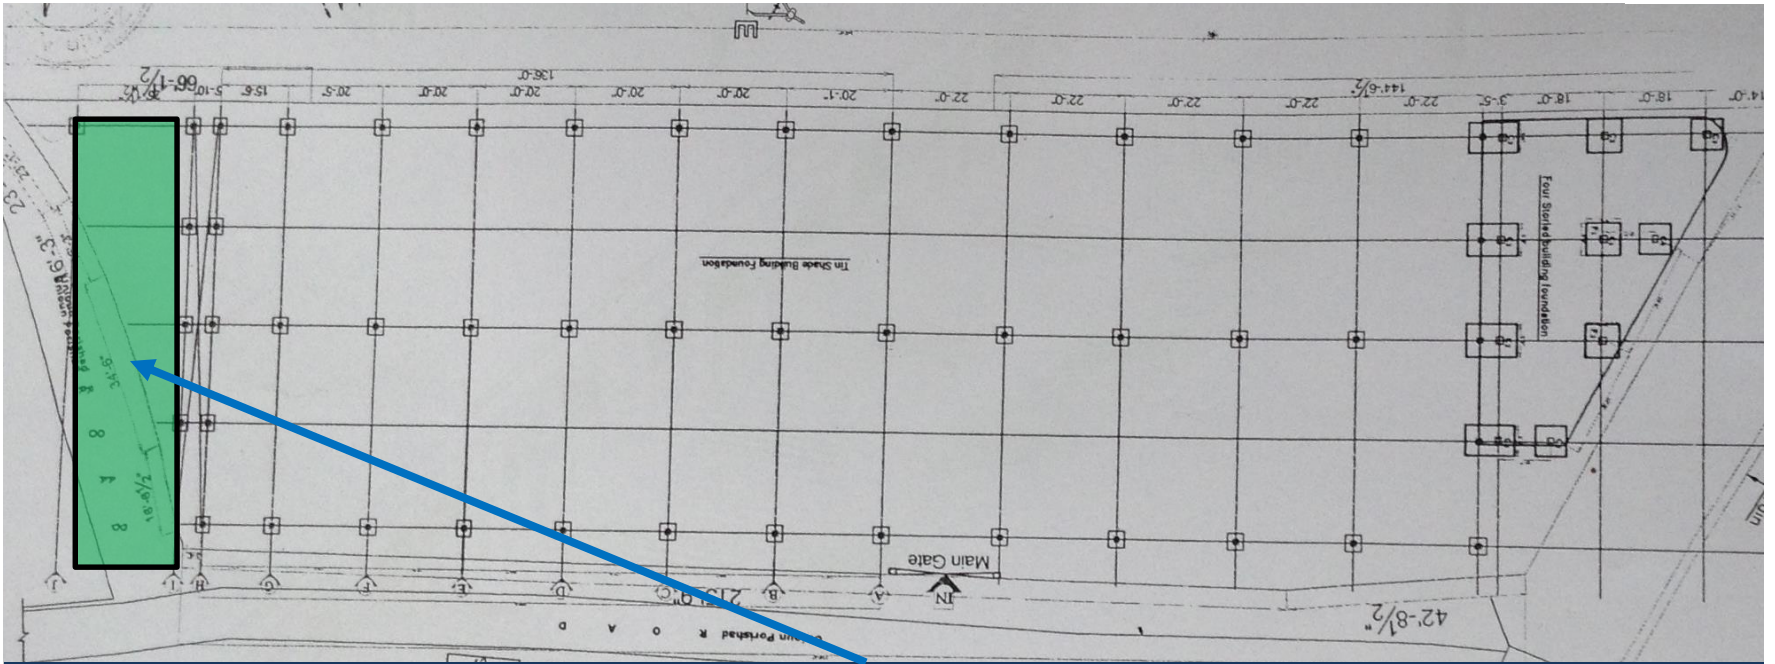
One additional bay was found in the South side of the building.

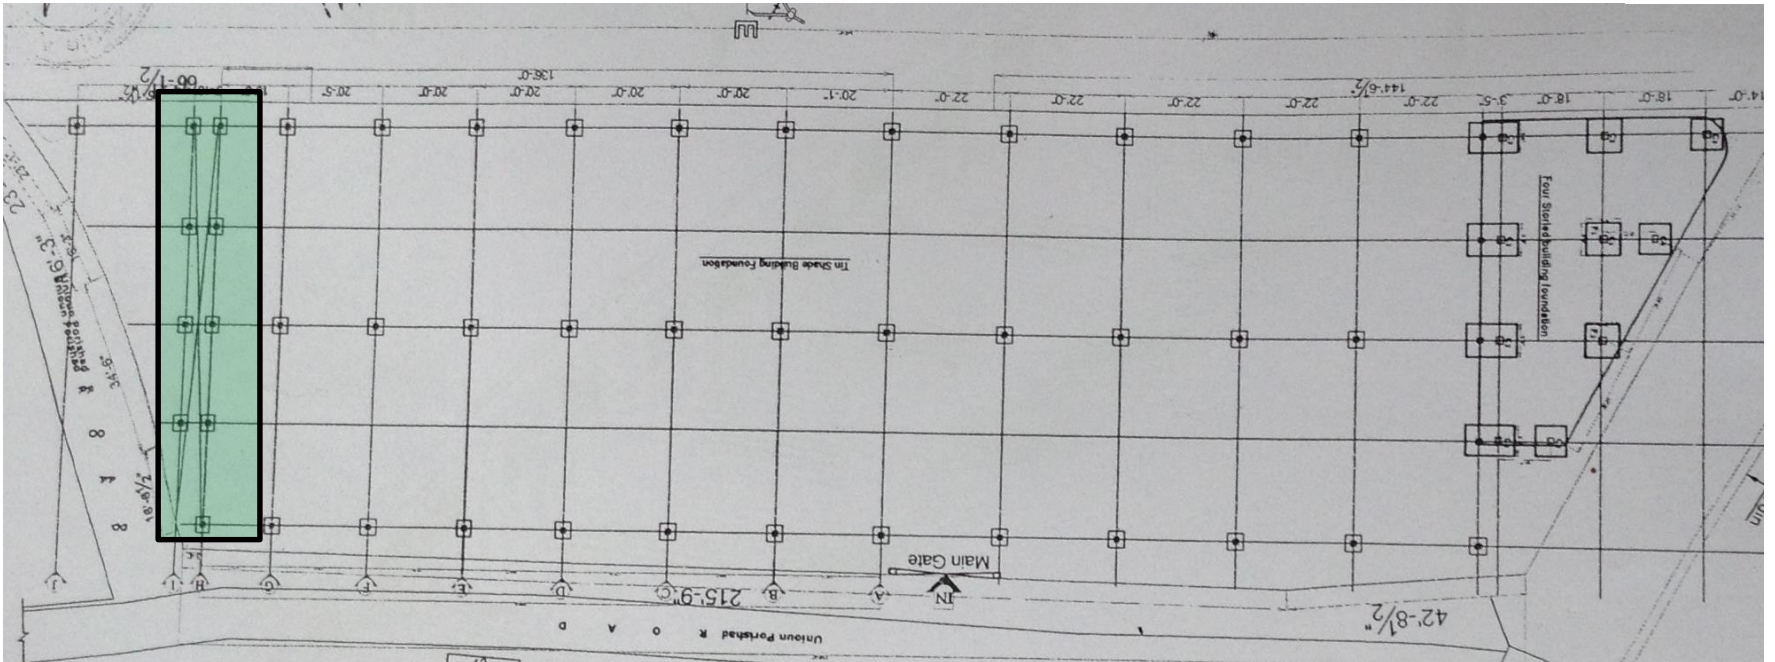
The proposed lateral bracing between these two grids is not present.

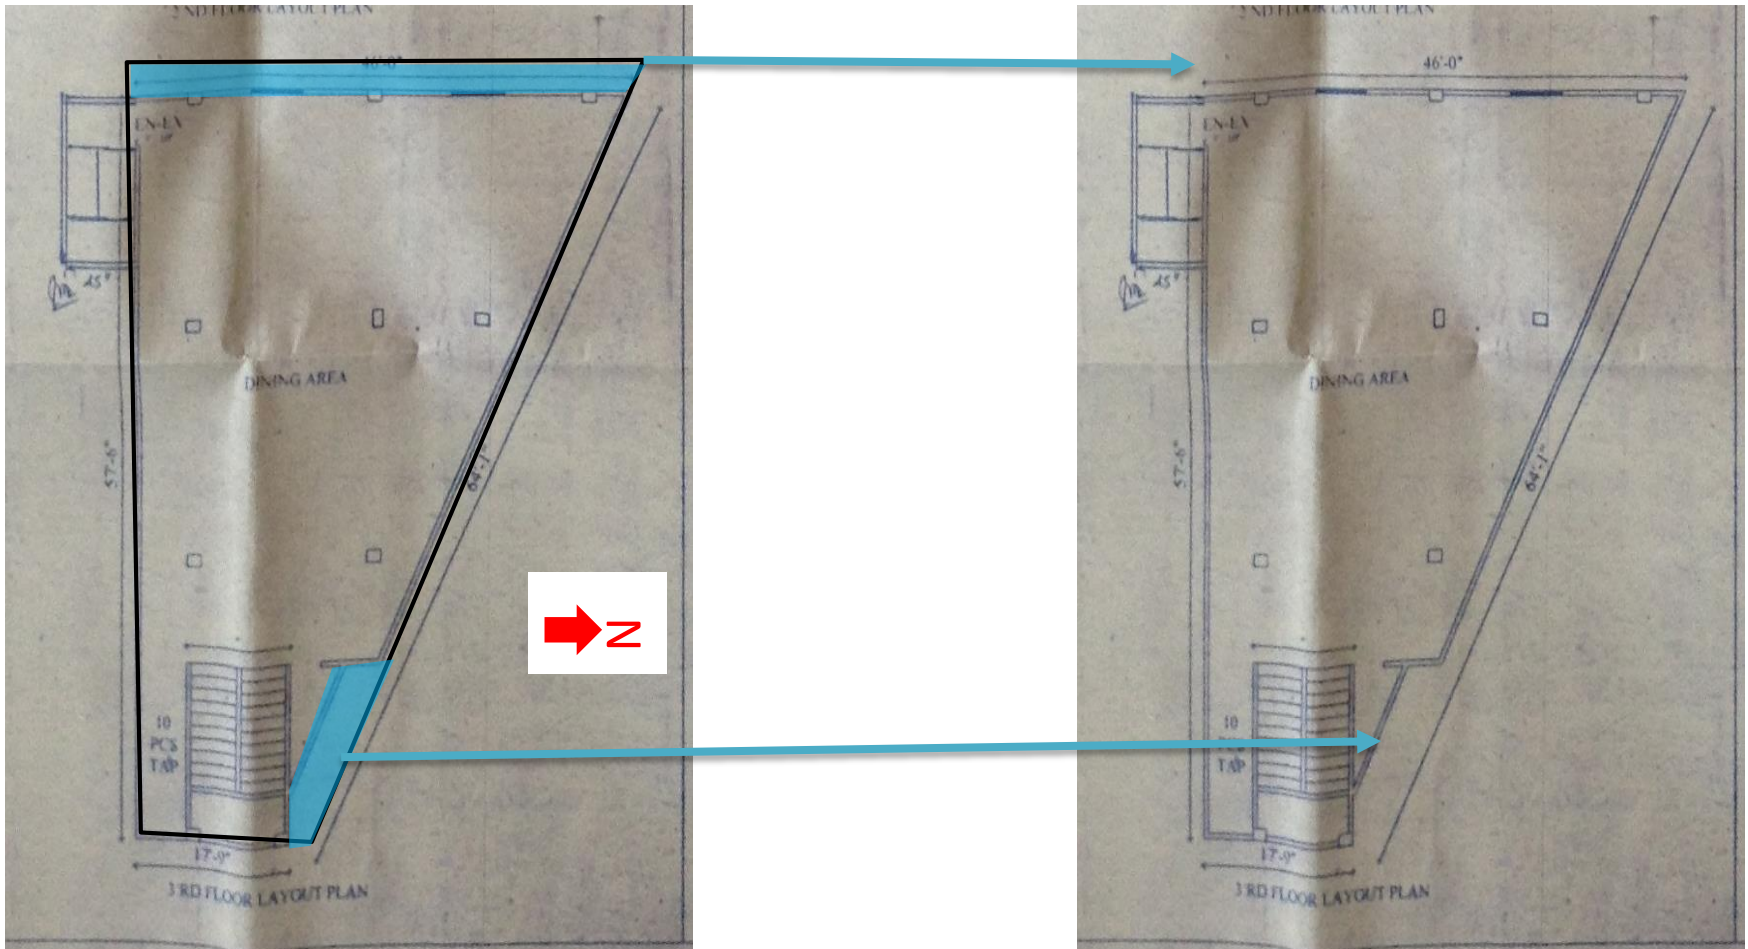
Additional Cantilevers were build beyond those shown on the Office Building permit drawings.

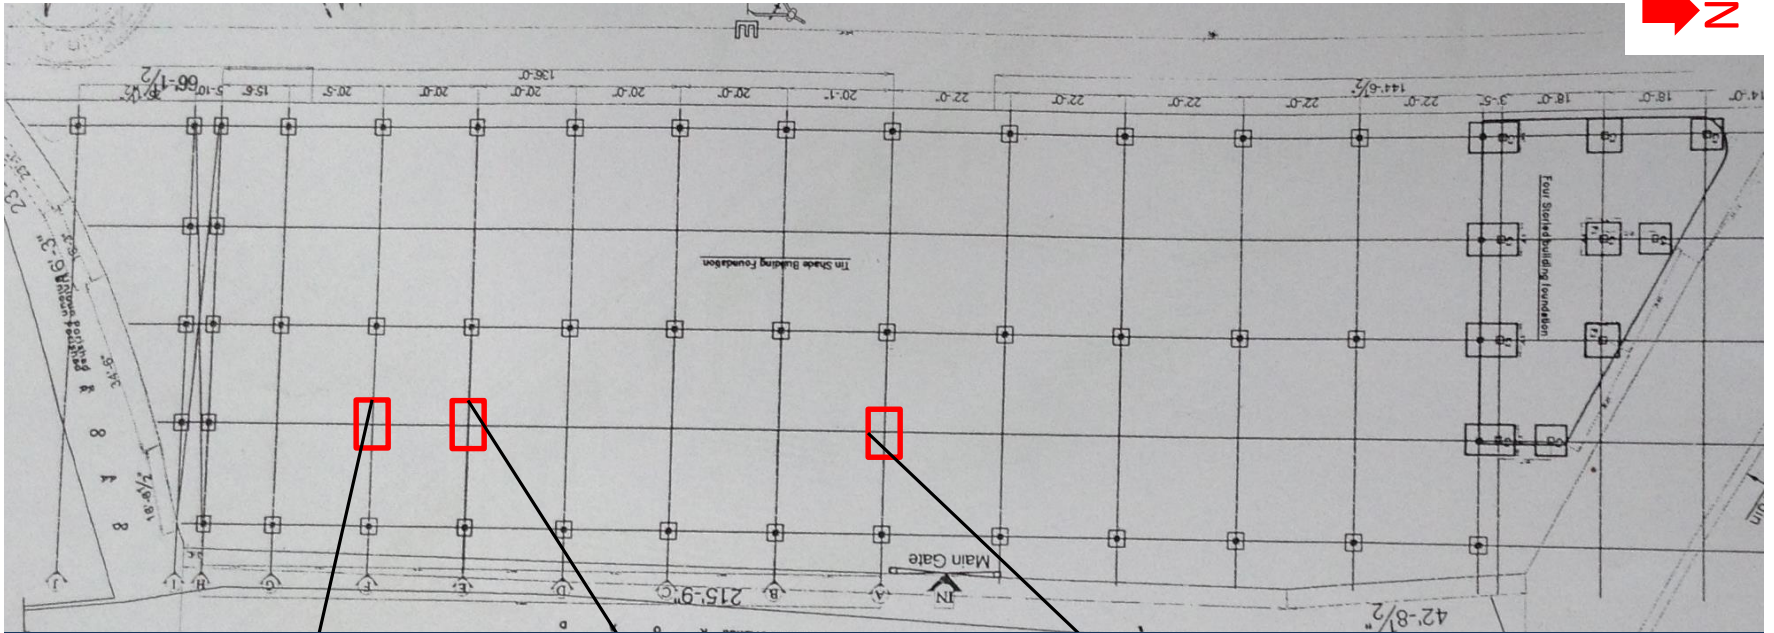
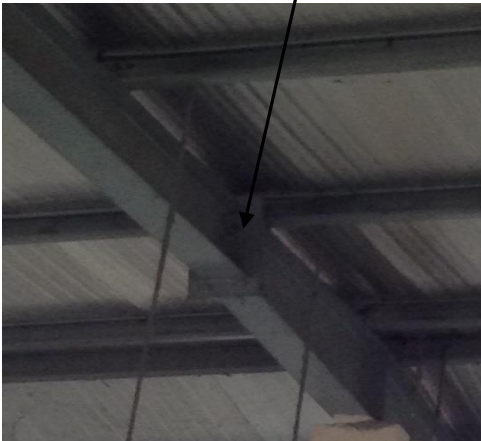
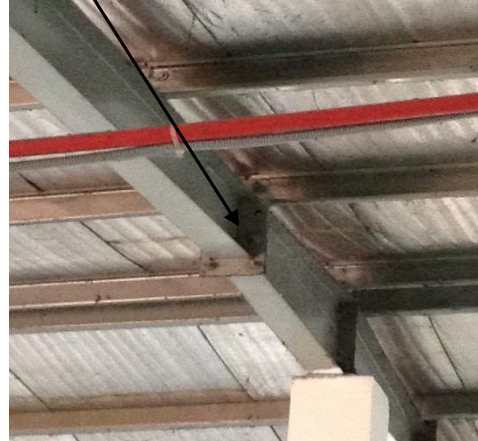
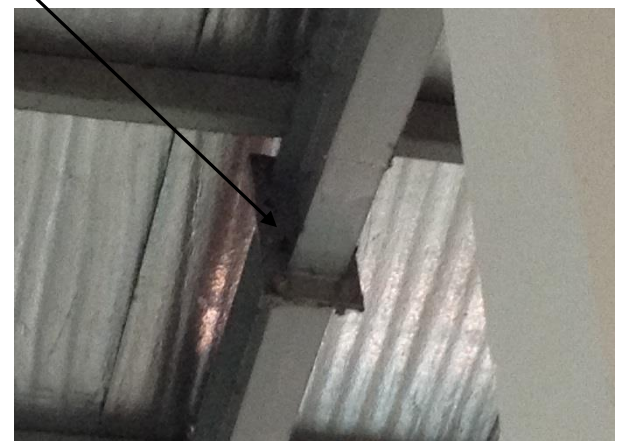
Missing Connection bolts in the Roof steel frame of the Production Building

Some connection bolts were missing in the Steel roof frame.

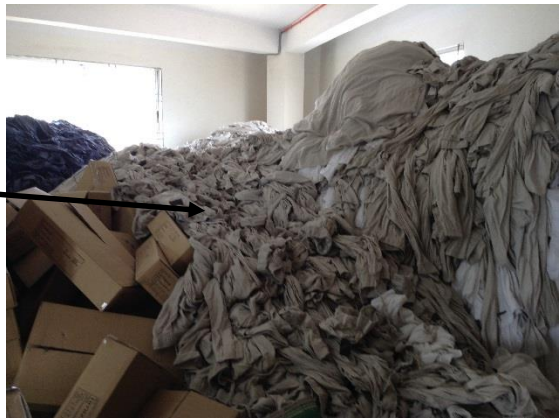
Loose garments storage – 2m height

5	Uncontrolled storage loading and water tanks (Office Building)	Building Engineer to confirm design loading on slabs and take appropriate action by removing storage loads where required.	6-months
6	Uncontrolled storage loading and water tanks (Office Building)	Engineer to design a loading plan for the building.	6-months
7	Uncontrolled storage loading and water tanks (Office Building)	Spread the load of the roof water tanks on a bigger area.	6-months

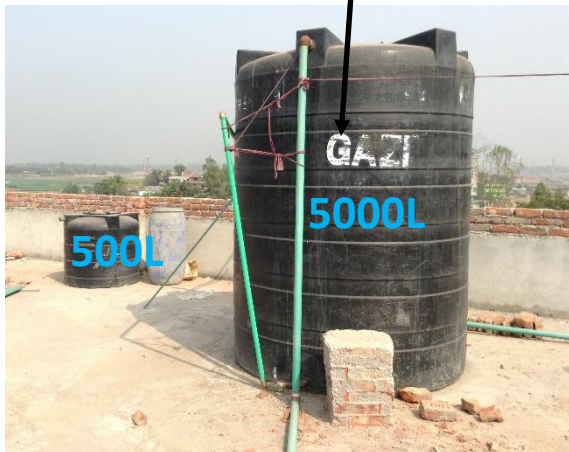
Water tank

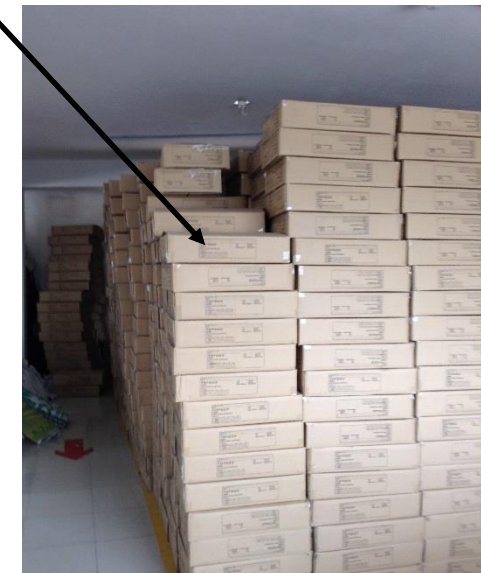
Finish goods packet storage – 2.4 m height

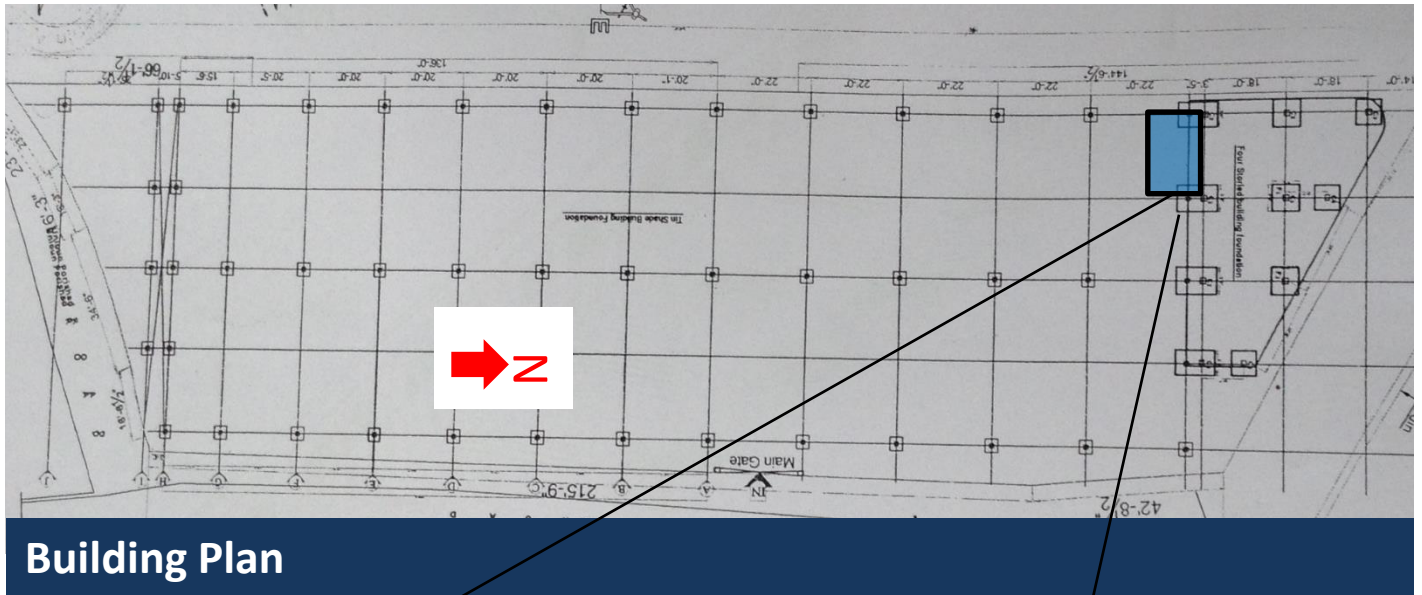
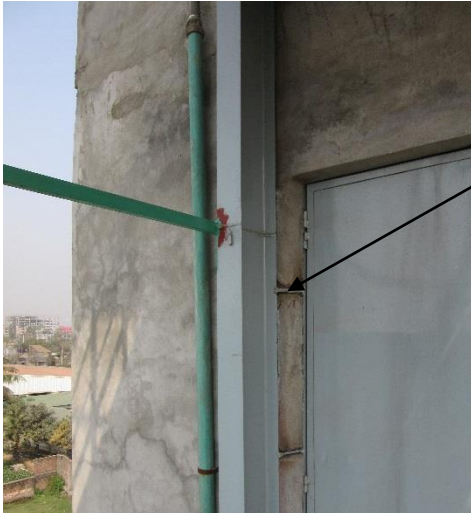
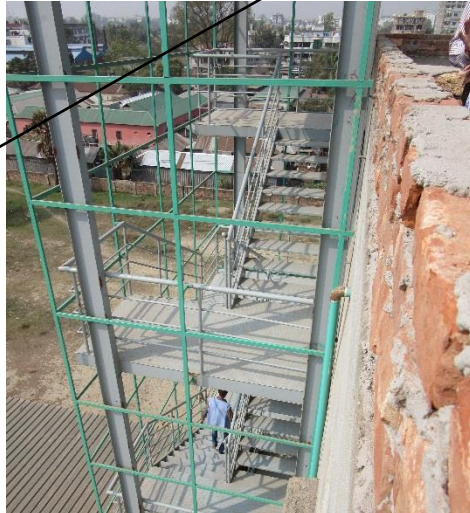
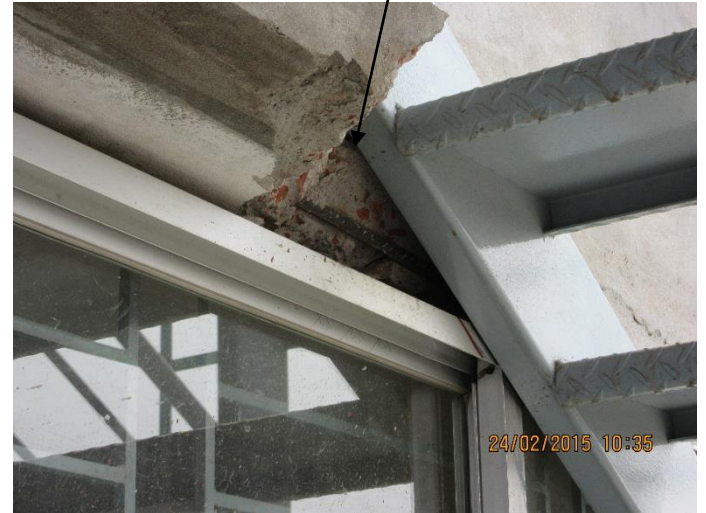
Building Plan

Lateral Stability of the steel stair structure

Lightweight steel stairs may not be adequately connected to the load bearing elements of the Office building and there is no lateral bracing.

Item No.	Observation	Recommended Action Plan	Recommended Timeline
8	Lateral Stability of the steel stair structure	Building Engineer to confirm design loading, lateral bracing and the connection to the Office Building.	6-months
9	Lateral Stability of the steel stair structure	Lightweight steel stairs to be reconstructed/upgraded to ensure structural adequacy under code vertical and lateral loads by the Building Engineer.	6-months
10	Apparently non-engineered lightweight roof of the Generator building	Lightweight steel roof are to be reconstructed/upgraded to ensure structural adequacy under code vertical and lateral loads by the Building Engineer.	6-months

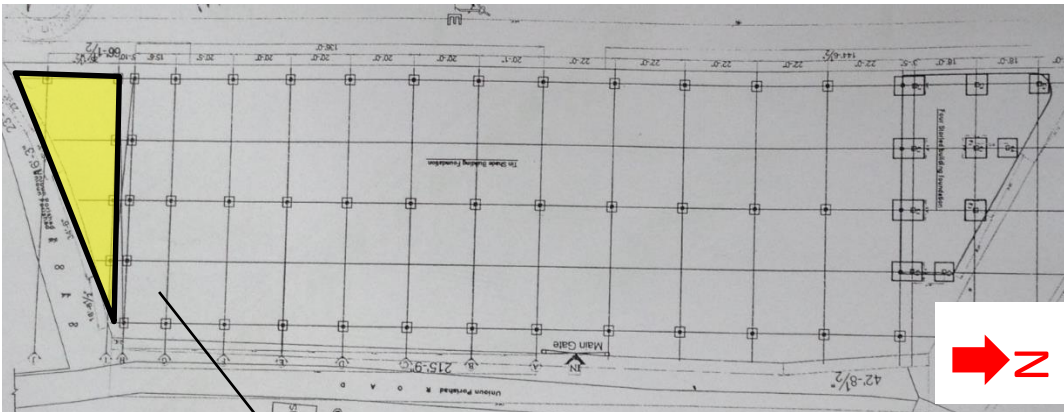
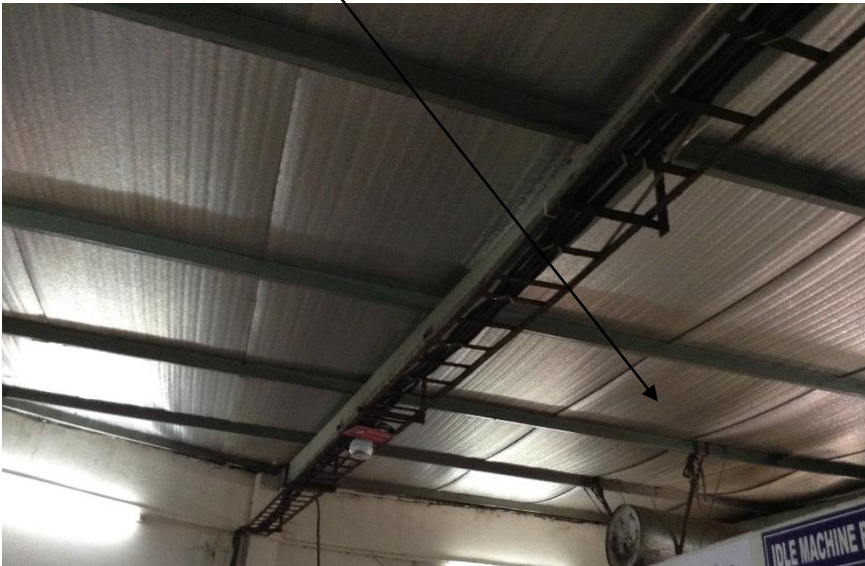
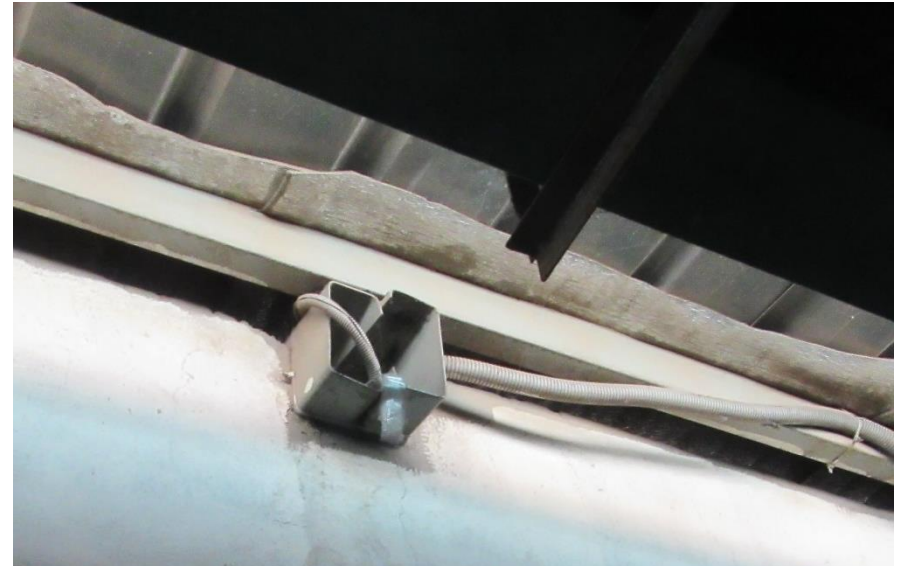
Building Plan

Apparently non-engineered roof structure of the Generator building

The Generator Building has an apparently non-engineered light weight steel roof structure. The roof frames appear to be supported on brick walls. The brick walls show some cracking under the connection point loads.
