# Interloop BD Ltd. (9994)

Plot 146, Khatian no. 40, Mouza 86 Soydana, PS-Joydevpur Dist., Gazipur, Dhaka  
(+23.961626N, 90.380531E)

18.MARCH.2014

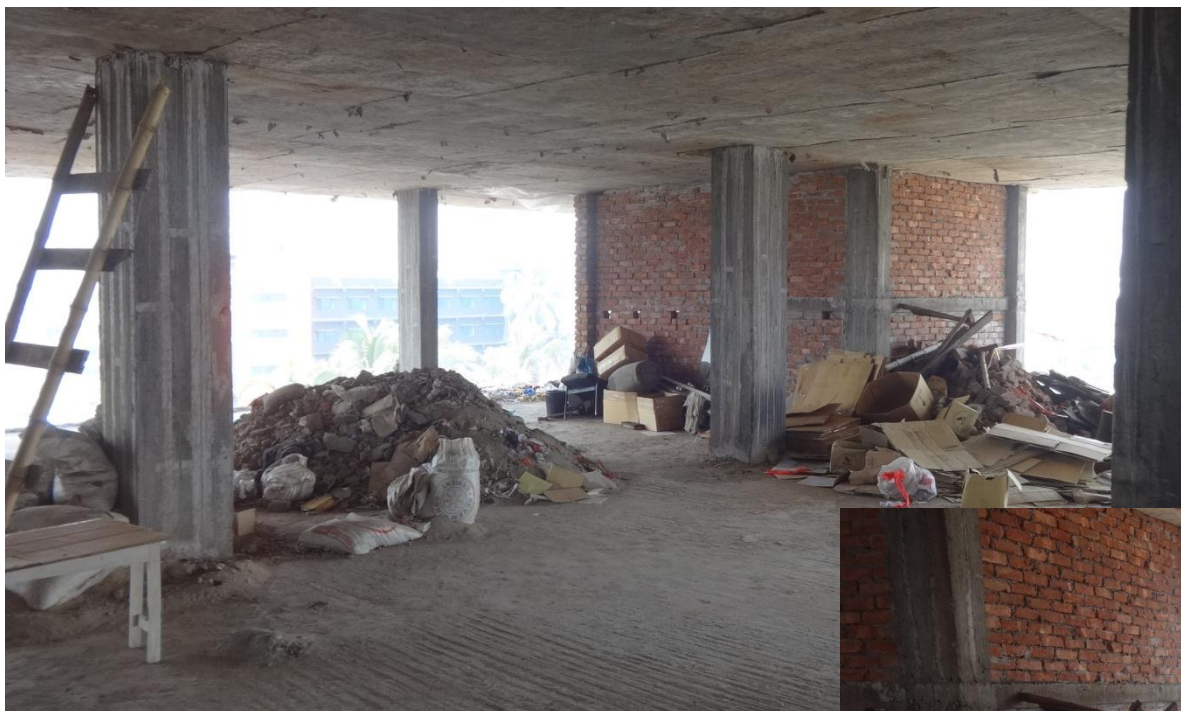
Piles of waste materials and bricks at the under-construction 5<sup>th</sup> floor level.

Uncontrolled and potentially very heavy piles of waste materials and bricks during construction.

Overloading of 5<sup>th</sup> floor during construction due to piles of waste materials and bricks.

Any waste should be immediately removed to ground level, and materials necessary for construction should be spread out so as to not exceed design loading.

- Remove any waste materials not required for construction and move to ground level.
- Spread out remaining necessary construction equipment so as not to exceed design loads.

- During construction ensure that workers do not store waste or other materials in piles on the slab. Waste should be removed immediately as it develops.

- Implement and adhere to a loading plan across the whole structure.
- Ensure that future storage loads do not exceed design loads.

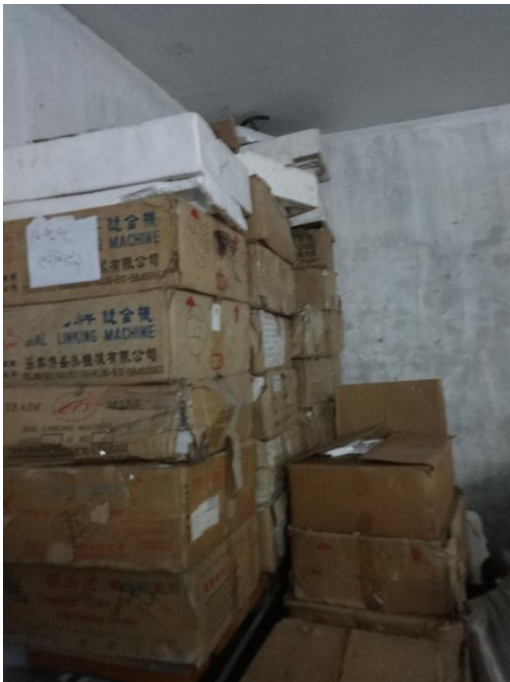
3 examples, taken from 1<sup>st</sup> and 3<sup>rd</sup> floor levels (not occupied by Interloop BD Ltd.), of excessive and uncontrolled storage loading. This should be properly assessed and regulated.

Left; boxes contain metal sewing machines and are therefore too heavy to be stored at such height.

Uncontrolled loading at 1<sup>st</sup> and 3<sup>rd</sup> floor levels leading to potential issues of overloading.

- With the assistance of in-house engineer, establish a maximum storage height to remain within design load of 3kN/m<sup>2</sup>.
- Reduce all storage to established height.

- Apply the same rules established in the loading plan (set out in item 2) to all floors of the building, regardless of tenant.

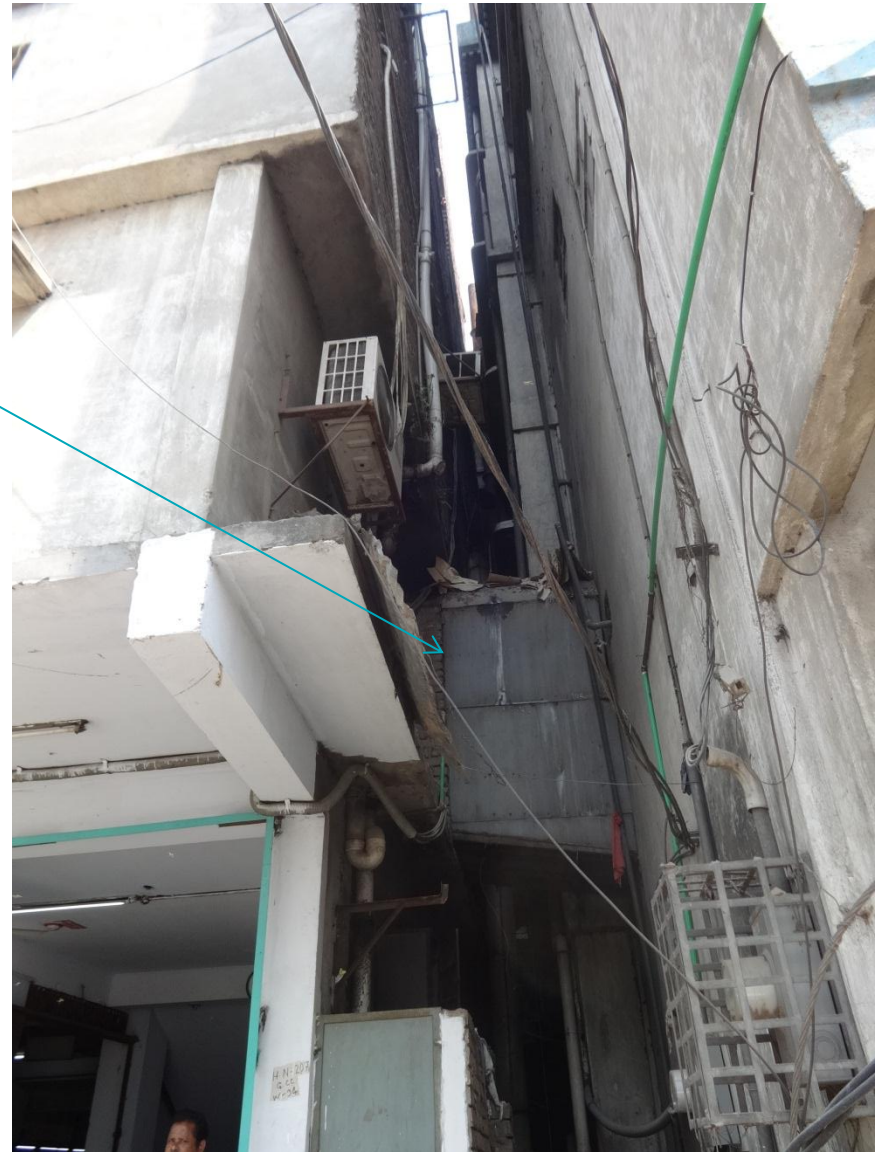
No sufficient lateral stability system was observed, either in the drawings or through the existing structure.

These images clearly show the flat slab construction employed, but it can also be seen to the right that the stair cores (one shown) are only of masonry construction and do not constitute shear walls.

No clear lateral stability system is in place; this requires further detailed analysis.

- Carry out a detailed structural assessment to determine the capacity of the existing structure, particularly against lateral loads.

- Implement any changes recommended by the detailed engineering assessment.

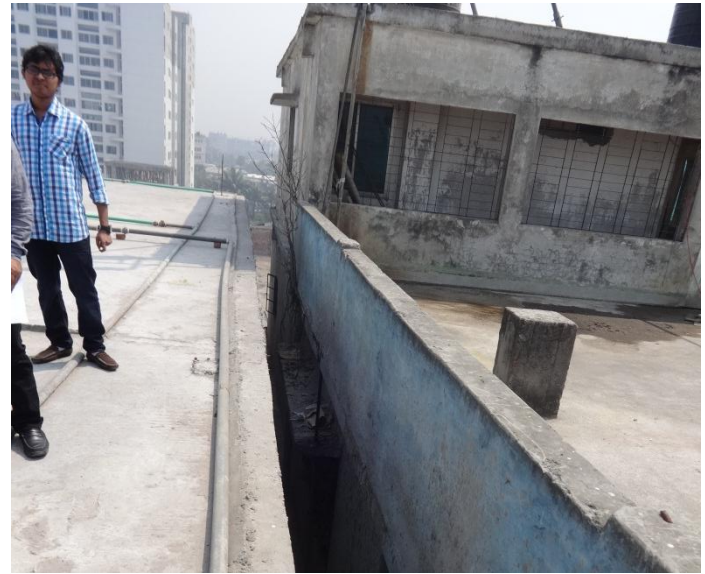
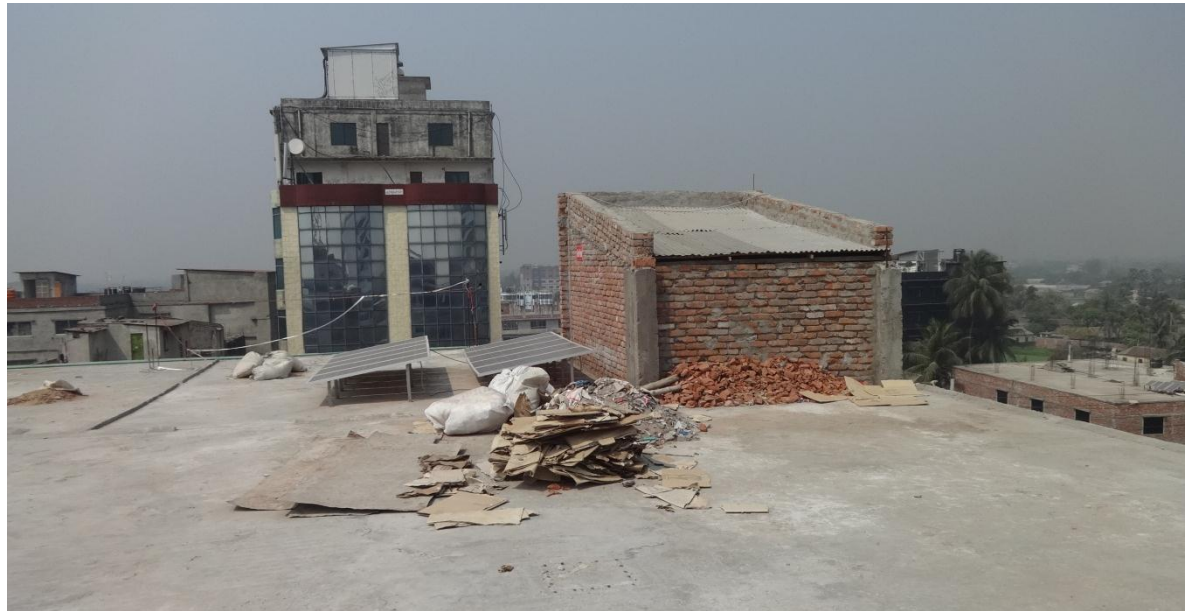
Waterproofing and perimeter wall yet to be added to roof level.

No waterproofing layer yet added to roof, leading to potential issues of water ingress and damage to structural members.

Waterproofing layer and perimeter wall to be applied at roof level as part of the on-going construction works.

Roof level construction is clearly incomplete, however it should be regarded as a necessity to add both a waterproofing layer and a perimeter wall. These actions will negate water ingress and a fall-hazard respectively.

- Apply a waterproof membrane across the full area of roof level.
- Construct a perimeter wall to a height of 1m, as detailed in building licence drawing.
