# Nippon Garment Industries Ltd.

93, Auchpara, Tongi, Gazipur - 1712  
(23.915849N, 90.393507E)

25<sup>th</sup> February 2015

# Observations

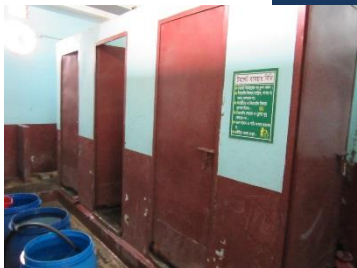
**Male Toilets**

**High stress level in column around toilet  
on Ground Floor from floor build up in  
toilets at first and second floor.**

Cursory calculations indicate column (marked with red circle) at the Ground Floor is highly stressed under their current loading condition.

| Item No. | Observation | Recommended Action Plan | Recommended Timeline |
|---|---|---|---|
| 1 | High stress level in all columns, in particular to columns around toilet on Ground Floor (grid lines J1, K1, L1, J2, K2 & L2). Core results indicate low concrete strengths | A Detail Engineering Assessment to be commenced on building 1, see attached Scope. | <b>Immediate - Now</b> |
| 2 | High stress level in all columns, in particular to columns around toilet on Ground Floor (grid lines J1, K1, L1, J2, K2 & L2). Core results indicate low concrete strengths | Building Engineer to review concrete strengths and as built reinforcement to columns supporting toilet area to assess column capacity and if necessary reduce floor loads (by removing toilet raised platform) in this area. | <b>Immediate - Now</b> |

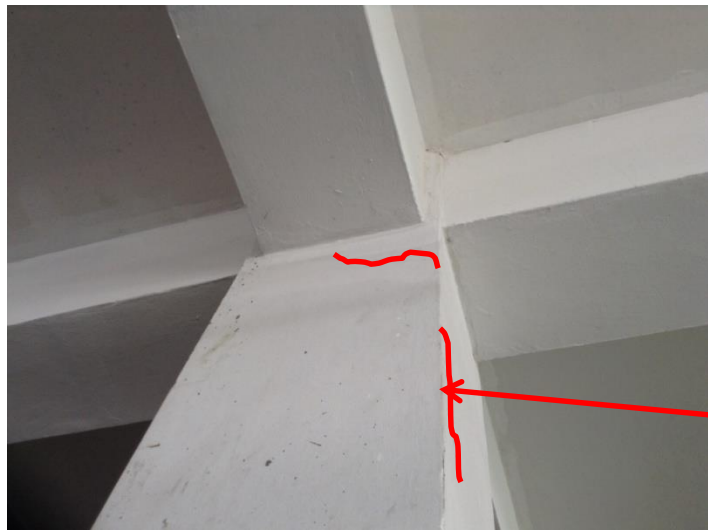
**Cracking on column at second floor**

| Item No. | Observation | Recommended Action Plan | Recommended Timeline |
|---|---|---|---|
| 6 | Cracking on beams and columns | As part of the DEA noted in Item 1 the Building engineer is to investigate the cracking in the beams | 6-weeks |
| 7 | Cracking on beams and columns | Building Engineer to expose surface of the concrete beam in a number of locations to determine if the cracking extends through the finish into the beam. Also beams repaired with epoxy to be checked in case of reoccured cracks and make recommendations for remedial measures if required. | 6-weeks |

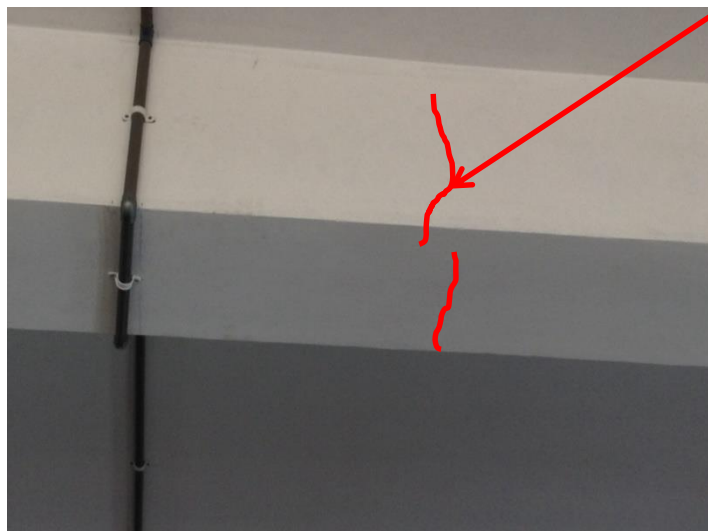
**Cracking on beam at first floor**

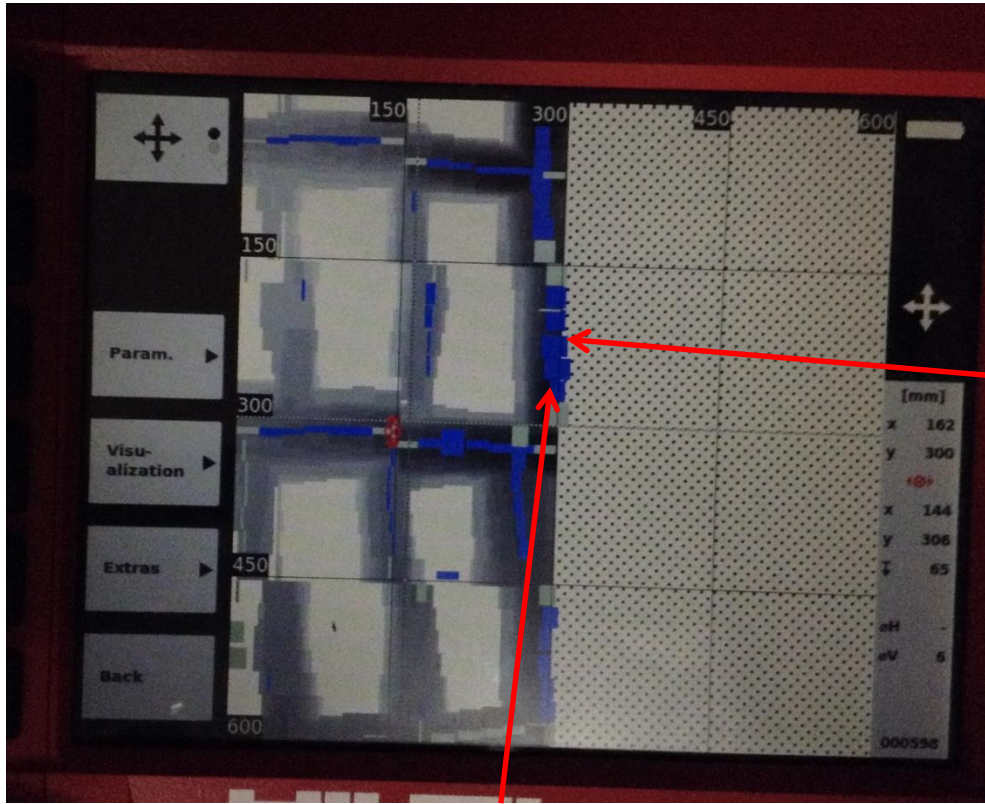
Ferroscan indicated 3 bars in each face (i.e. 8 bars in total). Drawings indicate 12 bars

| Item No. | Observation | Recommended Action Plan | Recommended Timeline |
|---|---|---|---|
| 10 | Discrepancy between information on drawings and site observations | As part of the Detail Engineering Assessment (see Item 1), Factory Engineer to update the engineering drawings (especially for number of rebars in columns). | 6-weeks |

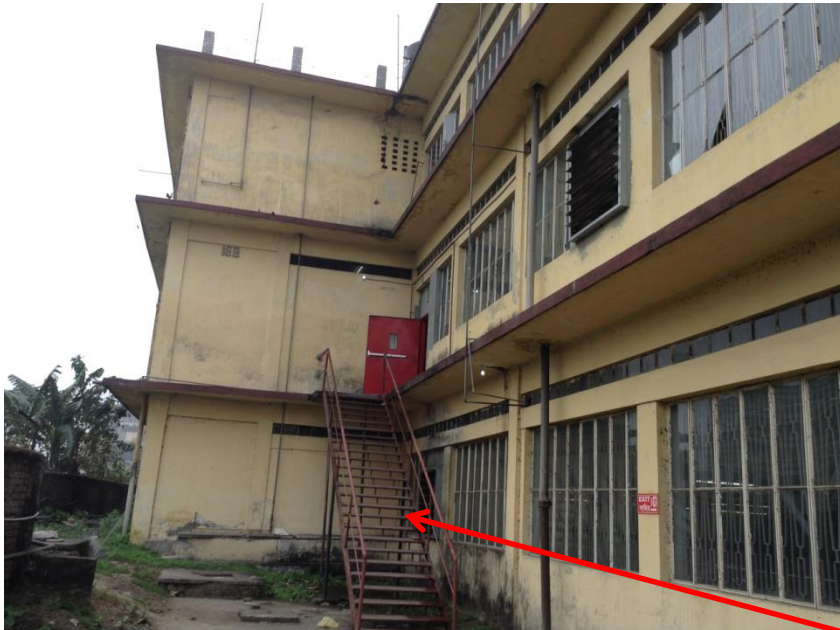
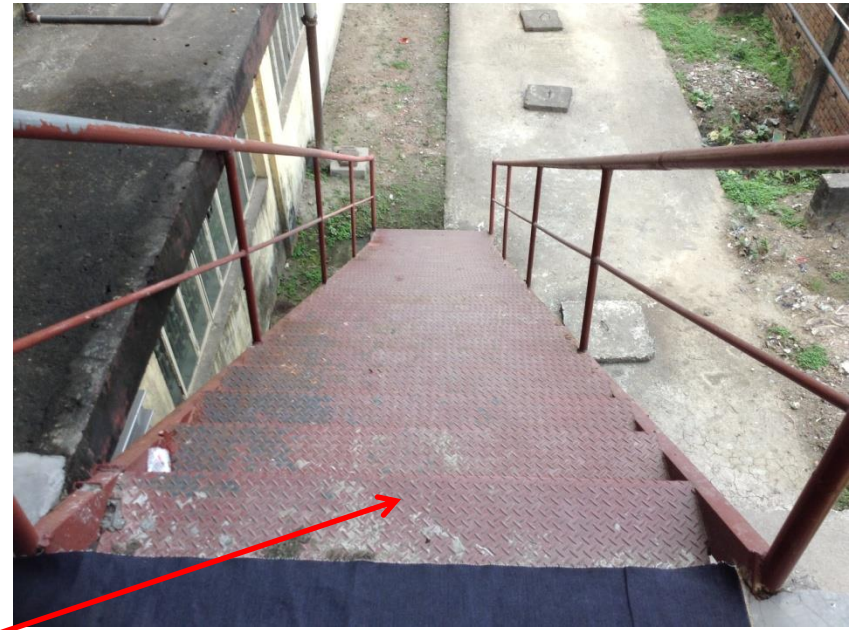
**Lightweight stair with minimal stability due to lack of vertical bracing and does not appear very robust. To be checked for full emergency stair loading.**

| Item No. | Observation | Recommended Action Plan | Recommended Timeline |
|---|---|---|---|
| 11 | Evacuation stairs lack stability and do not appear very robust | Building engineer to check the capacity of the evacuation stair and make any necessary alterations. | 6-months |

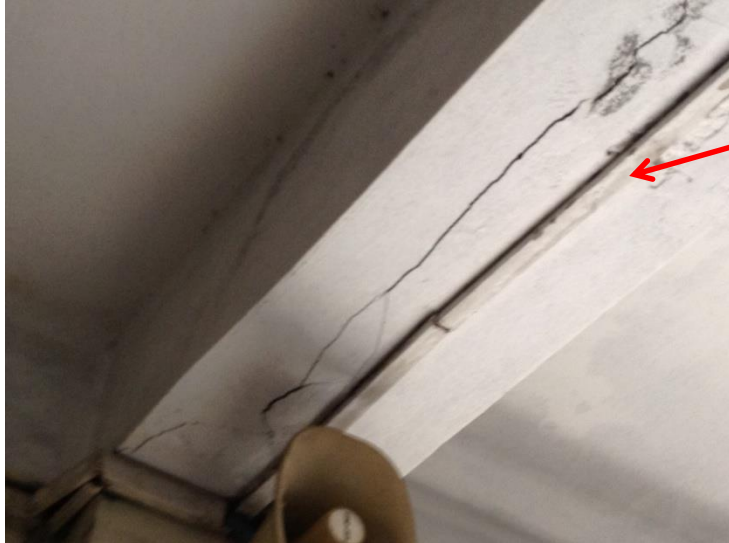
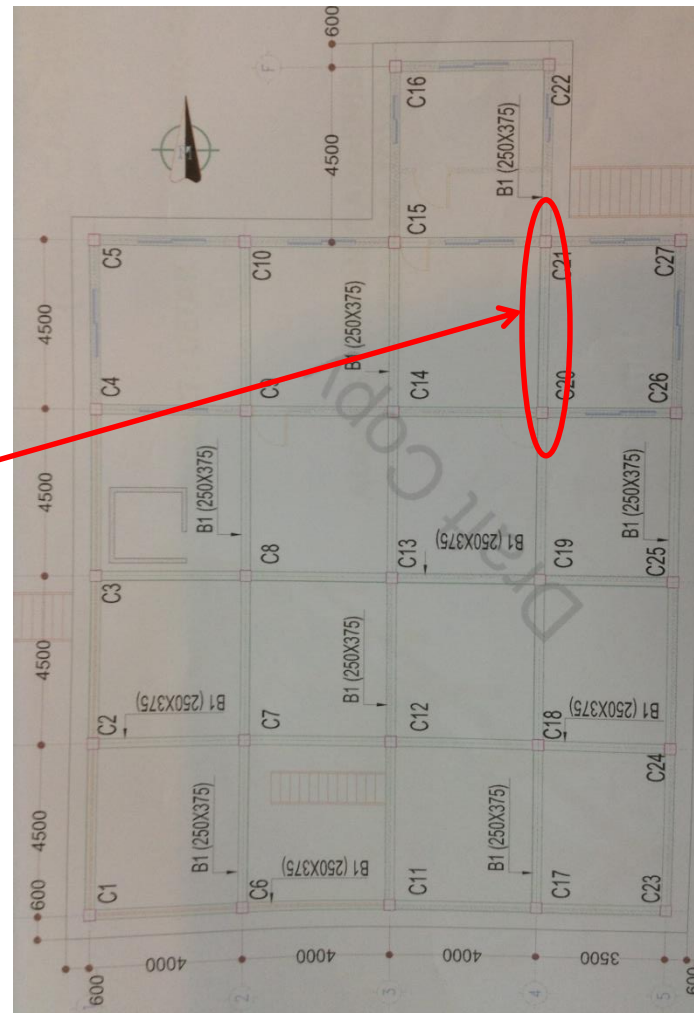
Significant cracking on beam at first floor

| Item No. | Observation | Recommended Action Plan | Recommended Timeline |
|---|---|---|---|
| 12 | Cracking to beam | Building engineer to make recommendations for remedial measures if required. | 6-weeks |

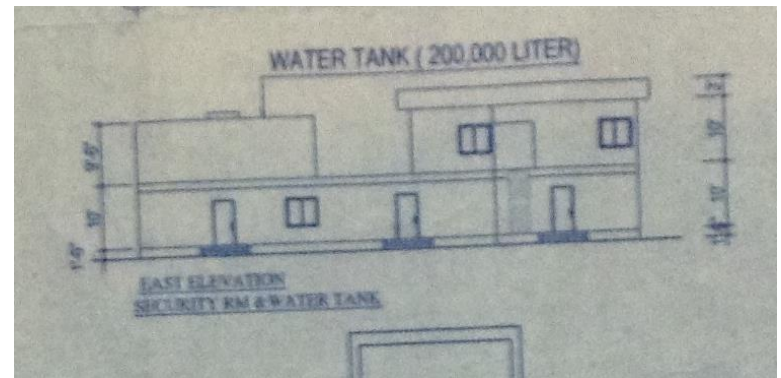
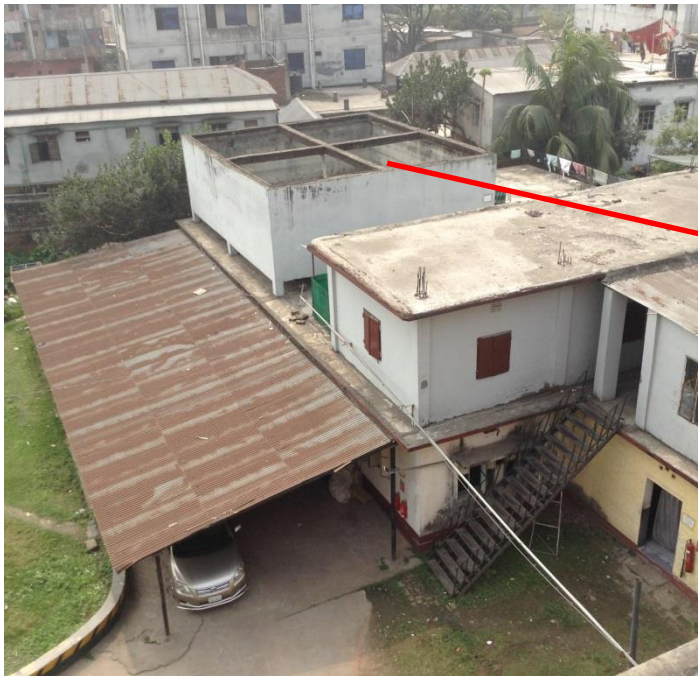
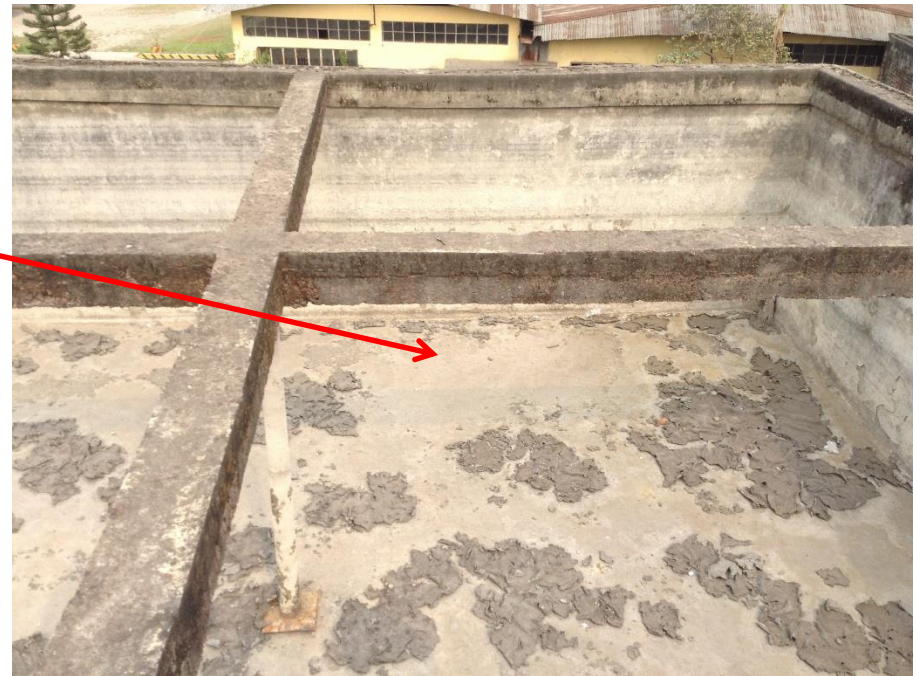
**Uncovered water tank (Not in Use).  
High stress level in columns under tank, if  
tank is filled in the future**

Cursory calculations indicate that columns below tank would be over stressed if tank gets filled with water.

| Item No. | Observation | Recommended Action Plan | Recommended Timeline |
|---|---|---|---|
| 15 | Uncovered water tank | Building Engineer to review concrete strengths and as built reinforcement to columns supporting the water tank to assess column capacity and if necessary reduce column loads by demolishing the tank or the columns need to be strengthened if the tank is required for future use. | 6-weeks |
| 16 | Uncovered water tank | Or clearly mark on tank that it is not to be filled and cover to prevent rain water filling (consider making hole in tank at base so water can not collect in tank) | 6-weeks |

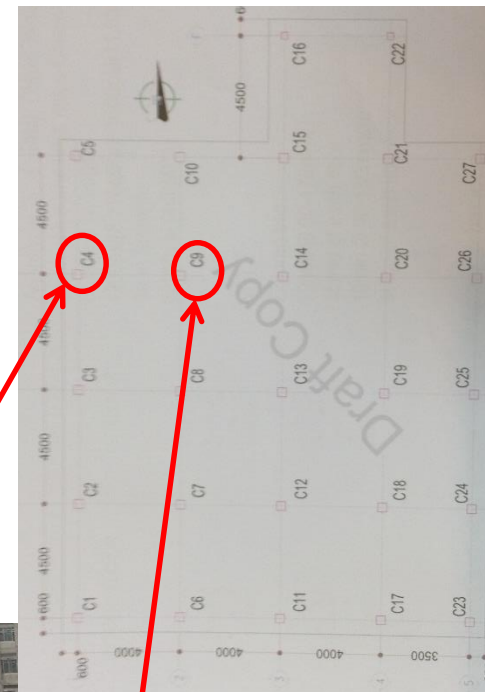
Only 6 rebars were observed on site. Drawings show 10 bars.

Column dimensions were measured as 300mmX300mm excl. plaster

| Item No. | Observation | Recommended Action Plan | Recommended Timeline |
|---|---|---|---|
| 17 | Discrepancies between information on drawings and site observations | Factory Engineer to update the engineering drawings (especially for number of rebars in columns). | 6-weeks |

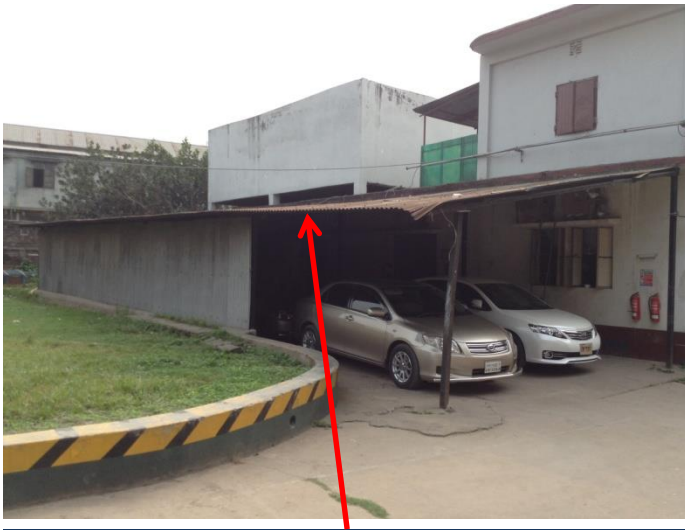
**Additional tin shaded parking area appeared non-engineered**

| Item No. | Observation | Recommended Action Plan | Recommended Timeline |
|---|---|---|---|
| 18 | Apparently non engineered structures | Building engineer to check the capacity of the lightweight steel structures and stairs and make any necessary alterations. | 6-months |

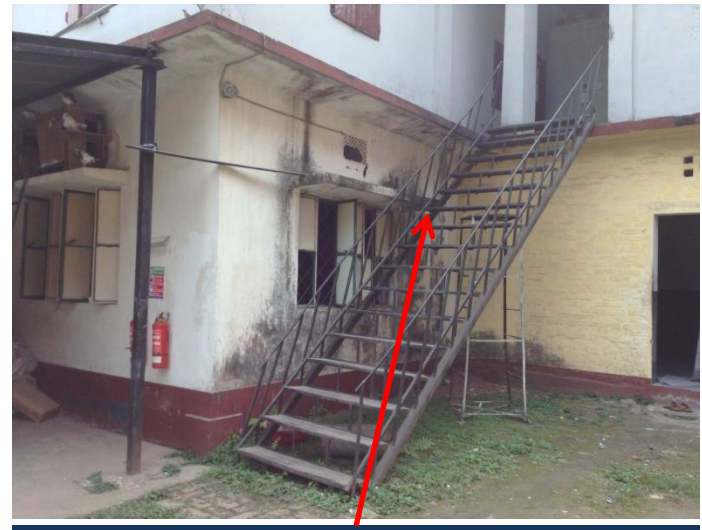
**Stair is constructed from small structural sections**

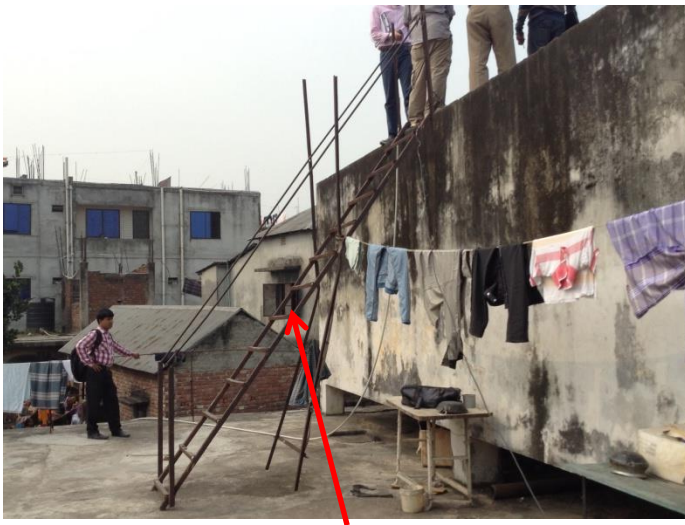
**Non-engineered stair structure for water reservoir**

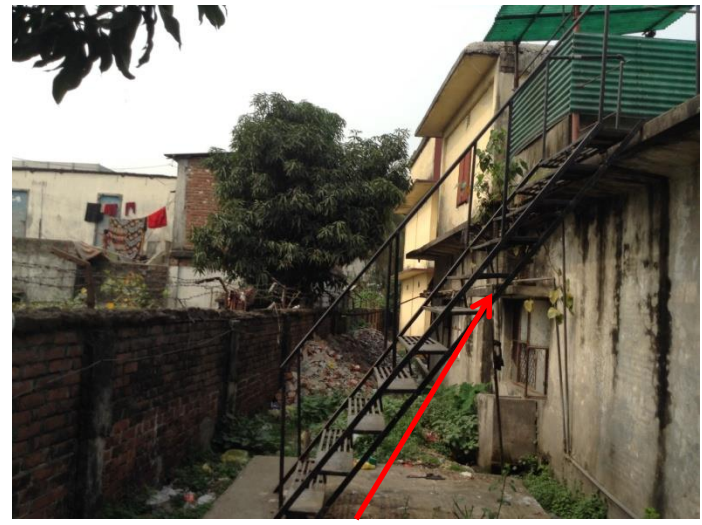
**Non-engineered stair structure**

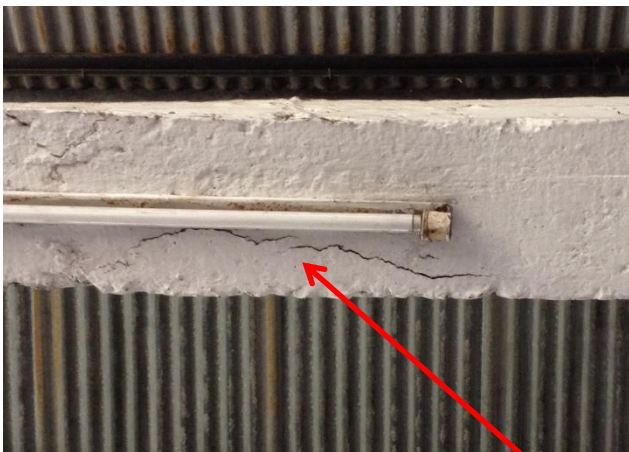
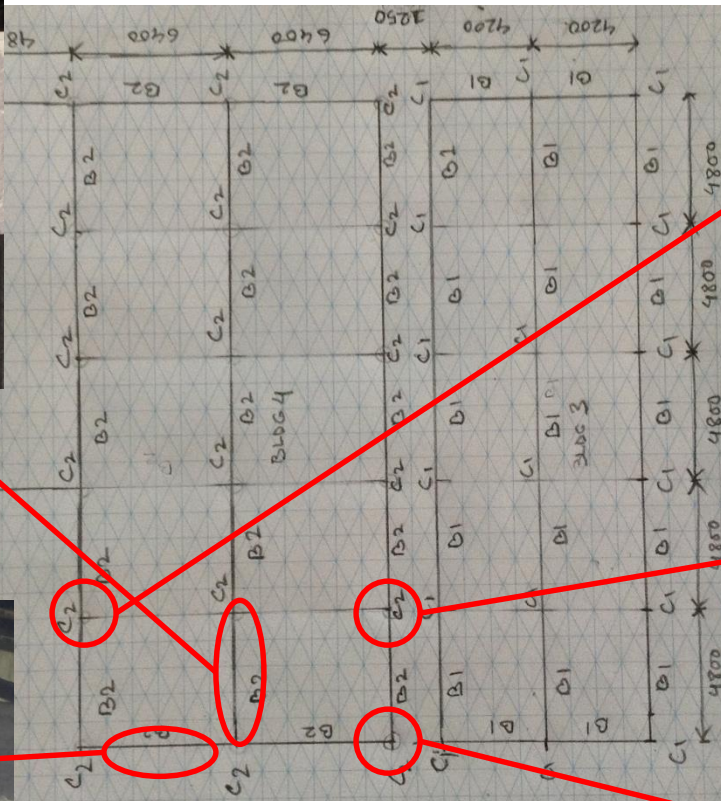
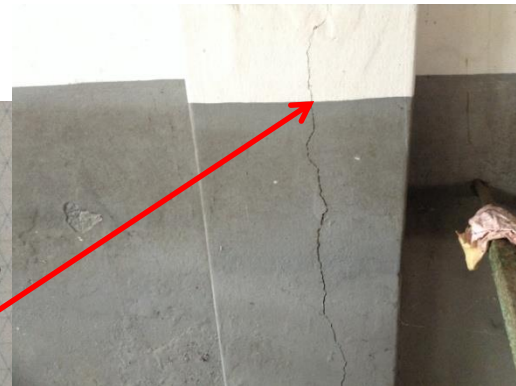
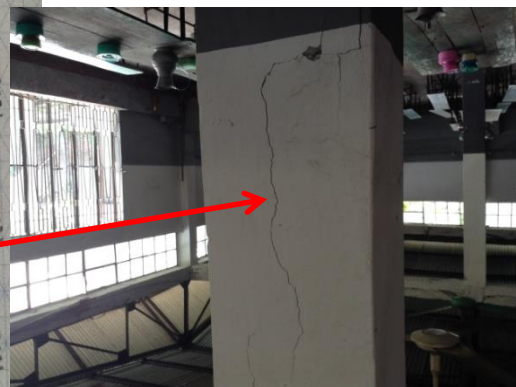
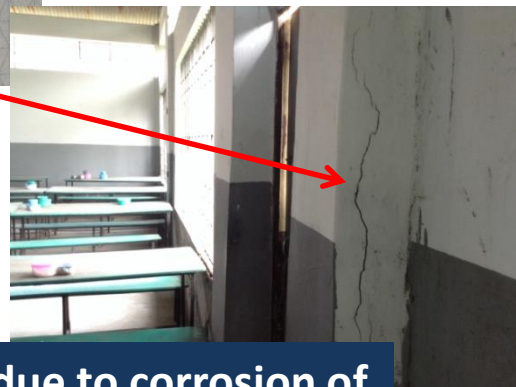
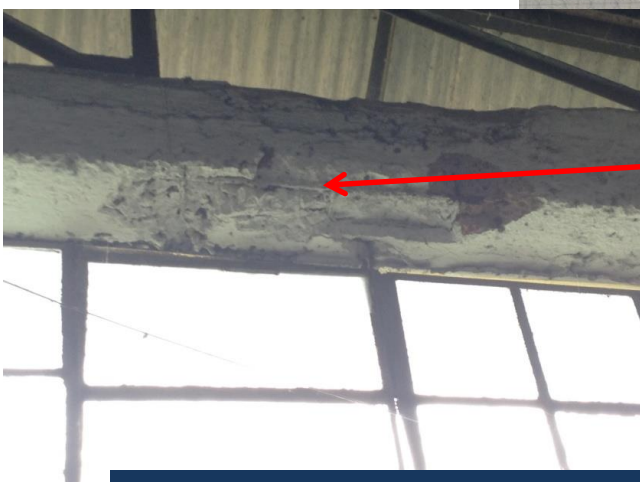
**Significant cracking on number of columns and beams (likely due to corrosion of reinforcement)**

| Item No. | Observation | Recommended Action Plan | Recommended Timeline |
|---|---|---|---|
| 22 | Cracking on columns and beams | Building engineer to investigate cause of cracking in columns and make recommendations for remedial measures. | 6-weeks |
| 23 | Cracking on columns and beams | Make structural alterations as advised by Factory Engineer. | 6-months |
