# Esquire Knit Composite Ltd

Plot # B-34, BSCIC 1/A, Kanchpur, Sonargaon, Narayangonj.  
(23.699169, 90.528957)

25<sup>th</sup> February 2015

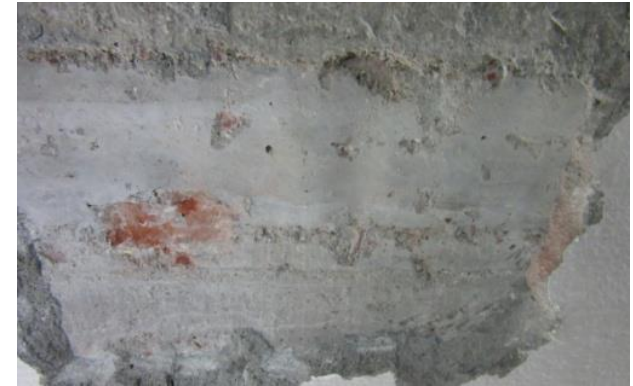
Tested Ground Floor Column –  
Brick Chips

**Columns appear to be stressed in excess of normal design limits**

Preliminary calculations indicate that working stress is at a level that warrants review for all columns.

A Detail Engineering Assessment of the building should also be carried out immediately in order to ascertain the adequacy all columns (see attached Scope).

Item No.	Observation	Recommended Action Plan	Recommended Timeline
1	Columns appear to be stressed in excess of normal design limits.	Factory Engineer to review design, loads and columns stresses in all columns.	<b>Immediate - Now</b>
2	Columns appear to be stressed in excess of normal design limits.	Verify insitu concrete stresses by taking 100mm diameter cores from a minimum of 4 columns. Verify grade of steel reinforcement used.	<b>Immediate - Now</b>
3	Columns appear to be stressed in excess of normal design limits.	A Detail Engineering Assessment of Factory to be commenced, see attached Scope.	<b>Immediate - Now</b>
4	Columns appear to be stressed in excess of normal design limits.	Detail Engineering Assessment to be completed.	<b>6-weeks</b>
5	Columns appear to be stressed in excess of normal design limits.	Make structural alterations as advised by Engineer.	<b>6-weeks</b>
6	Columns appear to be stressed in excess of normal design limits.	Update as-built drawings to reflect the actual structure	<b>6-weeks</b>

7	Columns appear to be stressed in excess of normal design limits.	Produce and actively manage a loading plan for all floor plates within the factory giving consideration to floor capacity and column capacity.	<b>6-weeks</b>
8	Columns appear to be stressed in excess of normal design limits.	Continue to implement load management plan (See Item 2)	<b>6-months</b>

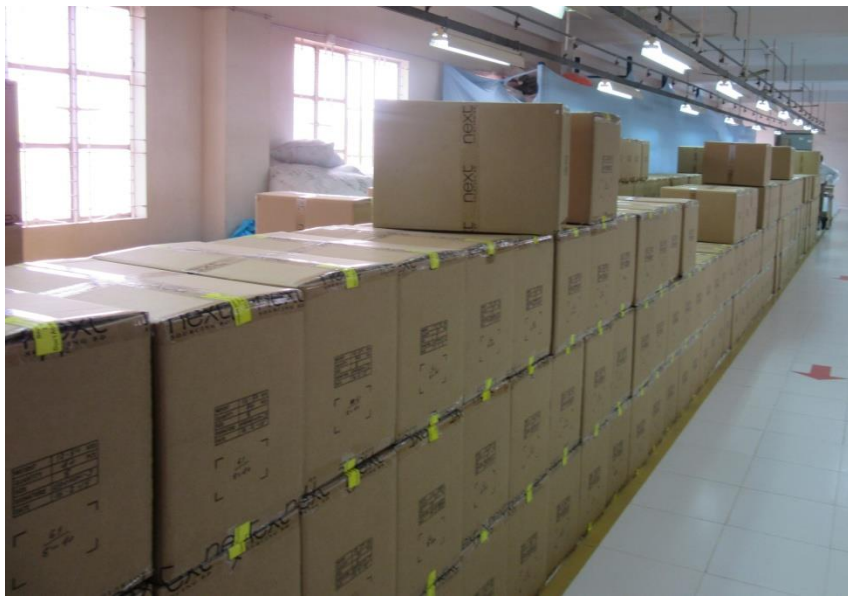
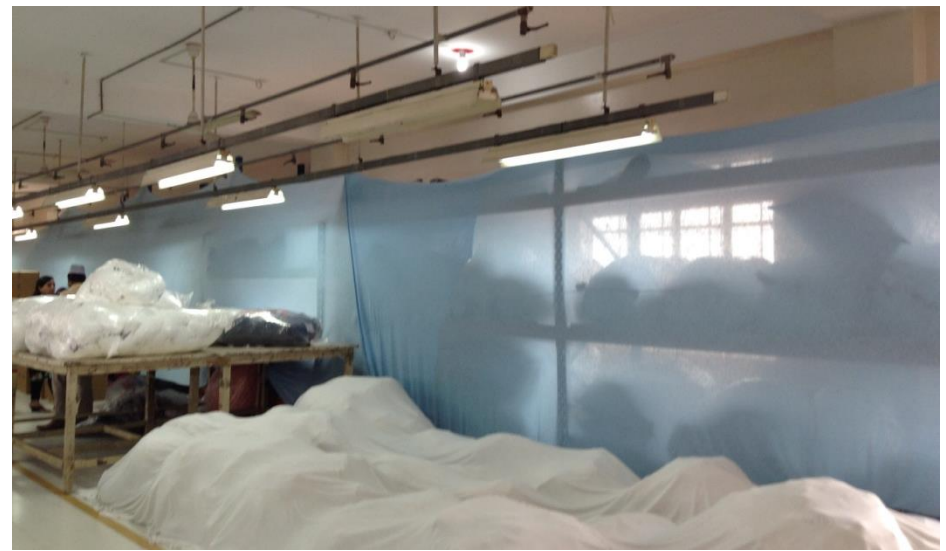
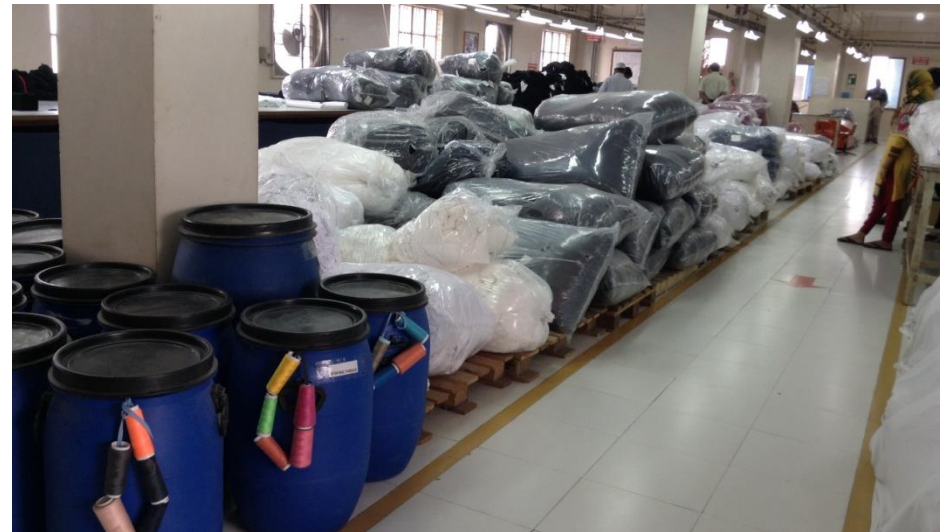
# Locally heavy floor loading in some storage areas

- Areas of high loading up to 3kPa
- Floor load management system is missing,
- Loading Plans are missing.

Item No.	Observation	Recommended Action Plan	Recommended Timeline
9	Locally heavy floor loading in some storage areas	Factory Engineer to investigate if the applied loading can be safely carried by the slabs, beams and by the columns.	6-weeks
10	Locally heavy floor loading in some storage areas	Produce and actively manage a loading plan for all floor plates within the factory giving consideration to floor capacity and column capacity. (Refer to Item 1)	6-weeks
11	Locally heavy floor loading in some storage areas	Continue to implement load management plan	6-months
