# Beq Knit Ltd/Beq Sweater Ltd/Tammam Design Ltd

Zirabo, Pukorpar, Asulia, Dhaka

01 April 2014

# Building Observations

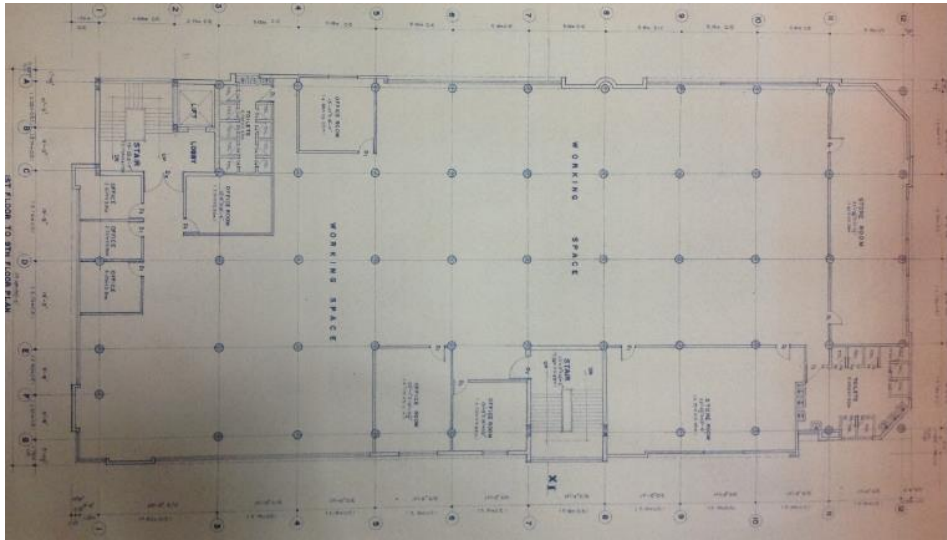
Typical column layout

**Columns in Building 1 appear to be stressed in excess of normal design limits**

**Outline calculations indicate column working stress is in excess of normal design limits in Building 1.**

**Immediately reduce all Live Load in building 1 to 1.5kPa**

**A Detail Engineering Assessment of the building is required (see attached Scope). Engineer is to perform detailed calculations based on as-constructed dimensions and concrete & reinforcement tests to prove column adequacy**

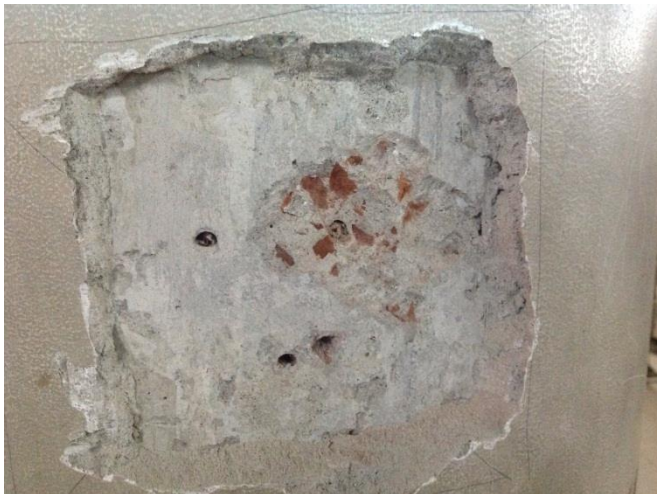
Tested Ground Floor Column – Brick Chips

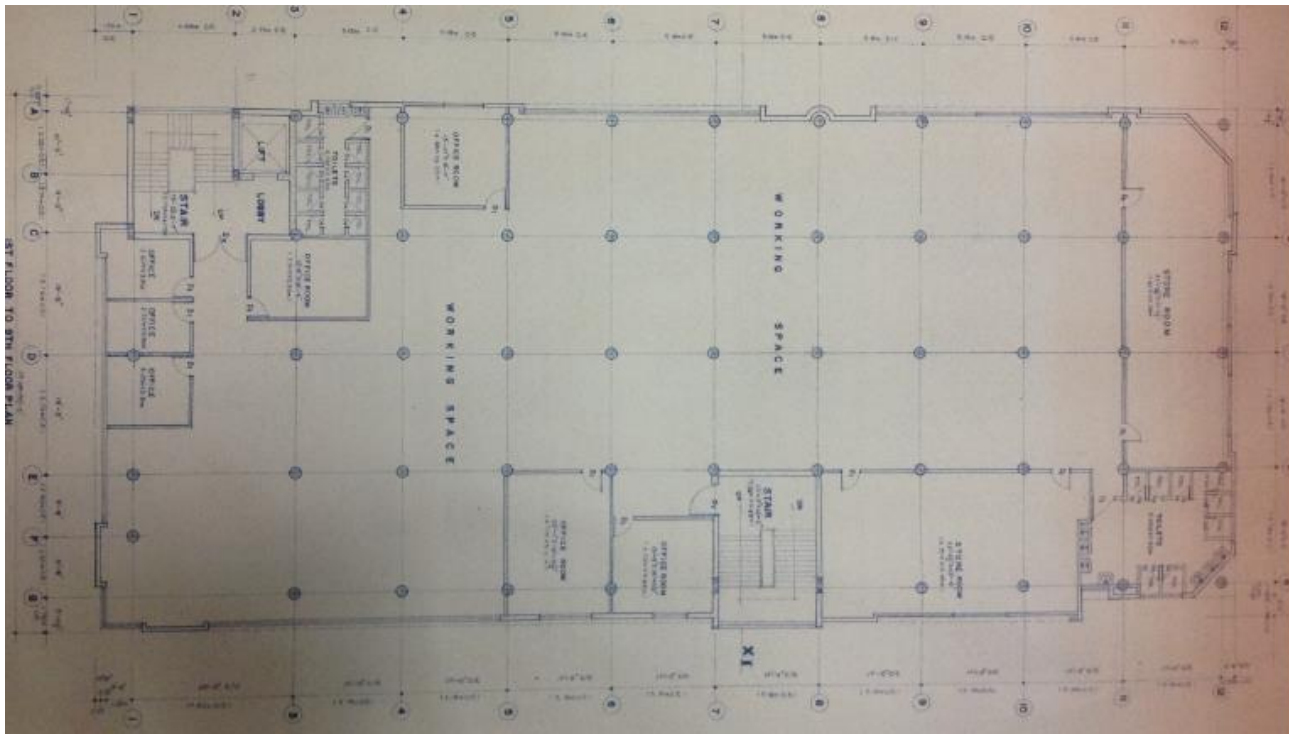
Lateral stability of Building 1 to be reviewed for following reasons:

- Slender columns with flat slab
- Façade brickwork does not line up with edge columns in most areas due to cantilevers, so little stability from infill brick walls

Lateral stability check to be included in Detail Engineering Assessment.

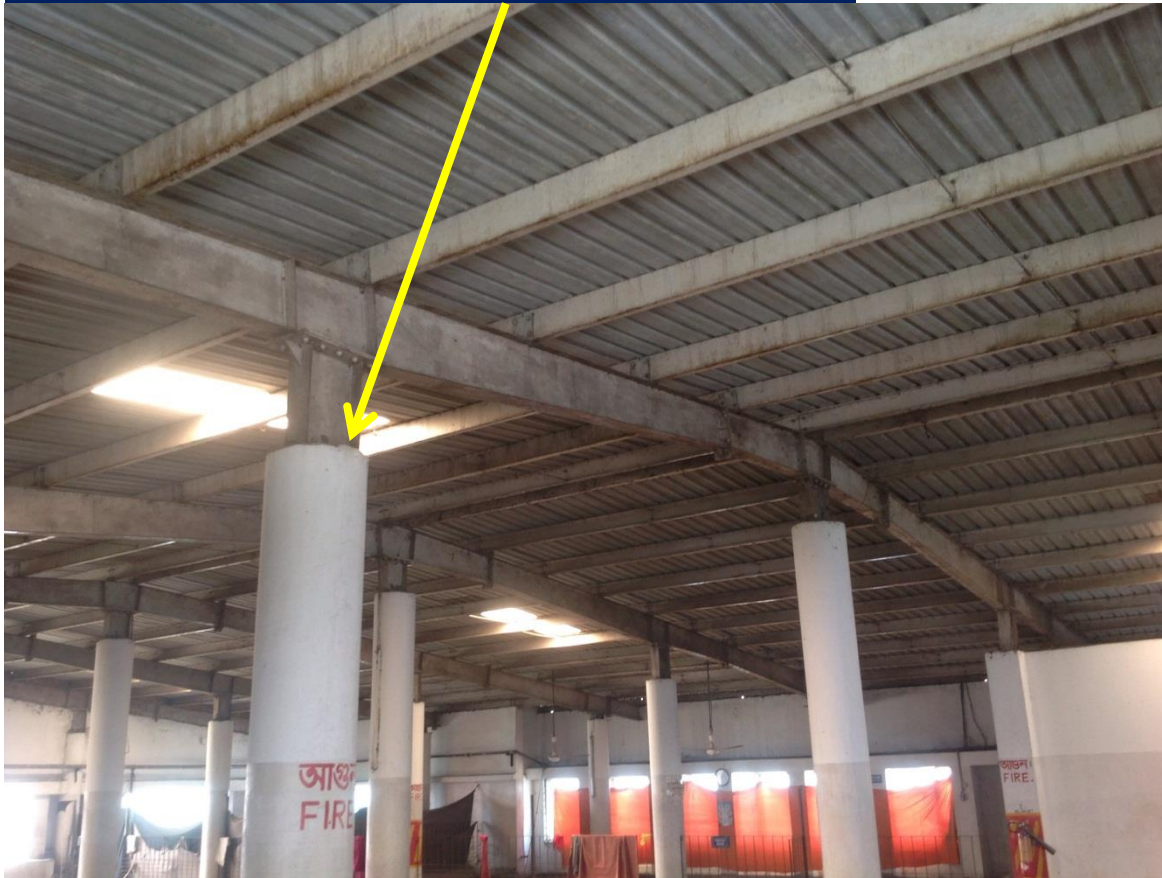
**Roof structure to Dining Area - may be susceptible to wind uplift and instability. Building Engineer to review.**

**Stability of steel roof to dining area to  
be reviewed by Building Engineer**

**Building Engineer to confirm support/connection detail at these locations.**

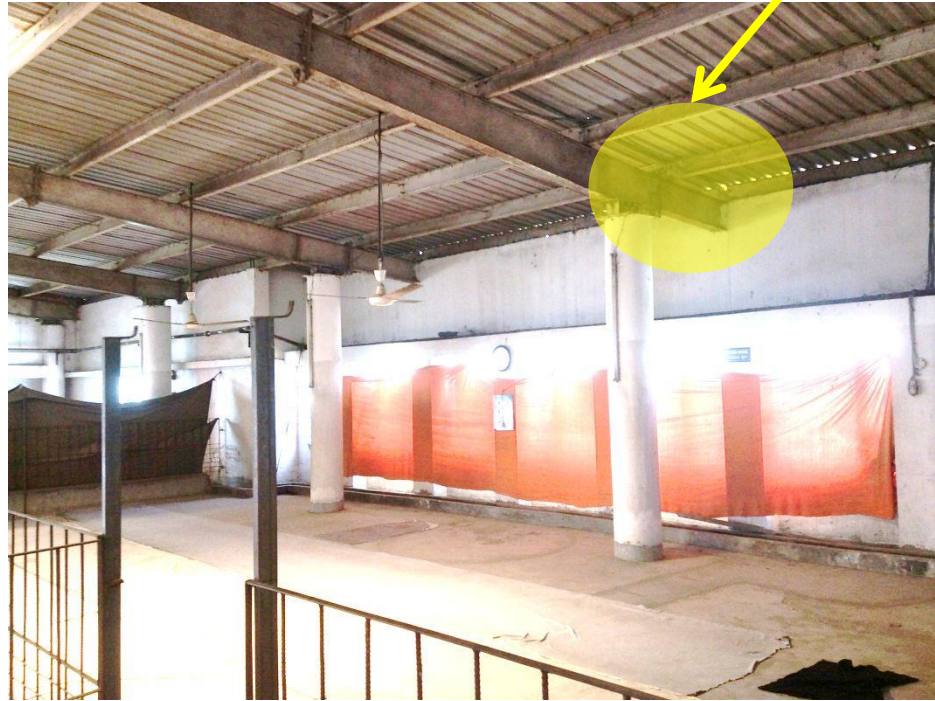
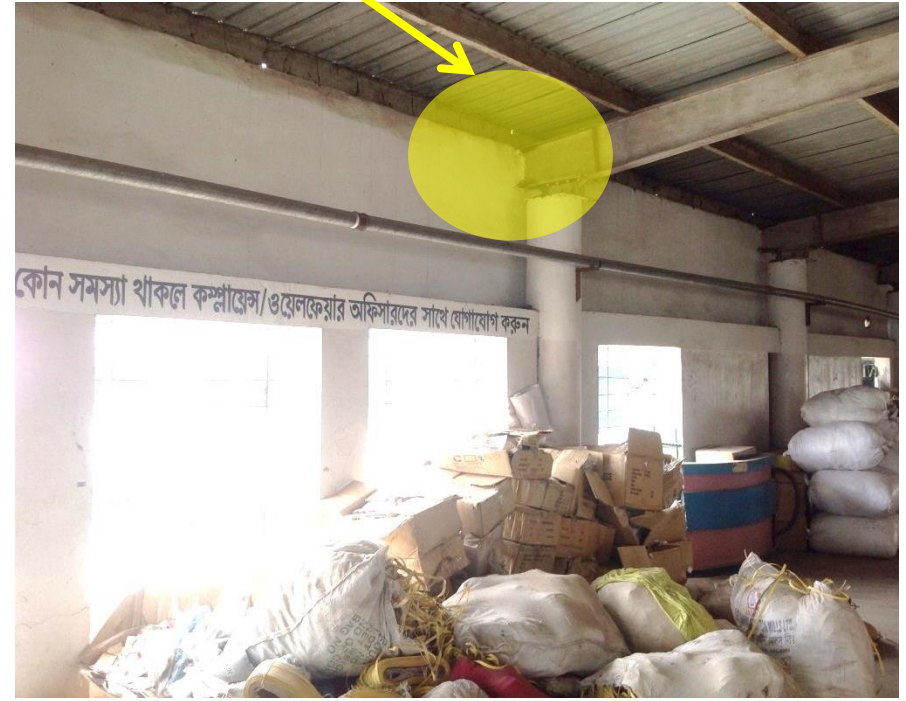
**Steel Roof to Dining Area  
Building 1**

**Cantilever beam connection to façade. Building Engineer to confirm support/connection detail at these locations.**

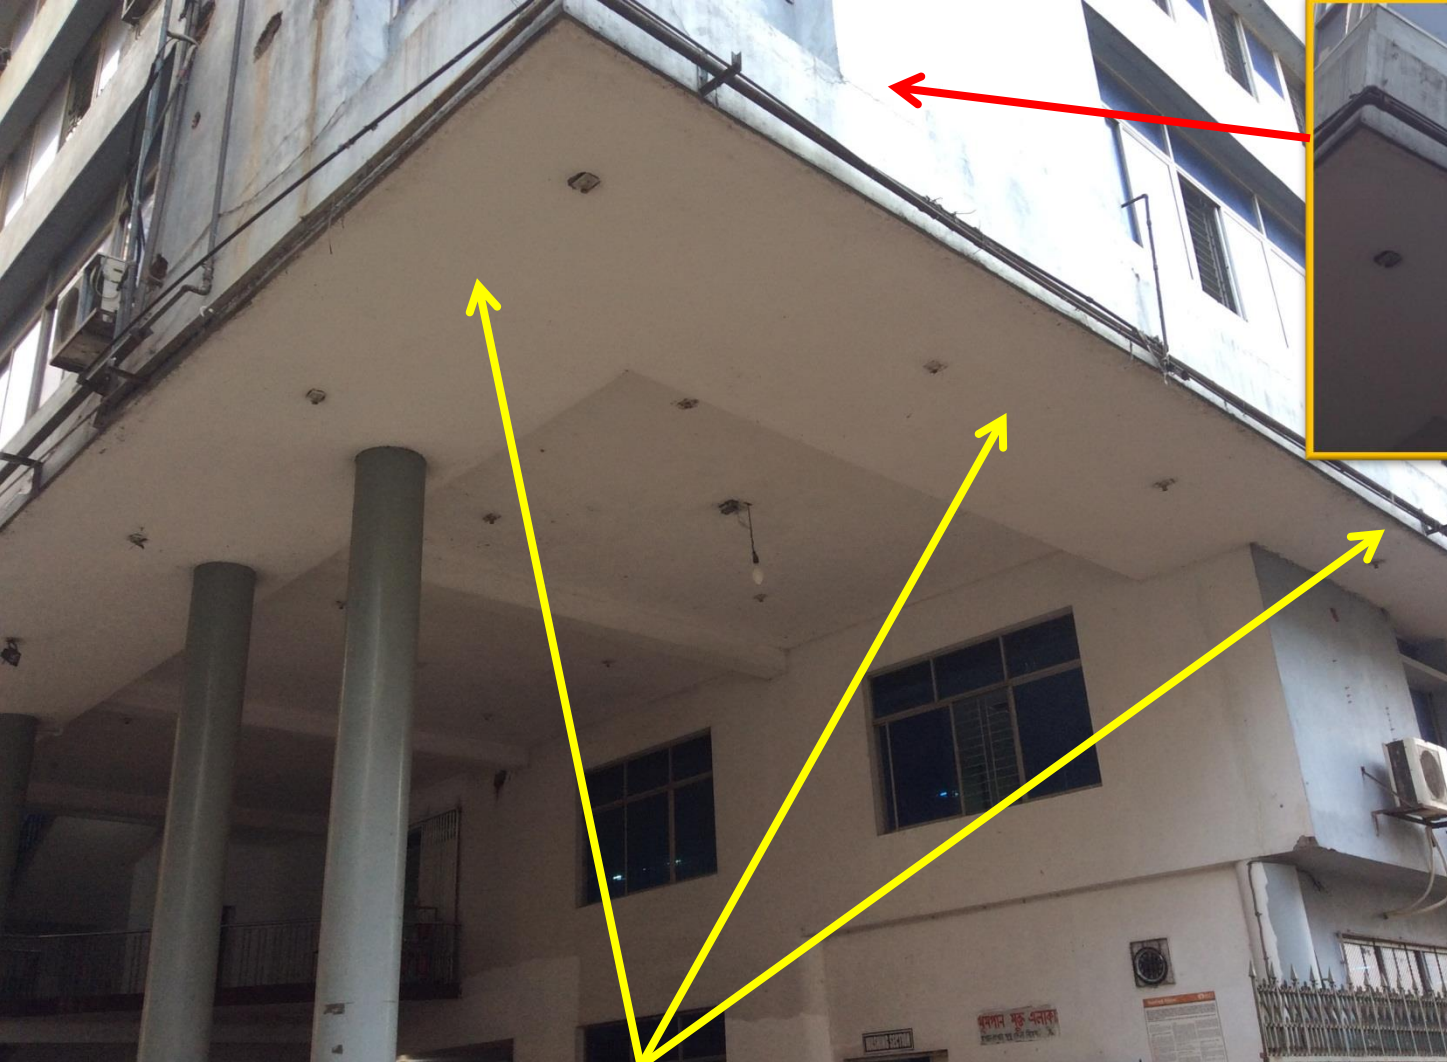
Cantilevered slabs in 2 directions with large line loads on edges as well as large storage loads in areas over. Building Engineer to review.

Cracking to be monitored/reviewed by engineer.

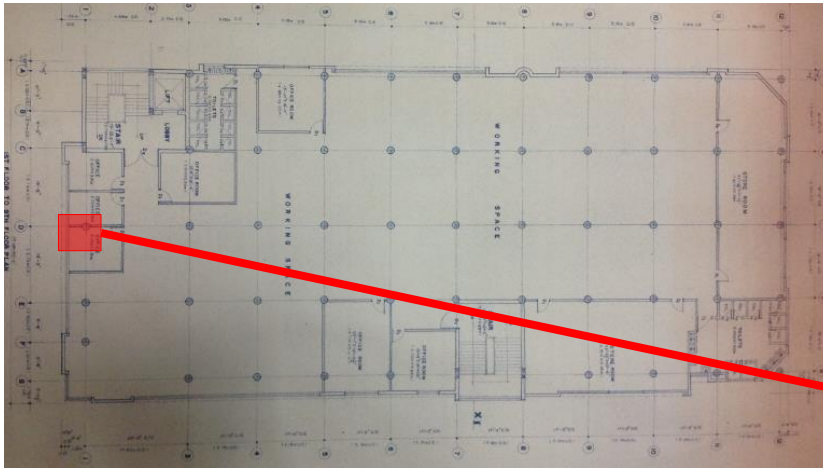
4<sup>th</sup> Floor Layout Plan

Slab Cantilevers from beam -  
Beam to Column connection is eccentric.  
Building engineer to review.

13	Eccentric beam/column connections – Building 1	As part of Detail Engineering Assessment (see Item 1), Building Engineer to review calculations of cantilevered structures, with eccentricity of beam and column connections included.	6-weeks
14	Eccentric beam/column connections – Building 1	Implement any actions arising from review.	6-months

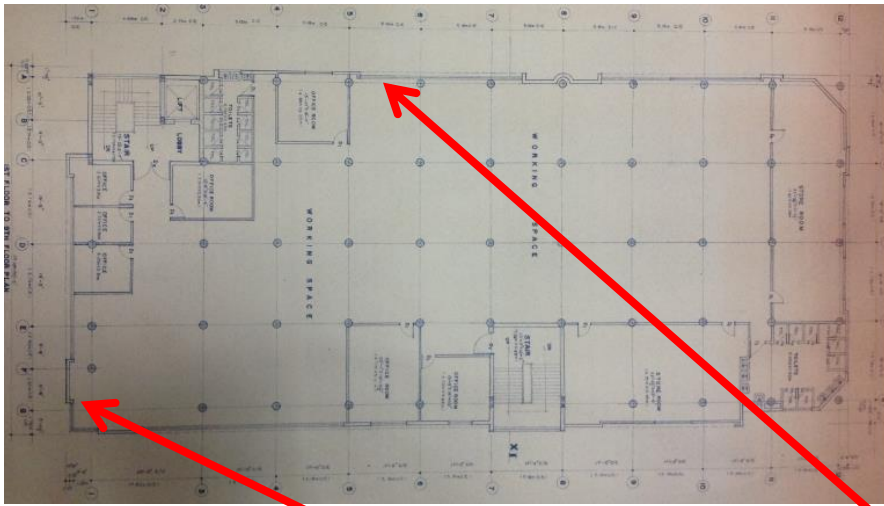
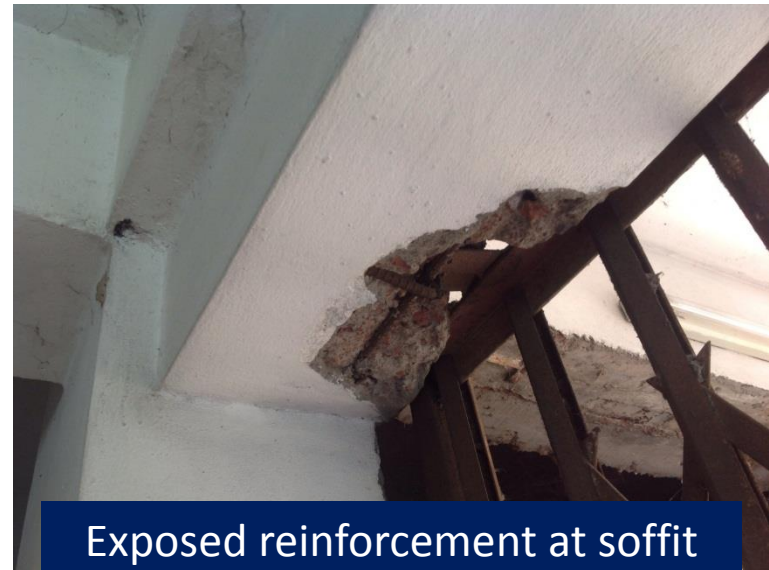
Exposed reinforcement at soffit to beam supporting roof slab in Building 2.

Reinforcement to be protected and concrete to be repaired at these locations.

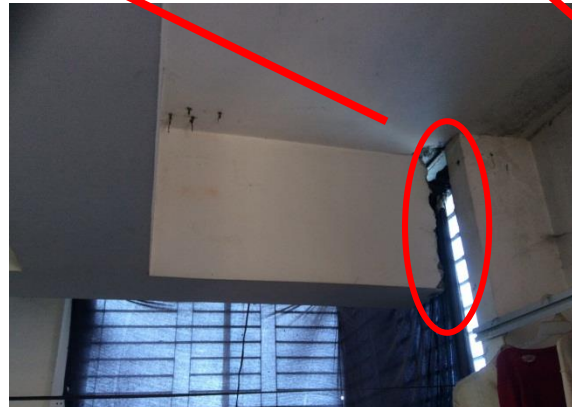
Exposed reinforcement at end of cantilever beam supporting 7<sup>th</sup> Floor (Roof) slab

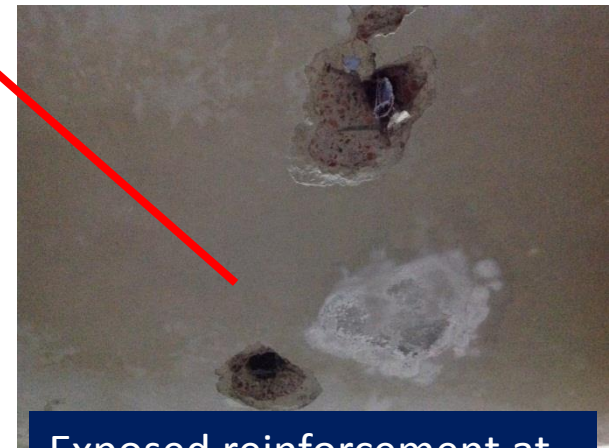
Exposed reinforcement at soffit to 1<sup>st</sup> floor slab.

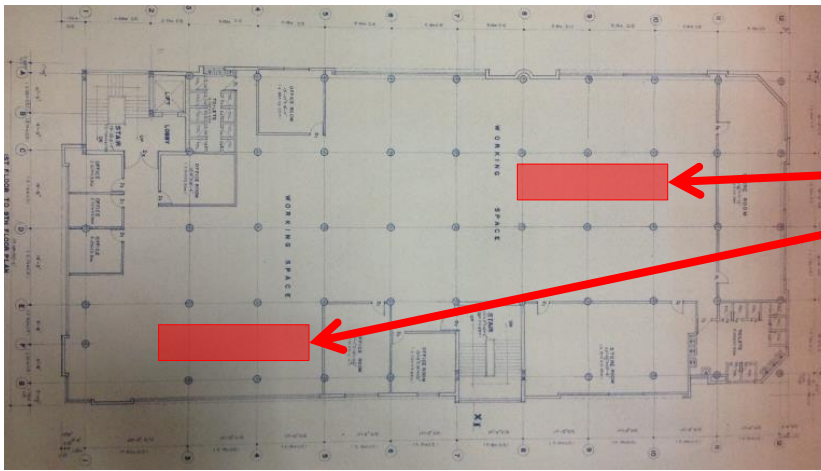
Soffit plan of 6th floor slab

Cracks noted in these locations

Beam cracks at soffit of 6th floor slab to be reviewed by removing plaster to assess whether cracks extend into structure.

21	Hairline cracking to slab soffits	Carry out structural repairs as necessary to slab structure	6-weeks
22	Hairline cracking to slab soffits	Structural elements to be monitored for cracking on an ongoing basis	6-months

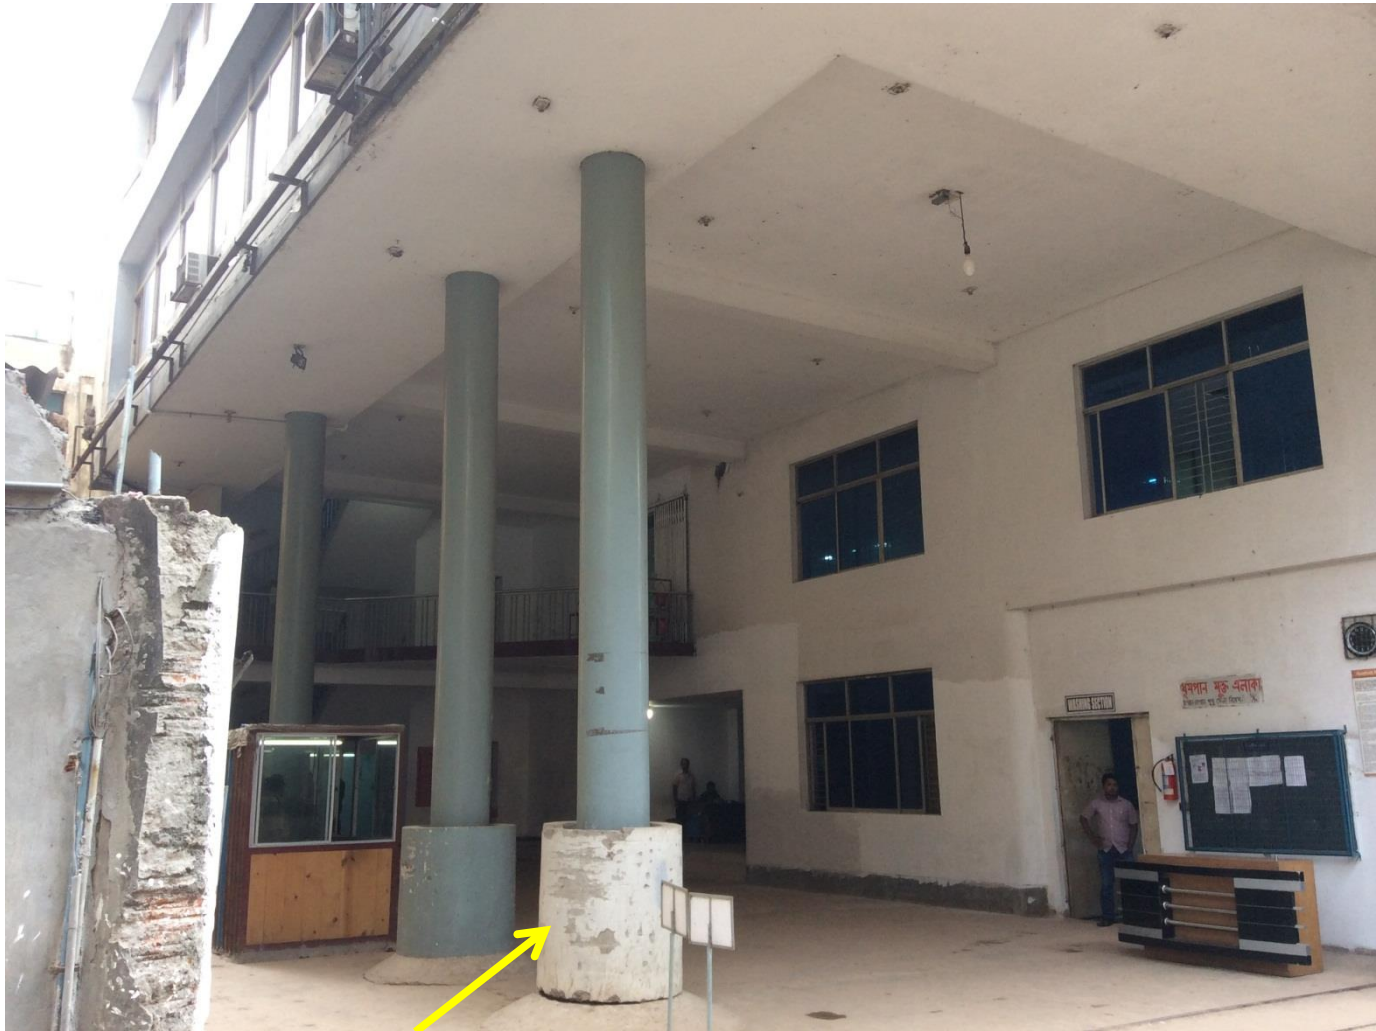
**Building 1 column at ground floor level susceptible to impact loading from vehicles. Existing protection to be reviewed for robustness**

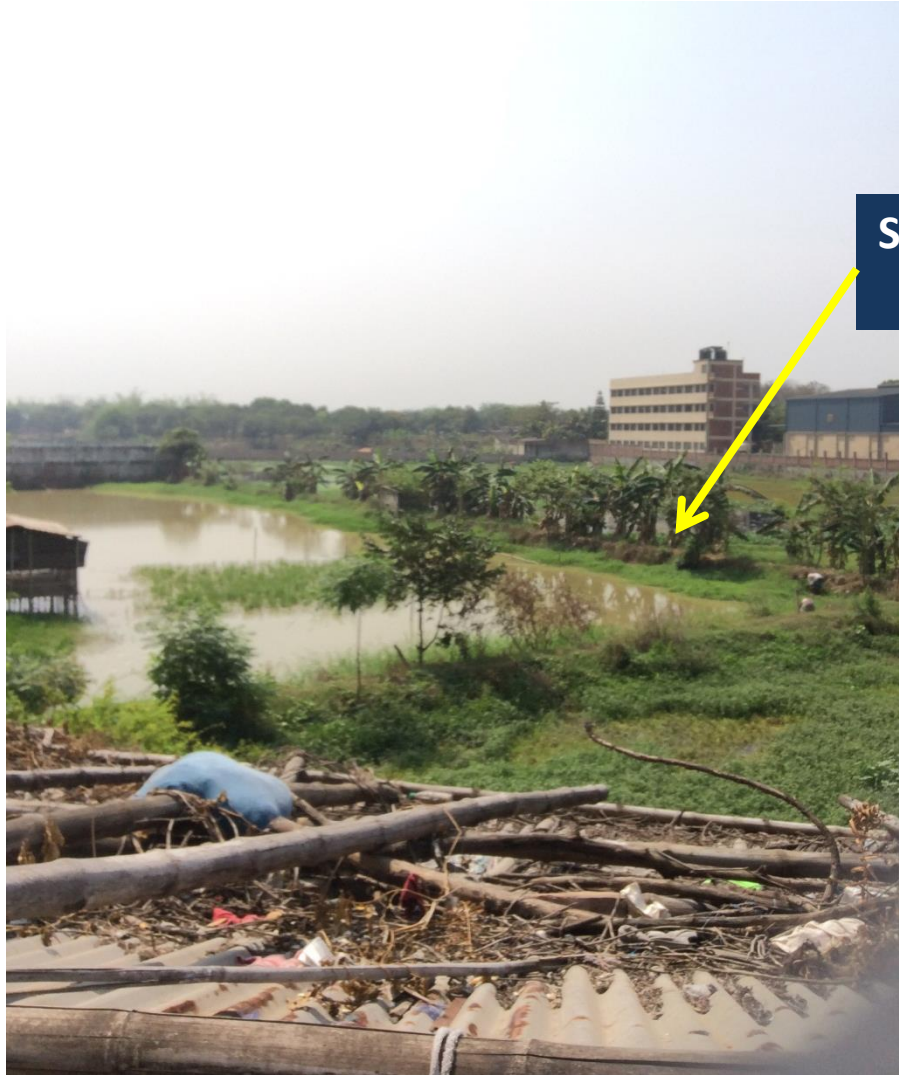
Surface water channel

Lake is very close to structure, though Management say the building has never flooded. Building engineer to monitor building for signs of water ingress and appropriate action to be taken if ingress occurs.

Item No.	Observation	Recommended Action Plan	Recommended Timeline
23	Proximity of Water Bodies	Building Engineer to monitor the structure for signs of water ingress and take preventative action if necessary.	<b>6-months</b>
24	Stability of steel structure of Dye Process building	The steel structure of the Dye Process building should be reviewed by the Building Engineer and, if required, upgraded to support code vertical and wind loads – alternatively, the area should be vacated and removed	<b>6-weeks</b>
25	Corrosion of steelwork in Dye Process building	Building Engineer to oversee cleaning of all corrosion from steelwork and the application of appropriate primer paint to all cleaned steelwork	<b>6-weeks</b>
26	Corrosion of steelwork in Dye Process building	Continue to monitor for corrosion and remediate as necessary	<b>6-months</b>

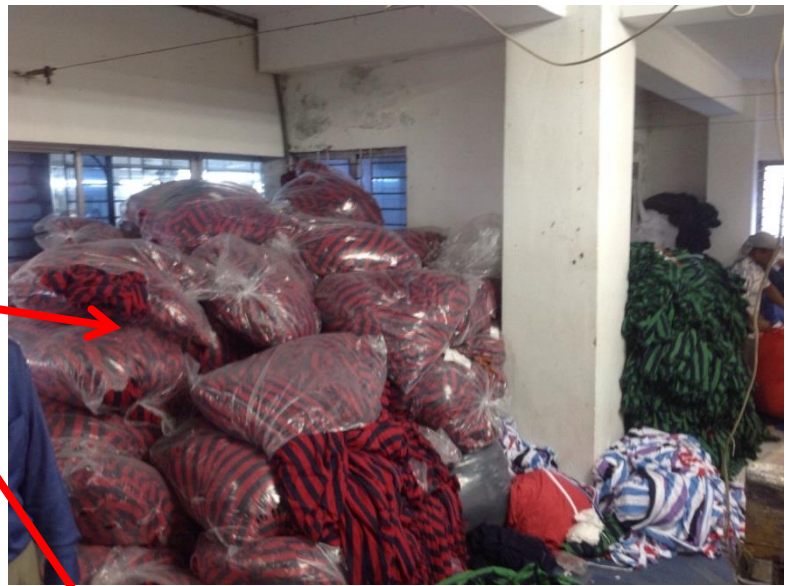
Uncontrolled stacking of material

Building Engineer to prepare controlled loading plans for all floors which will designate where storage can be placed.

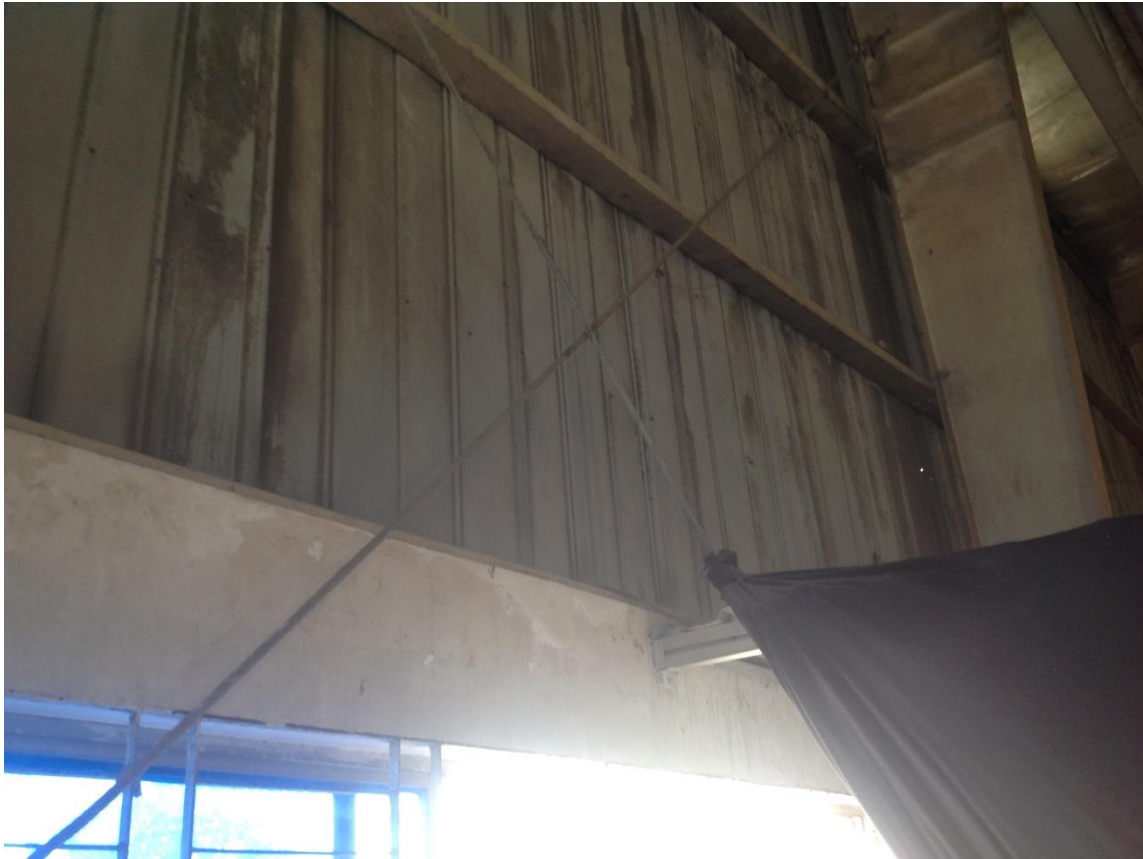
**Bracing was found to be comprised of rope which was loose. No bracing in some areas. Building engineer to review stability of entire structure.**

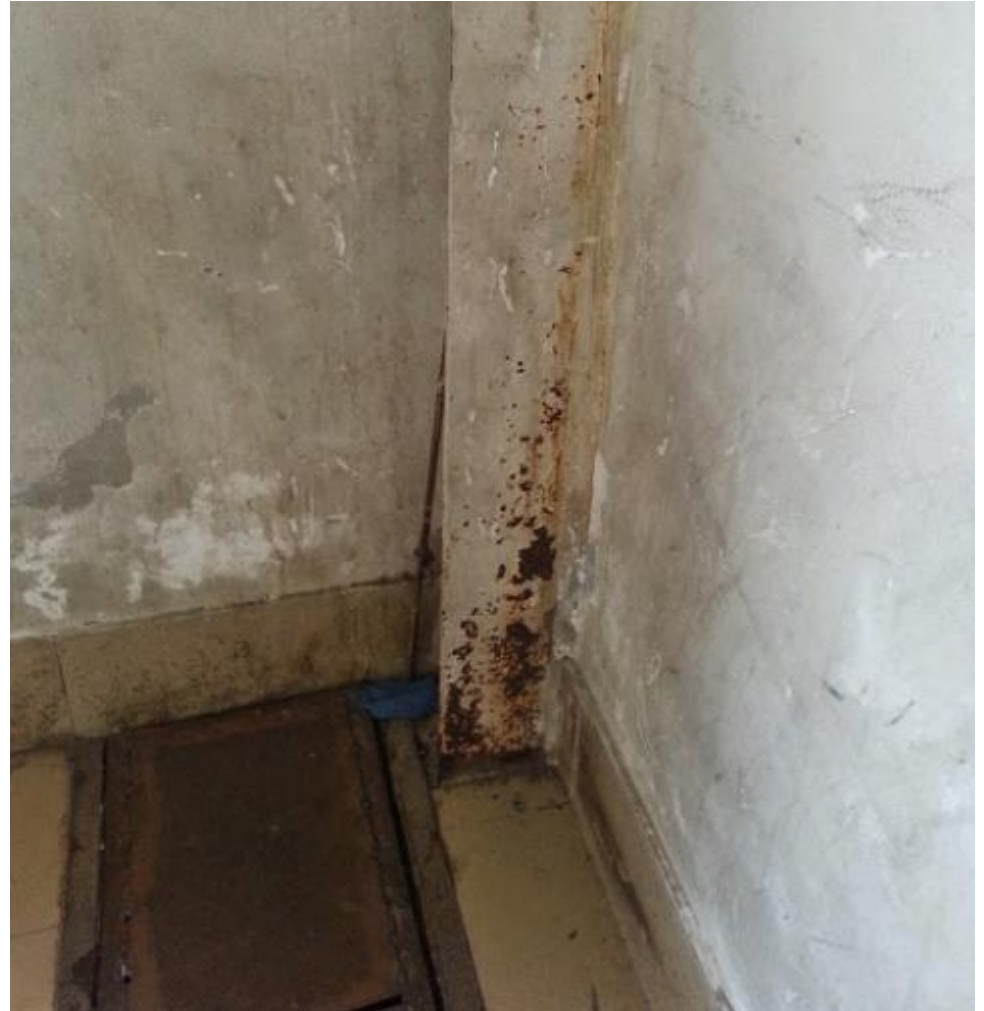
**Building Engineer to review cause of corrosion to steel columns. Causes should be mitigated and affected steel should be repaired.**
