Comfit Composite Knit LTD (Unit 2)

Amtola, Kathgora Bazar, Ashulia, Savar, Dhaka
(+23.907331N, 90.288456E)
29th March 2014

Executive Summary (Continued)

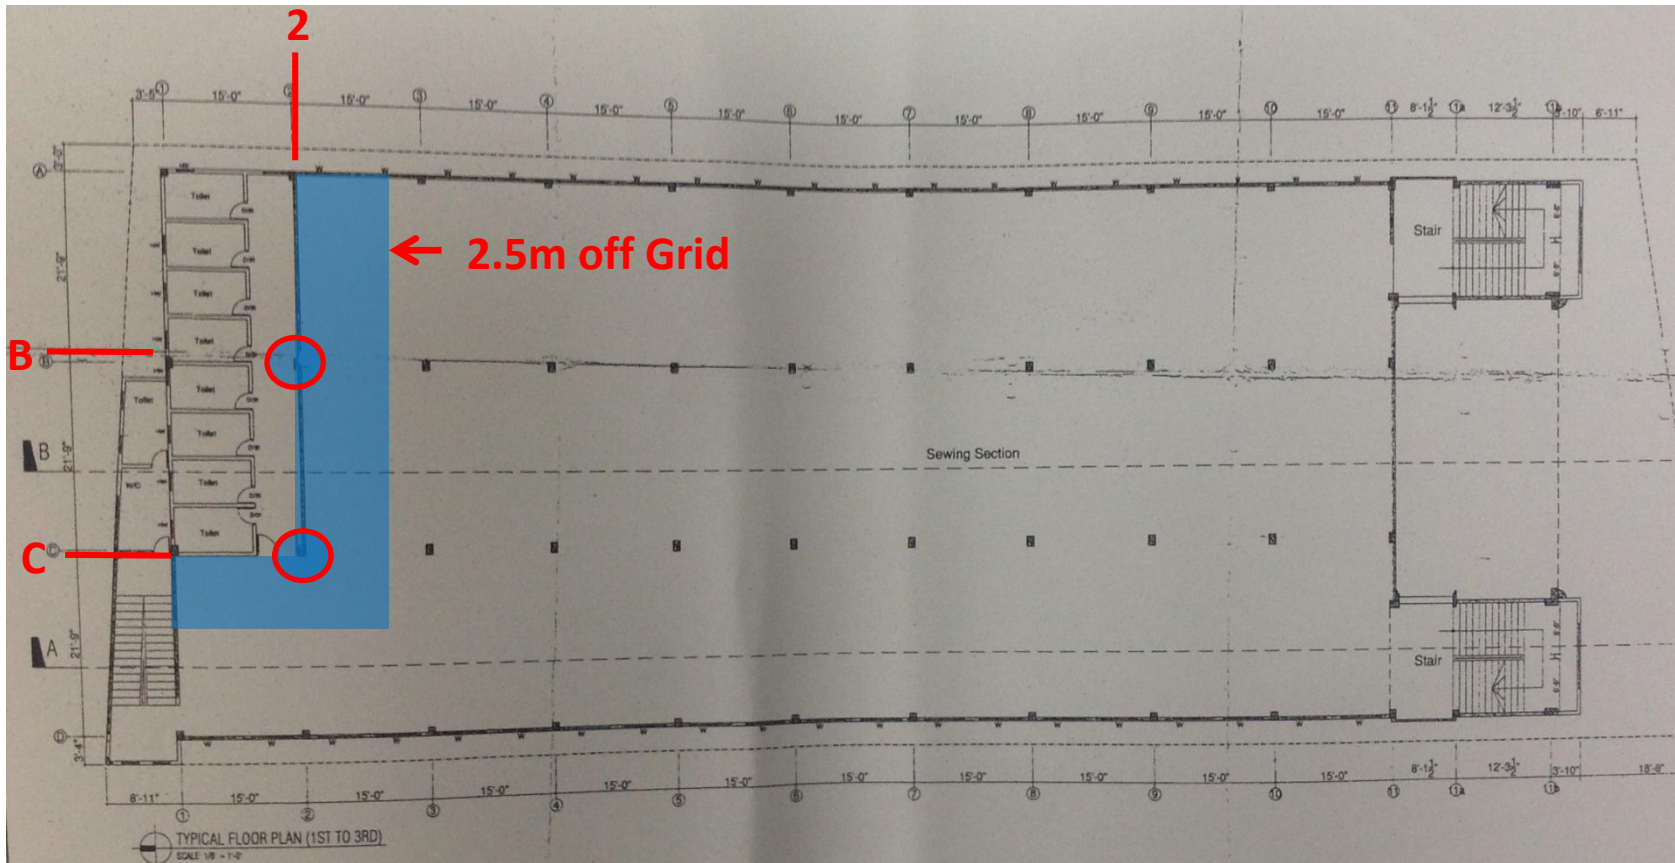
Immediate Action Required

- Vacate highlighted area on 1st to 3rd floors (Live load reduced to 0 KN/m² - toilets may be accessed through this area)
- All storage in highlighted area to be removed

1. **Loads to be reduced in the areas highlighted on the following sheet pending verification of column capacity by the Building Engineer.**
2. A Detail Engineering Assessment of the as constructed **Factory Building** is requested and this should be commenced immediately to the requirements of the scope attached and addressing the concerns as noted. The DEA should be completed within 6 weeks of issue of this report.

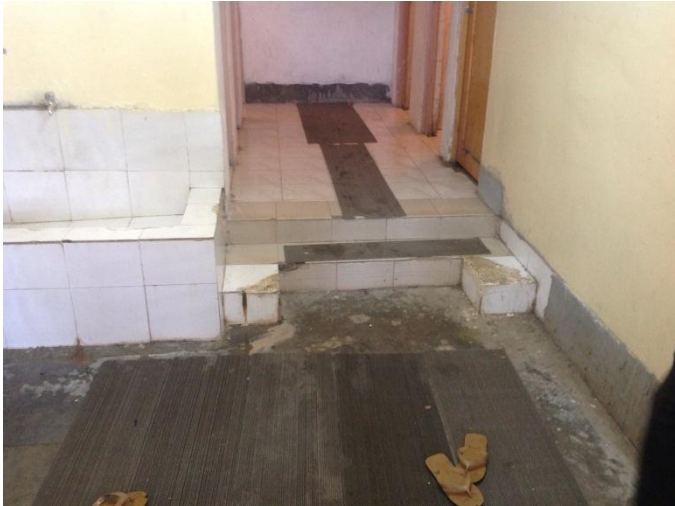
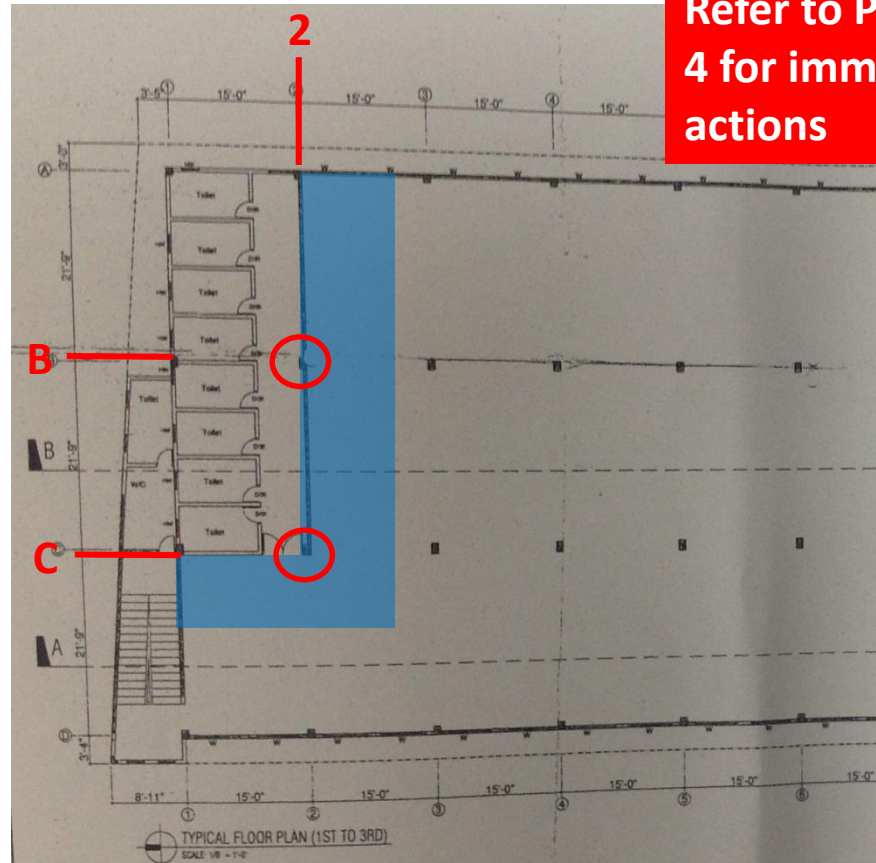
**Columns appear to be stressed in excess of
normal design limits**

Due to the heavy floor construction in the toilet areas at 1st to 3rd Floors, outline calculations indicate that the columns on Gridline 2 are highly stressed to levels that require immediate review

Refer to Pages 3 and 4 for immediate actions

Area highlighted to be vacated and Specific design check to be carried out on columns at ground floor level which support heavy toilet floor construction

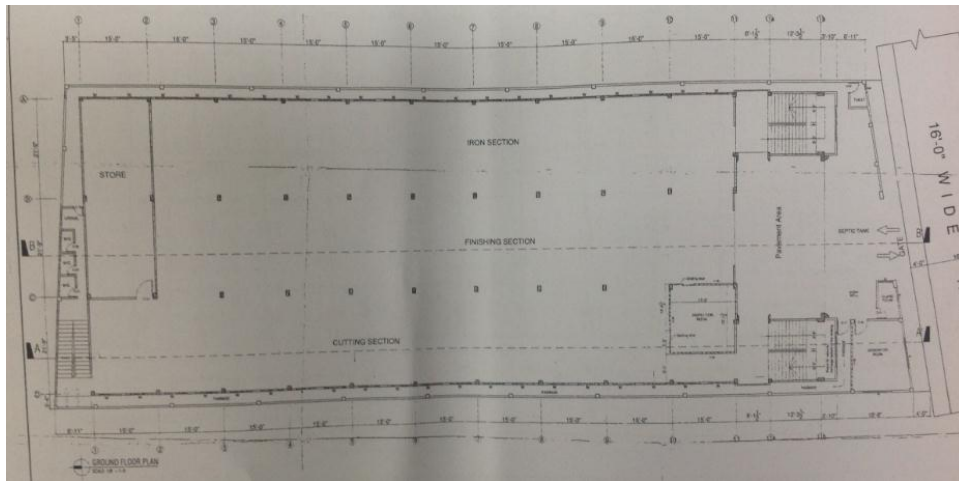
Typical column layout

Outline calculations indicate that column sizes appears to be smaller than required by code for the applied dead and live load, assuming typical concrete strength

Building Engineer to perform detailed calculations and concrete tests to prove column size and (if required) :

- Reduce loads further by preparation of allowable floor loading plans
- Carry out strengthening works

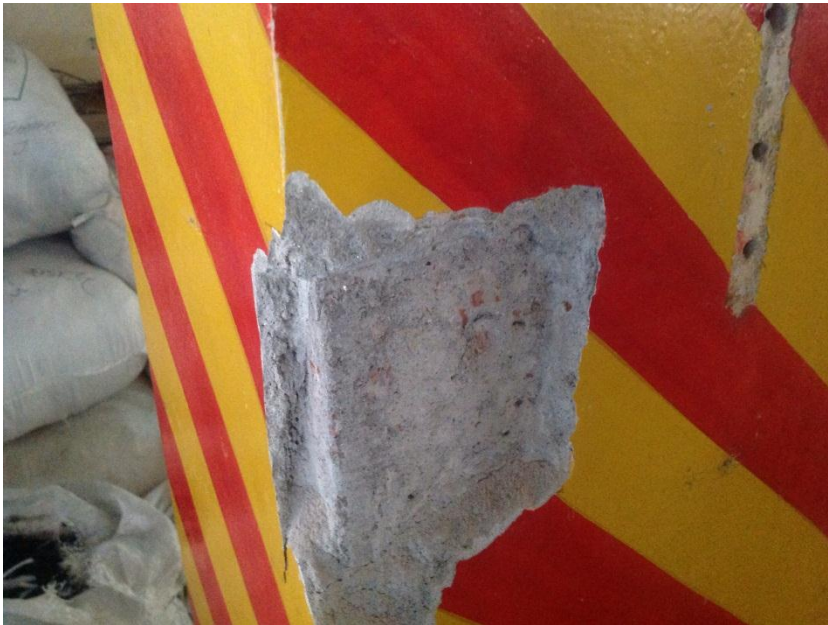
Tested Ground Floor Column – Brick Chip aggregate concrete

Column Strength

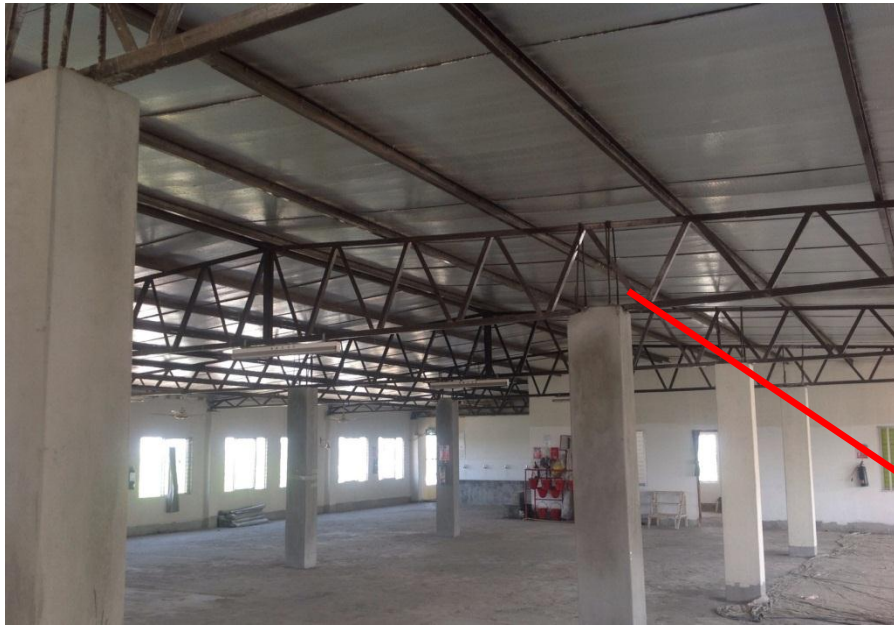
**Stability of steel roof to dining area to
be reviewed by Building Engineer**

**Roof structure held in place with reinforcement from columns
Roof truss support to be checked**

**Bottom Chord of Truss not supported at connection node –
Check Bending of member.**

Roof structure to dining area may be susceptible to wind uplift. Check required to confirm that the trusses to the steel roof over the dining area are adequately designed and braced to resist high wind loading. Building Engineer to review.

Roof structure not shown on the permit or structural design drawings.

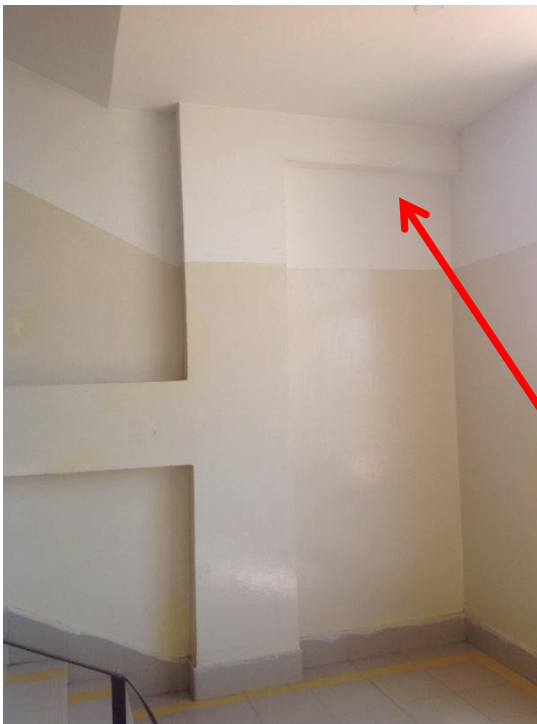
Stairwell cantilever beam

Cantilever to south end of stairwell has no back span apart from stairs

Engineer to verify as-built arrangement of stairwells, including cantilever beam, landing slab and supporting column adequacy.

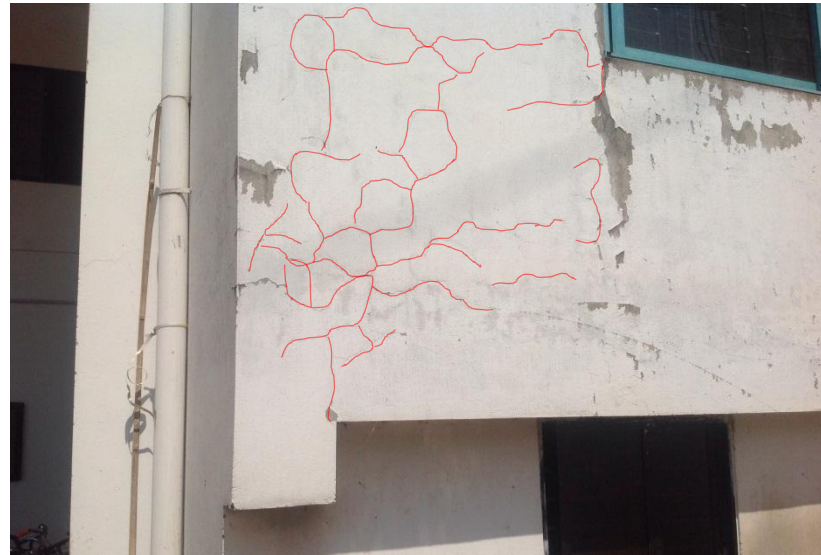
Cracking was noted in brickwork on exterior of stairwell

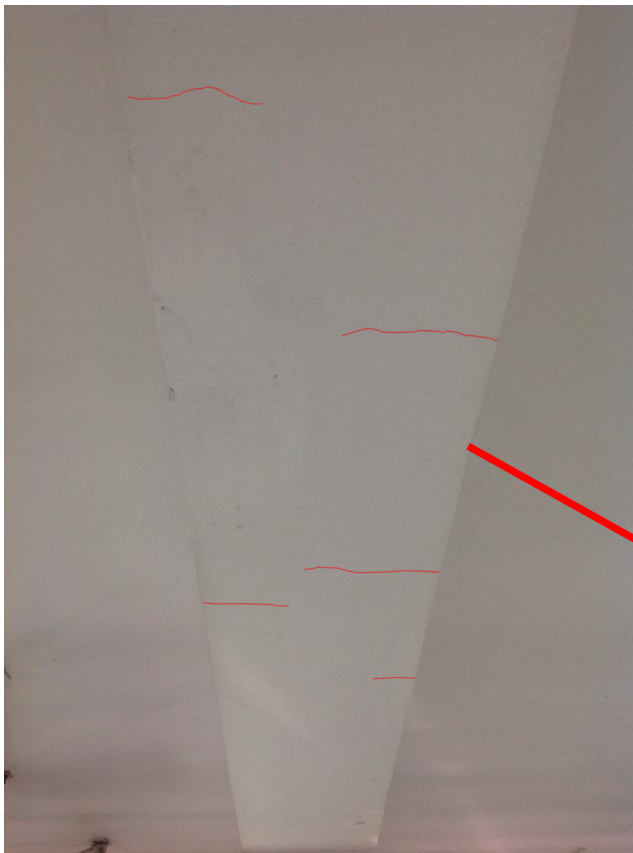
Cracking at soffit to beam supporting 2nd floor slab

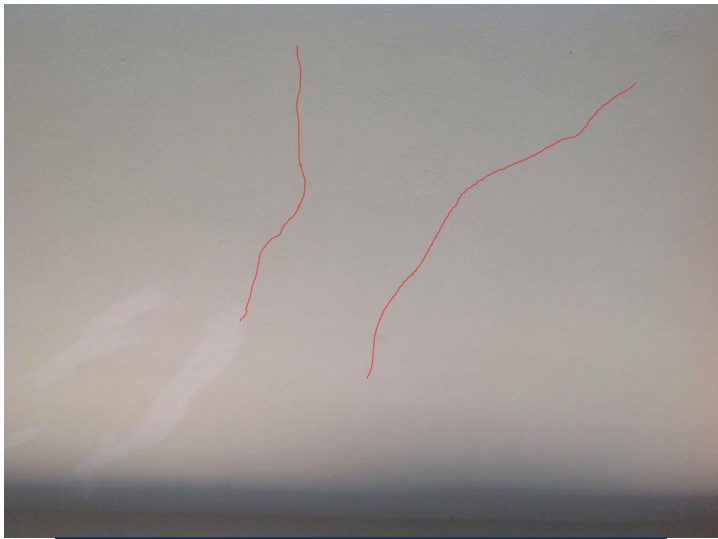
Cracking at soffit to fourth floor slab

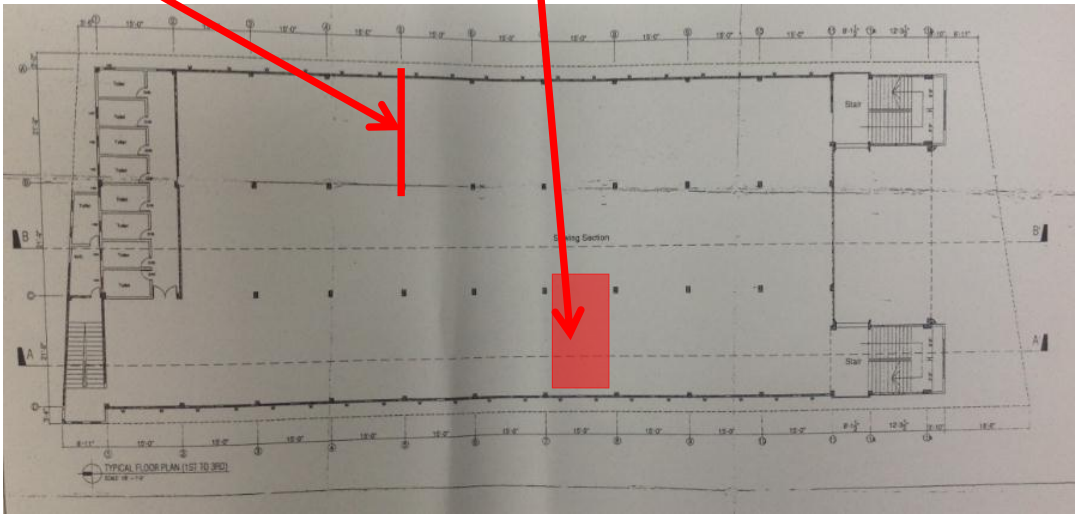
Typical plan showing crack locations on suspended slabs

Hairline cracking to beams and soffits of slabs

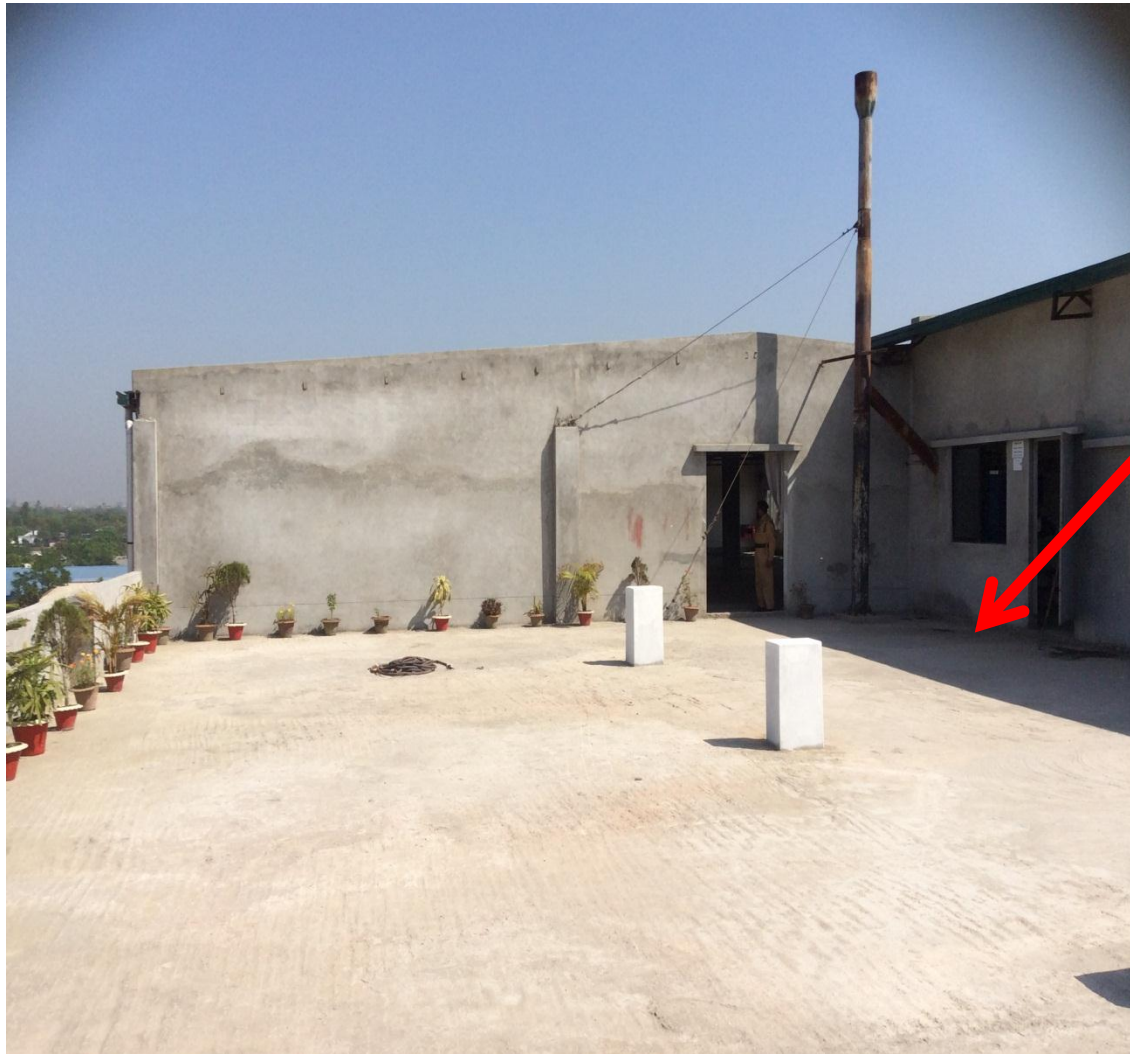
Water Proofing and Drainage at roof Level

Roof slab does not have any protection from water ingress and limited falls to small drainage outlets.

Potential for water load and damage in heavy rainfall
