# Confidence Knitwear Ltd.

South Dhanua, Nayanpur, Maona, Sreepur, Gazipur.  
(24.255162, 90.389317)

29 April 2014

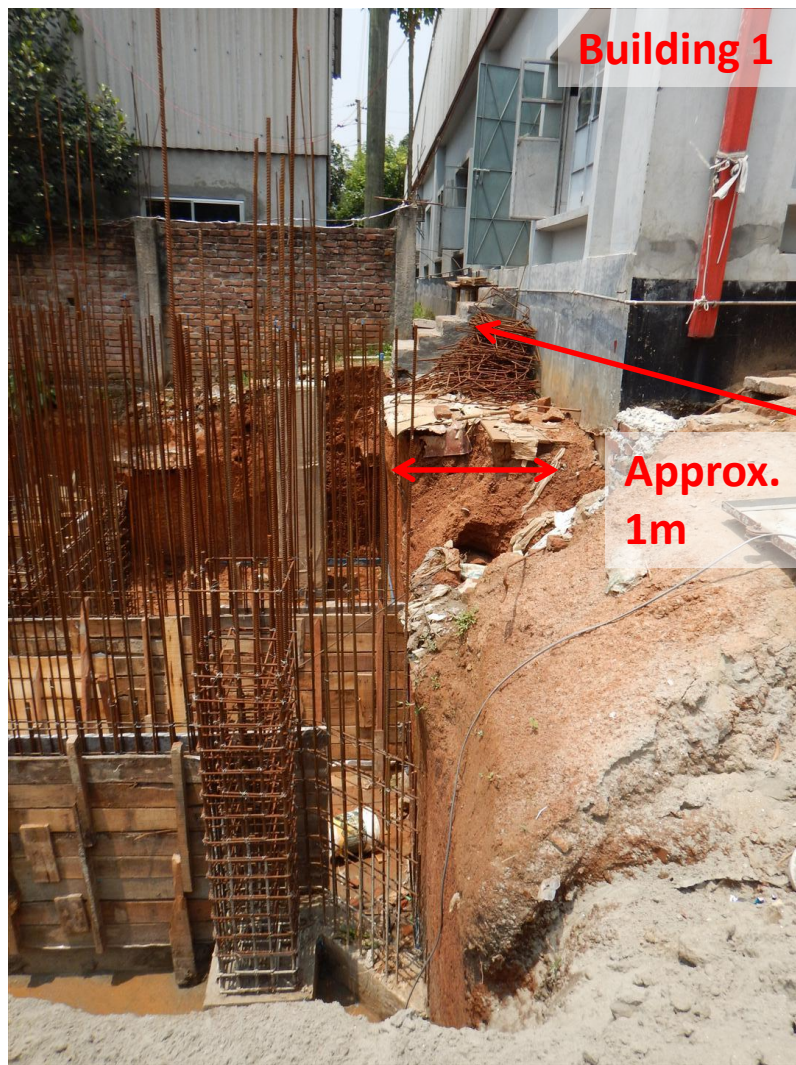
**Deep excavation for new building in very close proximity to Building 1. No retaining wall apparent.**

| Item No. | Observation | Recommended Action Plan | Recommended Timeline |
|---|---|---|---|
| 3 | Ongoing excavation in close proximity to Building 1 | Building Engineer to verify that the ongoing excavation adjacent to the rear (west) of Building 1 and Building 3 is not undermining existing building foundations. | 6-weeks |
| 4 | Ongoing excavation in close proximity to Building 1 | Building Engineer to verify that the new building (under construction) is capable of withstanding the surcharge loading from Building 1 and Building 3. | 6-weeks |

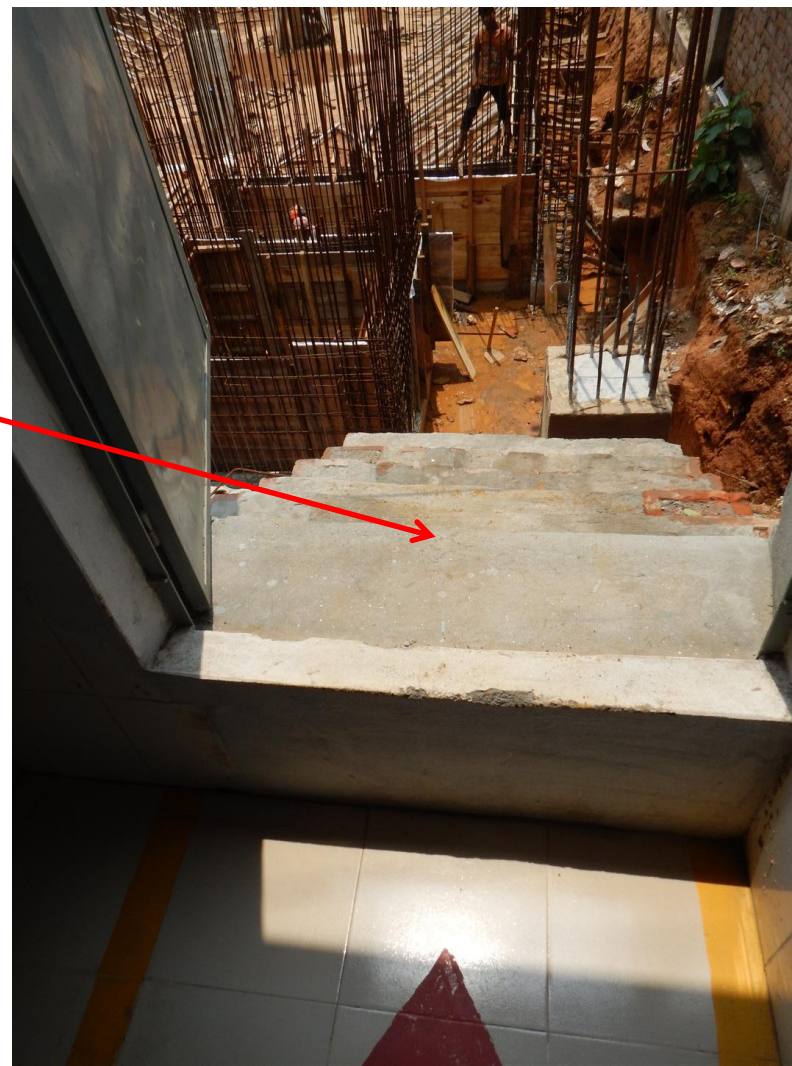
**Emergency exit from Building 1 leads directly into deep excavation and has not been blocked off. Risk of injury.**

| Item No. | Observation | Recommended Action Plan | Recommended Timeline |
|---|---|---|---|
| 1 | Ongoing excavation in close proximity to Building 1 | Exit signage indicating safe exit to rear of Building 1 (at location of ongoing construction) to be removed, and escape door to be closed | Immediate - Now |
| 2 | Ongoing excavation in close proximity to Building 1 | A qualified Fire Engineer to verify that existing fire routes are adequate or to advise on alternative routes. | Immediate - Now |

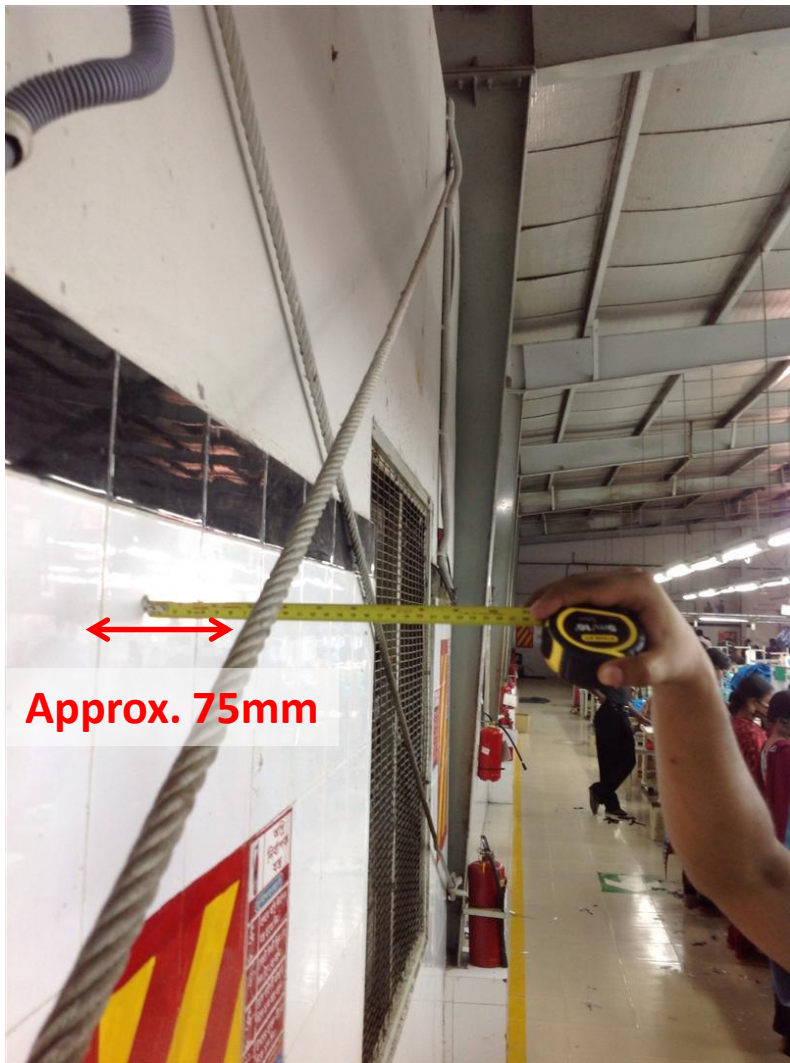
**Steel cable bracing in Building 1 was observed to be very loose. Cables can be pulled out of plane by 75mm**

| Item No. | Observation | Recommended Action Plan | Recommended Timeline |
|---|---|---|---|
| 6 | Unclear stability system for Building 1, Building 2 and Building 3 | Existing cables in braced bays in Building 1 and Building 2 to be tightened. | 6-weeks |

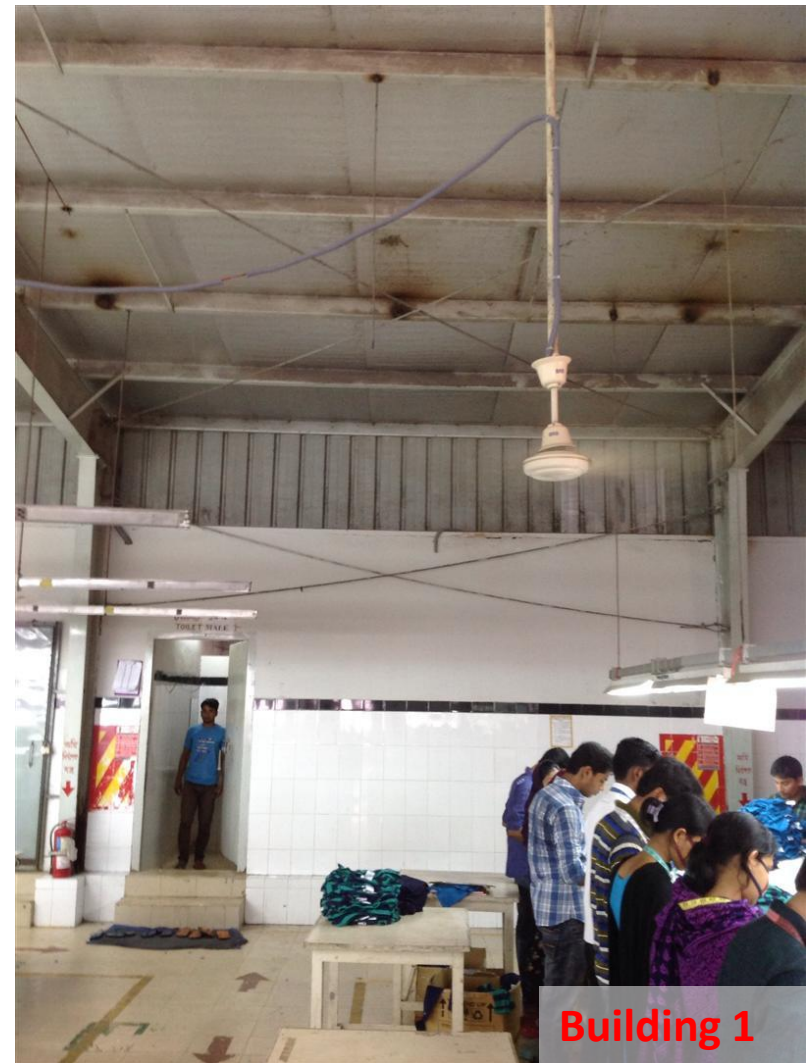
**Cross bracing in Building 1 does not always continue to supports. Catenary shape visible in slack cables.**

| Item No. | Observation | Recommended Action Plan | Recommended Timeline |
|---|---|---|---|
| 7 | Unclear stability system for Building 1, Building 2 and Building 3 | Building Engineer to review the lateral stability systems for Building 1, Building 2 and Building 3 and to design upgrading works, as required. | 6-months |

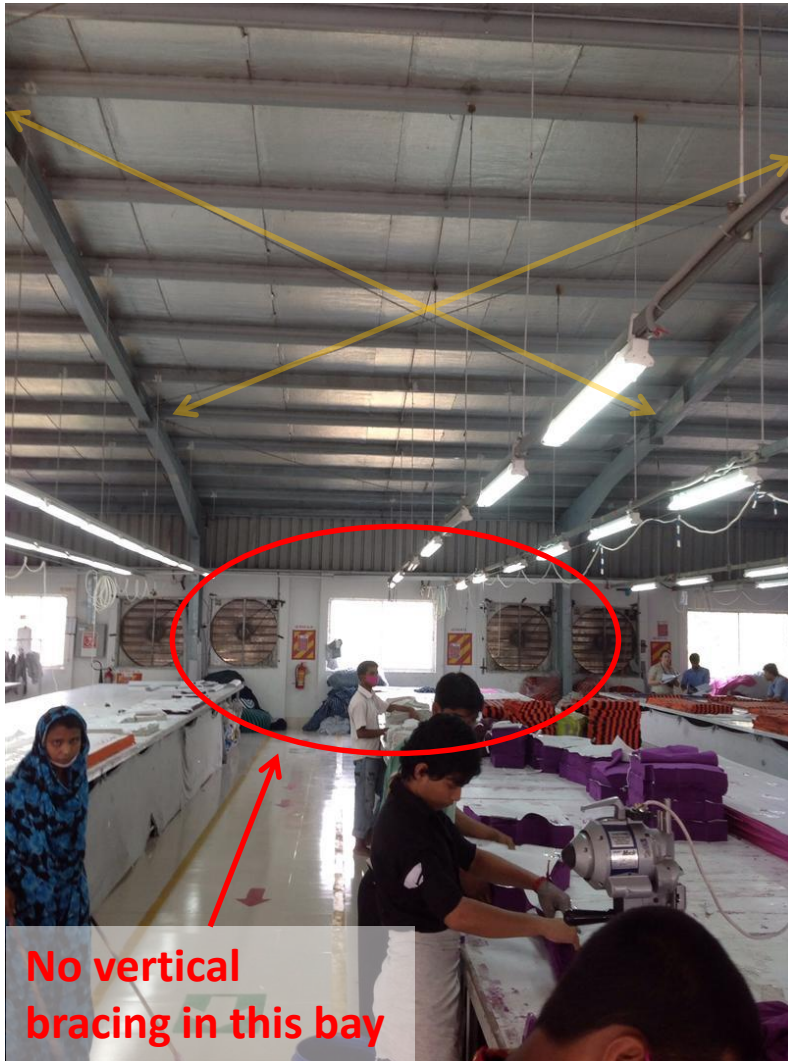
**Braced bay observed in roof of Building 2. Vertical bracing removed from this bay.**

| Item No. | Observation | Recommended Action Plan | Recommended Timeline |
|---|---|---|---|
| 5 | Unclear stability system for Building 1, Building 2 and Building 3 | Reinstate disconnected cables in braced bays in Building 2. | 6-weeks |

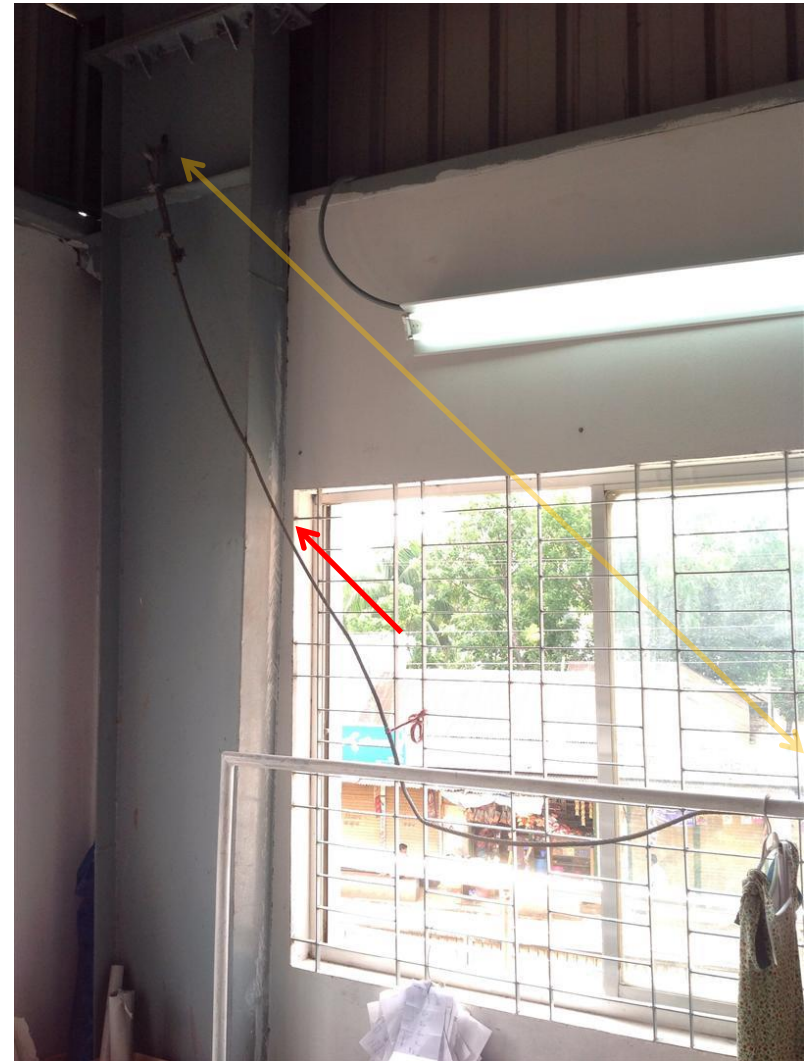
**Steel cables removed or disconnected at a number of locations in Building 2.**

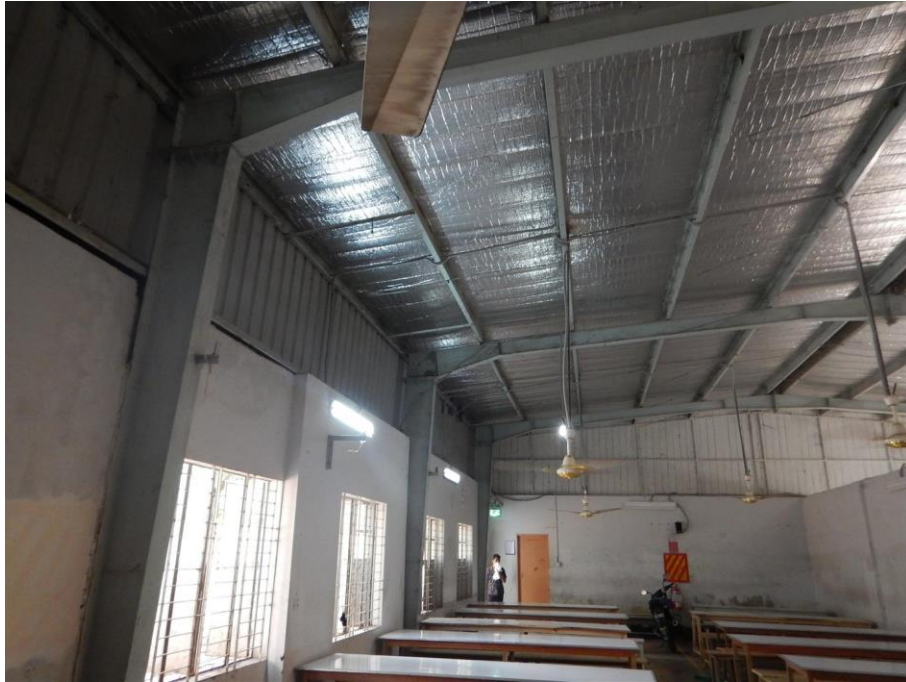
**No engineered roof bracing provided in Building 3.**

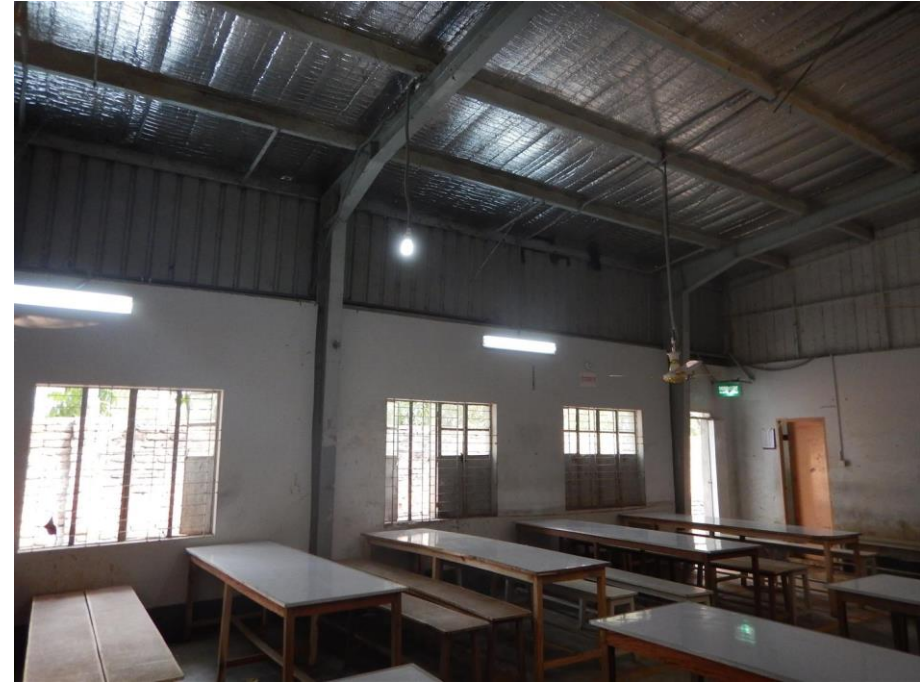
**No vertical bracing provided in Building 3. Lateral stability in long direction unclear.**

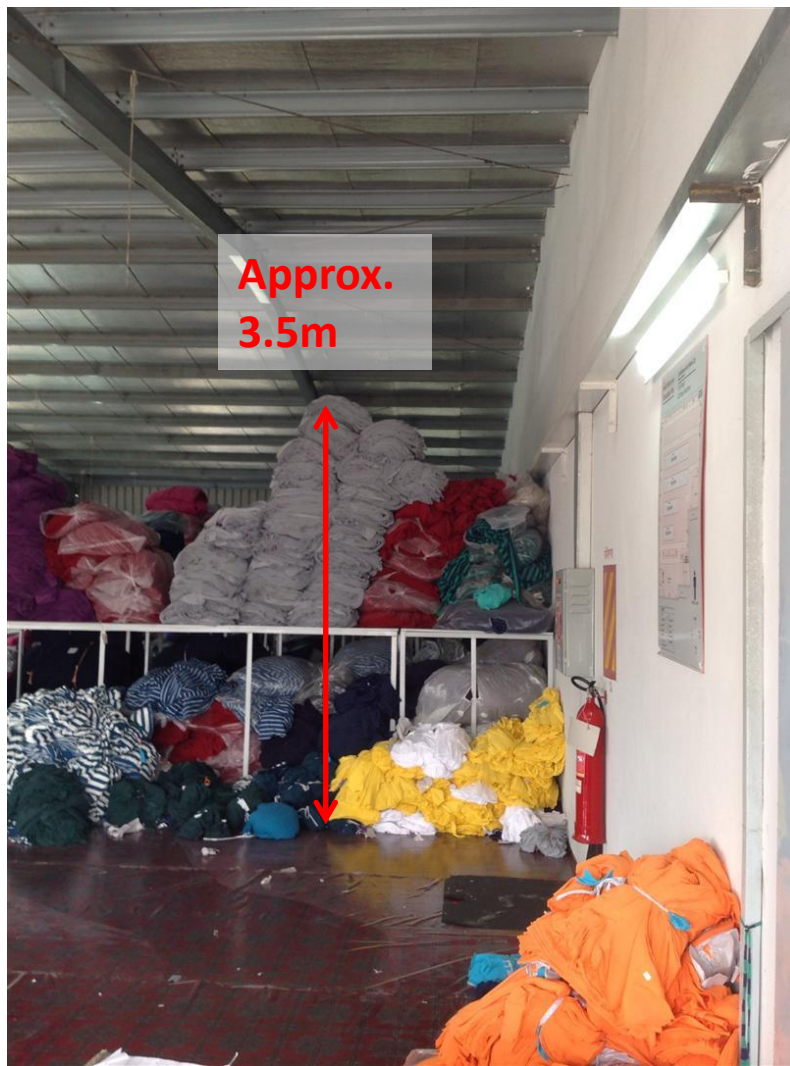
**Approx.  
3.5m**

**High storage loads on first floor of Building 2. Up to 3.5m high fabric storage observed.**

| Item No. | Observation | Recommended Action Plan | Recommended Timeline |
|---|---|---|---|
| 9 | Concentrated areas of high loading | Building Engineer to develop loads plans for all buildings, accounting for usage, floor build ups, solid partition walls and areas of concentrated loading. Factory management to implement load plans. | 6-weeks |

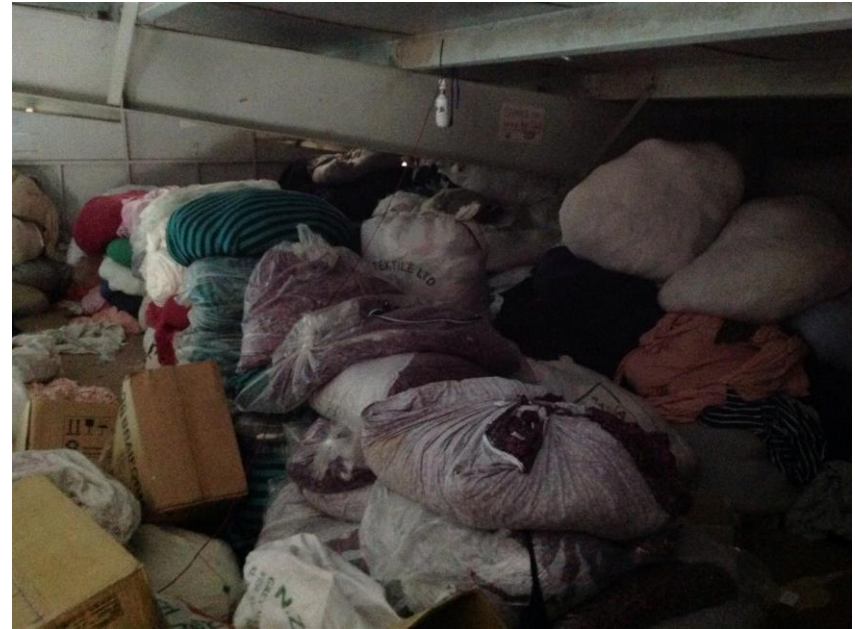
**Uncontrolled storage on mezzanine floor in Building 1. Non-engineered lightweight steel structure for mezzanine supported on masonry walls.**

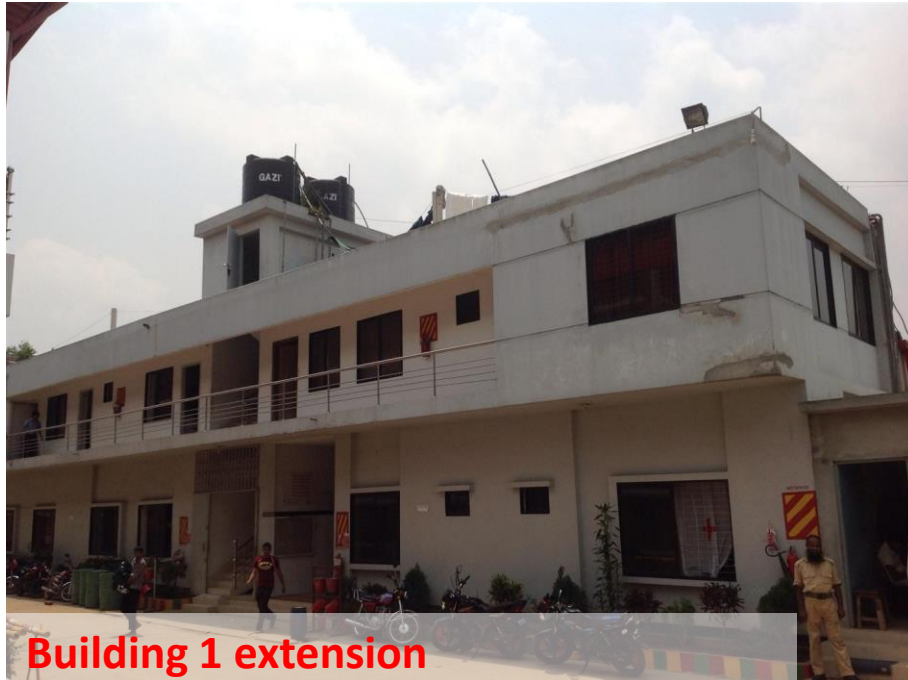
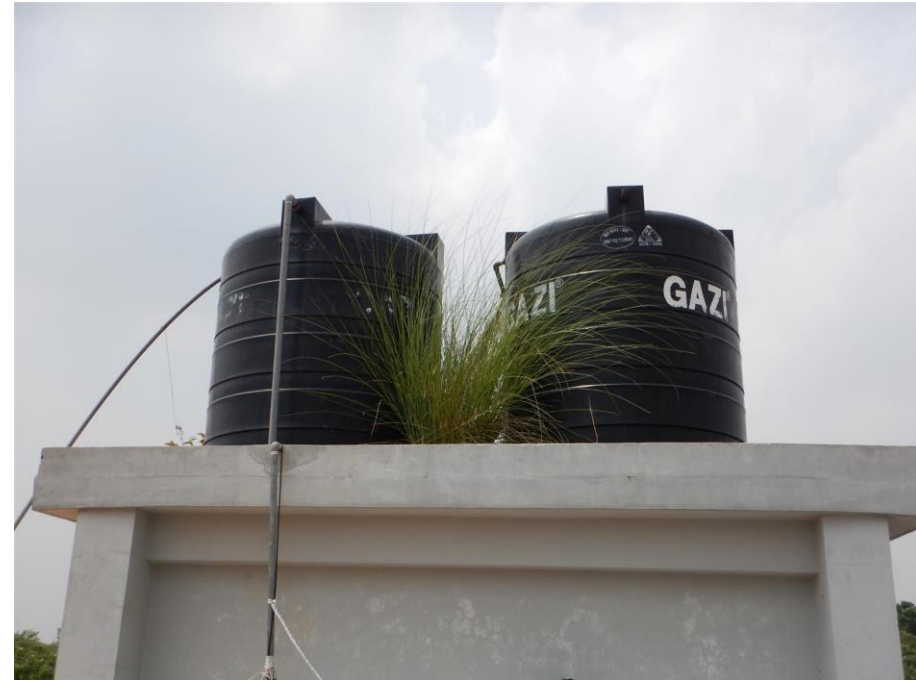
**Structure appears non-engineered.**  
**Slabs RC, piers and walls masonry, beams sometimes present in steel, sometimes omitted.**  
**Columns at first floor typically did not align with columns at ground floor.**

**No structural engineering drawings or details are available for extension to front of Building 1.**

| Item No. | Observation | Recommended Action Plan | Recommended Timeline |
|---|---|---|---|
| 11 | Non-engineered building extensions | Building Engineer to undertake a design review of Building 1 extension, paying particular attention to building stability system and capacity of masonry columns | 6-months |

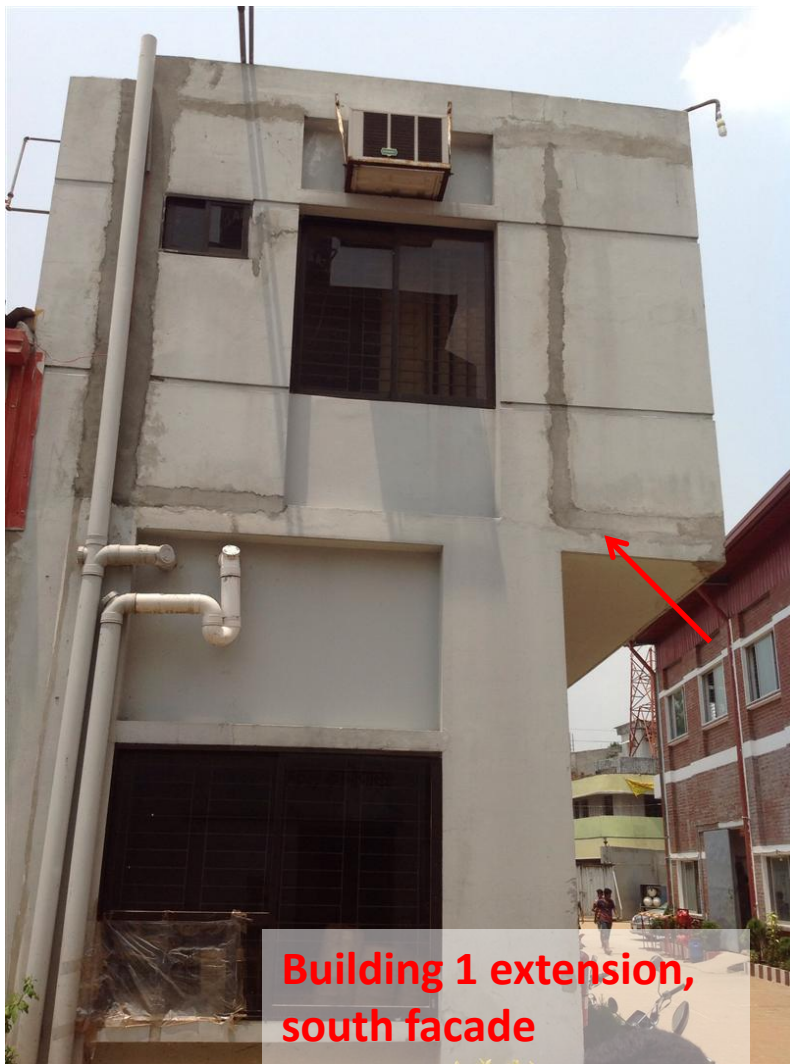
Evidence of movement of cantilever  
in Building 1 extension.

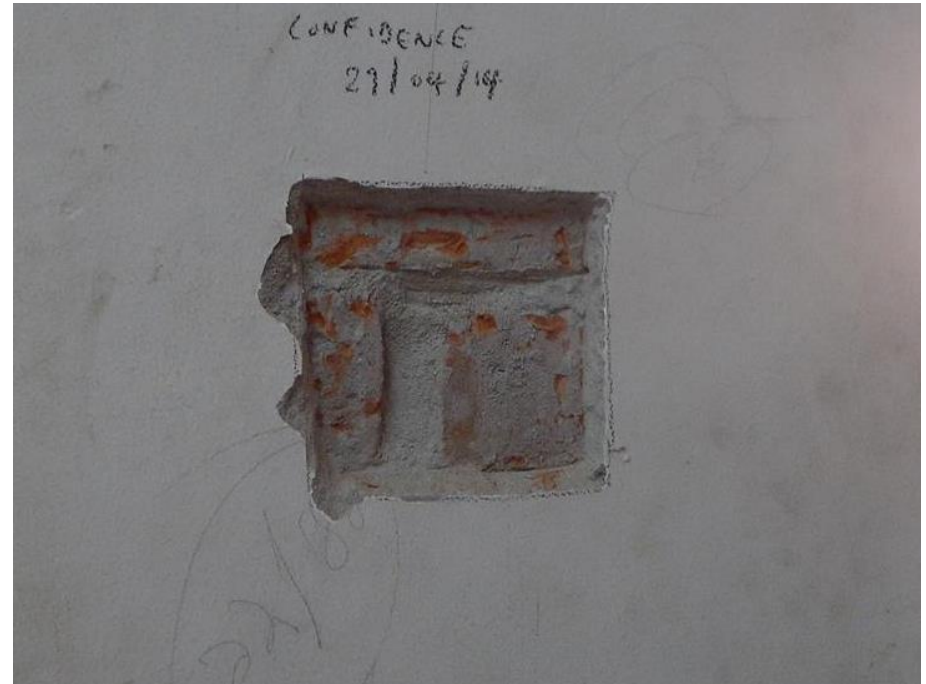
Load bearing unreinforced masonry piers  
observed at ground floor level. No evidence  
of reinforced concrete piers in Building 1  
extension.

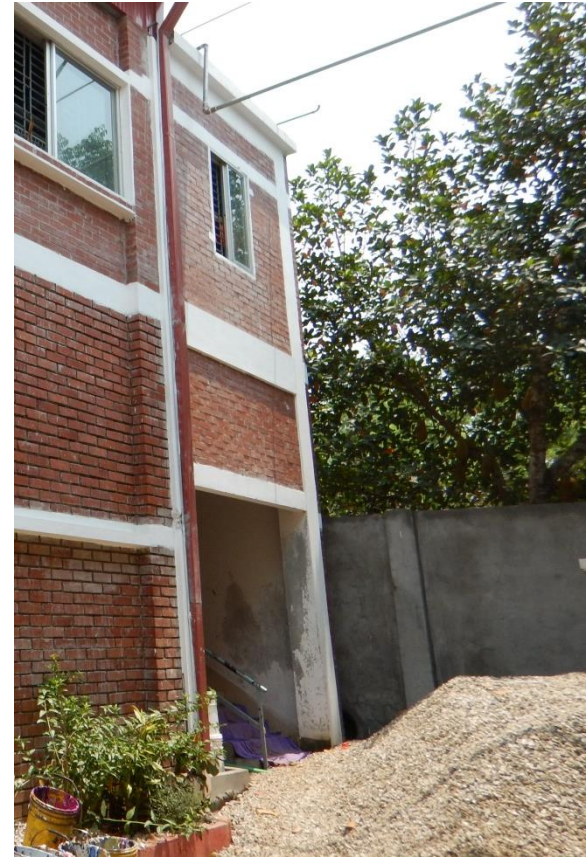
**No apparent stability system in rear extension to Building 2 in one direction.**

| Item No. | Observation | Recommended Action Plan | Recommended Timeline |
|---|---|---|---|
| 12 | Non-engineered building extensions | Building Engineer to undertake a design review of Building 2 and 3 extensions, paying particular attention to building stability system. | 6-months |

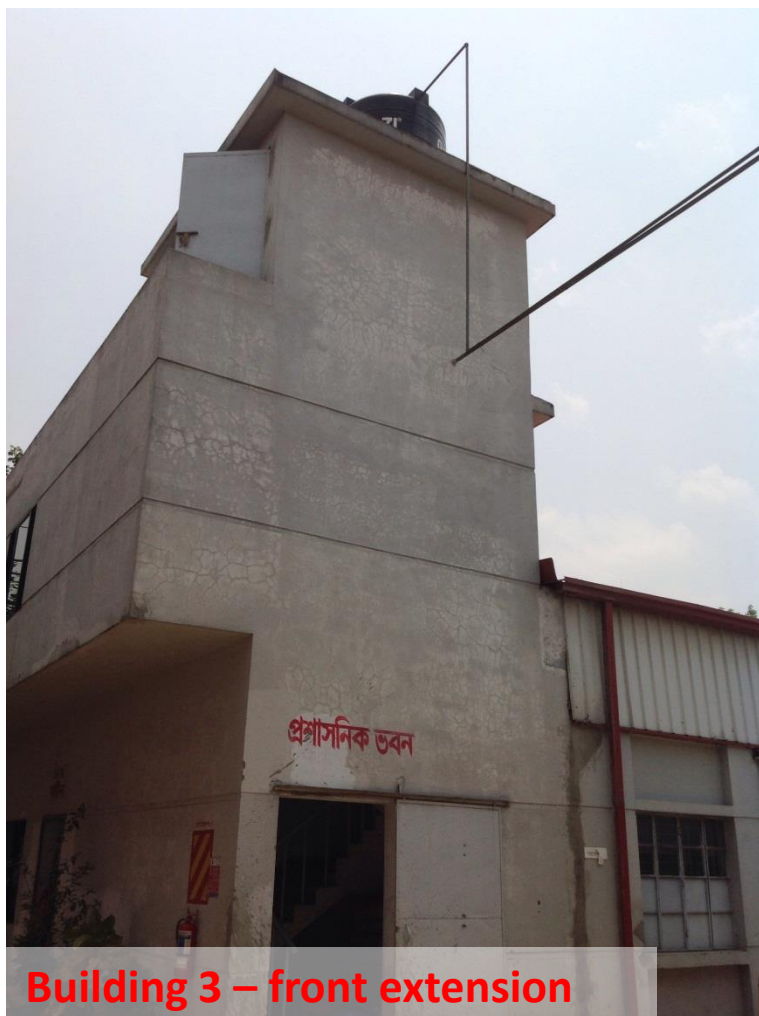
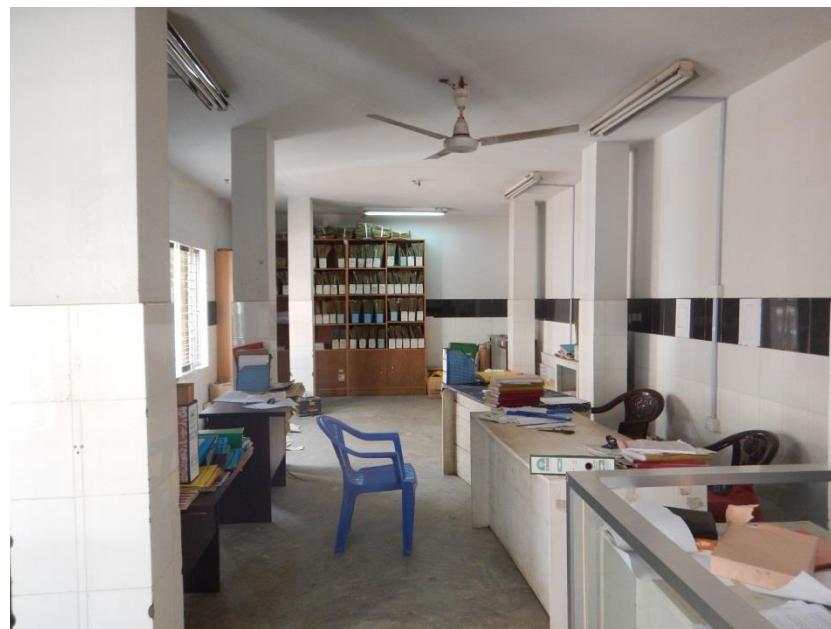
**No apparent stability system in front extension to Building 3**

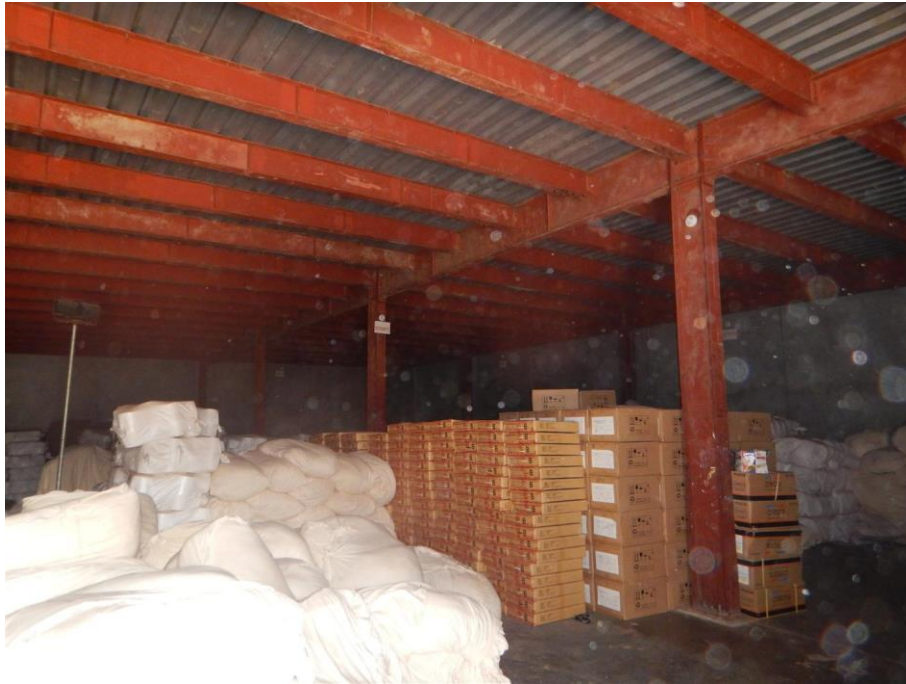
**No visible fire protection to steelwork supporting first floor in Building 2.**

| Item No. | Observation | Recommended Action Plan | Recommended Timeline |
|---|---|---|---|
| 14 | Fire protection to first floor in Building 2 | Building Engineer / Fire Engineer to advise on requirements for providing fire protection to steel elements to meet code requirements. | 6-months |

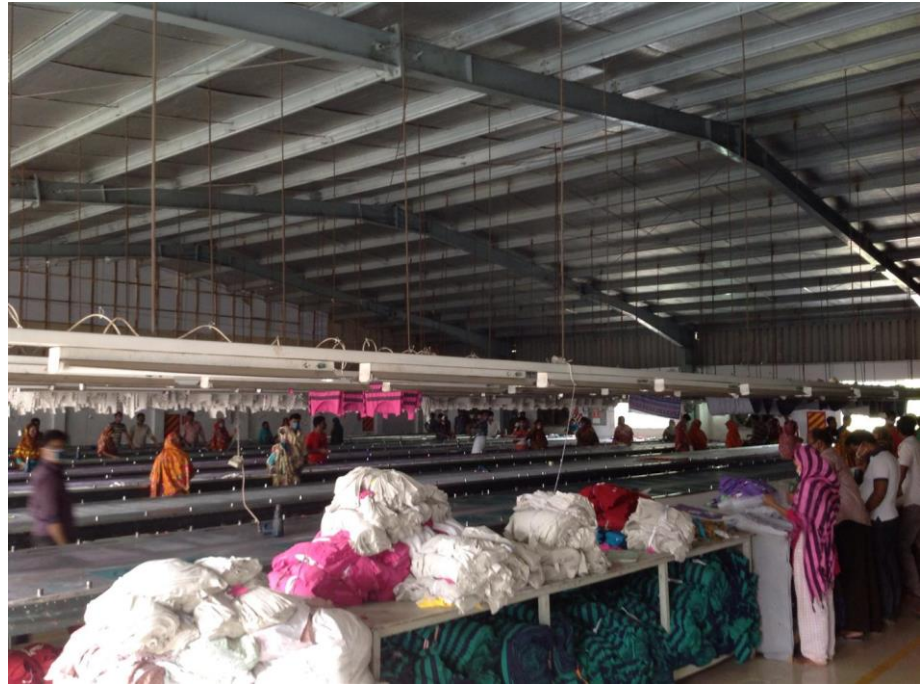
**First floor in Building 2 houses cutting, printing tables and storage.**

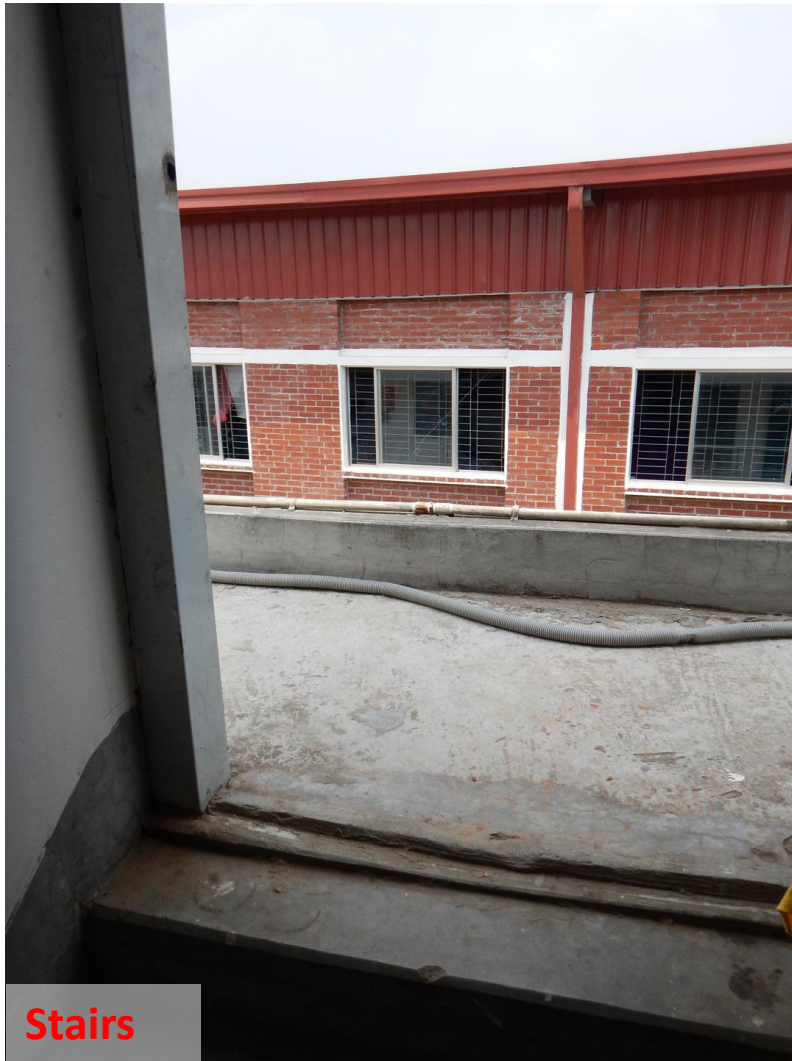
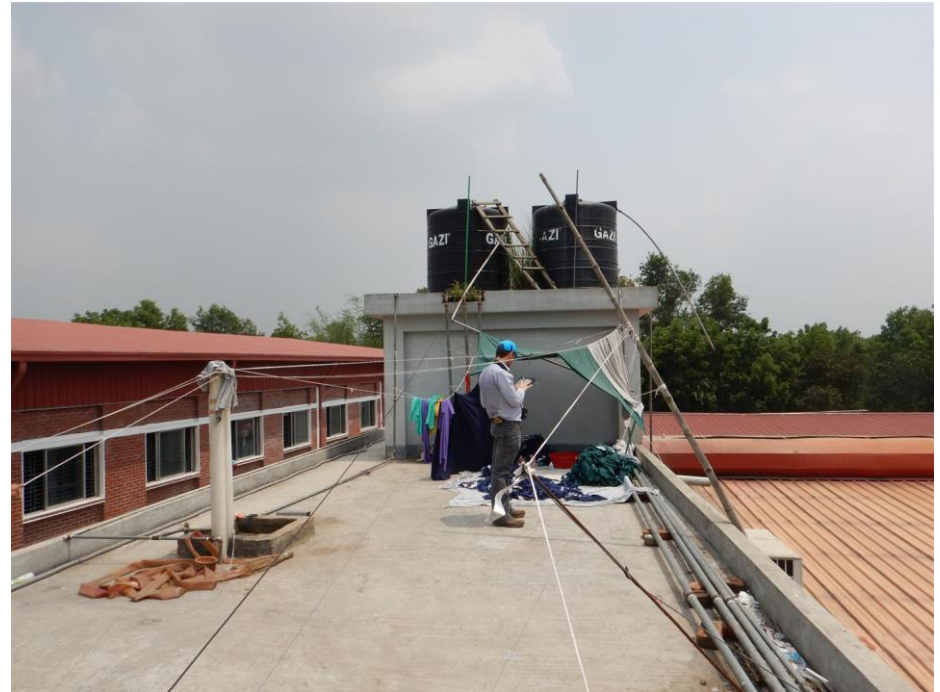
**Unprotected edge at top of stairs and around roof perimeter, leading to risk of falls (note roof is used for drying clothes).**

| Item No. | Observation | Recommended Action Plan | Recommended Timeline |
|---|---|---|---|
| 15 | Edge protection to roofs | All roofs directly accessible by stairs to be provided with handrails or parapets around all edges. | 6-months |

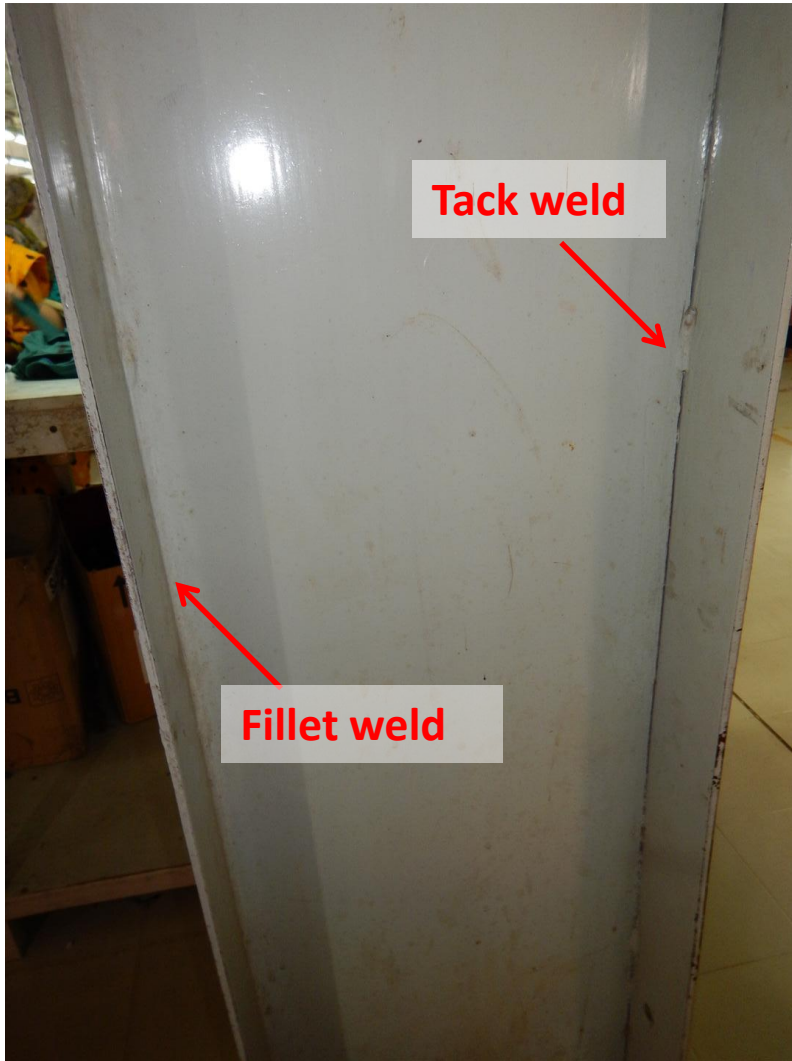
**Building 1 columns comprise of built up sections fillet welded on one side and tack welded on the other.**

| Item No. | Observation | Recommended Action Plan | Recommended Timeline |
|---|---|---|---|
| 16 | Steel Construction | Steelwork connections throughout all buildings to be reviewed by engineer and recommendations made for adjustment. | 6-months |

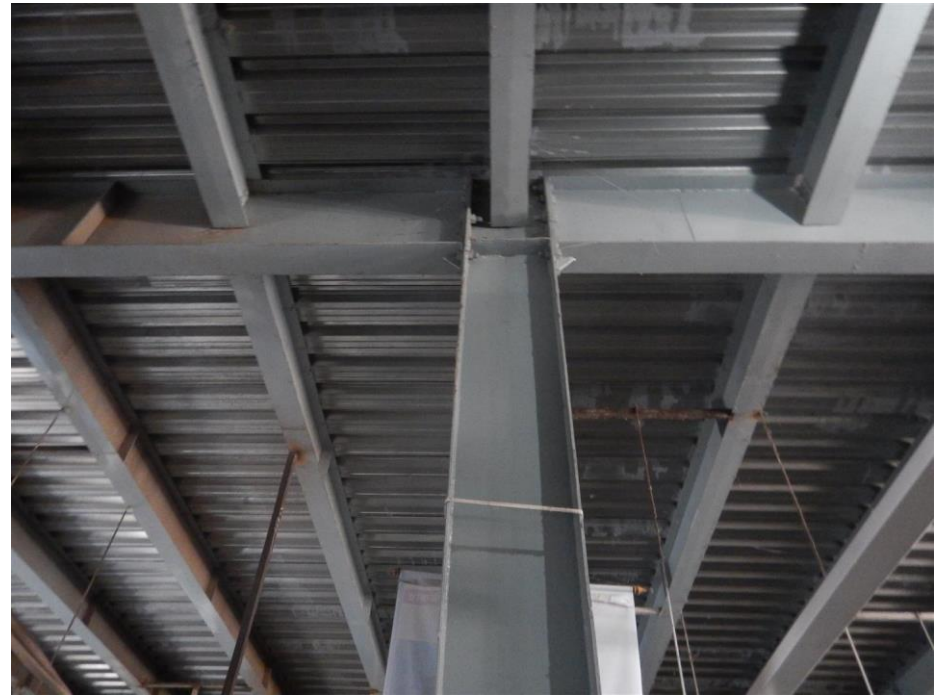
**Building 2 columns fully fillet welded, beams fillet welded on one side and tack welded on the other.**

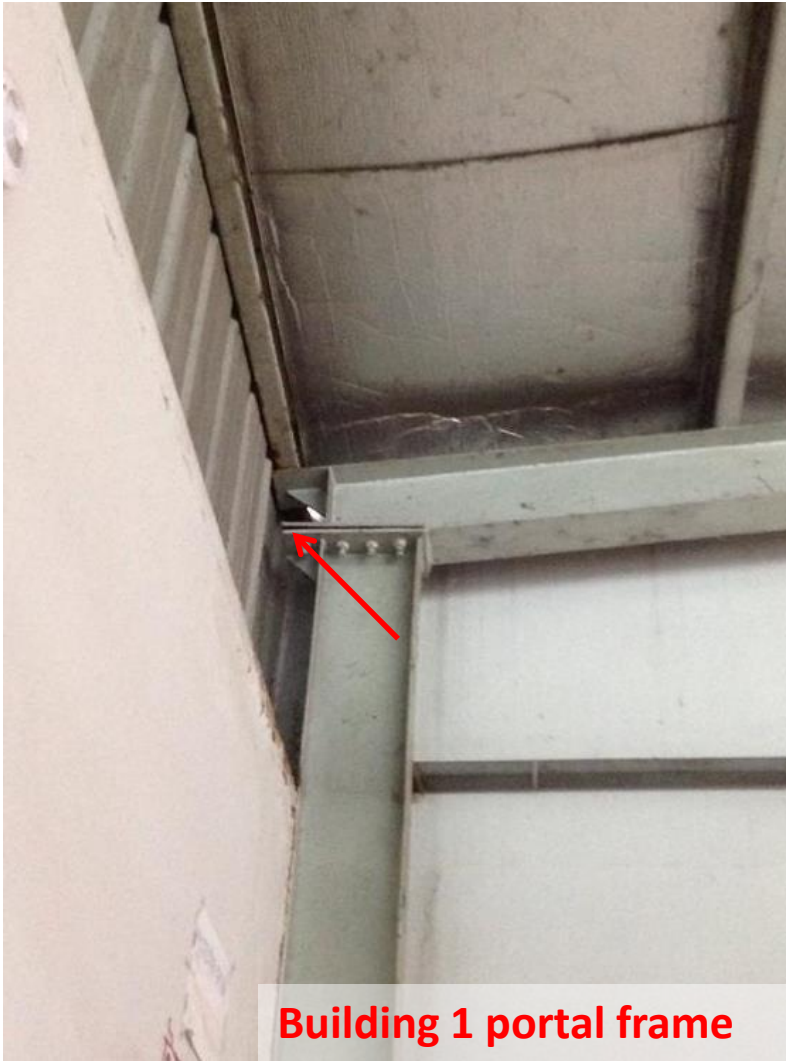
**Building 1 portal frame**

**Bolted connections at eaves of portal frame in Building 1 appear to be opening up.**

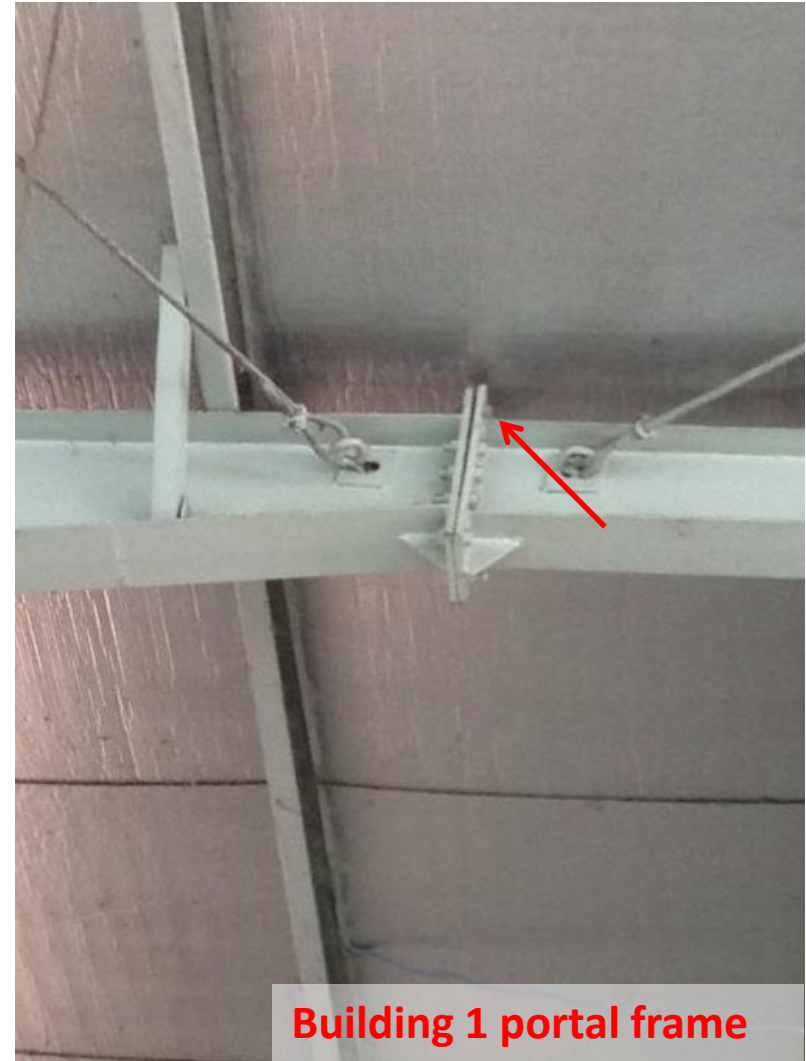
**Building 1 portal frame**

**Bolted end plate connections within rafter span in Building 1 appear to be opening up.**
