# Echotex Ltd

Chandra, Mouchak, Shafipur, Gazipur, Dhaka  
(+24.03892N, 90.2586 E)

6 February 2014

# **Building Observations Garment Factory**

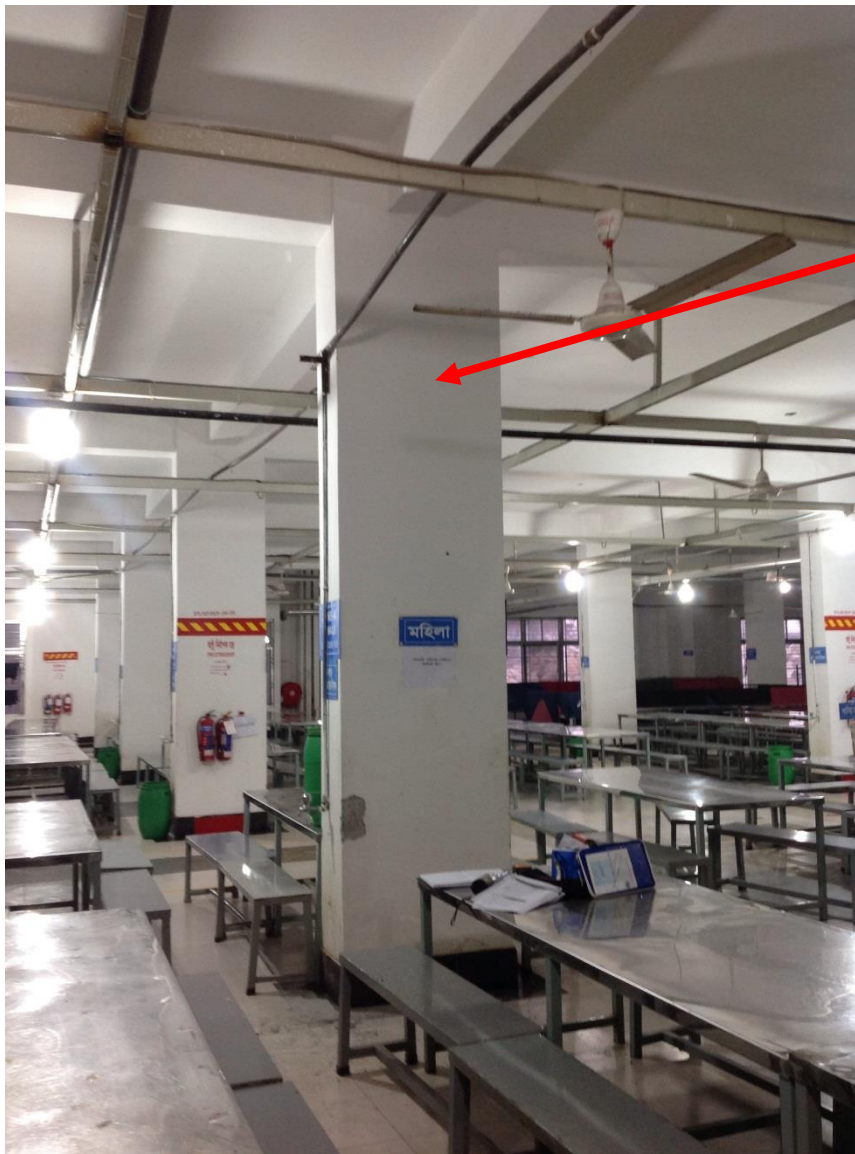
**Columns appear to be stressed in excess of  
normal design limits**

Cursory calculations indicate that column size appears to be smaller than required by code for the applied dead and live load, assuming typical concrete strength

Building Engineer to perform detailed calculations and concrete tests to prove column size and (if required) :

- Reduce loads by preparation of allowable floor loading plans
- Carry out strengthening works

| Item No. | Observation | Recommended Action Plan | Recommended Timeline |
|---|---|---|---|
| 1 | Verify the structural adequacy of building columns at all levels based on as built dimensions and material properties | Factory Engineer to review design, loads and columns stresses in area identified above. | 6-weeks |
| 2 | Verify the structural adequacy of building columns at all levels based on as built dimensions and material properties | Verify insitu concrete strength either by cores or existing cylinder strength data for 4 building columns. | 6-weeks |
| 3 | Verify the structural adequacy of building columns at all levels based on as built dimensions and material properties | Produce and actively manage a loading plan for all floor plates within the factory giving consideration to floor capacity and column capacity. | 6-months |

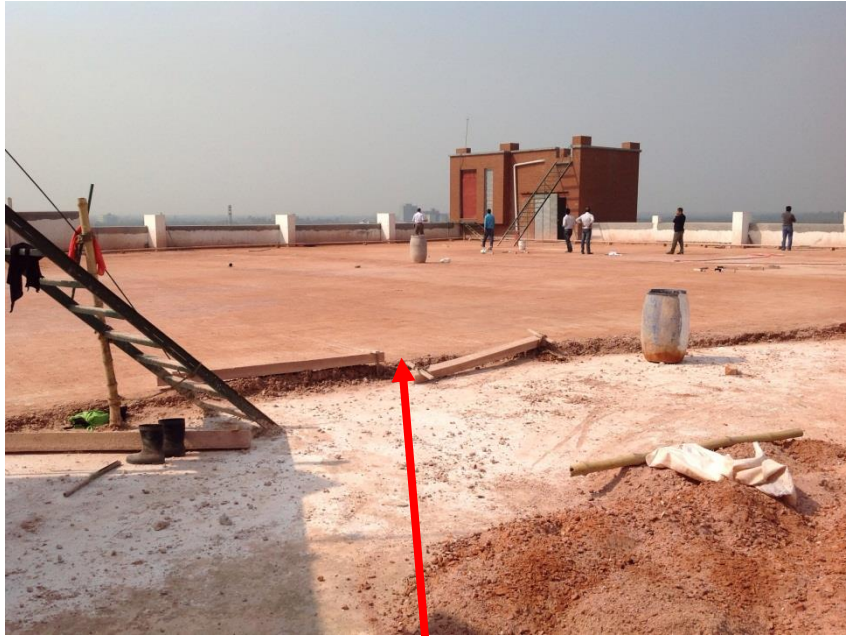
Average 125mm roof finishes build-up

**Engineer to check that roof beams/slab and support columns have been designed to accommodate roof build-up and water tank/plinth loads.**

| Item No. | Observation | Recommended Action Plan | Recommended Timeline |
|---|---|---|---|
| 4 | Structural adequacy of concrete roof and columns to support water tanks on plinths and roof weatherproofing build-up | Building Engineer to carry out design calculations to verify that roof beam/slab and columns have sufficient capacity to support fully filled water tanks, concrete plinths and roof finishes build-up | 6-weeks |

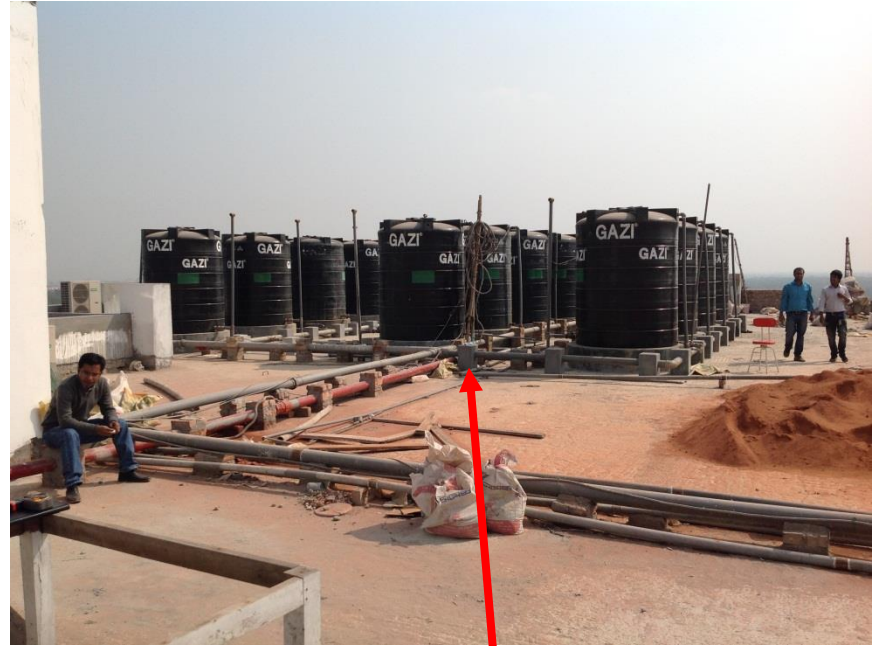
12 x 5000 Lt water tanks on 400 mm. high plinths

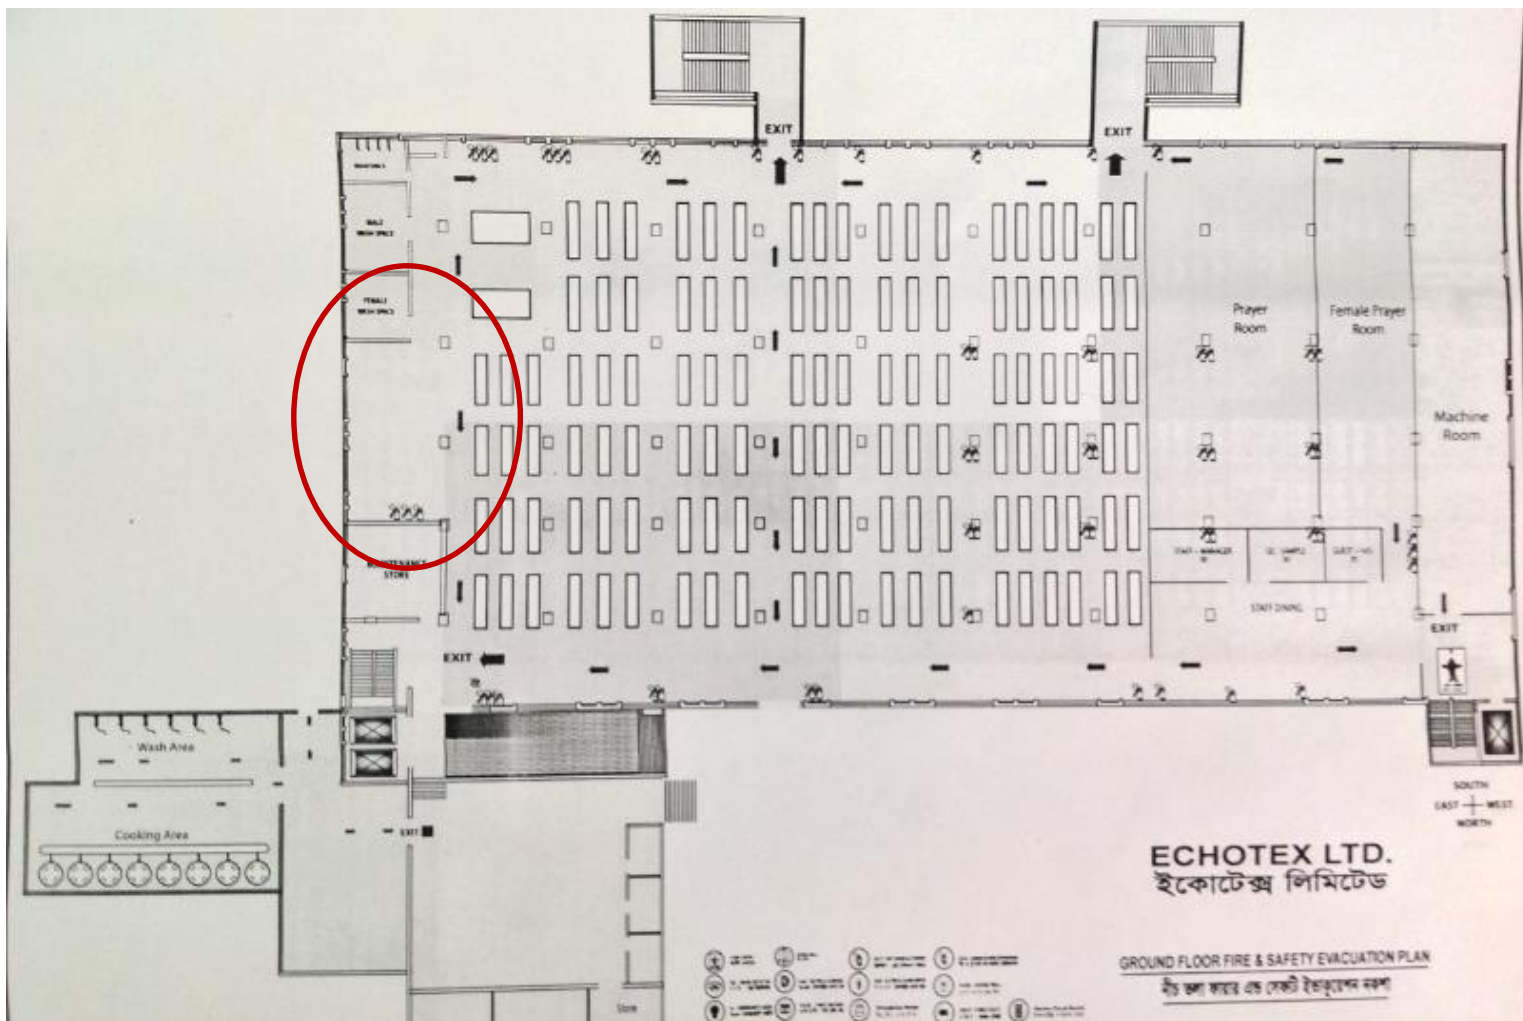
**Detailed structural drawings for the area at the east end of the Factory Building did not show the correct as-constructed layout**

We were provided with a separate set of drawings for this area at the end of the survey. The main drawings should be updated to include these.

| Item No. | Observation | Recommended Action Plan | Recommended Timeline |
|---|---|---|---|
| 5 | Detailed structural drawings for the area at the east end of the Factory Building did not show the correct as-constructed layout | Building Engineer to survey column/beam locations at the east end of the building and compare with structural drawings. Updated drawing to be prepared showing the correct as constructed layout. | 6-weeks |
| 6 | Detailed structural drawings for the area at the east end of the Factory Building did not show the correct as-constructed layout | Engineer to review the design calculations and confirm that the design (or an updated design if required) corresponds with the as-built structure. | 6-months |

| Item No. | Observation | Recommended Action Plan | Recommended Timeline |
|---|---|---|---|
| 7 | Detailed structural drawings for the area at the east end of the Factory Building did not show the correct as-constructed layout | Layout and structural drawings to be updated | 6-months |

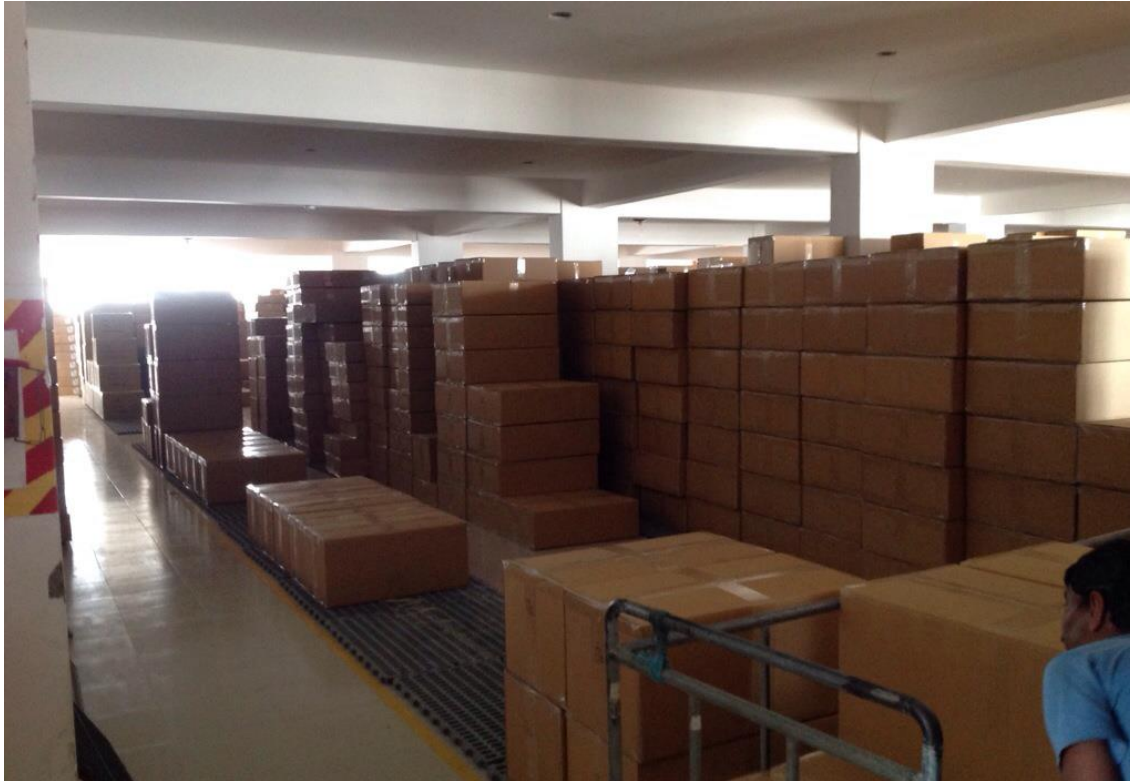
**Eight Floor**

**Some level of Storage loads were observed on each floor.  
Plan and height restrictions to be introduced to prevent future overloading.**

| Item No. | Observation | Recommended Action Plan | Recommended Timeline |
|---|---|---|---|
| 8 | Load management of storage loads | Produce and actively manage a loading plan for all floor plates within the factory giving consideration to floor capacity and column capacity. | 6-weeks |

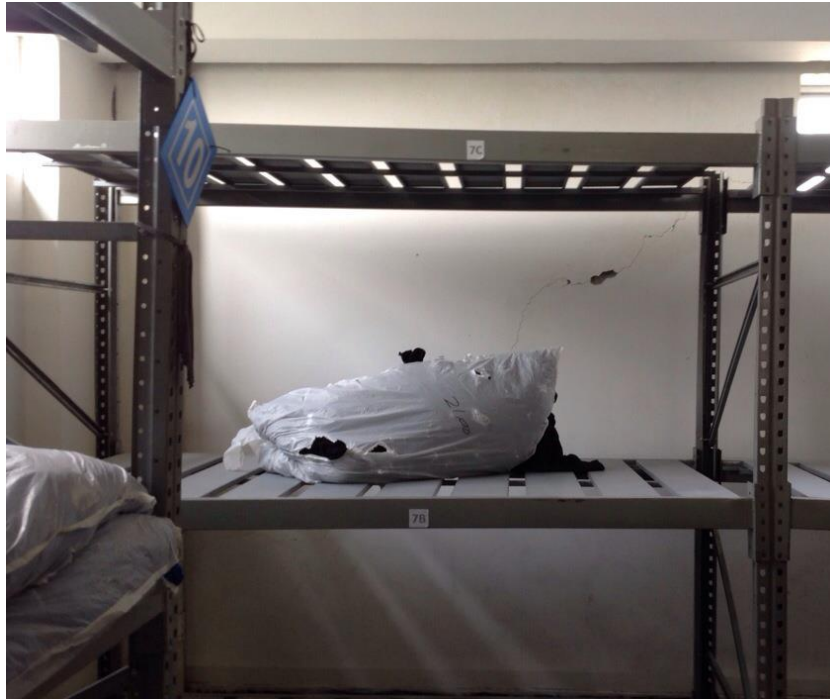
**Ninth floor Annex – diagonal crack. Building Engineer to determine cause and monitor crack width**

| Item No. | Observation | Recommended Action Plan | Recommended Timeline |
|---|---|---|---|
| 9 | Cracking to brickwork walls | Building Engineer to review cracking on an on-going basis and propose further remedial works , if required. | 6-months |

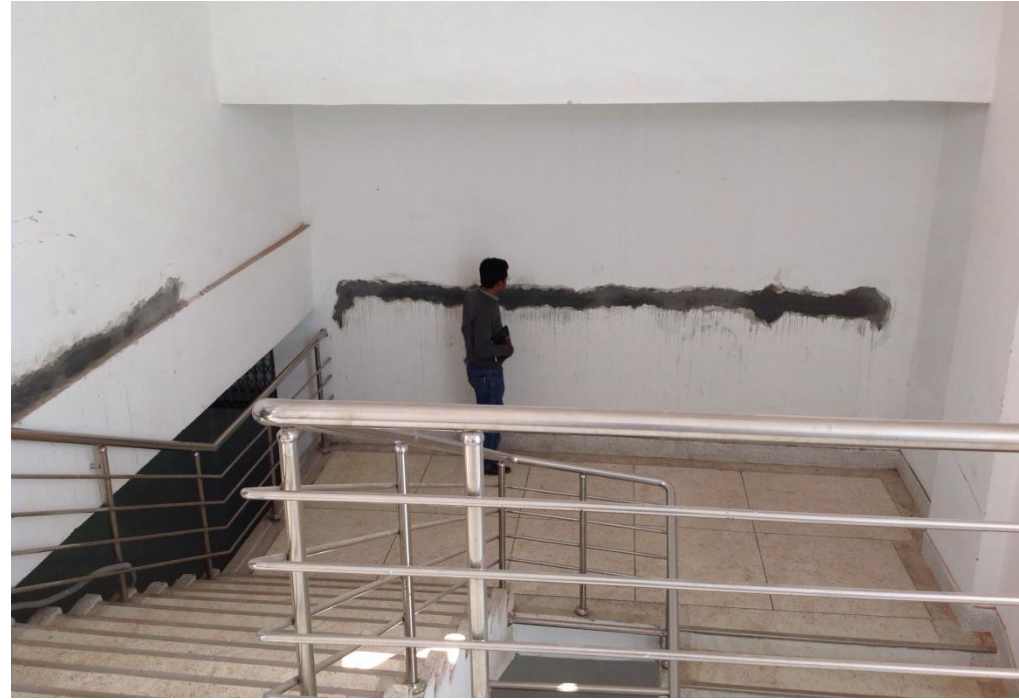
**Northeast Staircase between Roof and 9<sup>th</sup> floor (plaster 'repair' visible).**

**At upper levels, significant cracking was observed at the interface of the concrete structure and brick infill. Building Engineer should review.**

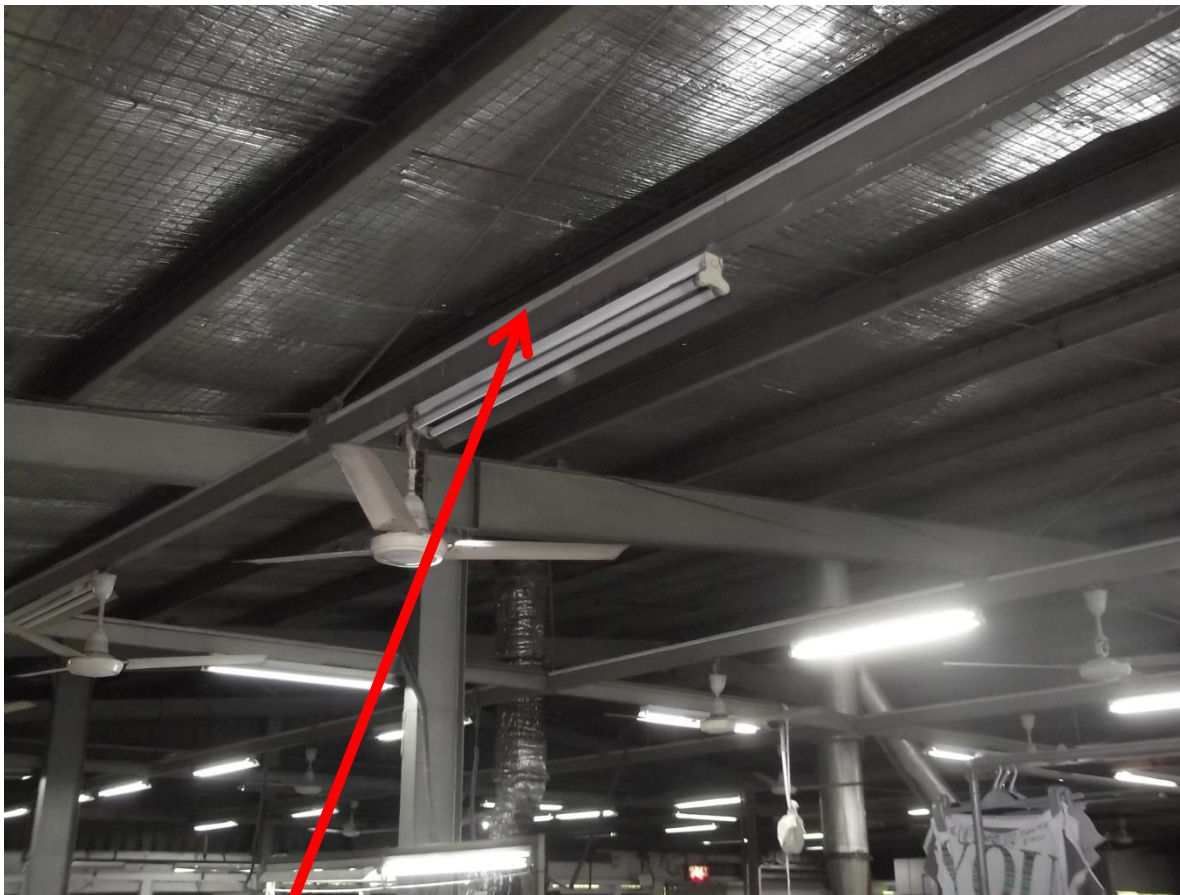
The structural drawings provided did not relate to the Printing Building.

No apparent lateral bracing system is provided to the roof or steel frame.  
Building Engineer to review

Building Engineer to prepare a set of as-built drawings.

| Item No. | Observation | Recommended Action Plan | Recommended Timeline |
|---|---|---|---|
| 10 | Printing Building - no apparent lateral bracing system is provided to the steel roof and frame and the structural drawings provided did not relate to this building | Building Engineer to review requirement for building bracing system | 6-months |
| 11 | Printing Building - no apparent lateral bracing system is provided to the steel roof and frame and the structural drawings provided did not relate to this building | Building Engineer to prepare as- constructed structural drawings. | 6-months |

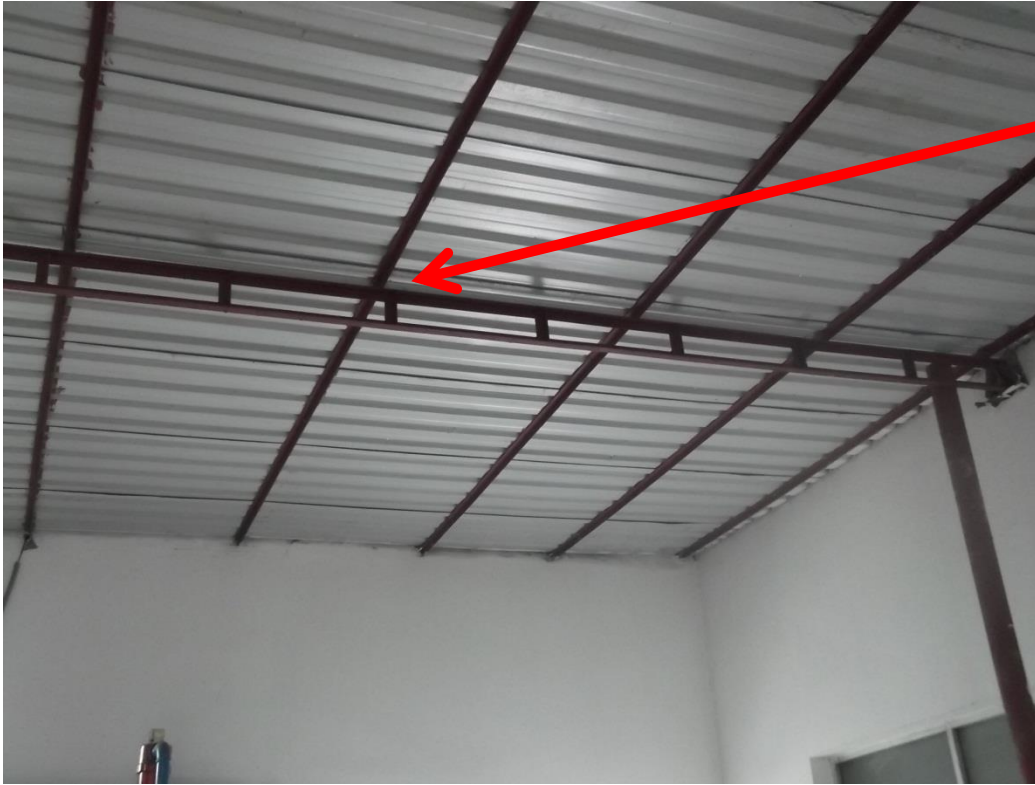
Lightweight steel roof to upper floor extension to north west of Utility Building

Roof truss is supported on adjacent brick wall and on column by tack weld connection

Building Engineer to review the lightweight steel structure and prepare engineering design calculations to verify the structure for code specified imposed live and wind loads

| Item No. | Observation | Recommended Action Plan | Recommended Timeline |
|---|---|---|---|
| 12 | Utility Building – upper floor extension at north west is of light steelwork construction | Building Engineer to review structural adequacy of the roof steelwork and connections between roof steel and columns within the upper floor extension to the Utility Building. | 6-months |

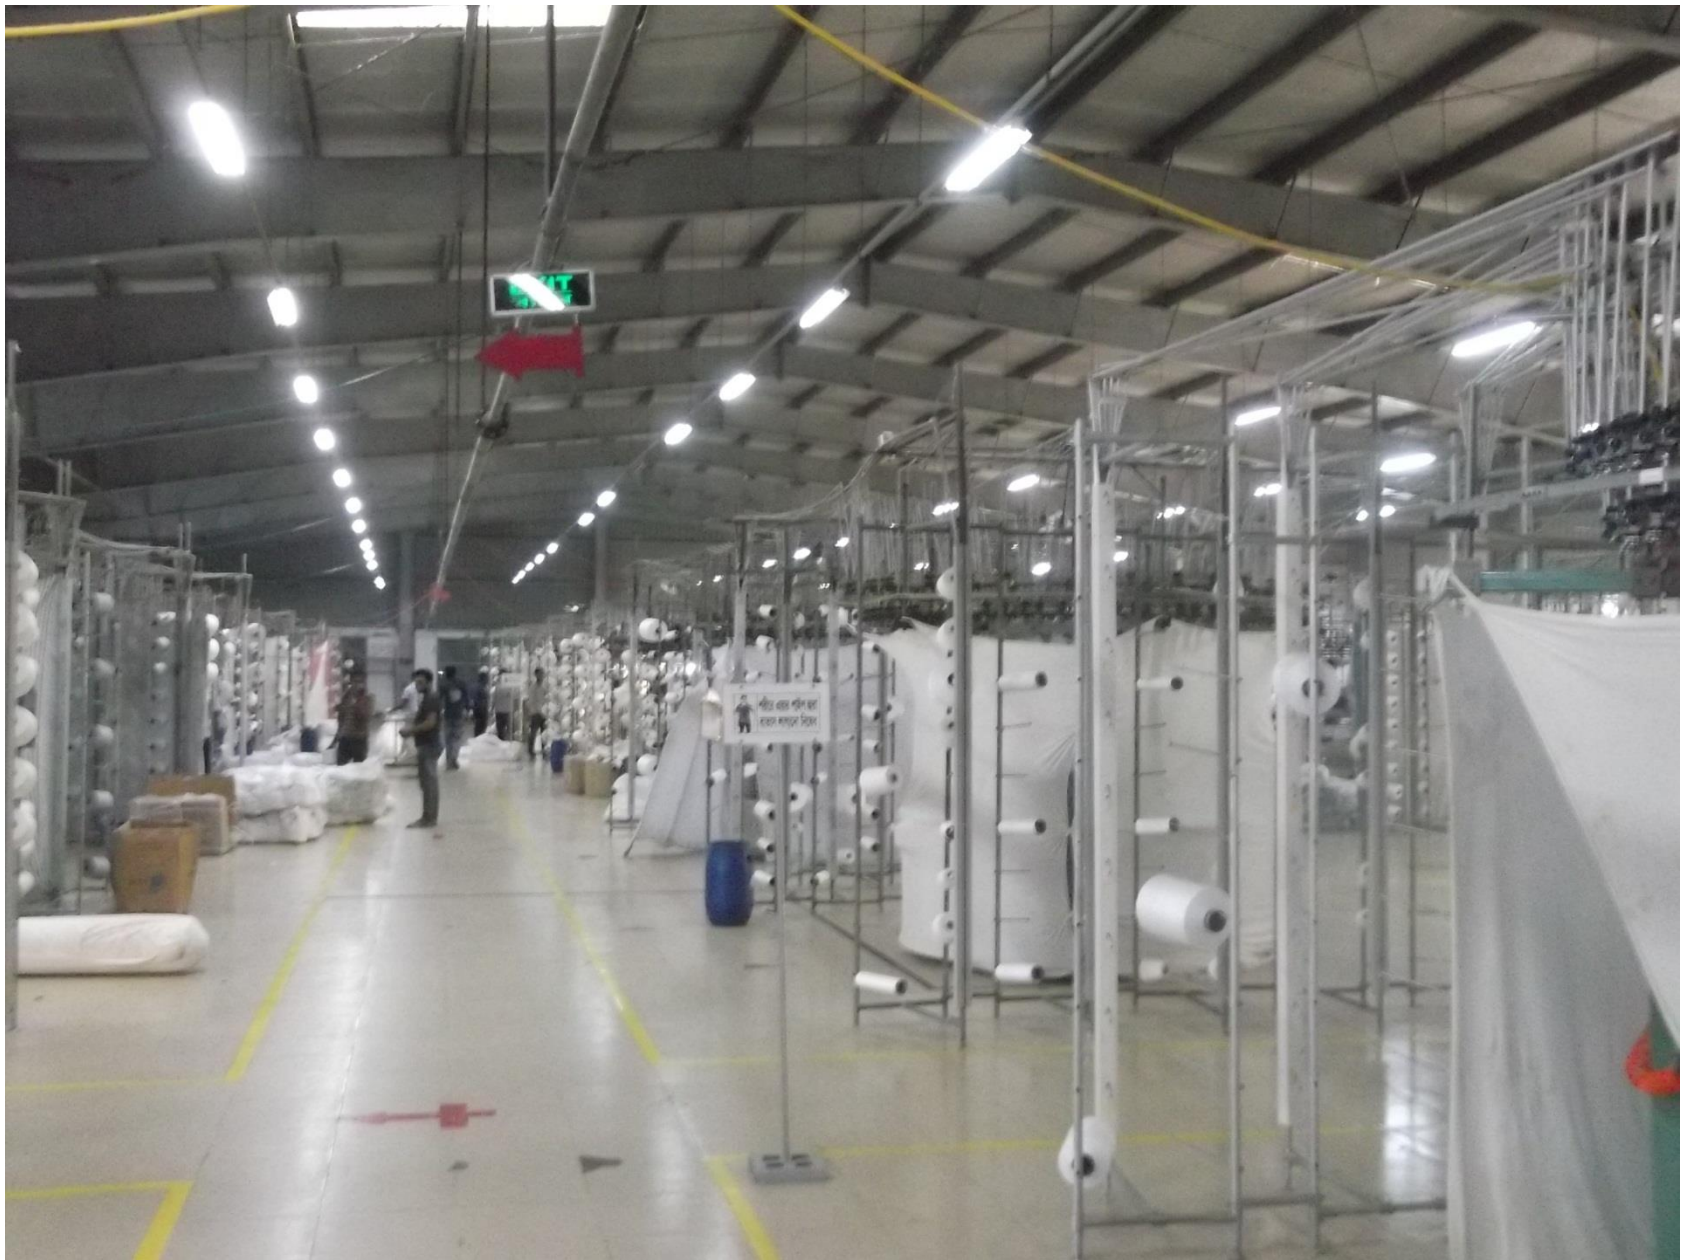
**Knitting & Dyeing Building – Horizontal bracing is provided in the plane of the steel roof structure, however no vertical bracing system is evident.**

| Item No. | Observation | Recommended Action Plan | Recommended Timeline |
|---|---|---|---|
| 13 | Knitting & Dyeing Building – Horizontal bracing is provided in the plane of the steel roof structure, however no vertical bracing system is evident. | Building Engineer to review possible requirement for lateral vertical bracing to the Knitting & Dyeing building structural frame. | 6-months |
