# Tusuka Denim Ltd and Tusuka Washing Ltd

490/1, Neelnagar, Konabari, Gazipur  
(24.010631, 90.328249)

1 March 2015

# Observations Building 1

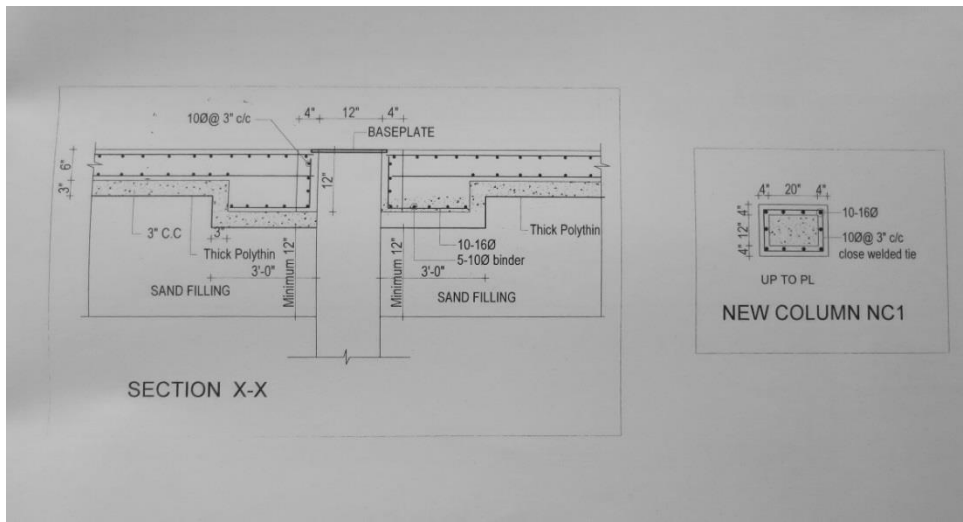
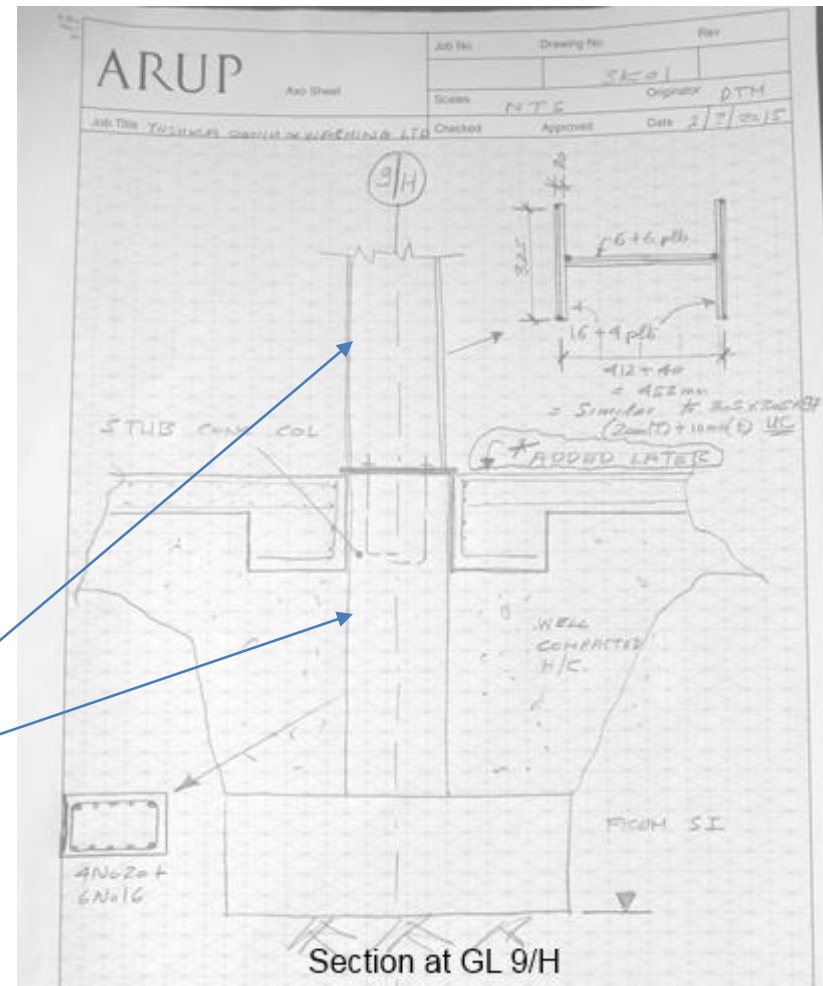
Section at GL 9/H Foundation

# High Stress in Stub Columns

Extract from Md. Mahfuzur Rahman drawing

RC Stub column highly stressed when design loads specified in Table 1 are applied.

| Item No. | Observation | Recommended Action Plan | Recommended Timeline |
|---|---|---|---|
| 1 | High Stress in Stub Columns | Factory Engineer to review design of stub columns for full loads noted in Table 1. | 6-months |
| 2 | High Stress in Stub Columns | Carry out appropriate strengthening works as deemed necessary to meet code requirements for stub columns | 6-months |
| 3 | High Stress in Stub Columns | Factory Engineer to prepare Allowable Loading Plans taking accounts of capacity of stub columns, allowable foundation pressure, steel columns and beams elements and of floor slabs. | 6-months |

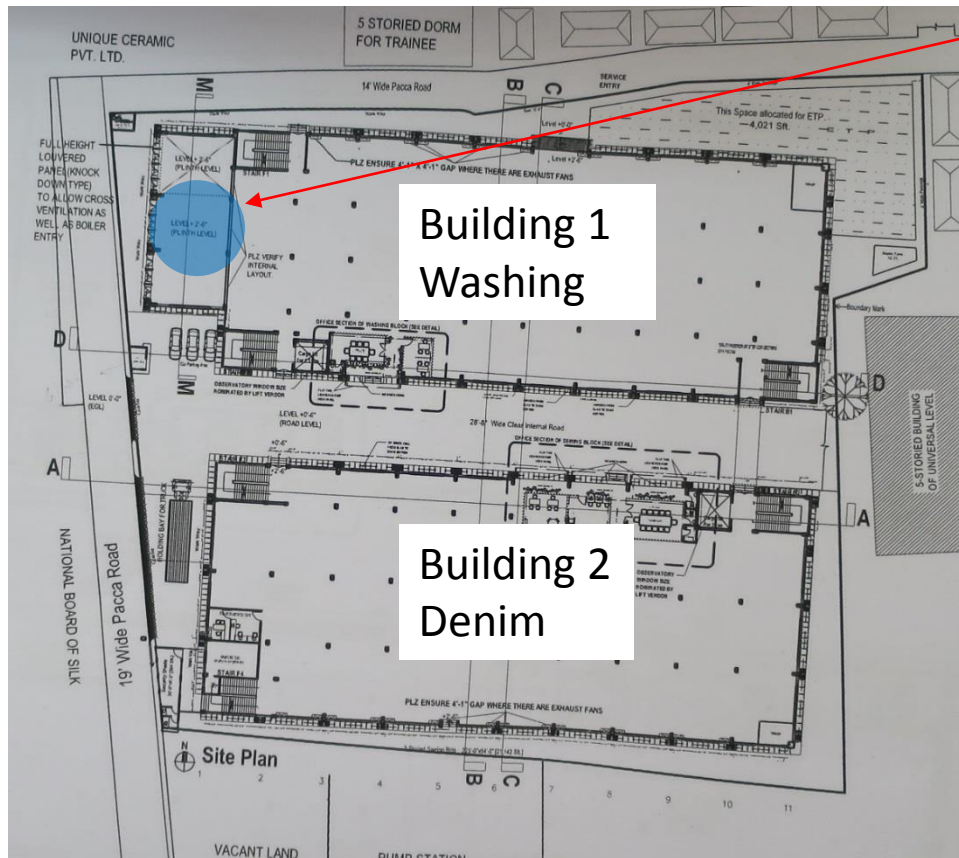
## Soils Report – Bore hole 9

# **Soils Report has low Allowable Bearing Pressure**

| Borehole No | Depth (m) | Cohesion, Ton/m <sup>2</sup> | Allowable Bearing Capacity, Ton/m <sup>2</sup><br>Raft foundation |
|---|---|---|---|
| BH-9 | 2.5 | 4.39 | 9.07 |

| Item No. | Observation | Recommended Action Plan | Recommended Timeline |
|---|---|---|---|
| 4 | Soils Report has low Allowable Bearing Pressure | Factory Engineer to review design of foundations at or near Bore Hole No 9 (9 Tons/sqm) shown in Soils Report. | 6-months |
| 5 | Soils Report has low Allowable Bearing Pressure | Carry out appropriate strengthening works or load reduction as deemed necessary to meet allowable bearing pressure for foundations in this area | 6-months |

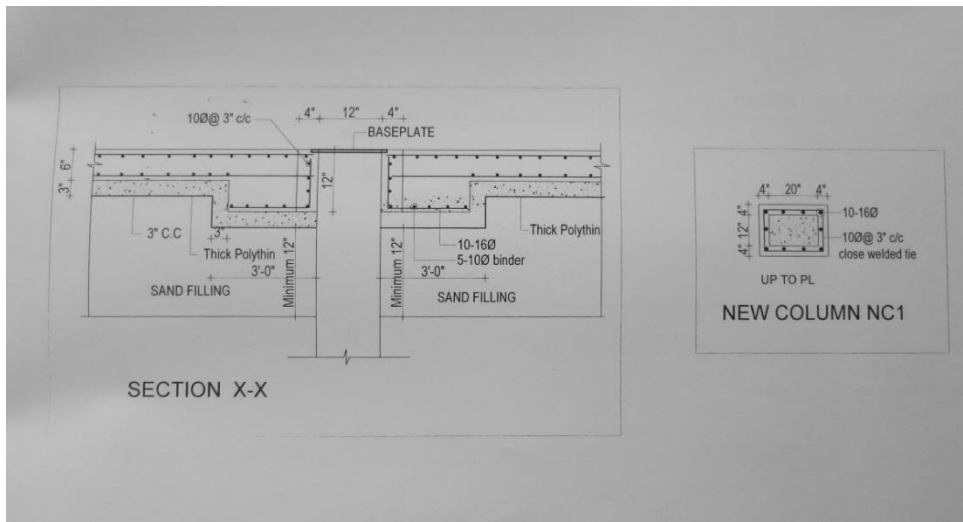
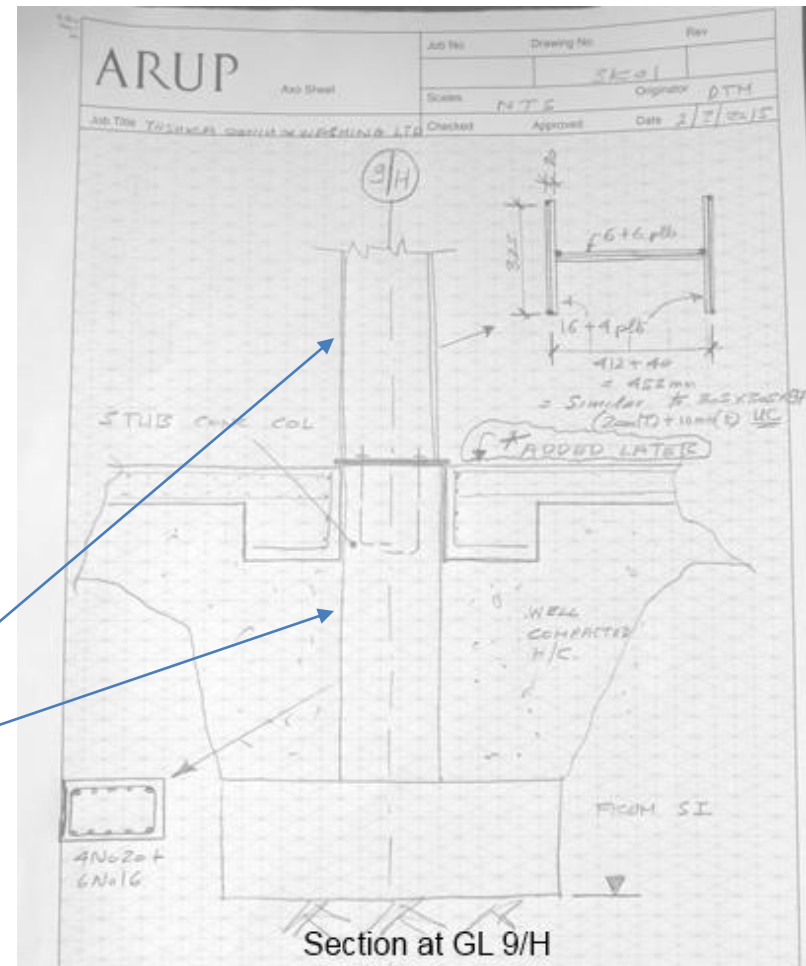
Typical Section

# High Stress in Stub Columns

Extract from Md. Mahfuzur Rahman drawing

RC Stub column highly stressed when design loads specified in Table 1 are applied.
