Ahmend Fashions

34/1, Darussalam Road, Dhaka
(23.783165 N, 90.351141 E)

Survey Date: 4th March 2015

Observations

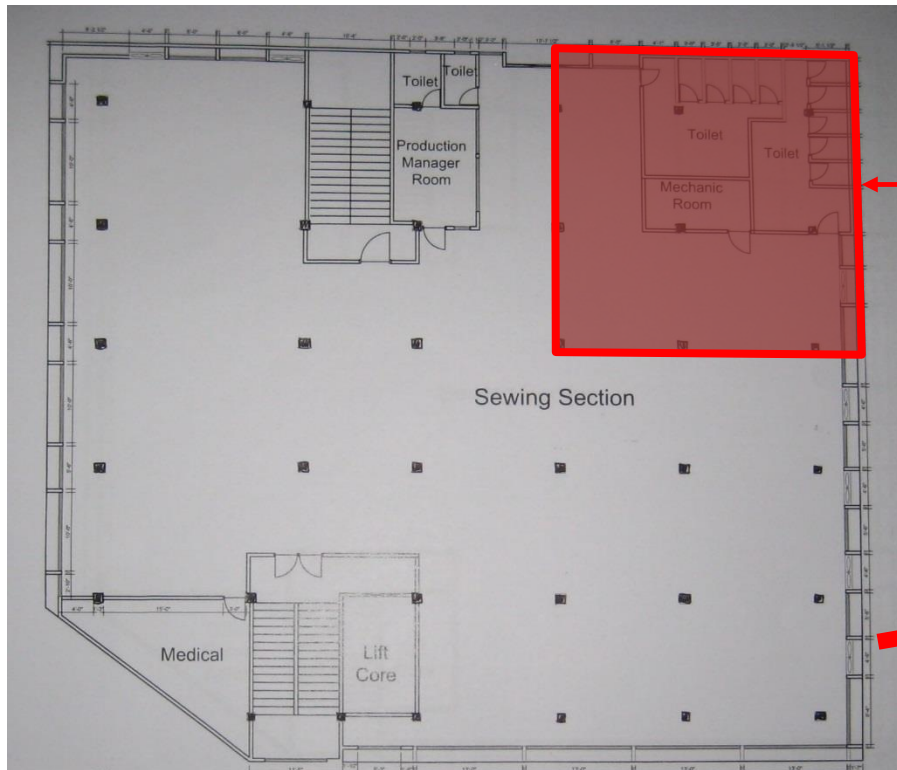
Highly-stressed columns

This area on **ALL** floors must be **IMMEDIATELY VACATED AND CORDONED OFF.**

- Cursory calculations indicate that all columns are very highly stressed, in particular those adjacent to the toilets in the north west corner.
- The permit drawings do not show cantilevers around the building edge and show the 6th floor as a roof, not a factory. Furthermore, the toilets have been built over a much larger area than shown on the permit drawings. This has significantly increased the load on the columns
- **IMMEDIATE ACTION:** The area highlighted above must be immediately vacated and cordoned off on ALL floors (including ground and basement).
- The floor loading in other areas of the factory should not be increased, and in any case must be limited to 2kPa.
- The Detail Engineering Assessment already in progress should prioritise the checking of the columns, in particular those in the area shown in red.

Item No.	Observation	Recommended Action Plan	Recommended Timeline
1	Highly-stressed columns	IMMEDIATE ACTION to vacate and cordon off area indicated above at all levels.	Immediate - Now
2	Highly-stressed columns	Loading in all other areas should not be increased and in any case must not exceed 2kPa.	Immediate - Now
3	Highly-stressed columns	Factory Engineer to review design, as-built column sizes, loads and column stresses in all areas, prioritising the area identified in red above.	Immediate - Now
4	Highly-stressed columns	Verify insitu concrete strengths by 100mm diameter cores from min. 4 columns at ground floor level (but not those beneath the toilets).	Immediate - Now
5	Highly-stressed columns	The Detail Engineering Assessment of Factory currently under way is to be continued - see attached Scope.	Immediate - Now
6	Highly-stressed columns	Produce and actively manage a loading plan for all floor plates within the factory giving consideration to floor capacity and column capacity.	6-weeks

7	Highly-stressed columns	Detail Engineering Assessment to be completed.	6-weeks
8	Highly-stressed columns	Implement load reductions as required by the Detail Engineering Assessment.	6-weeks
9	Highly-stressed columns	Continue to implement load plan.	6-months

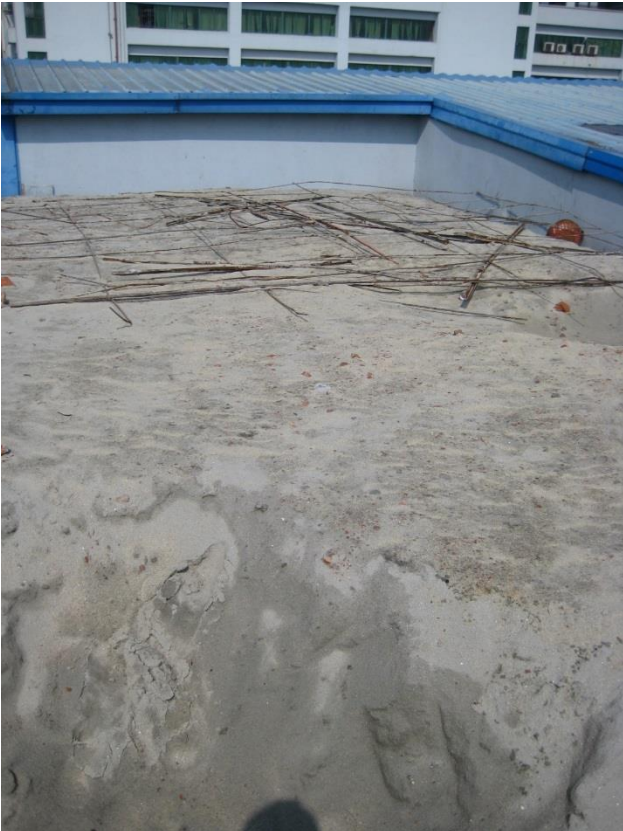
Sand on roof over east stair

Heavy Loading on roof

- There is a layer of sand approx. 400mm thick over the west stair.
- There are 6 no. 1000 litre water tanks on the roof over the east stair.
- Building engineer to check structure for load from water tanks and sand, and remove if required.

Item No.	Observation	Recommended Action Plan	Recommended Timeline
10	Heavy Loading on Roofs over east and west stairs	As part of the Detail Engineering Assessment (see Item 1), Building Engineer to check the capacity of the structure to carry the load from the water tanks and the sand.	6-weeks
11	Heavy Loading on Roofs over east and west stairs	Remove water tanks and/or sand from roof, as required.	6-weeks
12	Heavy Loading on Roofs over east and west stairs	Carry out any remedial structural works as required after assessment.	6-months
13	Beam and slab cracking at all floors	Sections of plaster finish to beams and slab to be removed to investigate if cracks penetrate the building structure.	6-weeks
14	Beam and slab cracking at all floors	As part of the Detail Engineering Assessment (see Item 1), Building Engineer to carry out design check on beams and slab taking into account the effect of the cracks on the structure	6-weeks

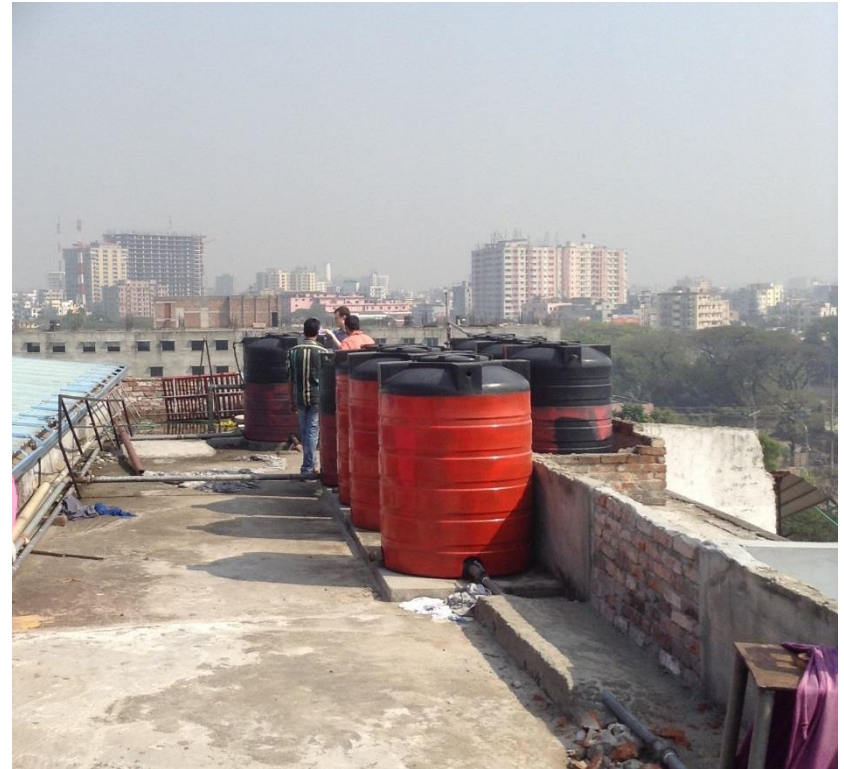
Water tanks on roof over west stair

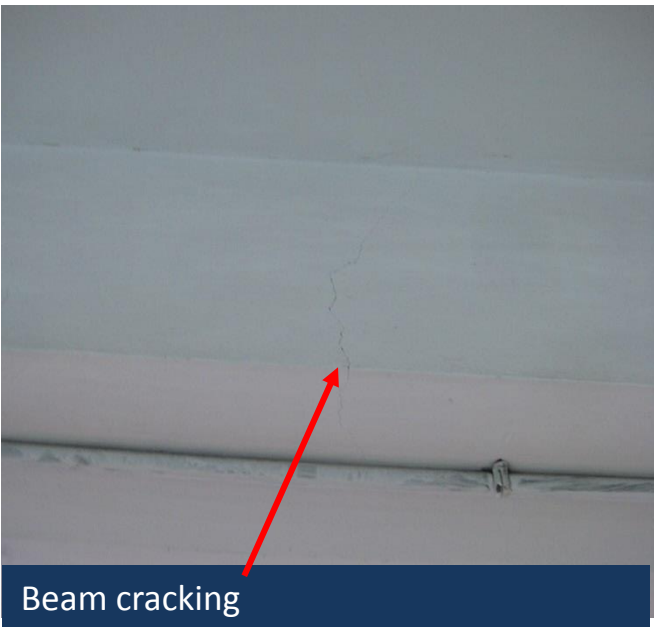
Beam cracking

Beam and slab cracking

- Cracking to underside of beam noted on all floors.
- Some cracks continue up the side of the beam and into the slab.
- Some cracks have been filled and painted.
- Building Engineer to investigate cracks and determine if they are structurally significant.

15	Beam and slab cracking at all floors	Carry out any structural remedial works to cracks as required following assessment.	6-months

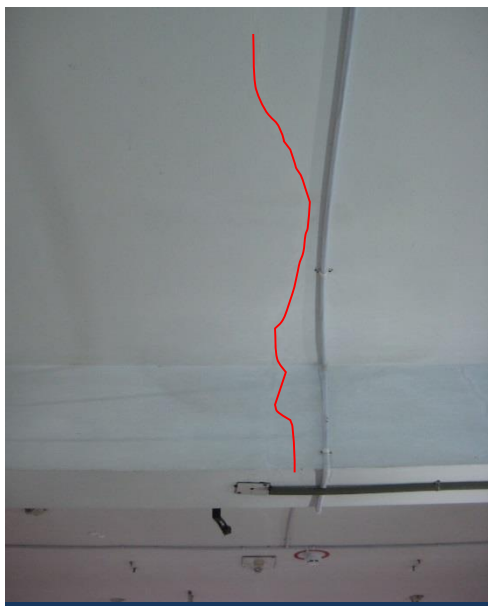
Crack continues up side of beam and into slab

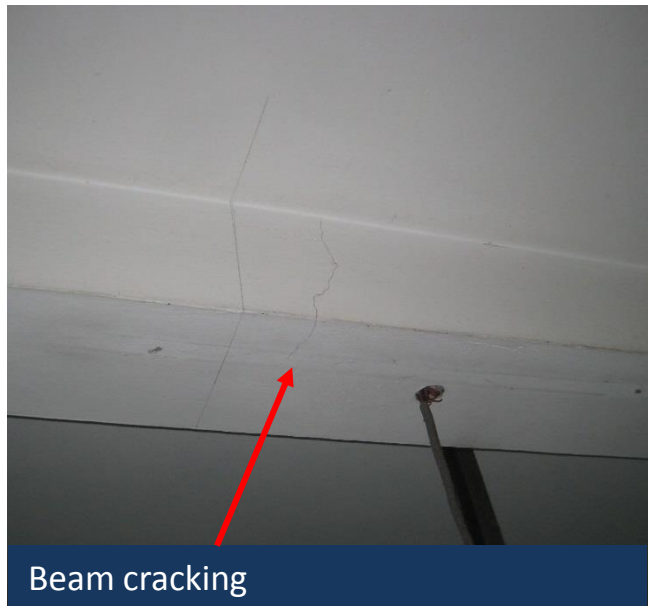
Beam cracking

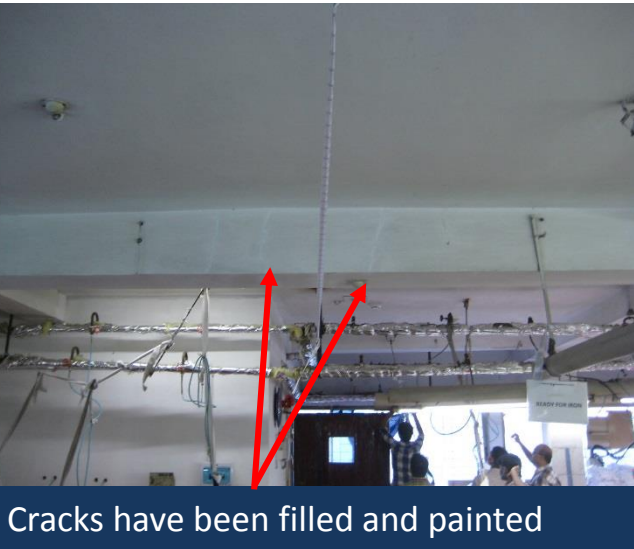
Cracks have been filled and painted

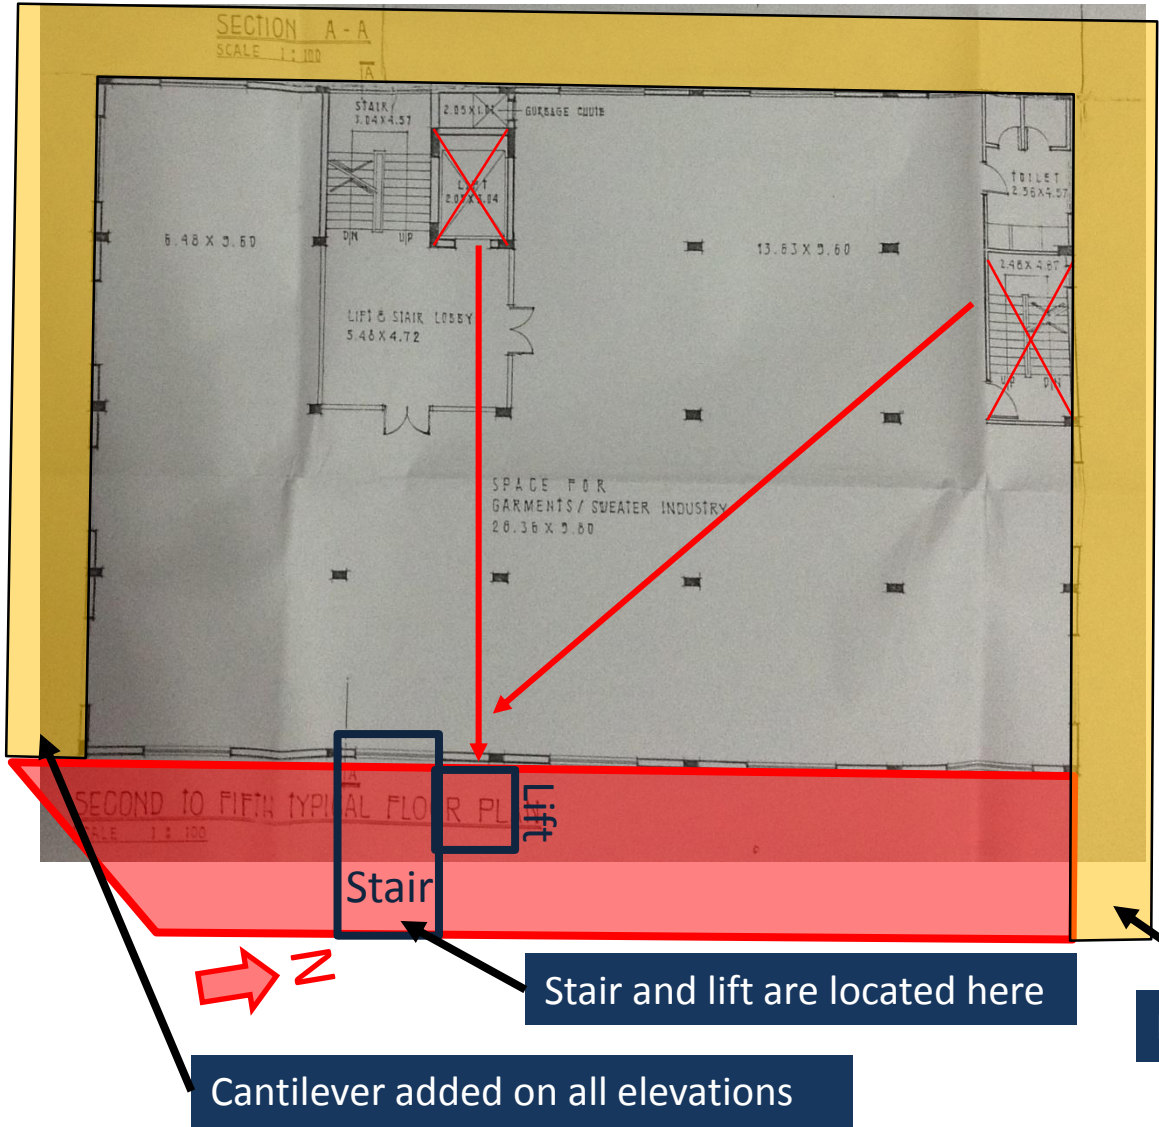
Drawings not consistent with as-built structure

Inconsistencies with Permit Drawings

- Cantilevers have been added on all elevations.
- Building has been extended to the east.
- Grid dimensions do not match.
- Stair & lift in different location.
- Roof is now a production floor.
- Toilets cover much larger area.

Cantilever added on all elevations

Stair and lift are located here

Building has been extended to east

As-built structure should be checked as part of the ongoing Detail Engineering Assessment.

Item No.	Observation	Recommended Action Plan	Recommended Timeline
16	Drawings not consistent with as-built structure	As part of the Detail Engineering Assessment (see Item 1), Building Engineer to survey as-constructed building, noting where discrepancies exist between drawings and actual layout.	6-weeks
17	Drawings not consistent with as-built structure	Structure (including foundations) to be checked based on the as-constructed layout, taking into account actual loads, material strengths, geometry and the use of the 6th floor as a factory floor.	6-weeks
18	Drawings not consistent with as-built structure	Updated drawings to be prepared which accurately represent the as-constructed layout.	6-months
19	Column in Delivery Area vulnerable to impact from vehicles	As part of the Detail Engineering Assessment, Building Engineer to review column design and the potential for vehicle impact to columns in delivery area.	6-weeks

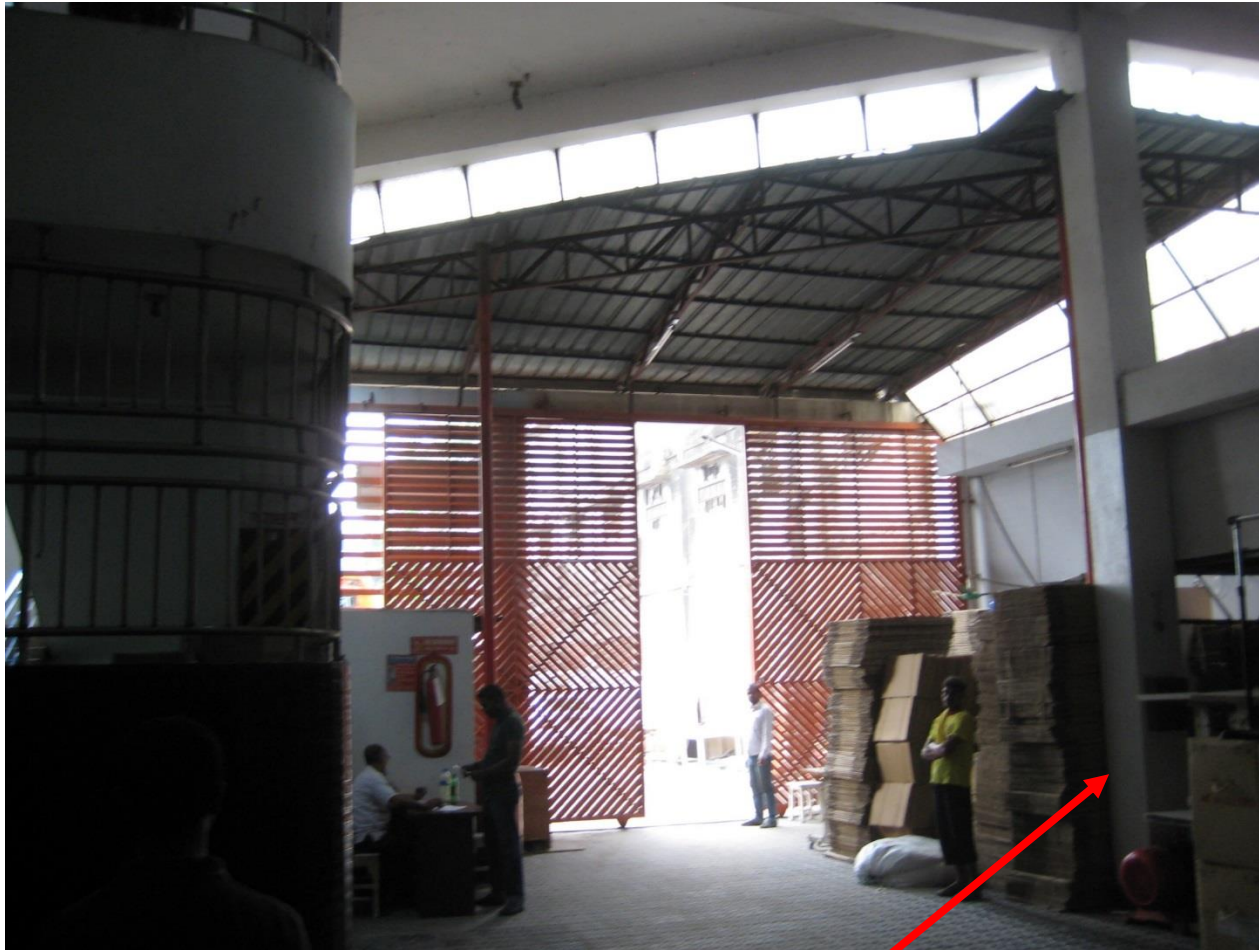
Column in Delivery Area vulnerable to impact from vehicles

Vulnerable Column

- Column in the delivery area in the south east corner of the building is susceptible to impact loading from vehicles.
- Building engineer to check column for vehicle impact loading, and provide protection to column as required.

20	Column in Delivery Area vulnerable to impact from vehicles	Provide impact protection to column if required.	6-months
