# Nafisa Apparels Ltd.

7<sup>th</sup> March 2015

# Building Observations

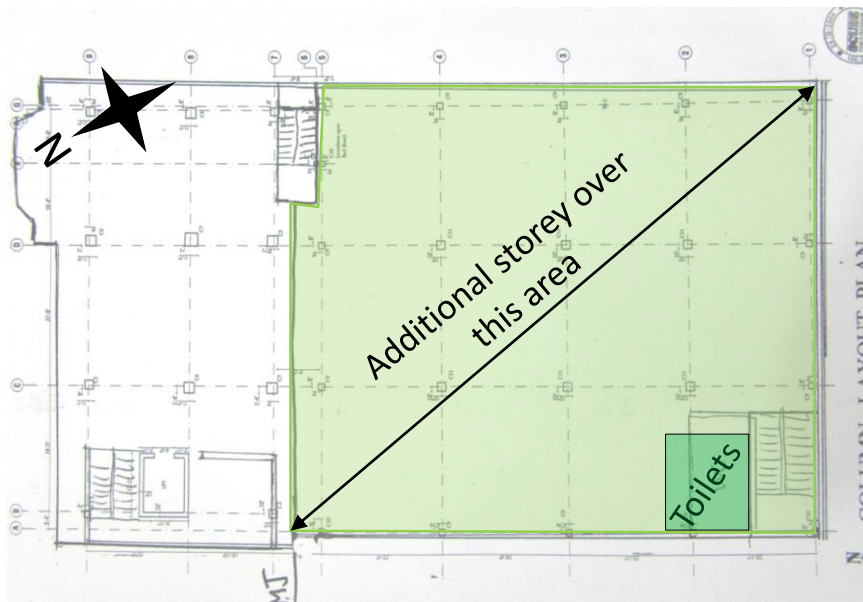
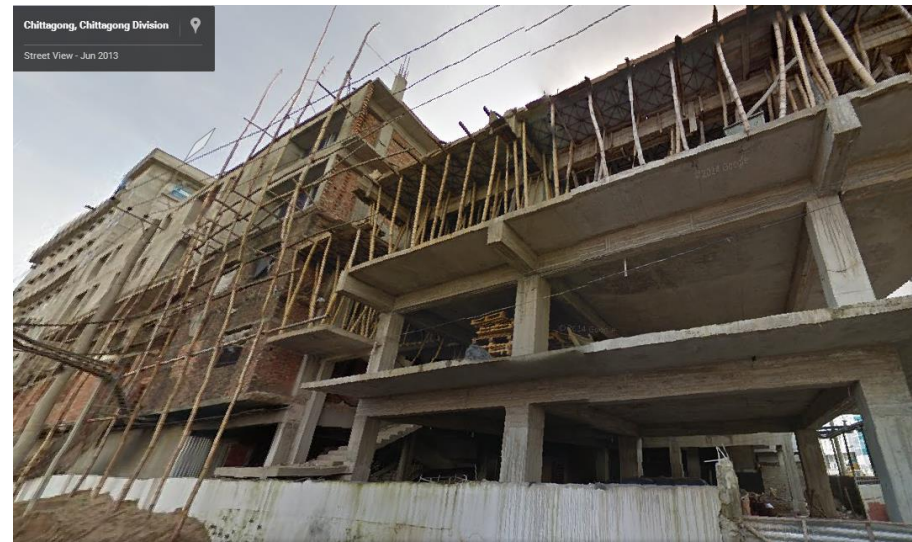
# Highly-stressed columns (Original building)

Columns at ground floor level appear to be stressed in excess of normal design limits

| Item No. | Observation | Recommended Action Plan | Recommended Timeline |
|---|---|---|---|
| 1 | Highly-stressed columns (Original building) | Factory Engineer to review design, loads and columns stresses in area identified above. | 6-weeks |
| 2 | Highly-stressed columns (Original building) | Verify in-situ concrete strength by 100mm dia. cores from min. 4 no. ground floor columns in this area. | 6-weeks |
| 3 | Highly-stressed columns (Original building) | Factory engineer to confirm number and diameter of bars in the columns at ground floor, as the reinforcement drawings did not always match the scanned reinforcement or the structural drawing. | 6-weeks |
| 4 | Highly-stressed columns (Original building) | Produce and actively manage a loading plan for all floor plates within the factory giving consideration to floor capacity and column capacity. | 6-months |

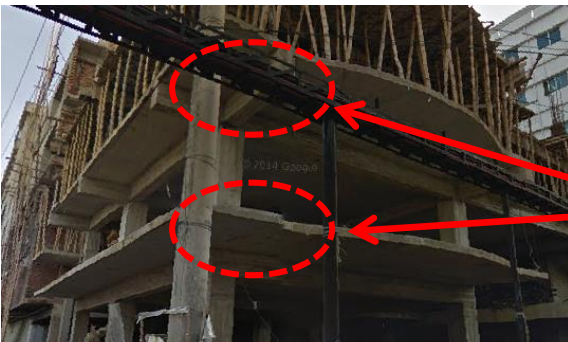
Construction photo of front cantilever (Google)

No Cantilever beam at any level

No Cantilever beam at 1st floor level, all other floors have cantilever beams.

| Item No. | Observation | Recommended Action Plan | Recommended Timeline |
|---|---|---|---|
| 5 | No beams in 1st floor cantilever (Extension) | Factory engineer to carry out design check of cantilever slab at 1st floor level. | 6-months |
| 6 | No beams in 1st floor cantilever (Extension) | Any strengthening works arising from design check to be implemented. | 6-months |

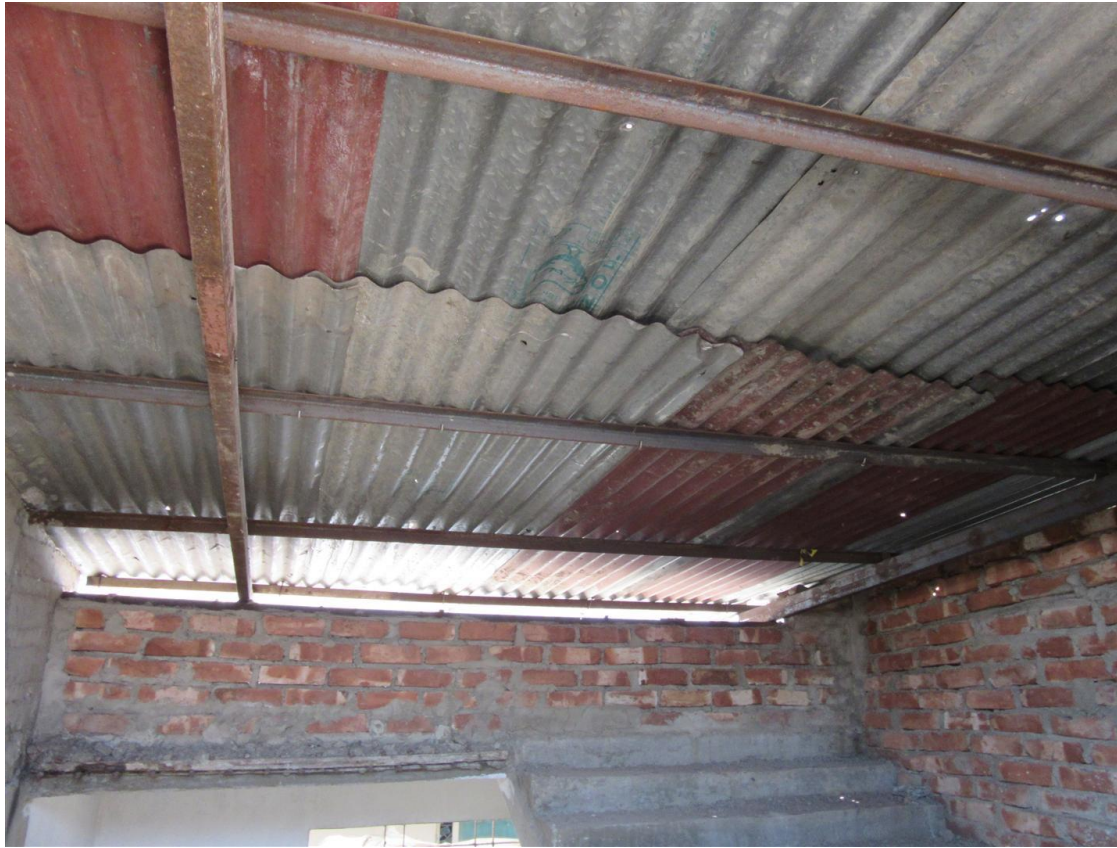
# Non-engineered roof structure

- Non-engineered roof structure without bracing system.
- Roof structures susceptible to uplift in high winds.
- Factory Engineer to assess tying connection to brick walls.

| Item No. | Observation | Recommended Action Plan | Recommended Timeline |
|---|---|---|---|
| 7 | Non-engineered steel roof structure (Extension) | Factory Engineer to perform design check for lightweight steel roofs, including lateral stability and uplift in high winds. | 6-months |
| 8 | Non-engineered steel roof structure (Extension) | Carry out any works arising from design check. | 6-months |
