# **FIRE SAFETY INSPECTION REPORT**

## **CHERRY INTIMATE LTD**

**PLOT#105, DHAKA EXPORT PROCESSING ZONE,  
ASHULIA, SAVAR DHAKA**

May 8, 2014

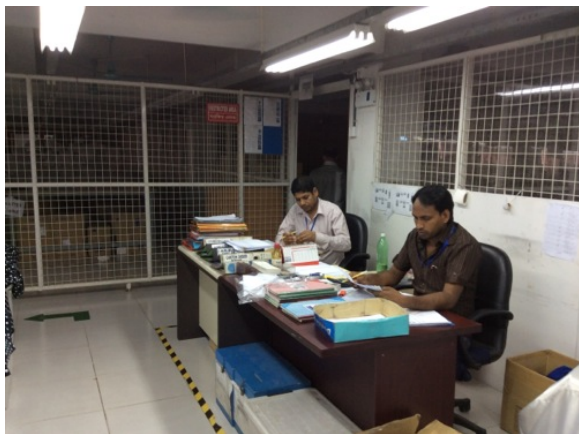
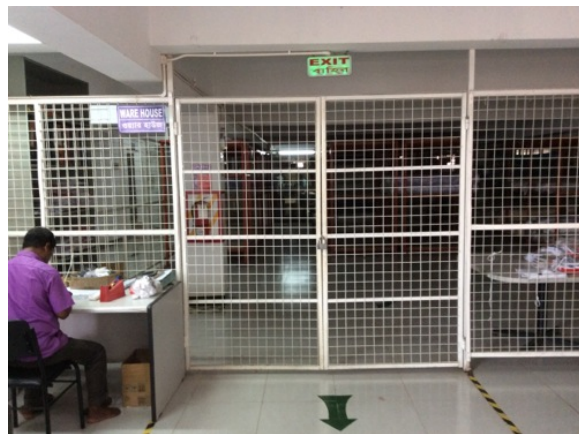
| No. | Category | Finding | Recommendation | Remediation Timeframe |
|---|---|---|---|---|
| F-1 | Fire Rated Construction | Areas used for combustible storage are not separated by fire-rated construction on the ground floor. | Provide dedicated storage rooms separated by minimum 1-hr fire-rated construction. | Within 3 months |

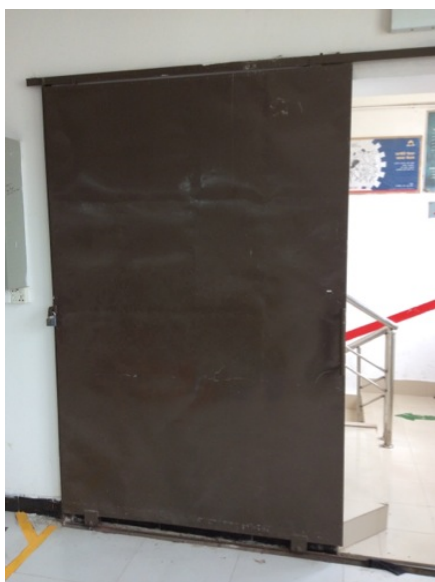
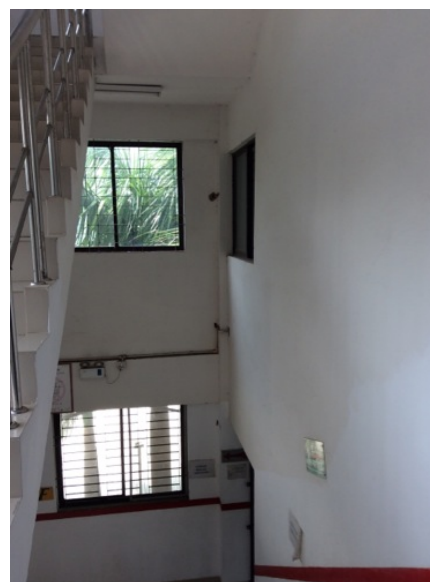
| F-2 | Fire Rated Construction | The exit stairs are not separated from work areas on each floor by fire-rated construction in every exit stair. | Provide minimum 1.5-hr fire rated doors and seal all unprotected openings to separate the exit stairs from work areas and other building spaces on all floor levels. Ensure that the fire doors are self-closing and positive latching and that they are provided with fire exit (panic) hardware where serving production floors.<br><br>If fire doors are required to be held open for functional reasons, provide automatic-closing devices tied to the fire alarm system. | Within 3 months |

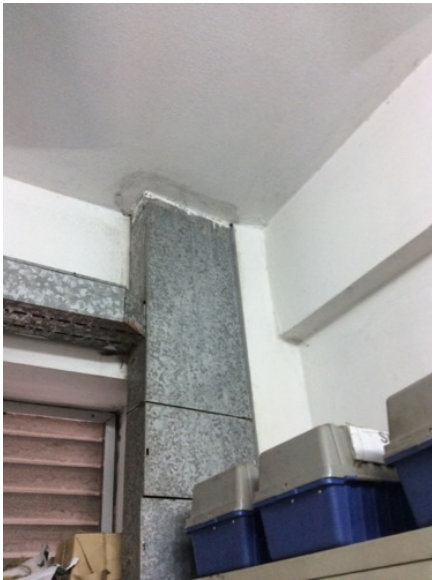
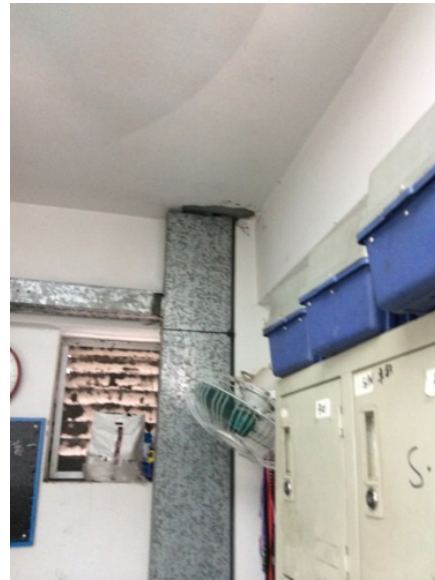
| F-3 | Fire Rated Construction | Unsealed penetrations and openings are located in the fire-rated floor/ceiling assemblies through 1st to 3rd floor. | Provide a minimum 2-hr fire-rated shaft to separate the utility risers from each floor level. | Within 3 months |

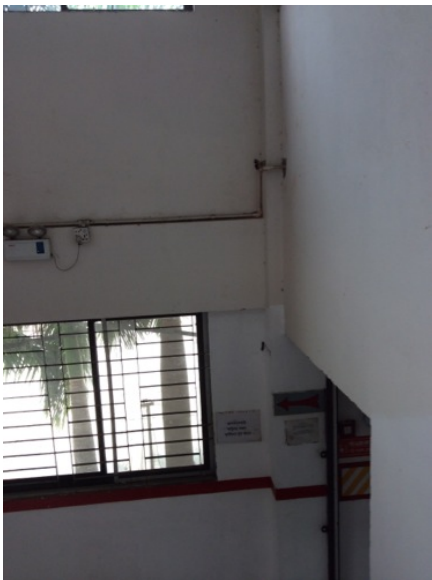
| F-4 | Fire Rated Construction | Unsealed penetrations and openings are located in exit stair enclosures on 2nd floor. | Seal all penetrations and openings in exit stair enclosure walls to maintain the fire separation. | Within 3 months |

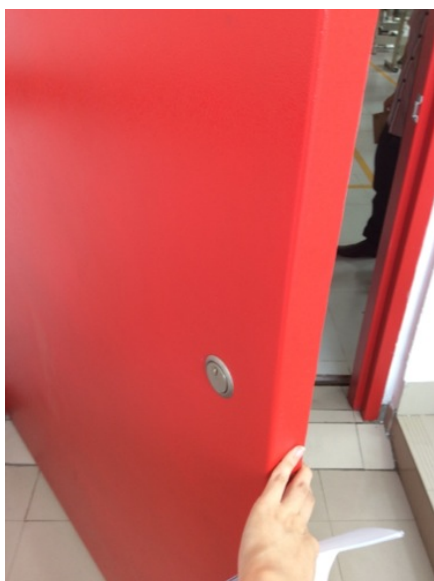
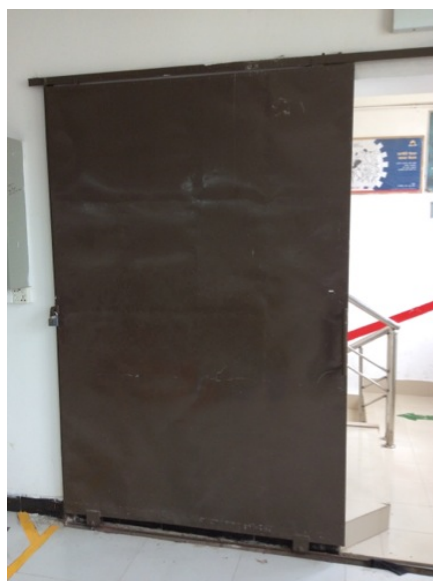
| F-6 | Egress | Egress doors with locking features are provided at building exits, exit stairs and exit discharge on every floor. | <p>Remove locking features from all egress doors / gates.</p> <p>If locks are required for security reasons, utilize special door locking features complying with NFPA 101.</p> | Immediate | |

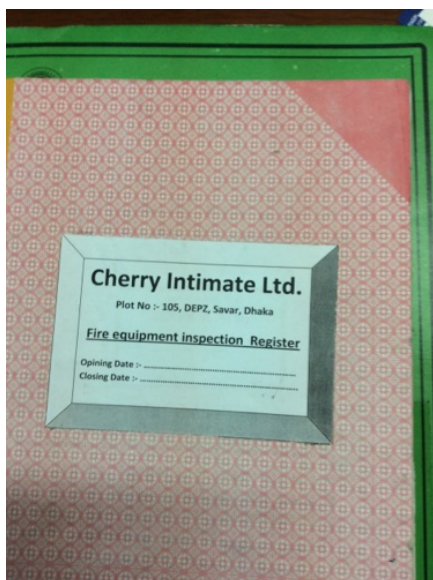
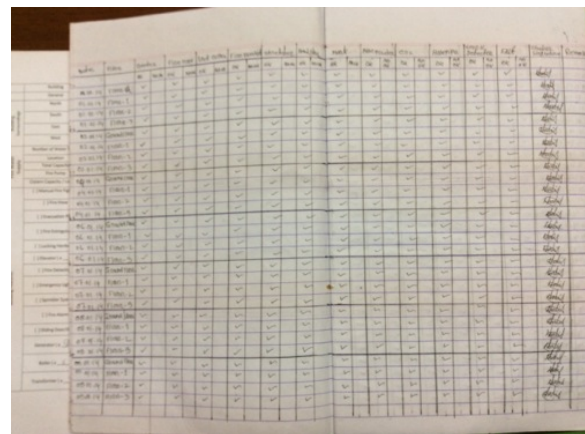
| F-10 | Egress Lighting | Inspection, testing, and maintenance records for the emergency lighting system were not in accordance with ACCORD standard | Inspect, test and maintain the emergency lighting system in accordance with The ACCORD standard. Keep written records on-site. | Within 3 months |
