# Cotton Clothes (BD) Ltd.

Kazi Tower, 27 Road, Gazipura, Tongi, Gazipur  
(23.920254, 90.388785)

8<sup>th</sup> March 2015

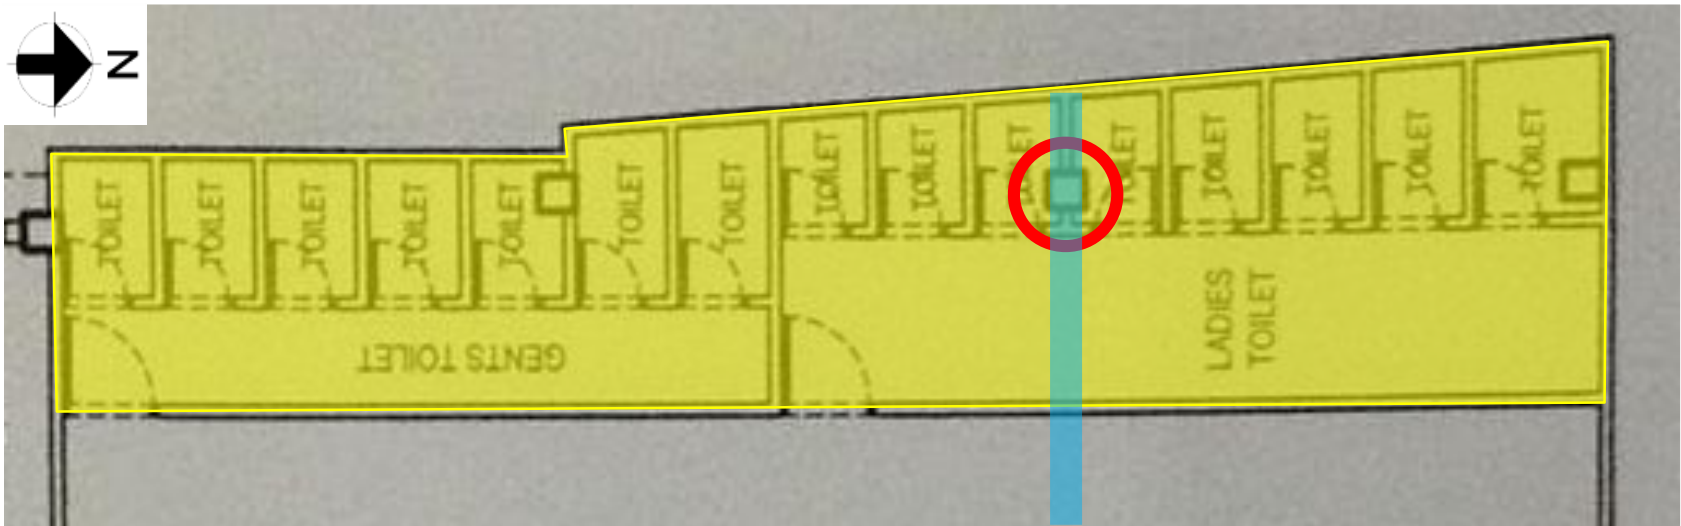
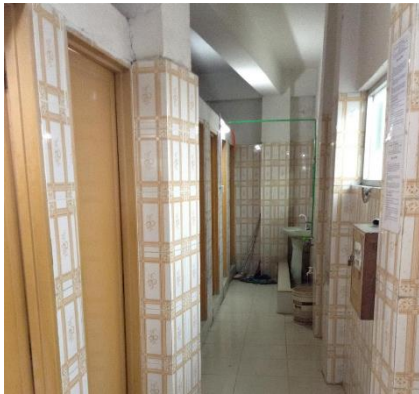
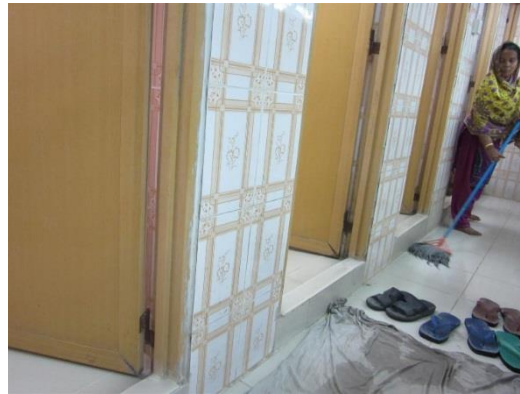
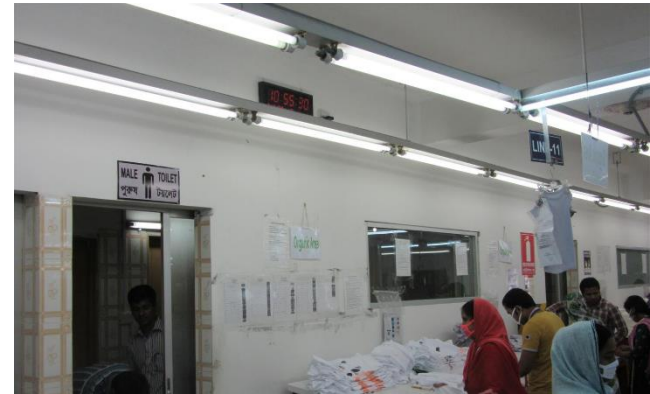
**Column in toilet area  
appears overstressed**

Initial calculations indicate that the highlighted column appears to be highly stressed due to façade cantilever and heavy toilet build-up (floor, walls, overhead slab).

Item No.	Observation	Recommended Action Plan	Recommended Timeline
1	Toilet column appears overstressed	Building engineer to review design, loads and column stresses in area identified above.	6-weeks
2	Toilet column appears overstressed	Verify in-situ concrete strength either by taking 100mm dia. cores from 4 columns at Ground Floor or by using existing cylinder strength data for the ground floor columns if available.	6-weeks
3	Toilet column appears overstressed	Produce and actively manage a loading plan for all floor plates within the factory giving consideration to floor capacity and column capacity.	6-months
4	Toilet column appears overstressed	Any remedial measures recommended by building engineer to be implemented.	6-months
5	Mid-span crack in slab above loading bay (missing beams)	Building engineer to review design, loads and slab stresses in area identified above.	6-weeks
6	Mid-span crack in slab above loading bay (missing beams)	Avoid increasing live loads in the rooms immediately above the affected slabs pending engineering review (i.e. do not use for storage)	6-weeks

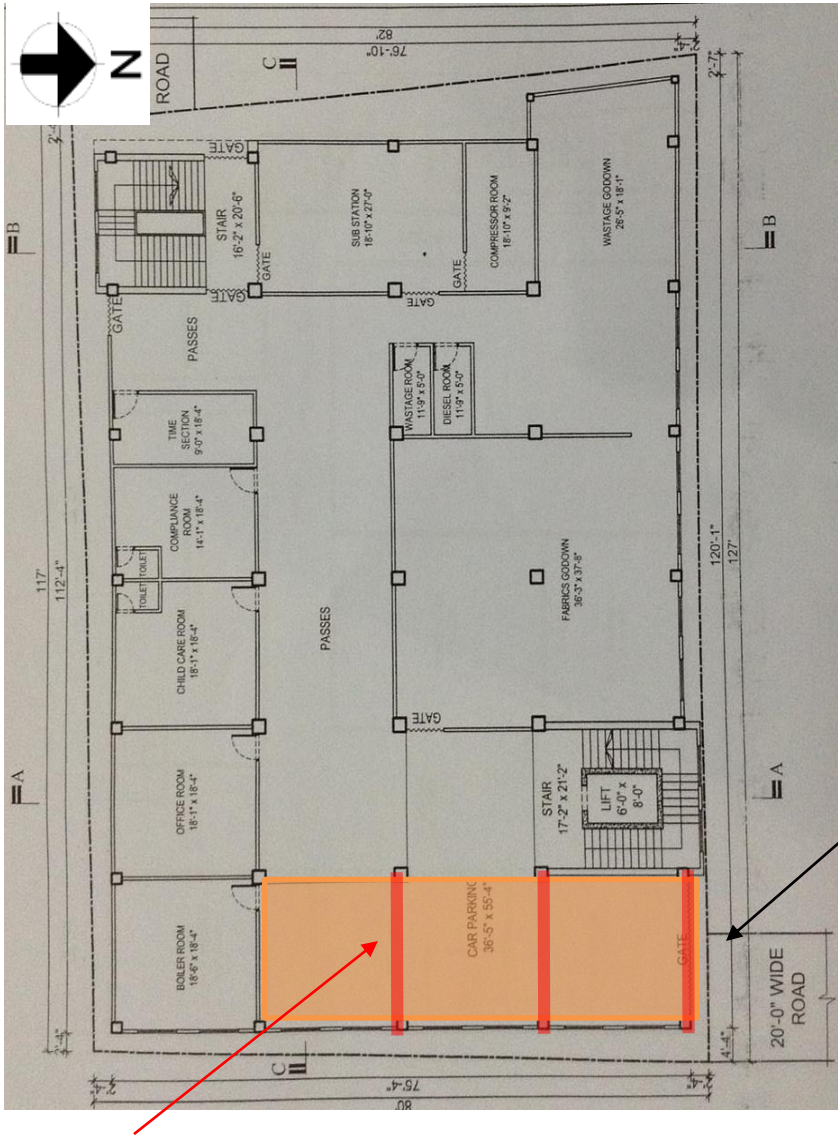
# Mid-span crack in slab above loading bay (missing beams)

Crack in mid-span of slab; appears to be due to deflection/bending in slab

7	Mid-span crack in slab above loading bay (missing beams)	Produce and actively manage a loading plan for all floor plates within the factory giving consideration to floor capacity and column capacity.	6-months
8	Mid-span crack in slab above loading bay (missing beams)	Any remedial measures recommended by building engineer to be implemented.	6-months

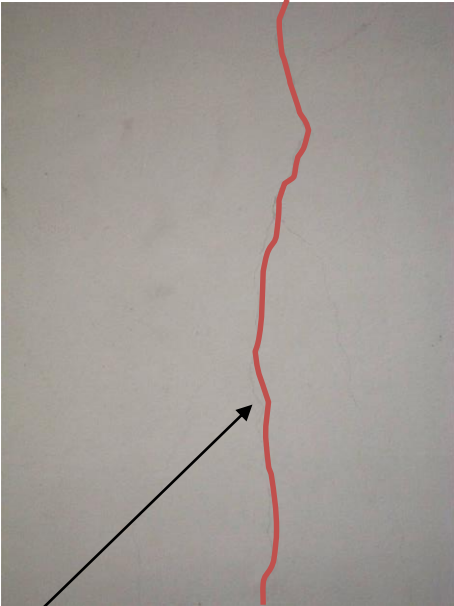
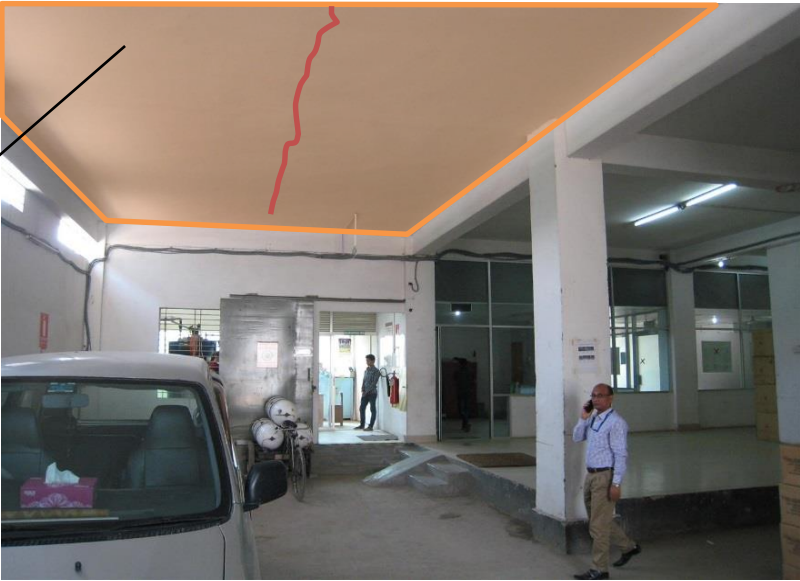
Missing beam in 1<sup>st</sup> floor slab.

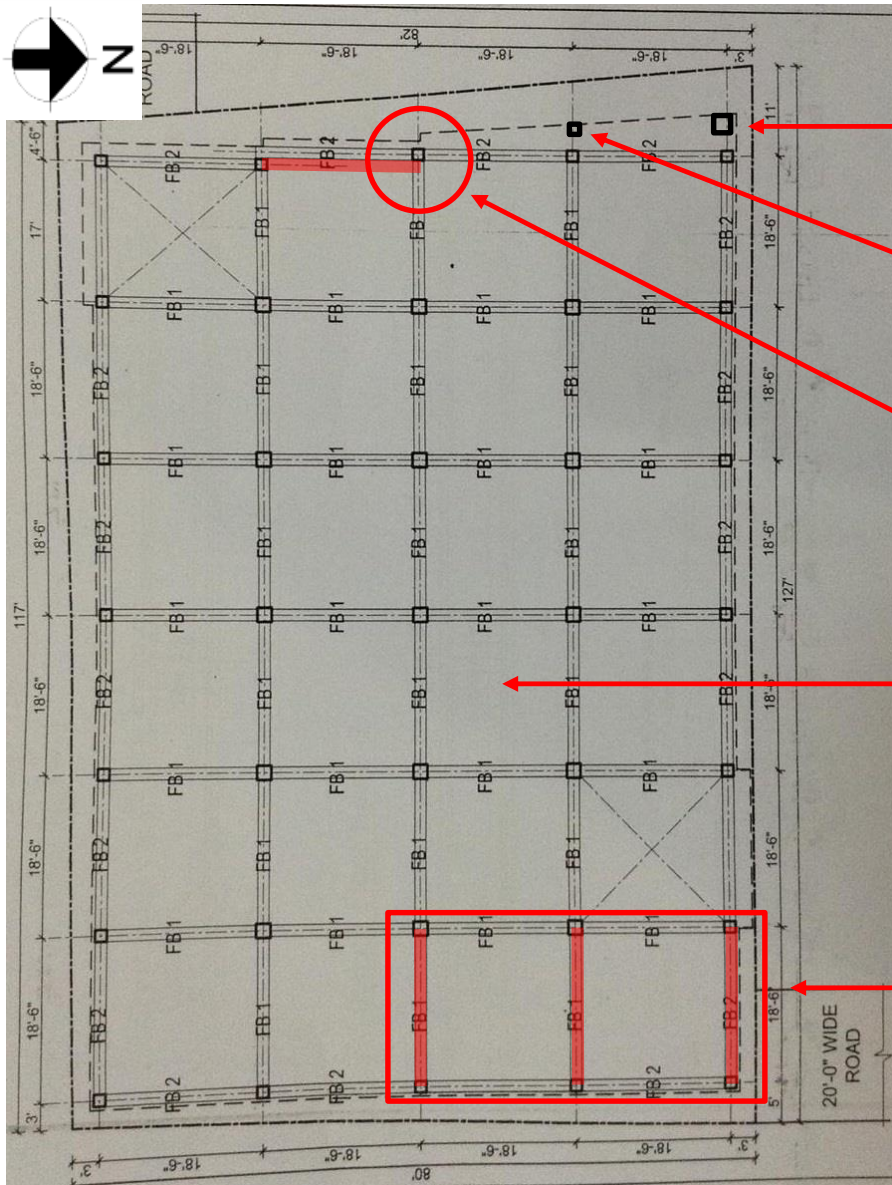
# Discrepancies between drawings and on site observations

- Corner column on each level (confirmed on all floors)
- Perimeter column in cantilever area, but only Ground to 1<sup>st</sup> floor
- As drawn beam framing does not match site observations
- Design drawings show slabs as 150 mm thick but site measurements appear to indicate 120 to 135 mm thick.
- Missing beams in 1<sup>st</sup> floor slab above ground floor parking area

Item No.	Observation	Recommended Action Plan	Recommended Timeline
9	Discrepancies between drawings and on-site observations	Update as-built drawings.	6-months
10	Cracking in slabs and beams	Verify slab thickness in the middle of at least one bay at each level, e.g. by drilling a small hole through slab.	6-months
11	Cracking in slabs and beams	Building engineer to review design, loads and slab stresses.	6-months
12	Cracking in slabs and beams	Conduct regular inspection of cracks.	6-months
13	Settlement induced cracks in brickwork façade	Conduct regular inspection of cracks.	6-months
14	Settlement induced cracks in brickwork façade	If cracks grow larger engage an engineer to investigate cause and determine if structural remedial works are necessary.	6-months
15	Lightweight roofs with non-engineered connections	Building engineer to check the structures with particular reference to wind uplift and connection / anchorage details and make recommendations.	6-months

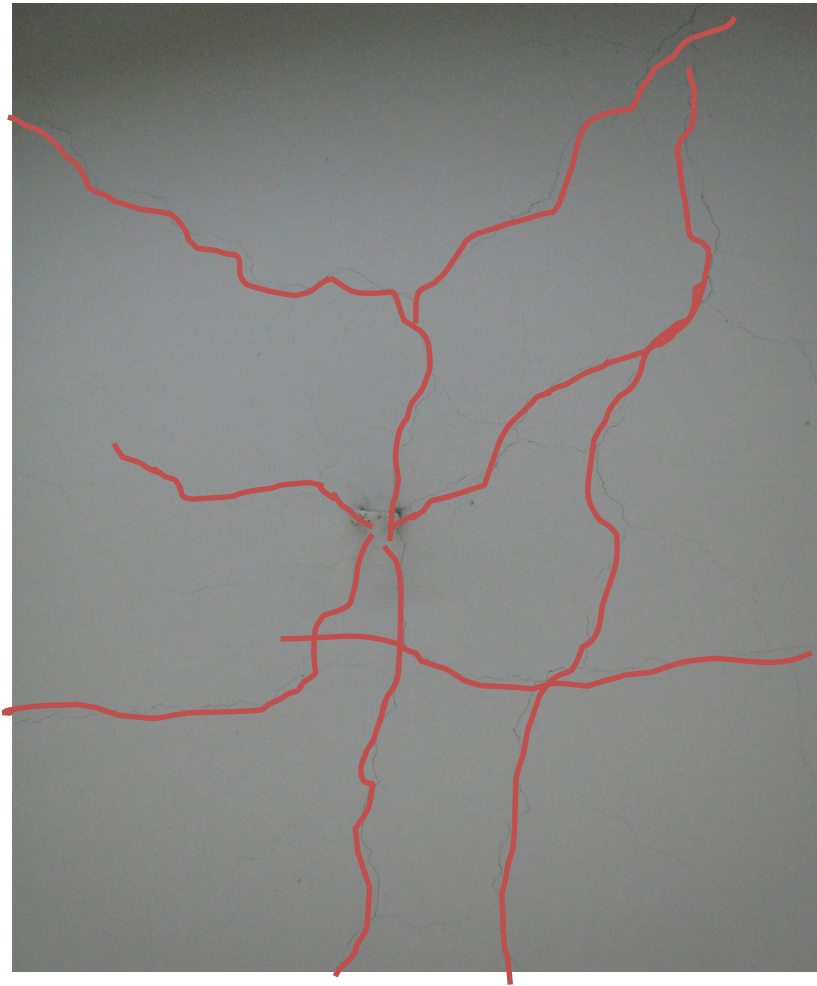
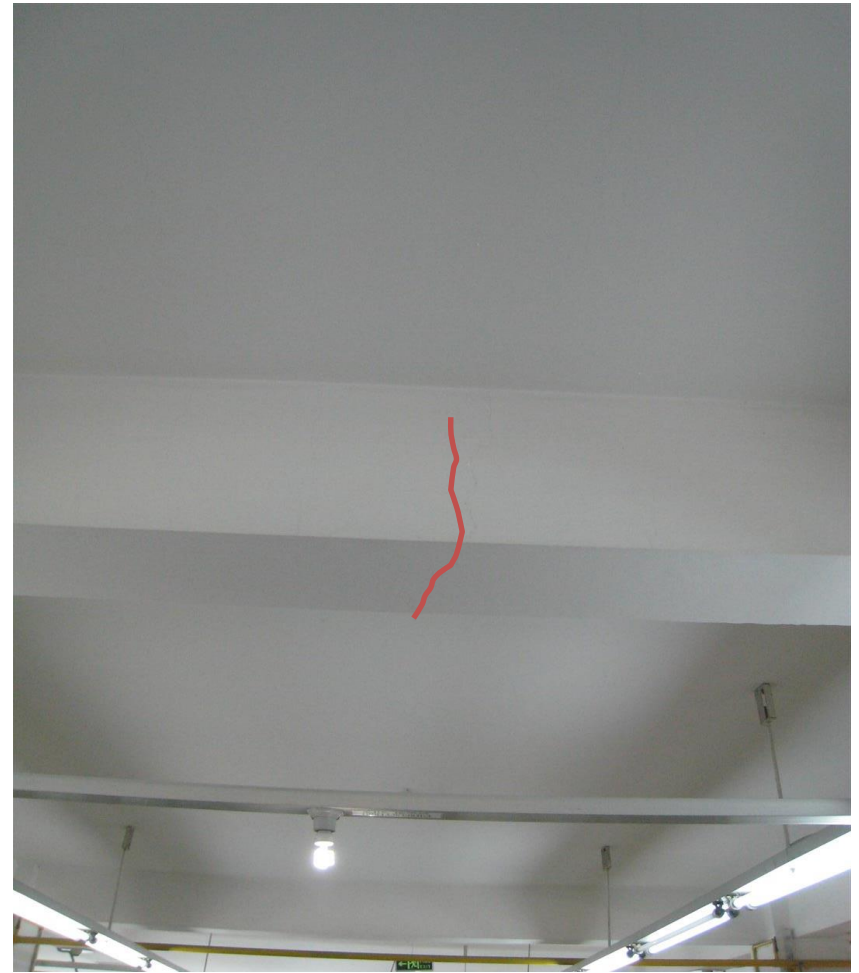
# Cracking in Slabs and Beams

Cracks in slabs and beams on all floors but most prevalent on 3<sup>rd</sup>, 4<sup>th</sup> and 5<sup>th</sup> floor (roof). Appears to be due to deflection/bending - example illustrated with crack patterns on 5<sup>th</sup> floor.

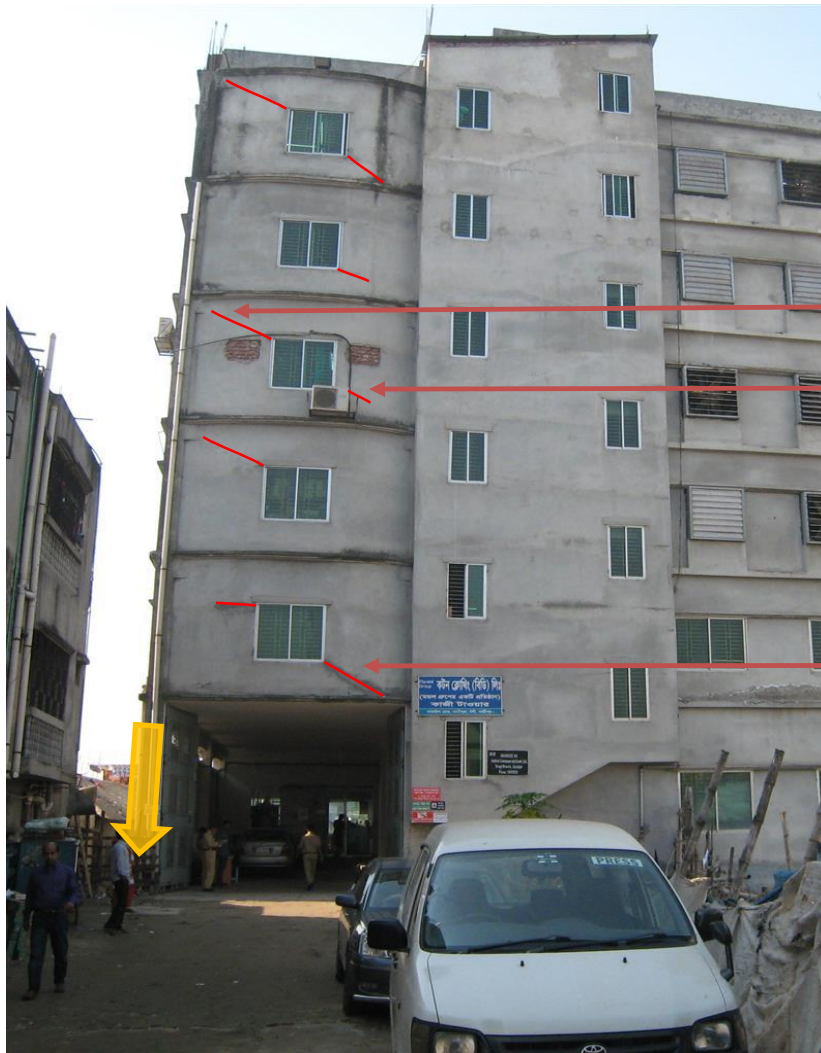
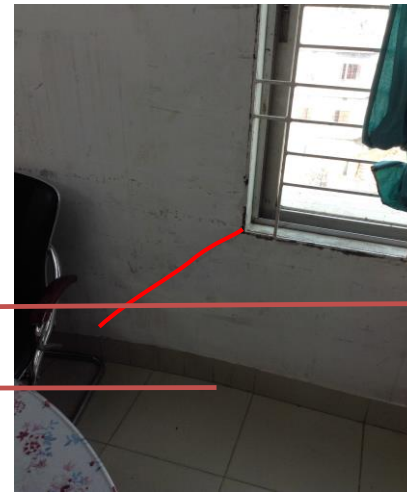
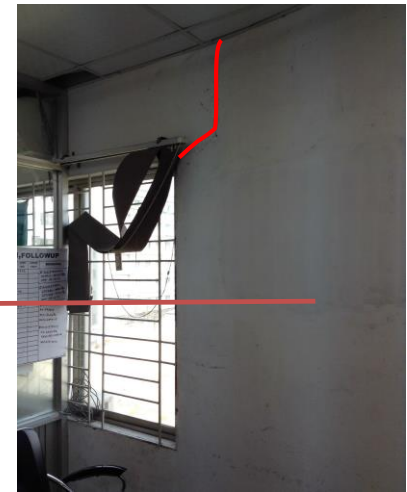
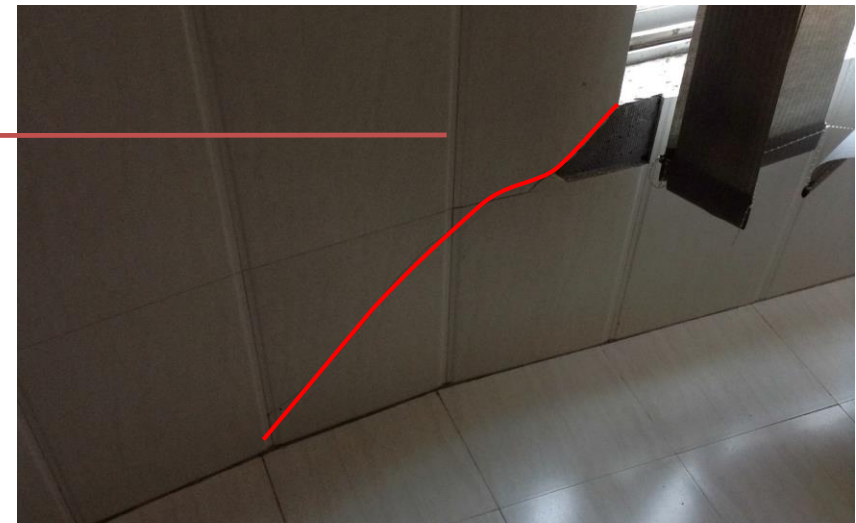
**Cracks in masonry facade,  
possibly settlement induced**

Cracks in façade brick work at North Elevation possibly due to settlement of perimeter column (similar orientation of cracks on several panels)

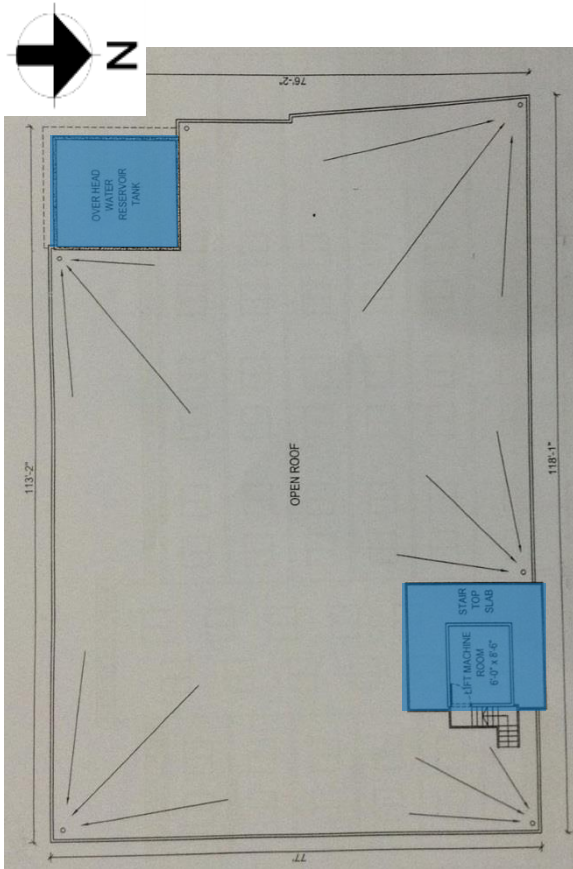
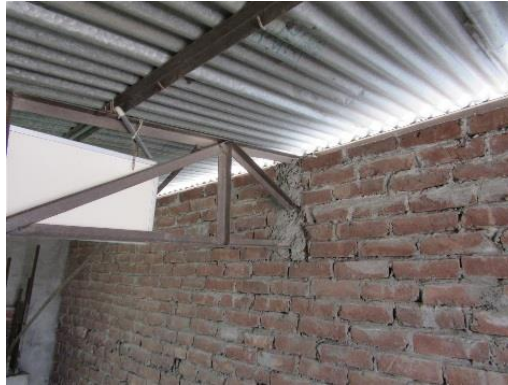
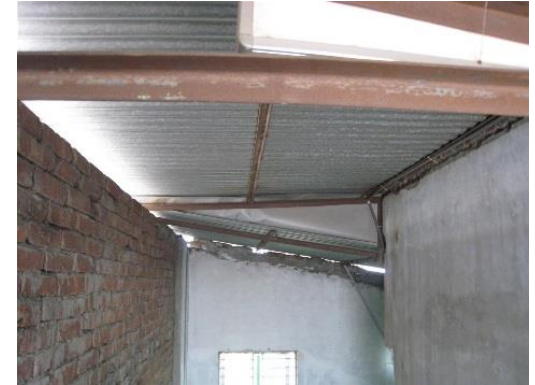
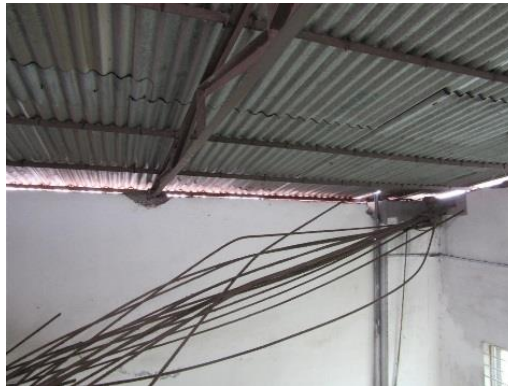
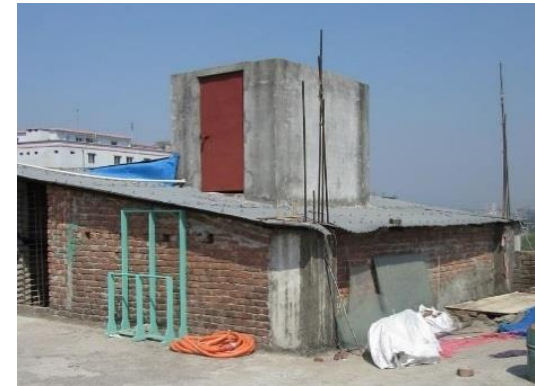
# Lightweight roofs with non-engineered connections

Lightweight roofs appear susceptible to wind uplift, particularly edge overhangs. Some of the details appear non-engineered.

16	Lightweight roofs with non-engineered connections	Implement recommendations of building engineer.	6-months
17	Restraint to brickwork façade at south west core	Building engineer to check restraint to brickwork façade and make recommendations.	6-months
18	Restraint to brickwork façade at south west core	Implement recommendations of building engineer.	6-months

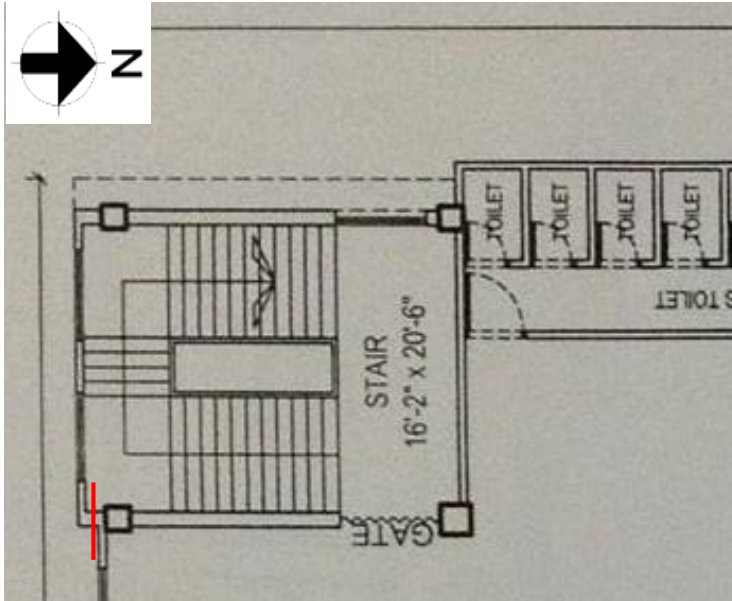
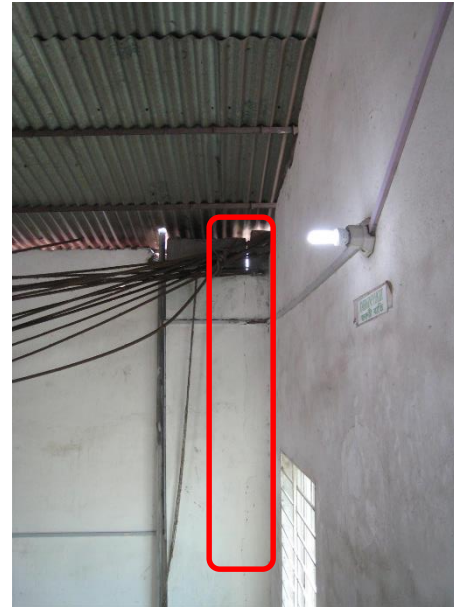
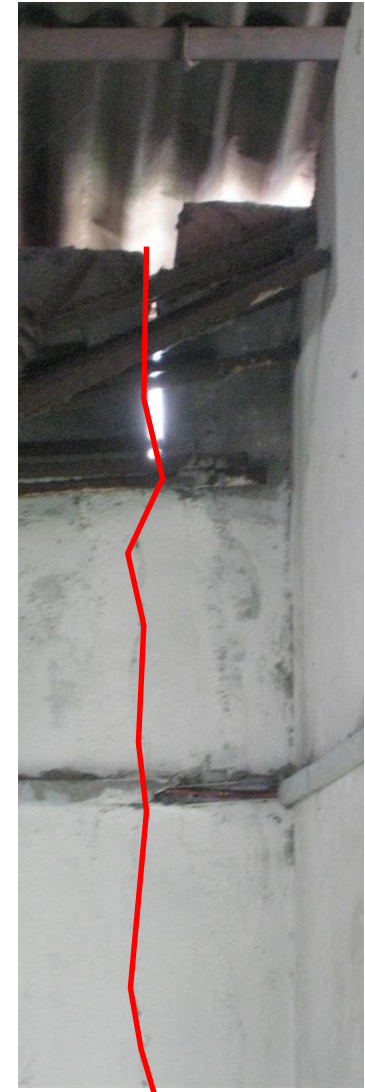
# Restraint to brickwork façade at south west core

Façade brickwork at south west stair core appears unrestrained to RC column. Risk of falling brickwork in strong winds / if problem worsens.
