# Meghna Knit Composite Meghna Dresses Ltd

Gilarchala, Sreepur, Gazipur, Dhaka  
(+24.1861°N, 90.4254°E)

3 November 2013

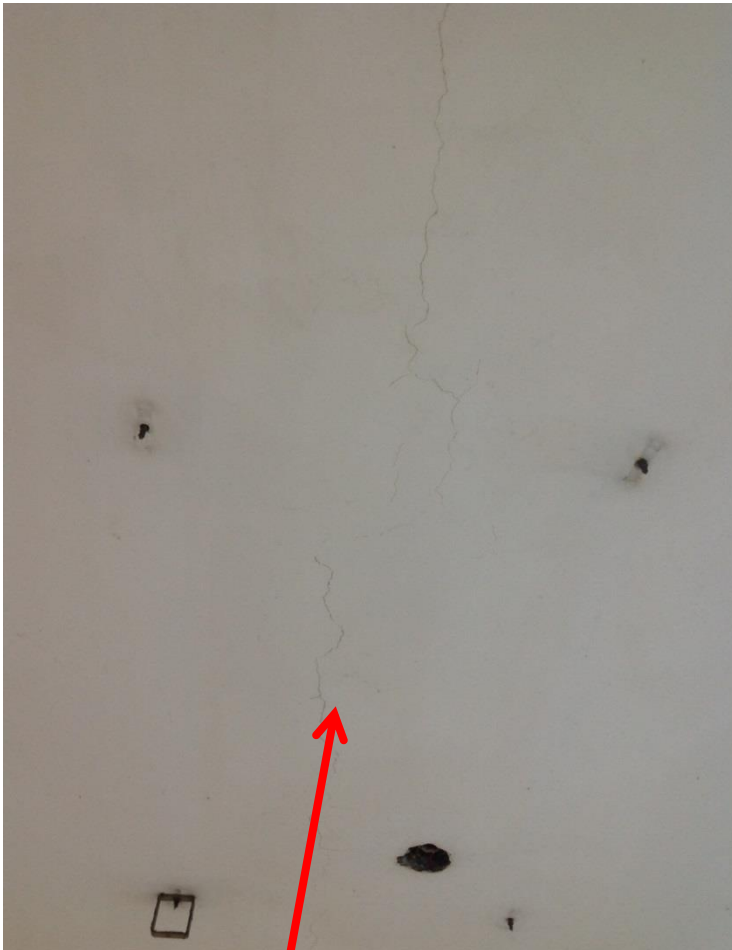
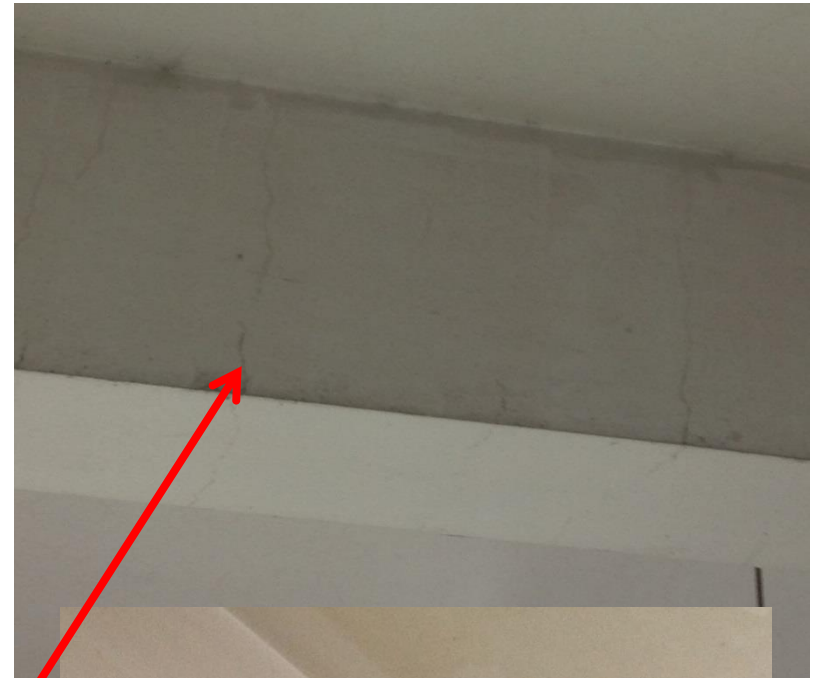
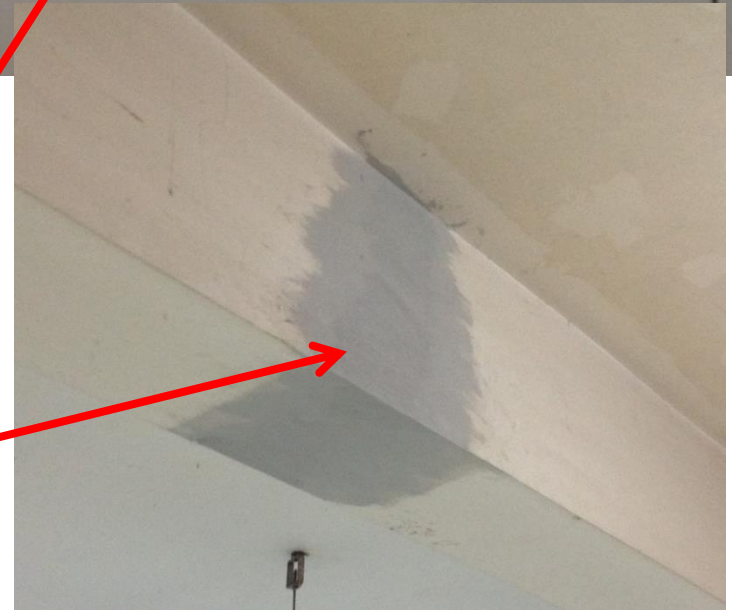
## Beam & Slab Cracks

**Cracking to beams and slab on the soffit of the third floor (investigation required to confirm if cracking is within plaster only)**

| Item No. | Observation | Recommended Action Plan | Recommended Timeline |
|---|---|---|---|
| 5 | Hairline cracks in beams and slab on soffit of 3rd floor | Sections of plaster finish to beams and slab to be removed to investigate if cracks penetrate the building structure. | 6-Weeks |
| 6 | Hairline cracks in beams and slab on soffit of 3rd floor | Building Engineer to carry out design check on beams and slabs to confirm that these cracks are non-structural. | 6-Months |

| Item No. | Observation | Recommended Action Plan | Recommended Timeline |
|---|---|---|---|
| 7 | Hairline cracks in beams and slab on soffit of 3rd floor | Building Engineer to prepare Allowable Floor Loading Plans | 6-Months |

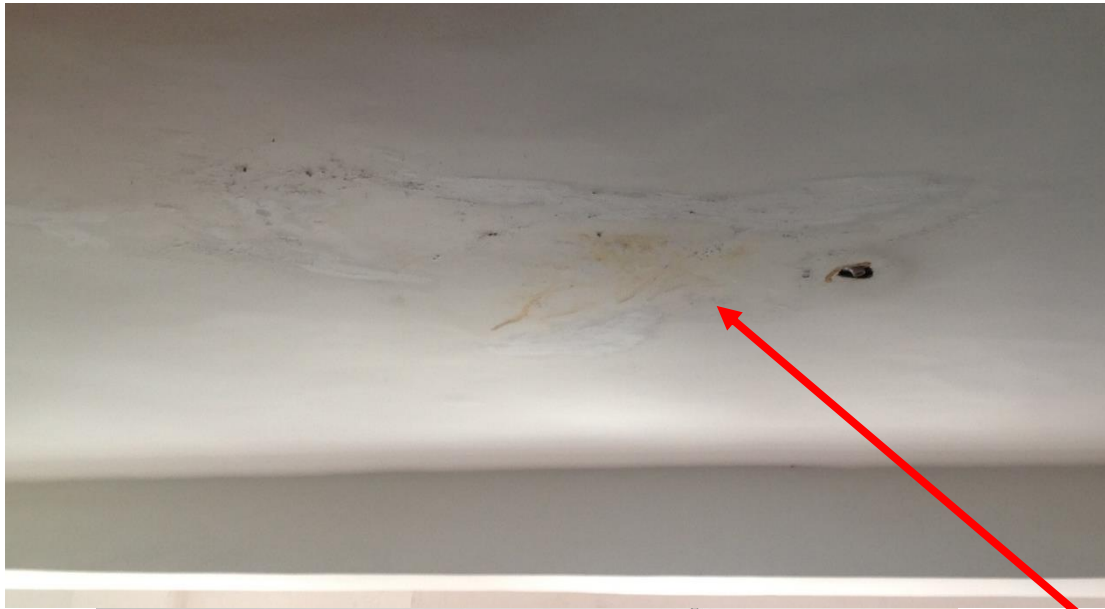
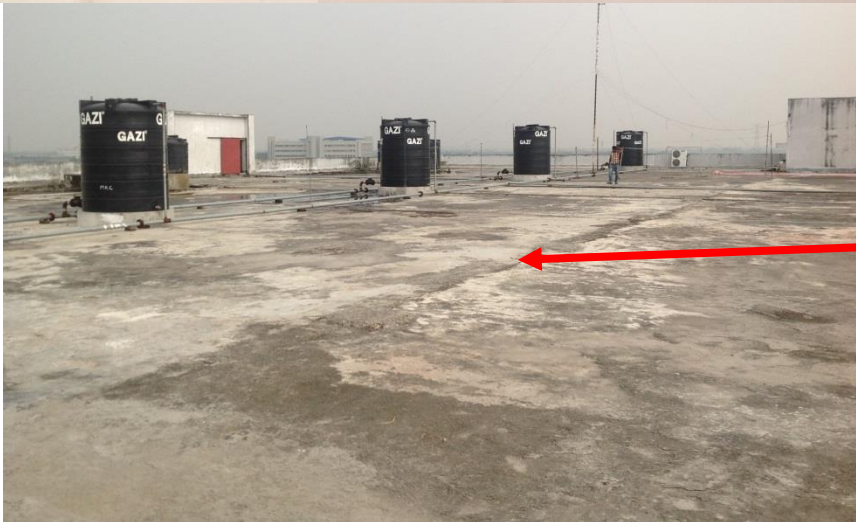
## **Dampness to Building Fabric**

**Water damage to  
underside of roof slab  
with no visible signs of  
cause on roof level**

| Item No. | Observation | Recommended Action Plan | Recommended Timeline |
|---|---|---|---|
| 8 | Localised dampness - water causing damage. | Building Engineer to inspect water damaged structure including the exterior and propose a suitable repair. | 6-Months |

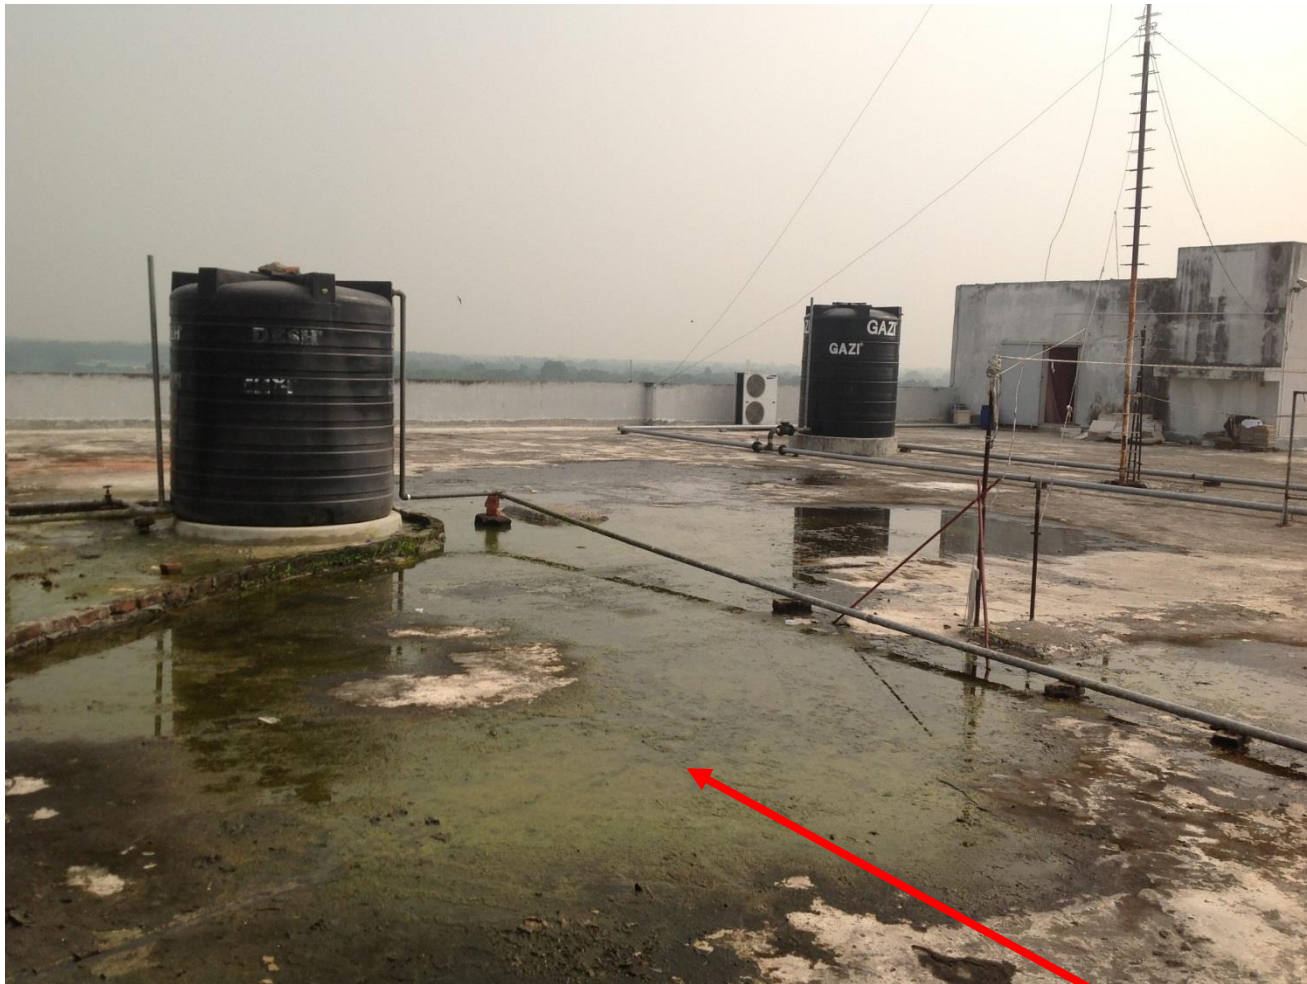
**Dampness to Building Fabric**

**Ponding of water on roof  
in localised areas**

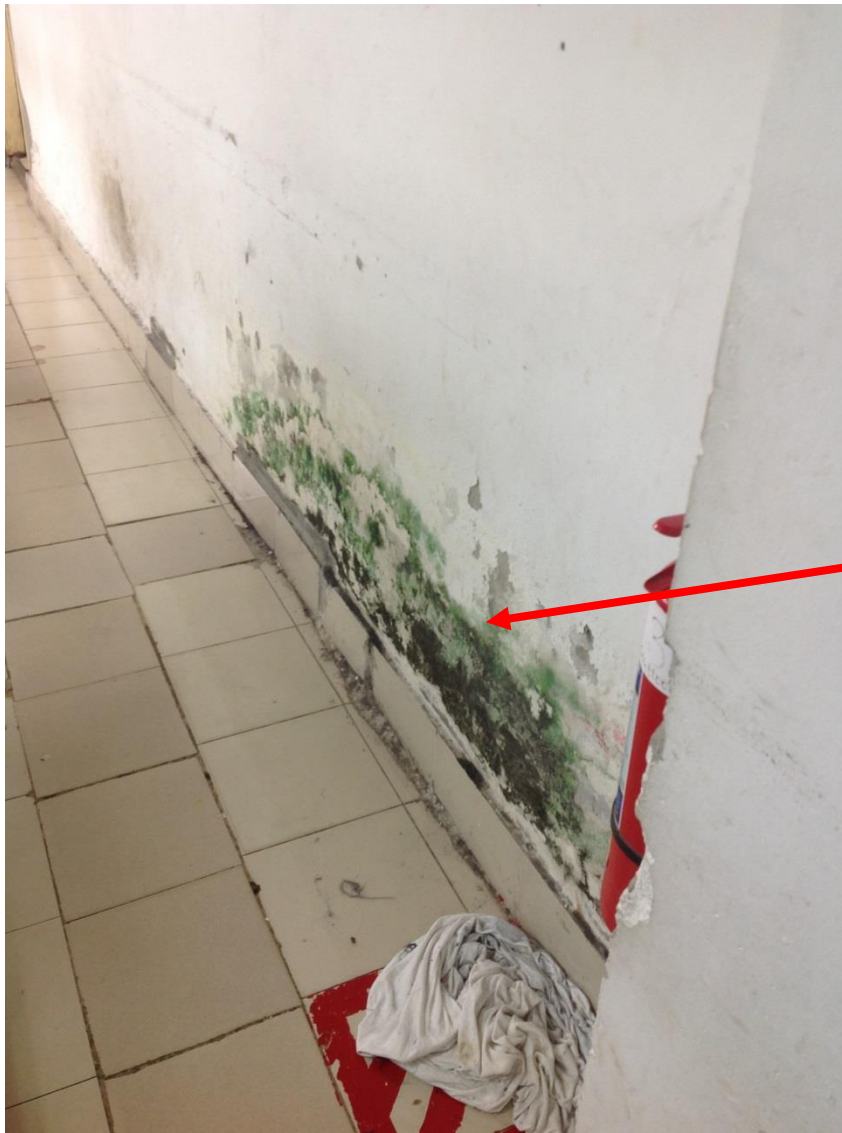
**Dampness to Building Fabric**

Water damage to wall  
behind WC and shower  
area on 4<sup>th</sup> Floor

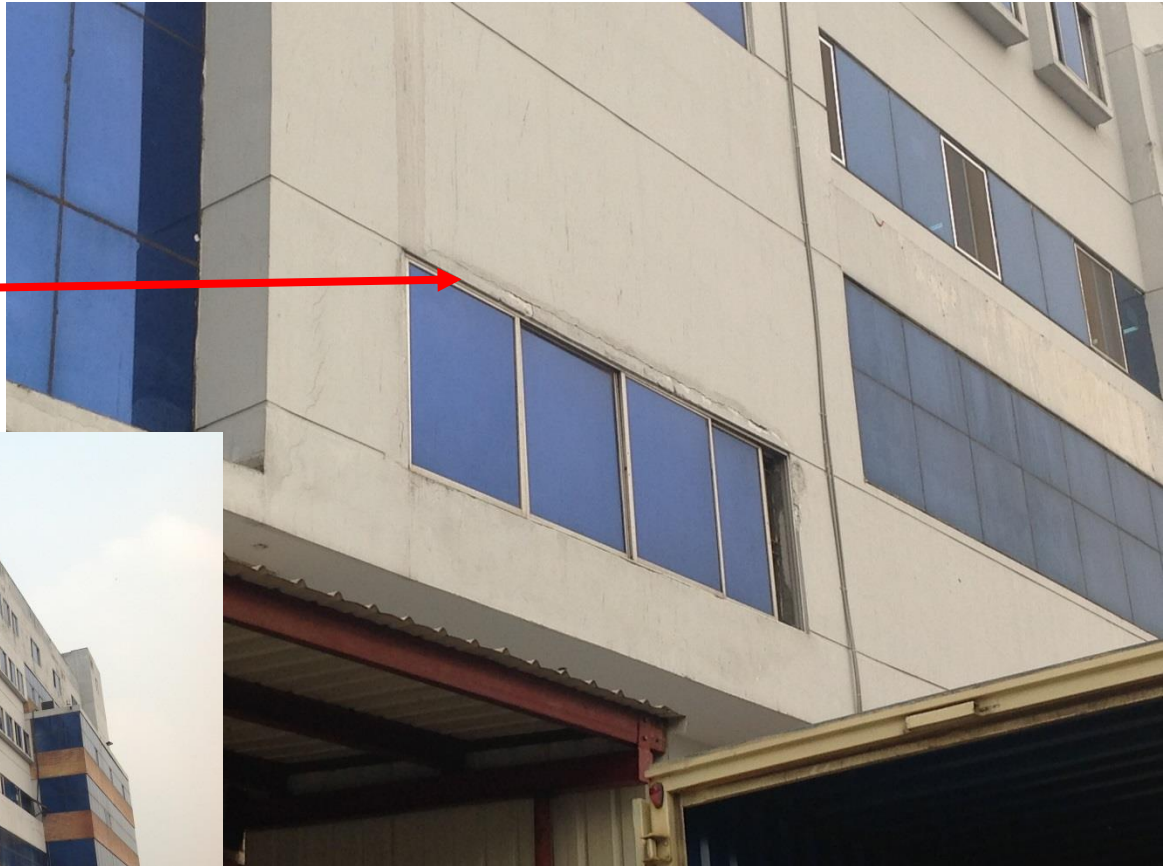
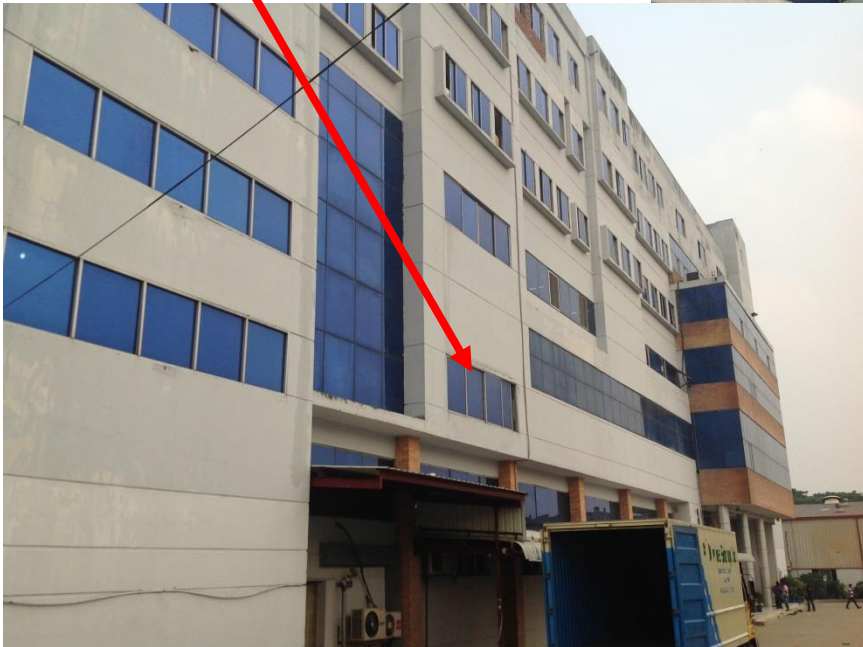
## **Spalling of Plaster Render**

**Spalling of plaster render  
above window on South  
Elevation – 1st Floor**

| Item No. | Observation | Recommended Action Plan | Recommended Timeline |
|---|---|---|---|
| 9 | Spalling of plaster over 1st floor window on South elevation. | Building Engineer to inspect spalling of plasterwork over the window and to propose a suitable repair. | 6-Months |

| Item No. | Observation | Recommended Action Plan | Recommended Timeline |
|---|---|---|---|
| 10 | Spalling of plaster over 1st floor window on South elevation. | Repair works to be carried out | 6-Months |

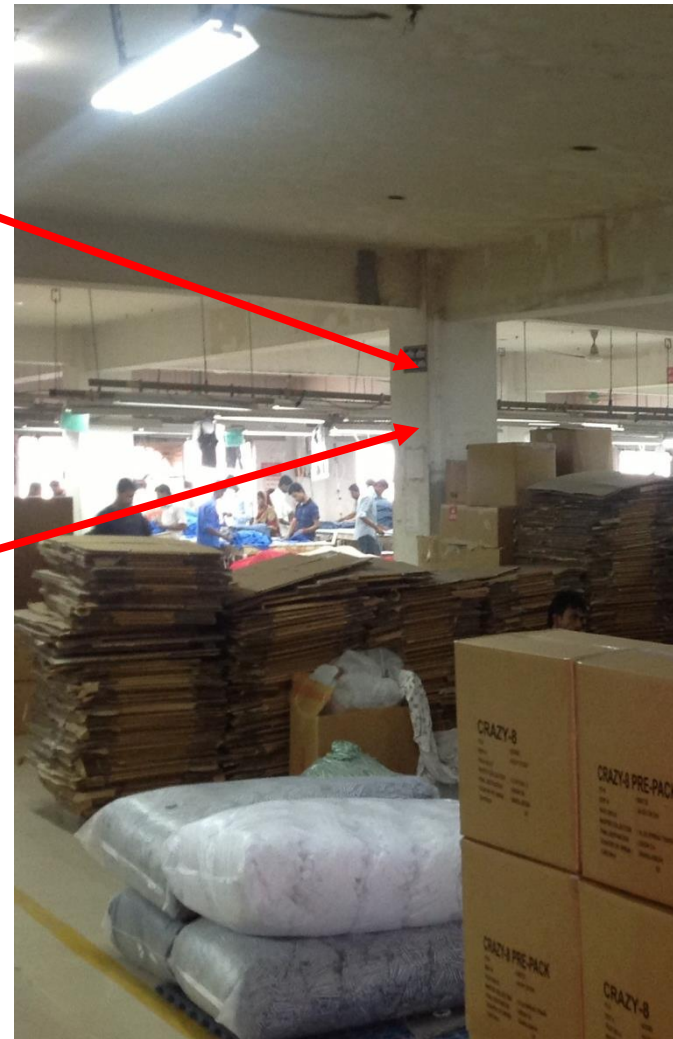
**Check on column loads and design required**

**Check on column loads and design required-  
for all internal building columns**

**Cursory calculations indicate that column sizes may be smaller than required by code for the applied dead and live load, assuming typical aggregate concrete strength**

**Engineer to verify insitu concrete strength & reinforcement and perform detailed calculations to code to prove column size and (if required) :**

- Reduce loads by vacating floors and removing addition structures
- Reinforce columns

| Item No. | Observation | Recommended Action Plan | Recommended Timeline |
|---|---|---|---|
| 1 | Verify column design and concrete strengths for all internal columns within the factory | Factory Engineer to review design, loads and columns stresses in area identified above. | 6-Weeks |
| 2 | Verify column design and concrete strengths for all internal columns within the factory | VVerify insitu concrete stresses either by cores or existing cylinder strength data for all internal columns within the factory. | 6-Weeks |
| 3 | Verify column design and concrete strengths for all internal columns within the factory | Produce and actively manage a loading plan for all floor plates within the factory giving consideration to floor capacity and column capacity. | 6-Months |

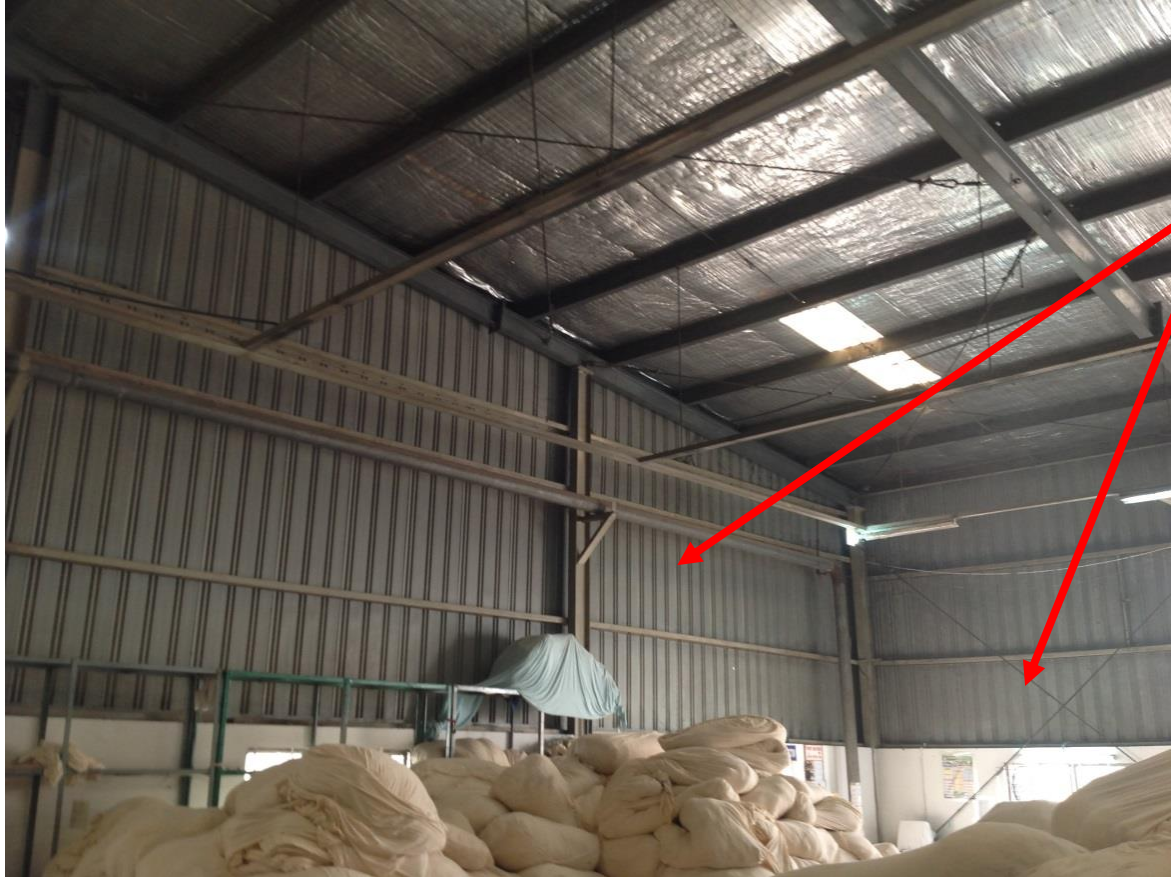
**Dyeing Building stability system:  
Check required**

Vertical stability system to steel frame seems incomplete in Dyeing building – some end bays are missing bracing or have incomplete bracing.

| Item No. | Observation | Recommended Action Plan | Recommended Timeline |
|---|---|---|---|
| 11 | Dyeing Building - Vertical steel bracing- some end bays are missing bracing or have incomplete bracing. | Building Engineer to review design of vertical stability bracing to steel structure for code compliance. Installation of additional vertical bracing to be proposed if required. | 6-Months |
