# M.T Sweaters Ltd. Banga Fashion Ltd.

Plot # 1703-1704, Gacha, Gazipur Sadar, Dhaka  
(23.93638N, 90.37576E)

12 March 2014

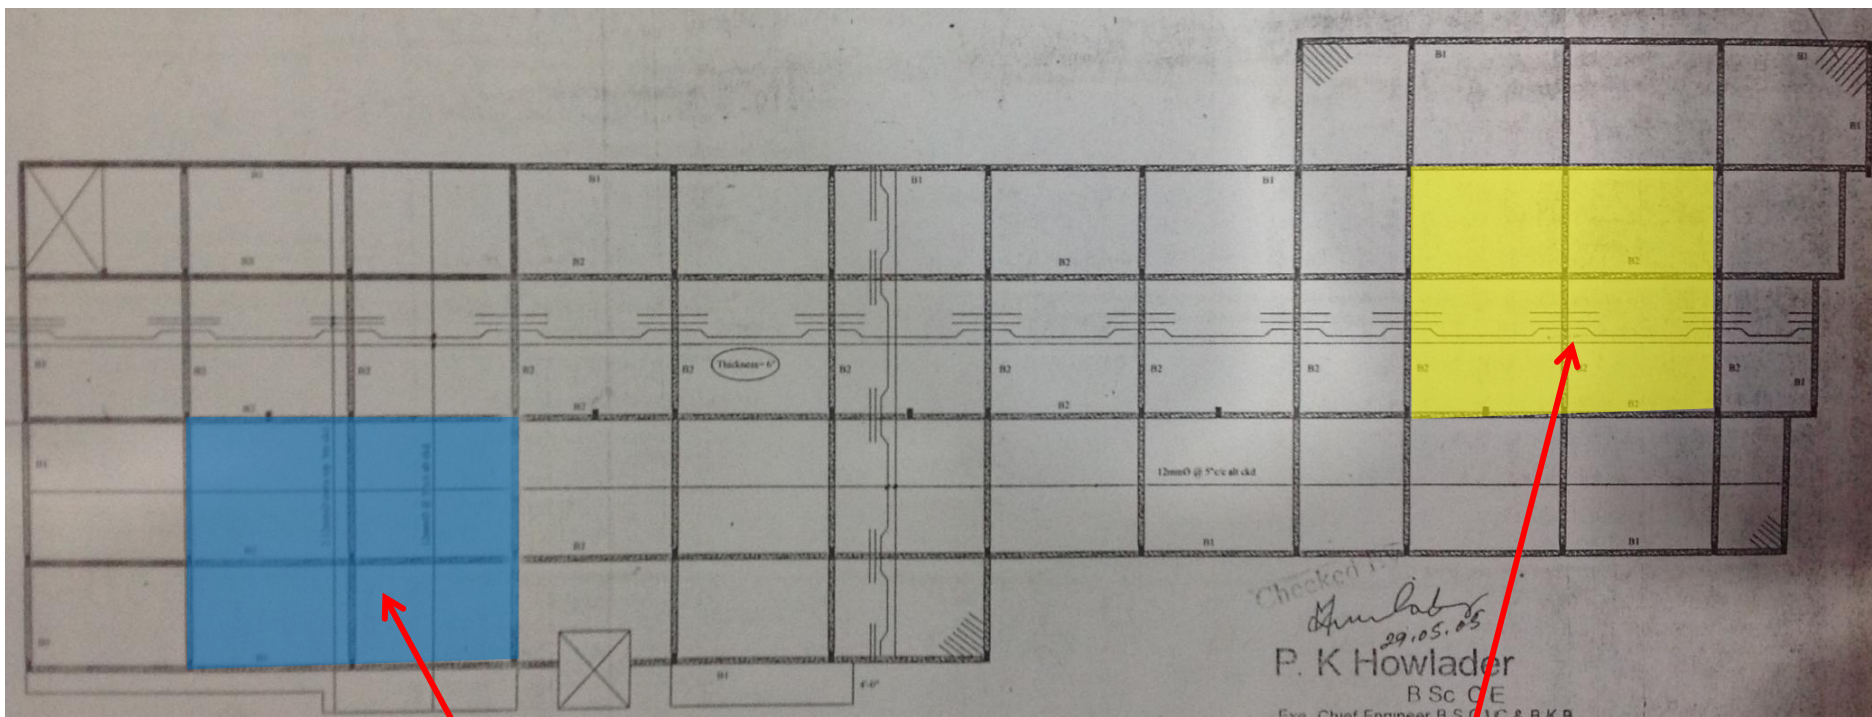
Typical Floor Plan

- Live loading on highlighted area to be reduced to 1.0kPa on 1<sup>st</sup> and 4<sup>th</sup> floors and area to be fully vacated on 2<sup>nd</sup> and 3<sup>rd</sup> floors.
- Loading on 5<sup>th</sup> floor not to increase from present loading

- Live loading on highlighted area between 1<sup>st</sup> and 4<sup>th</sup> floors to be reduced to 1.5kPa on 3<sup>rd</sup> floors and fully vacated on 1<sup>st</sup> floor.
- Loading on 5<sup>th</sup> and 6<sup>th</sup> floors not to increase from present loading

1. **All construction works should be halted pending confirmation by the Building Engineer that the structure, including columns and foundations, is adequate to carry these additional loads.**
2. **Loads to be reduced in the areas highlighted on the following sheet pending verification of column capacity by the Building Engineer.**
3. A Detail Engineering Assessment of the as constructed **Factory Building** is requested and this should be commenced immediately to the requirements of the scope attached and addressing the concerns as noted.

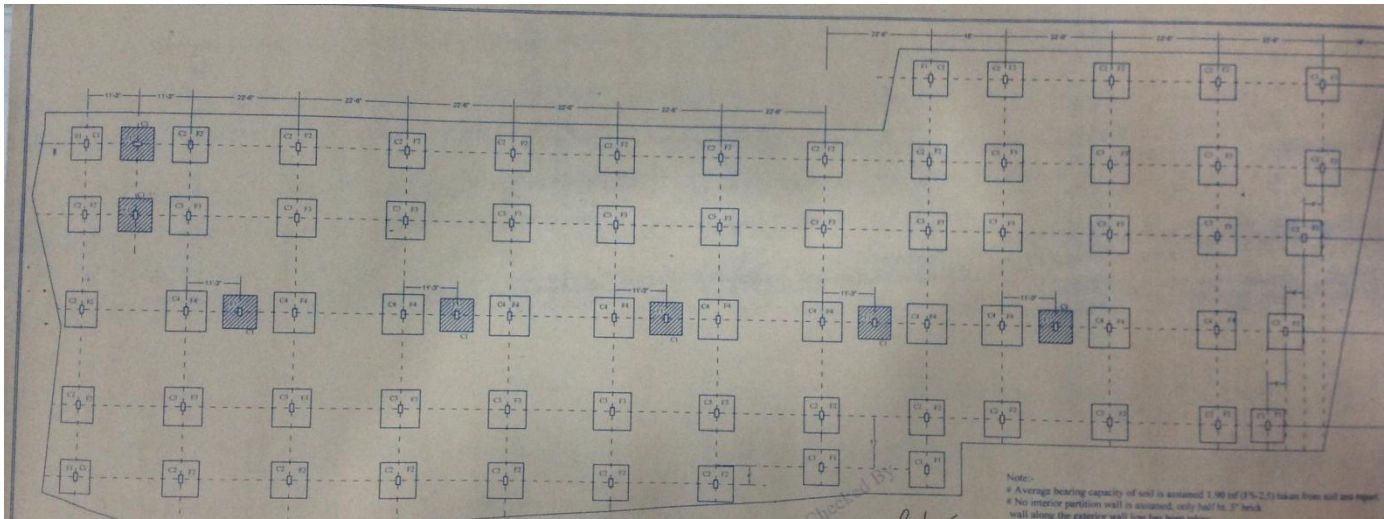
**Columns appear to be stressed to levels that  
require immediate review**

**Cursory calculations indicate that columns are stressed to levels that require immediate review**

**Building Engineer is to perform detailed calculations including a Detail Engineering Assessment (See attached scope) and concrete tests to prove column size and (if required):**

- Further reduce loads by vacating floors
- Reinforce columns

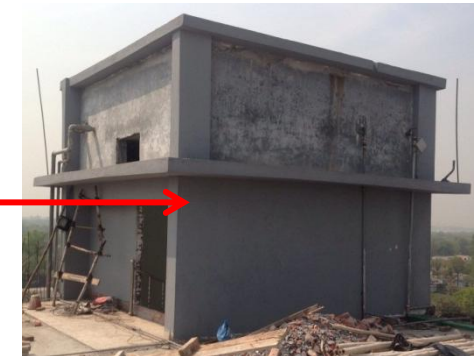
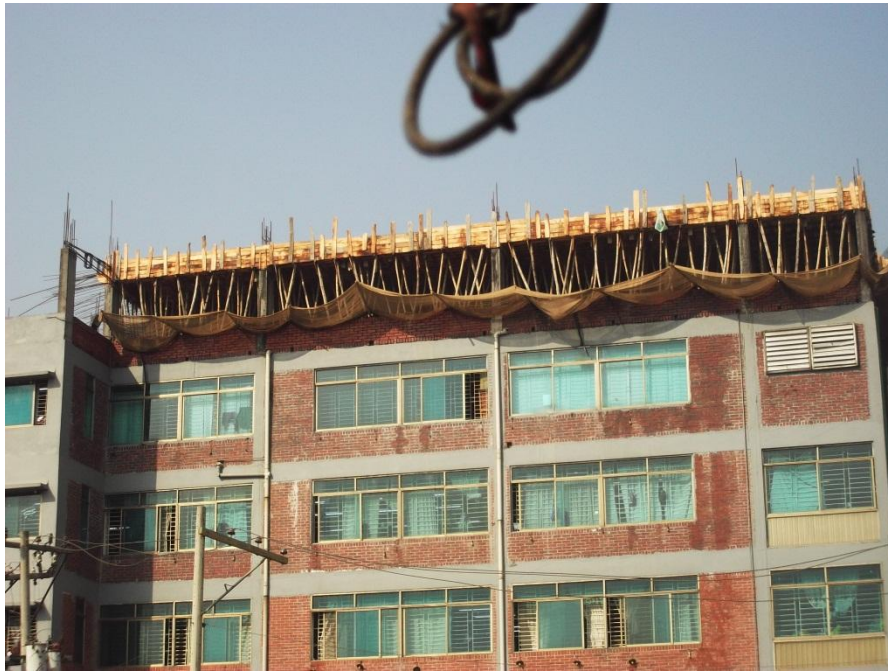
**6<sup>th</sup> storey under construction.  
Construction progressing from  
north to south.**

**Column design check to consider if the additional  
storey can be supported by the building columns  
within the design code specified parameters.**

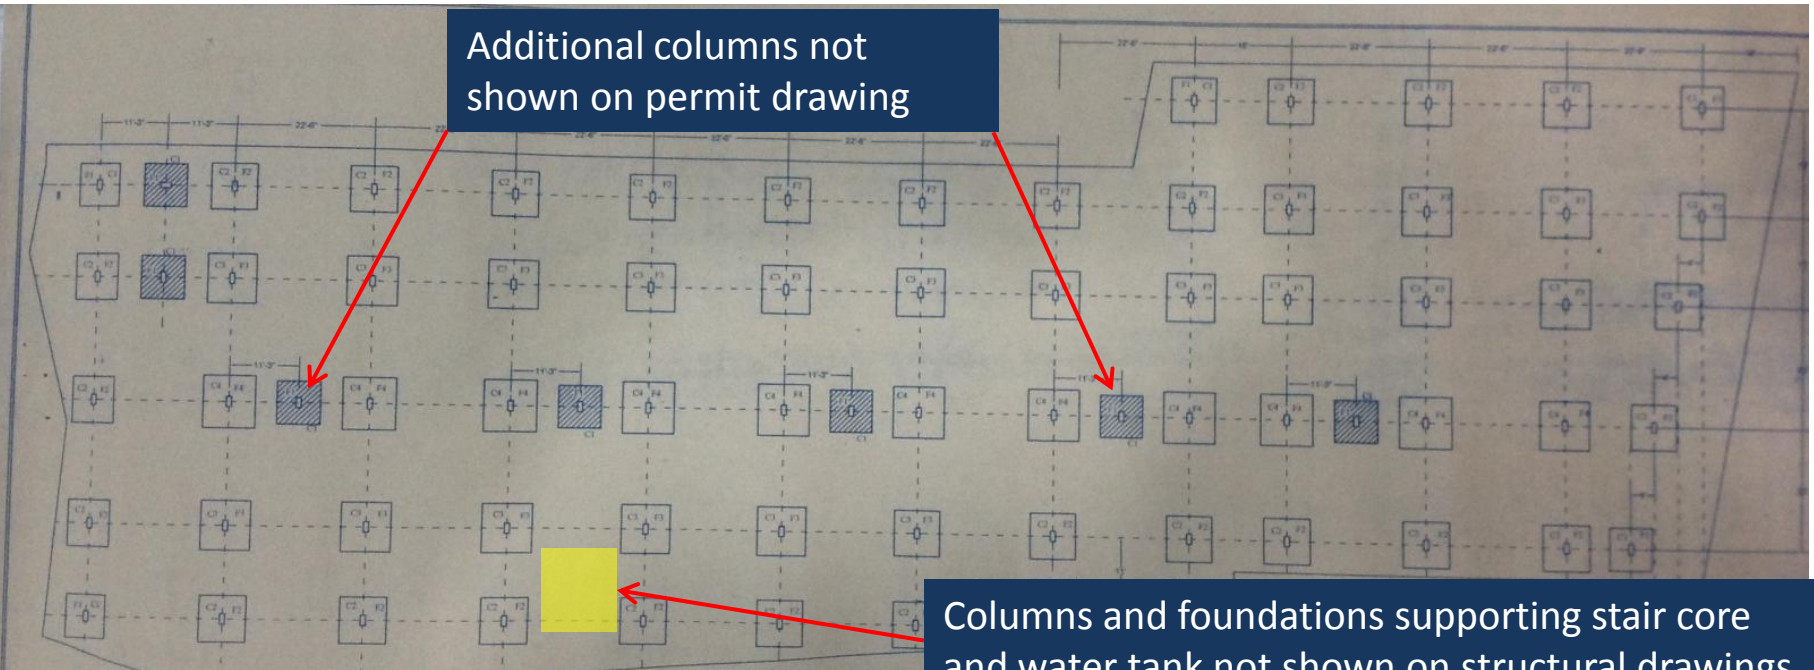
Typical floor plan

Additional columns not shown on permit drawing

Columns and foundations supporting stair core and water tank not shown on structural drawings

Permit drawings show 6 storey factory building and structural drawings are for a 4 storey factory building with additional columns which are not included on permit drawings.

**Building Engineer to survey as-built structure and update drawings**

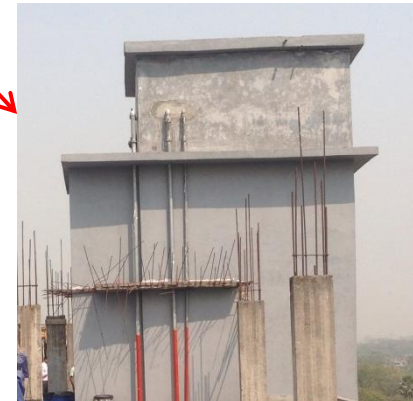
Stair Core & Water Tank

**Structural/Permit drawings not consistent**

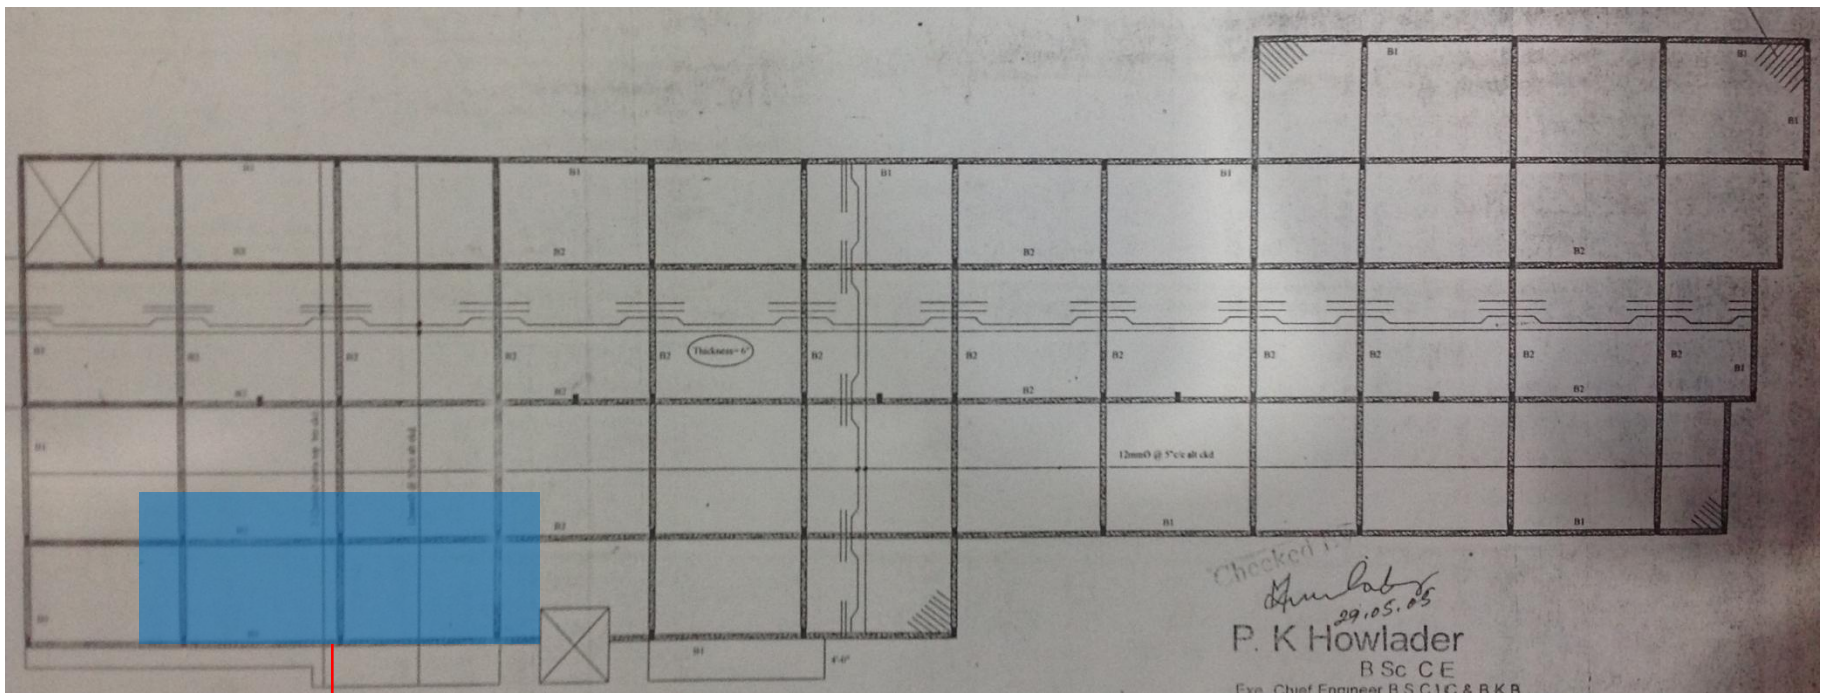
Typical floor plan

# **Design check required for Washer and Dryer loads on 1<sup>st</sup> and 4<sup>th</sup> floors to confirm floor slab load capacity**

| Item No. | Observation | Recommended Action Plan | Priority |
|---|---|---|---|
| 14 | Design check required for Washer and Dryer loads on 1st and 4th floors to confirm floor slab load capacity | Extent of loading within Washer and Dryer areas on 1st and 4th floors, including floor build-up, to be surveyed and capacity of floor slab to be assessed to confirm that the floor slab is designed to carry these loads. | 6-weeks |

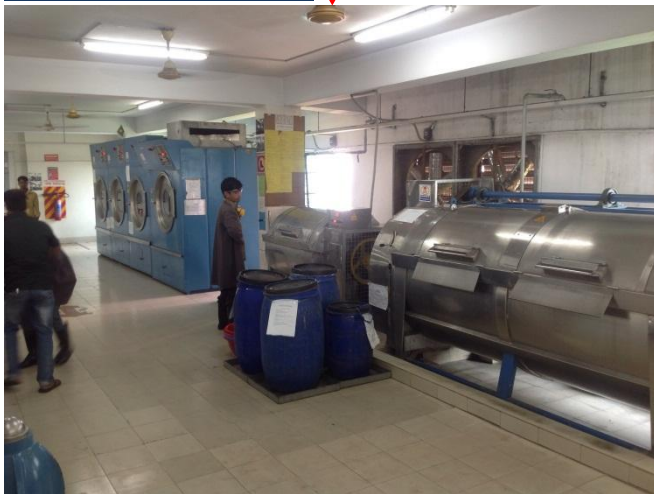
Floor build-up and equipment

180mm (max) high floor build-up in Washer & Dryer Area including equipment loads supported by concrete slab on 1<sup>st</sup> and 4<sup>th</sup> floors.

Building Engineer to check that the slab has been adequately designed and constructed to carry additional load due to floor build-up and equipment in these areas.

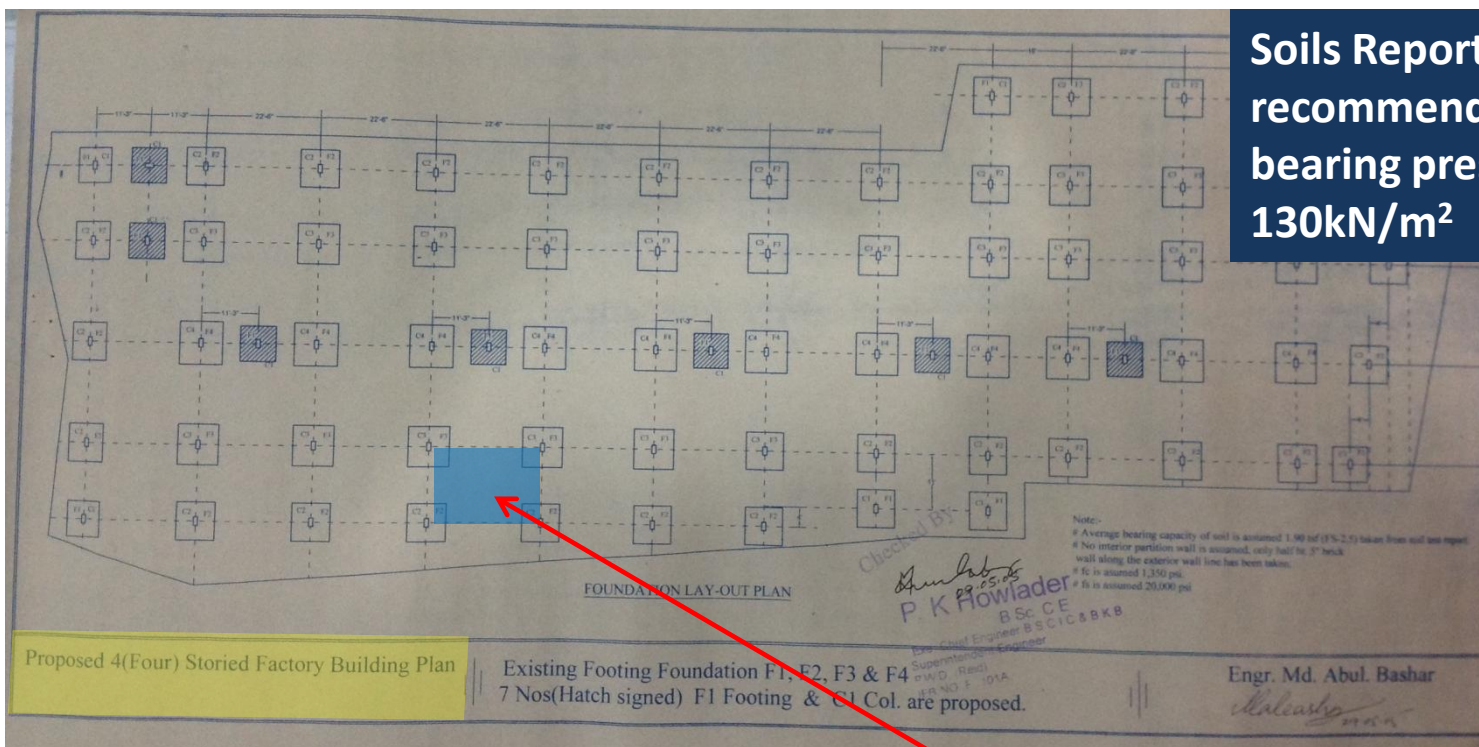
## Structural Foundation Plan

**Soils Report 2013  
recommends allowable  
bearing pressure of circa  
130kN/m<sup>2</sup>**

Foundations shown appear to be designed for a four storey factory building (highlighted yellow). Building Engineer to confirm bearing capacity of pad footings in all areas.

Foundation not indicated under stair core and water tank (area highlighted blue). Building Engineer to confirm presence and bearing capacity of foundation at this location

| Item No. | Observation | Recommended Action Plan | Priority |
|---|---|---|---|
| 17 | Estimated foundation bearing pressure in excess of Soils Report recommendation | Building Engineer to review the Geotechnical (Soils) Report by comparison with the construction drawings and the size of pad foundations as constructed | 6-weeks |
| 18 | Estimated foundation bearing pressure in excess of Soils Report recommendation | Building Engineer to confirm by calculations and records of site construction that foundation bearing is adequate - estimated bearing pressure appears to be in excess of that recommended (circa 130kN per sq m) in the Soils Report. | 6-weeks |

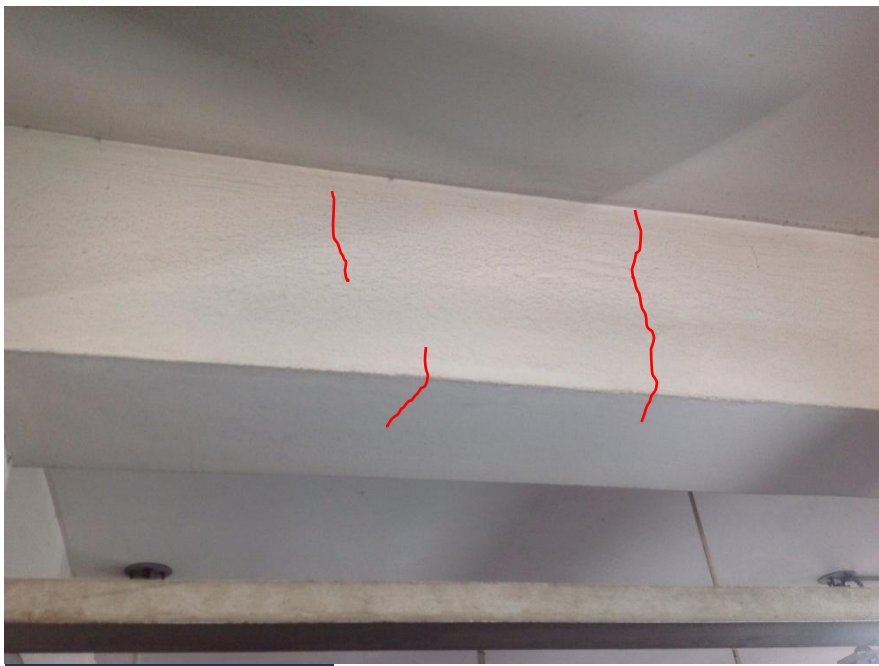
Beam Cracking

# Hairline cracking of beams on a number of floors

Beam and slab cracks to be reviewed on all floor levels by removing plaster to confirm that cracks do not extend into structure.

| Item No. | Observation | Recommended Action Plan | Priority |
|---|---|---|---|
| 19 | Hairline cracking of beams on a number of floors | Sections of plaster finish to beams to be removed to investigate if cracks penetrate the building structure. | 6-weeks |
| 20 | Hairline cracking of beams on a number of floors | Building Engineer to carry out design check on beams to confirm that these cracks are non-structural. | 6-months |

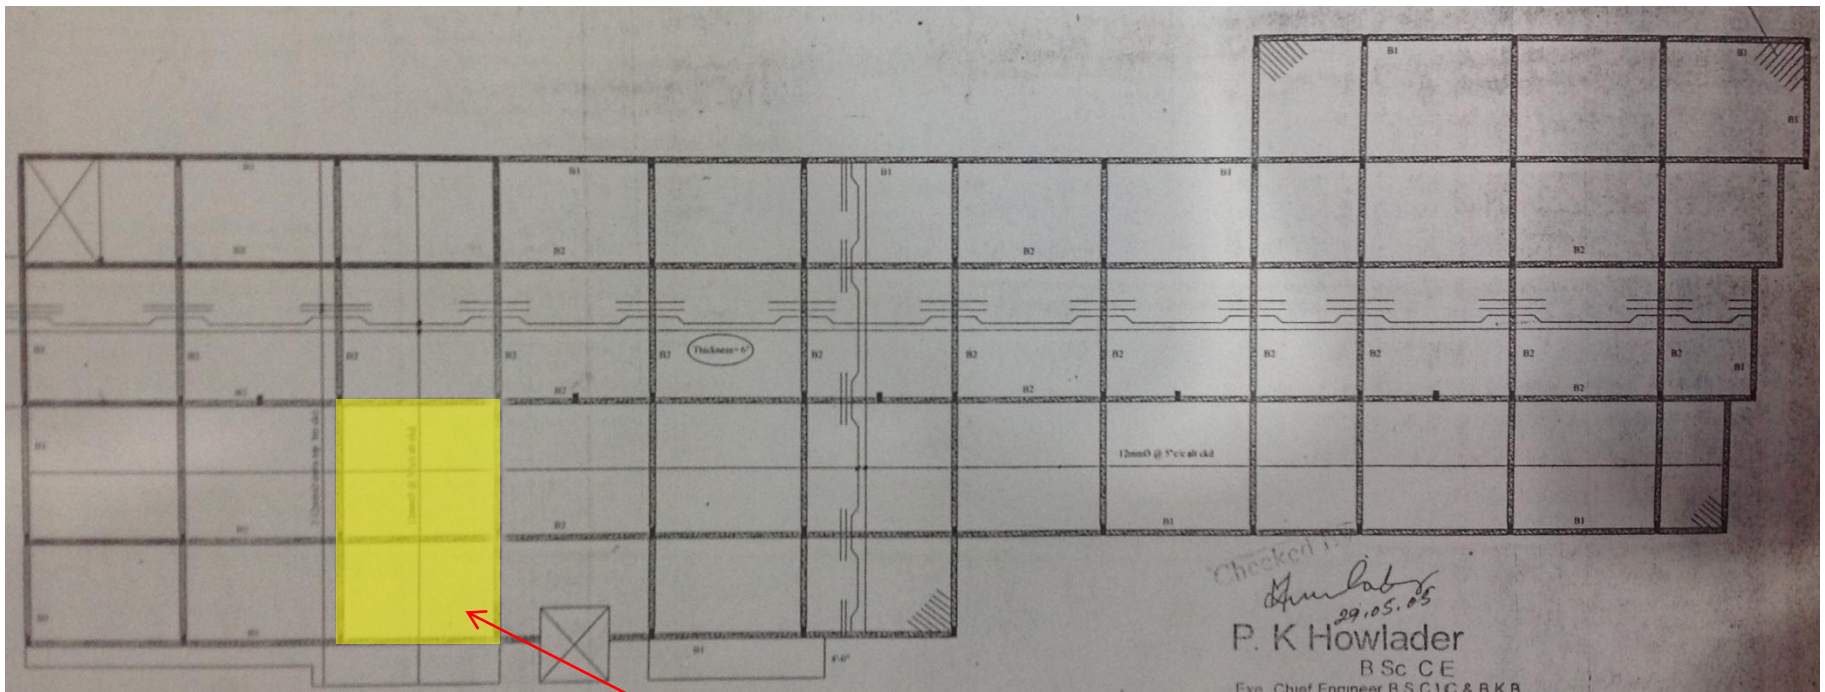
3<sup>rd</sup> Floor Plan

# **Management of storage loads in the 3<sup>rd</sup> floor Inventory Area**

Building Engineer to prepare controlled loading plans for all floors which will designate where storage can be placed.
