# KDS IDR Ltd.

CDA Plot # 15 (P)+16, Mohora I/A, Chandgaon, Chittagong  
(22.398815N, 91.865572E)  
Survey Date: 11<sup>th</sup> March 2015

# Observations

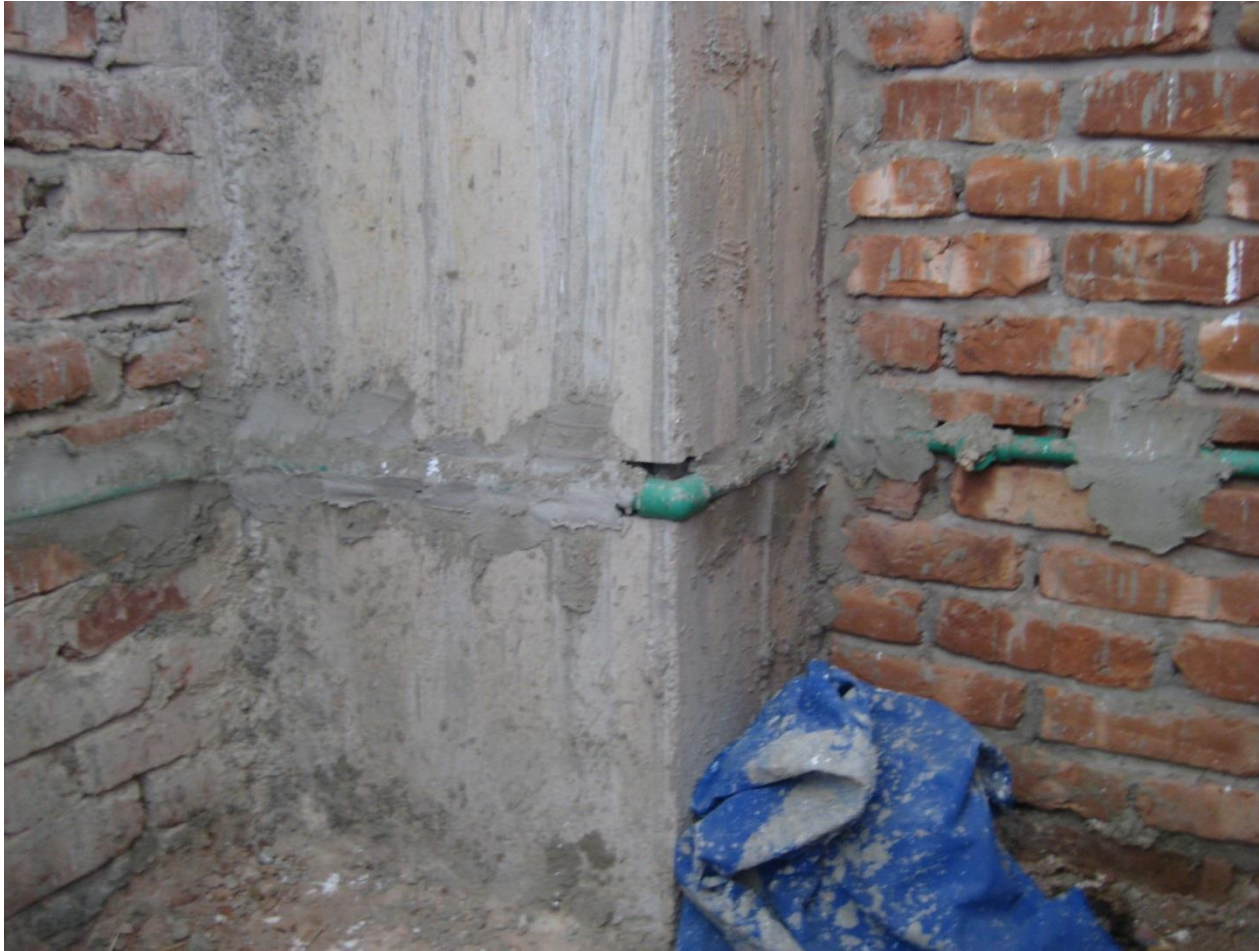
# Office Building - Pipe chased into column at 3rd floor level

A pipe has been chased into a column at 3<sup>rd</sup> floor in the office building

| Item No. | Observation | Recommended Action Plan | Recommended Timeline |
|---|---|---|---|
| 1 | Office Building - Pipe chased into column at 3rd floor level | Pipe to be removed. | 6-weeks |
| 2 | Office Building - Pipe chased into column at 3rd floor level | Building Engineer to ascertain whether reinforcement has been damaged. If damaged, Building Engineer to assess impact on strength of column. | 6-weeks |
| 3 | Office Building - Pipe chased into column at 3rd floor level | Carry out any strengthening works as required. | 6-weeks |
| 4 | Office Building - Pipe chased into column at 3rd floor level | Column to be repaired with concrete repair material of same design strength as column concrete. | 6-weeks |

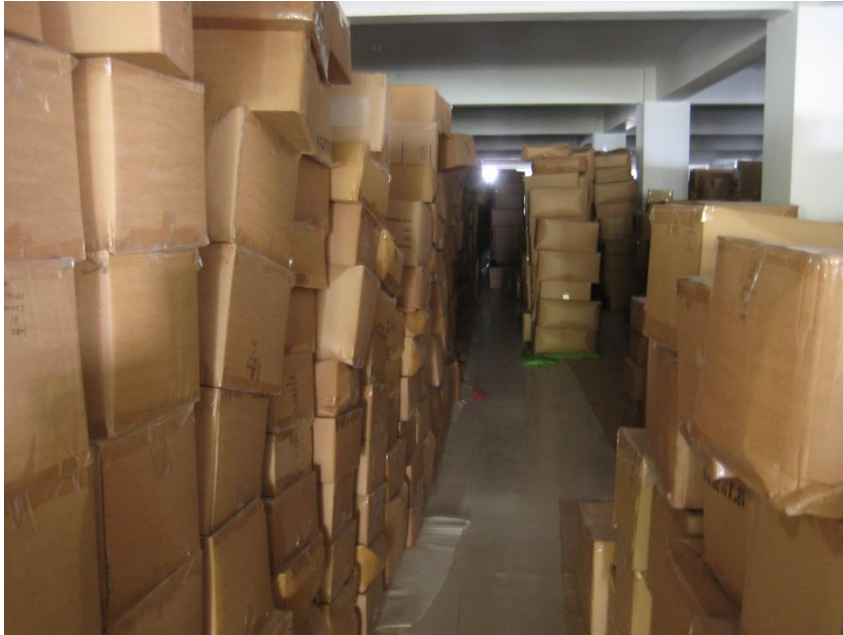
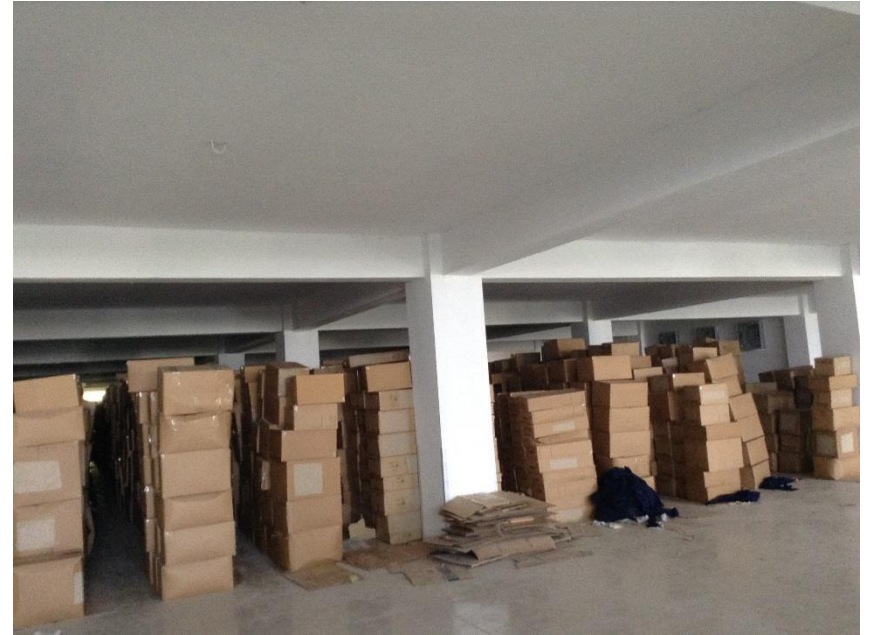
# Factory Building - Storage Loads

### Storage loading requires management

- Storage on the 6<sup>th</sup> floor appeared to be unmanaged.
- Cursory calculations suggest that the loading from the boxes is in the region of 3.6kPa.
- Loading plans are not available for this level, but for other floors the typical load allowance is 2kN/m<sup>2</sup> (42psf).
- The loading plans appear to show the typical load allowance for the factory to be 2kN/m<sup>2</sup> (42psf). Whilst this would appear adequate for most areas of the factory based on the loading observed during the survey, it is not particularly generous and careful management will be required at all times to ensure that it is not exceeded.

| Item No. | Observation | Recommended Action Plan | Recommended Timeline |
|---|---|---|---|
| 5 | Factory Building - Storage Loads | Boxes on 6th floor to be redistributed to reduce load to within design load allowances. | 6-weeks |
| 6 | Factory Building - Storage Loads | Ongoing management of loading throughout factory. | 6-months |

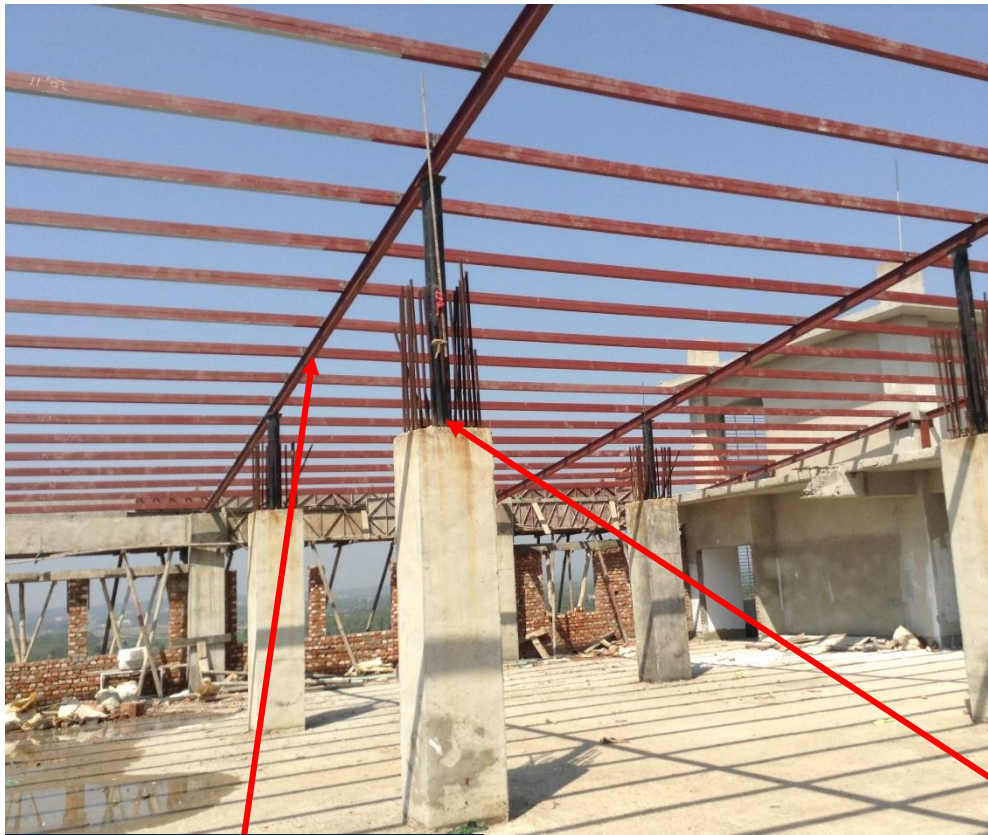
Roof beams appear slender

- The steel roof beams appear very slender.
- The connection detail between the rafter to the steel post and from steel post to the concrete column could not be determined during the survey. This should be checked to ensure that the roof is tied down against wind uplift loads.

| Item No. | Observation | Recommended Action Plan | Recommended Timeline |
|---|---|---|---|
| 7 | Factory Building - Steel roof over dining hall requires review | Building Engineer to review design of roof to determine adequacy to withstand Code vertical and horizontal loads. | 6-weeks |
| 8 | Factory Building - Steel roof over dining hall requires review | Carry out any strengthening or remedial works arising from review. | 6-months |

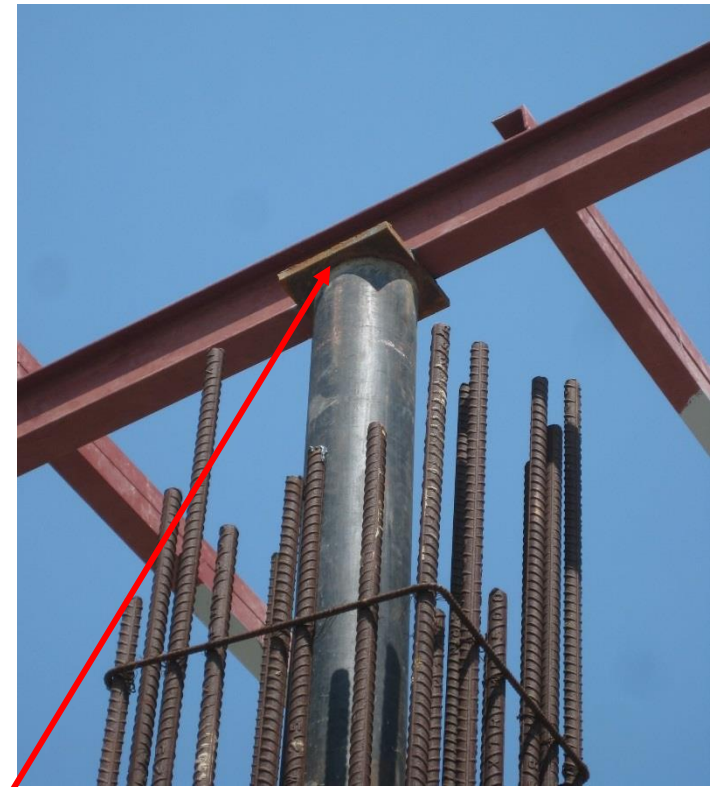
Rafter/post and post/column connection details could not be determined during survey.

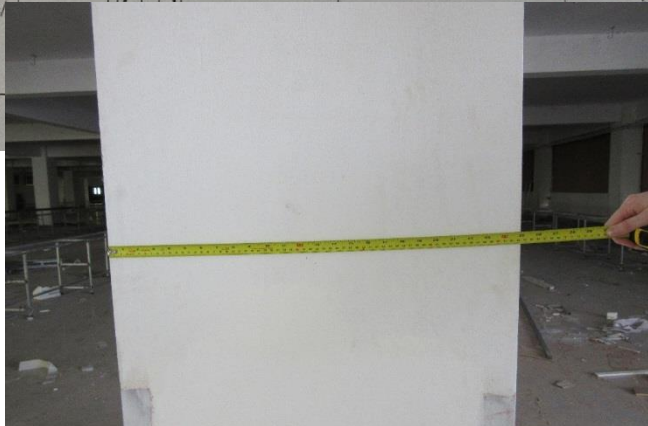
**Column Schedule**

### As-built columns above 2<sup>nd</sup> floor not consistent with drawings

- Internal columns noted on drawings as 27" (685mm) square, but those above 2<sup>nd</sup> floor measure as 25" square with finishes - say 24" (610mm) without finishes. (Ground and 1<sup>st</sup> floor columns match the drawings)
- Number of bars in internal columns at all levels appeared to be less than shown on the drawings (based on Ferrosan and bars projecting from the columns at roof level)

| Item No. | Observation | Recommended Action Plan | Recommended Timeline |
|---|---|---|---|
| 9 | Factory and Office Buildings - Inconsistencies between structural design information and as-built structure | Building Engineer to check structure of Factory and Office buildings for as-built column sizes and reinforcement. | 6-weeks |

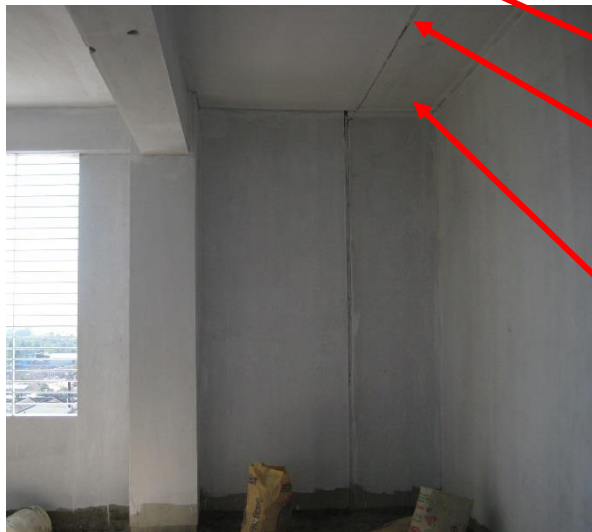
- Beams beyond column line are not present.
- Expansion joint is located 650mm off wall of factory. Drawing shows joint on line of wall.
- This section of the slab appears to cantilever from the factory. As there is a stair void on the other side of the wall, it will have no backspan.

| Item No. | Observation | Recommended Action Plan | Recommended Timeline |
|---|---|---|---|
| 10 | Factory and Office Buildings - Inconsistencies between structural design information and as-built structure | Building Engineer to check structure adjacent to expansion joint between Factory and Office buildings for as-built arrangement, considering missing beams and slab cantilevering from Factory building. | 6-weeks |

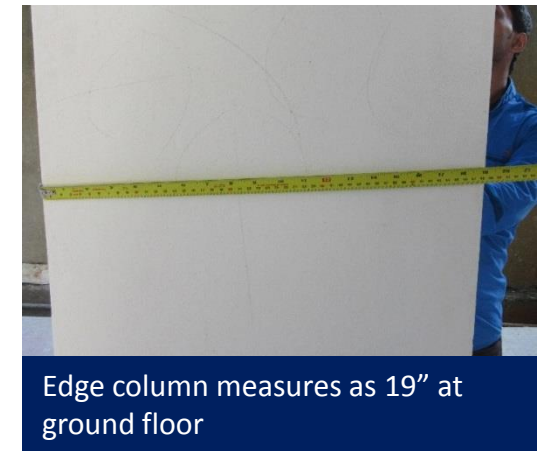
### As-built columns not consistent with drawings

- Edge columns noted on drawings as 24" x 22" (610mm x 560mm) but those measured on site at are 25" x 19" with finishes - say 24" x 18" (610mm x 455mm) without finishes (at all levels of the building)
- Beams shown on drawing adjacent to expansion joint are not present on upper floors.
- Expansion joint on upper floors is not built in position shown on the drawings.
- Expansion joint is not visible at mezzanine floor.
- Expansion joint has been rendered over and has cracked.

| Item No. | Observation | Recommended Action Plan | Recommended Timeline |
|---|---|---|---|
| 11 | Factory and Office Buildings - Inconsistencies between structural design information and as-built structure | Accurate set of as-built drawings to be produced. | 6-months |
