# S.F. Jeans Ltd.

Karol Shurichala, Sofipur, Mouchak, Kaliakoir, Gazipur

# Observations

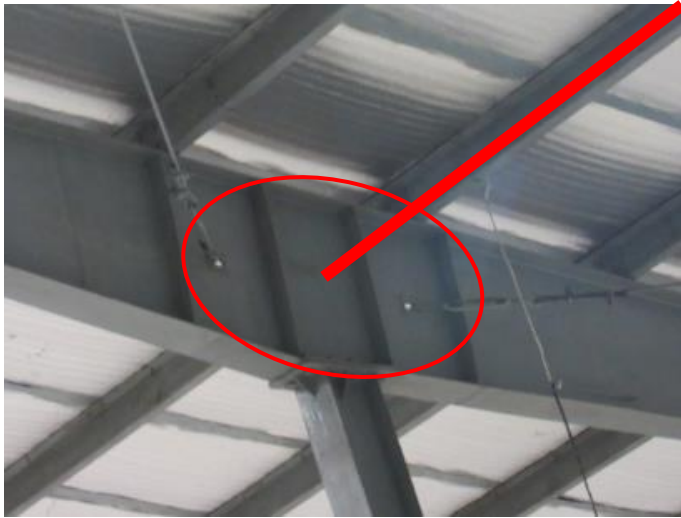
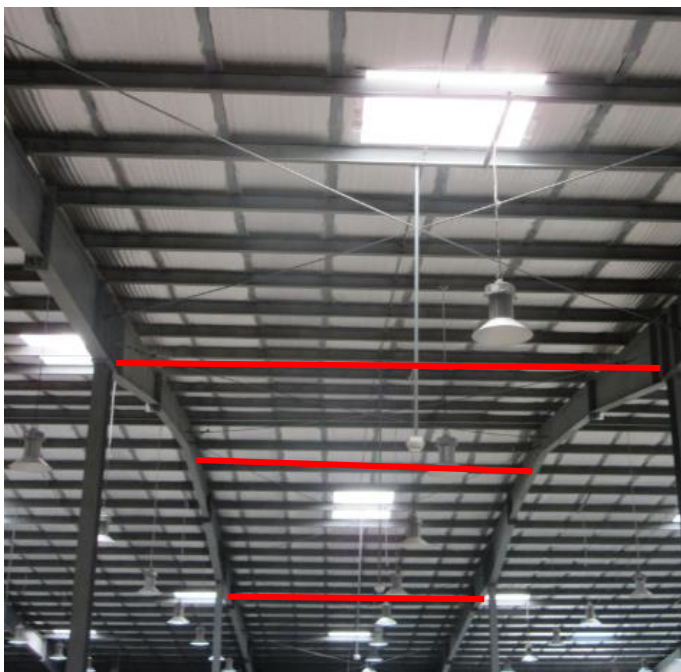
Roof bracing – no obvious compression struts

The bracing system should be reviewed by the Building Engineer. Some additional works may be required :

1. Tensioning of the bracing tie wires
2. Instalment of the compression struts in roof bracing

| Item No. | Observation | Recommended Action Plan | Recommended Timeline |
|---|---|---|---|
| 1 | Defects in the steelwork | Engage Building Engineer to carry out a detailed review of the steelwork including connections and roof bracing. | 6-months |

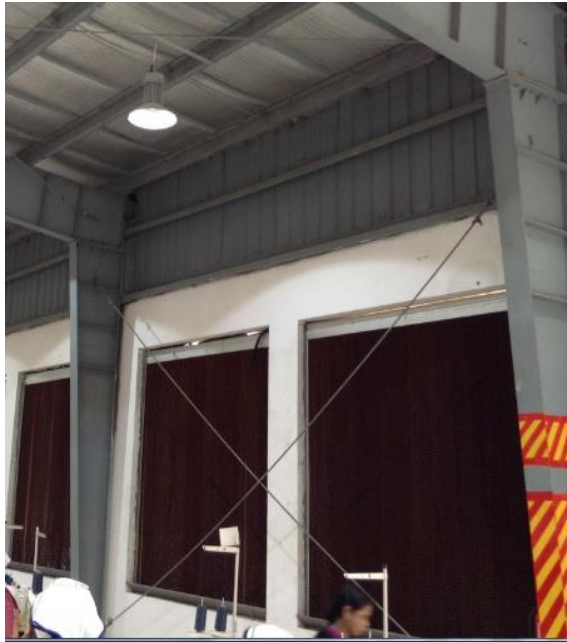
Vertical X-bracing is loose.

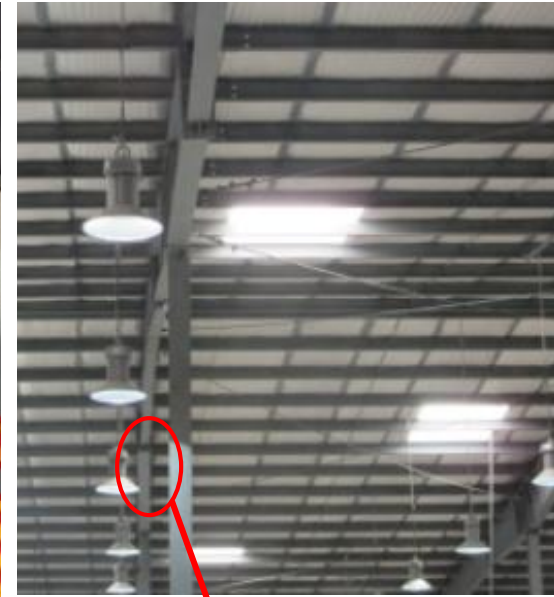
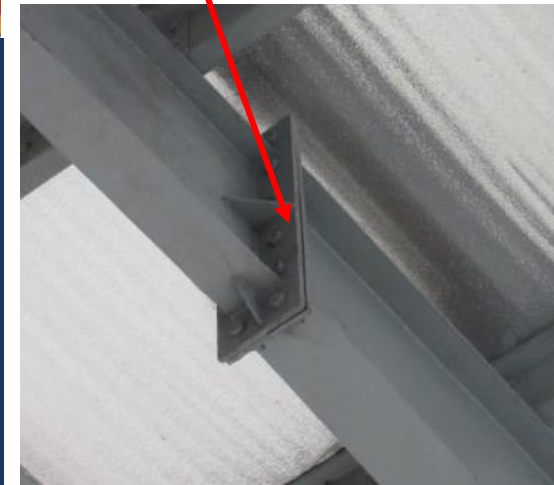
Roof girder connection appears to have rotated

| Item No. | Observation | Recommended Action Plan | Recommended Timeline |
|---|---|---|---|
| 2 | Defects in the steelwork | Carry out any remedial work to steelwork as directed by the Building Engineer. | 6-months |

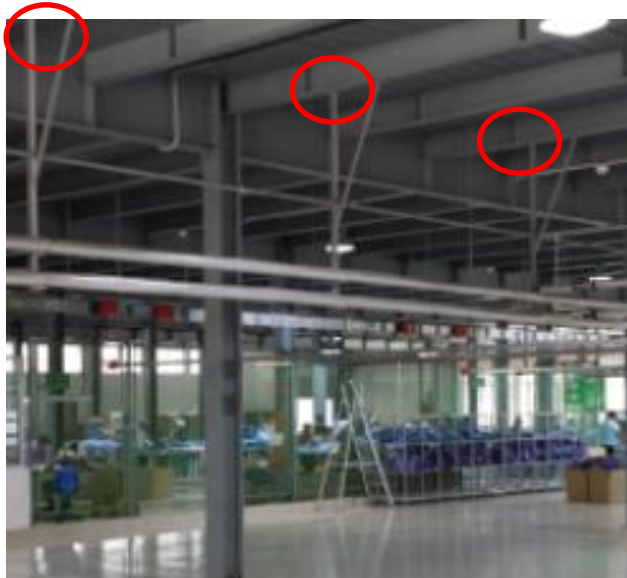
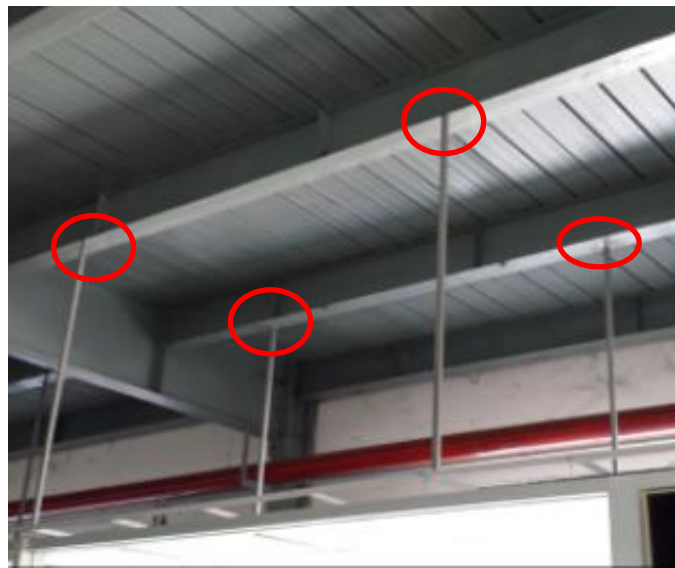
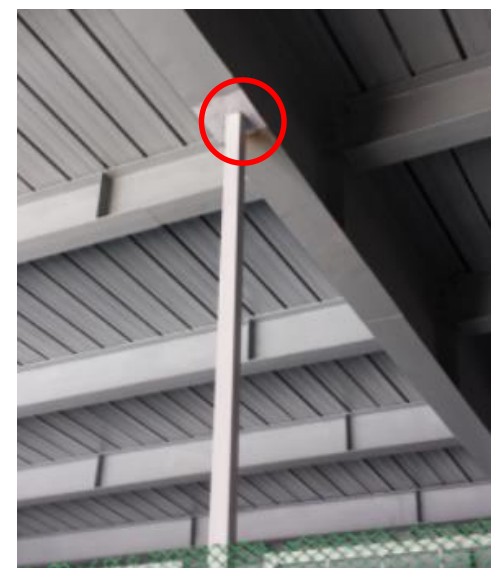
Non-engineered welding of the hanging of the secondary steel work

Non-engineered welding of the hangers to steel beams may cause plastic defect in the tension zone of the sections.

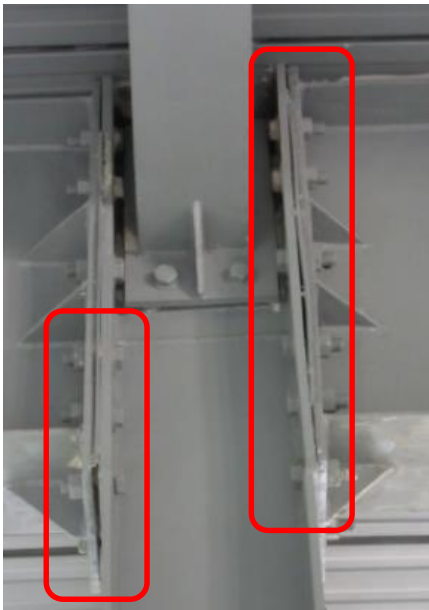
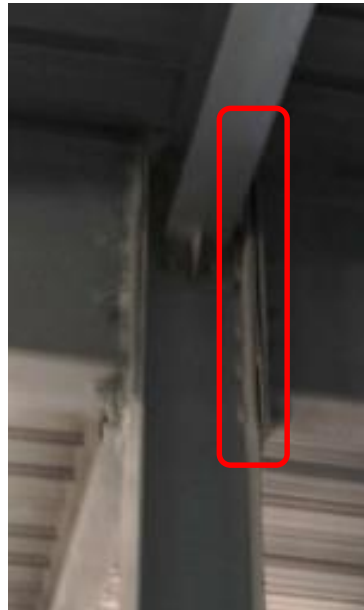
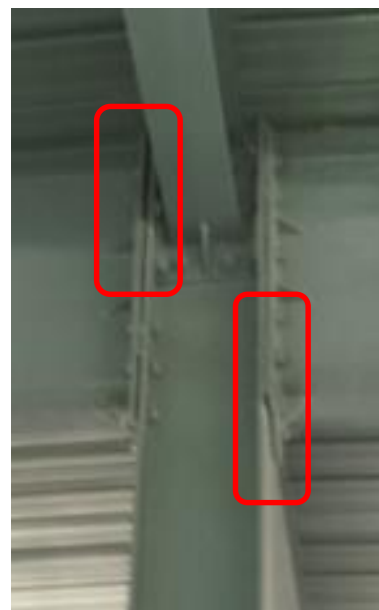
Defects (gaps and plate deformations) require design check of capacity.

Gaps in the bolted connections in many places, require design check

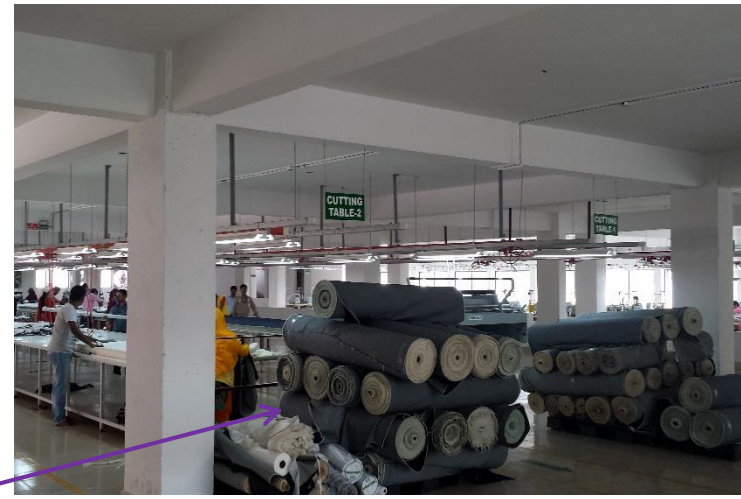
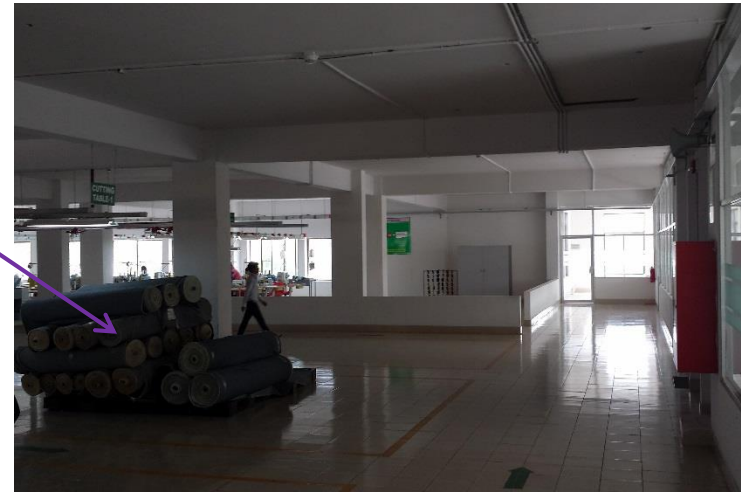
1.2 – 1.4m high stack of rolled Denim  
Average load assumed 5 kPa

| Item No. | Observation | Recommended Action Plan | Recommended Timeline |
|---|---|---|---|
| 3 | Heavy loading on floors | Engage a Building Engineer to update allowable loading plans for all floors based on column capacity (allowing for future floors) and floor beam and slab capacity. | 6-months |
| 4 | Heavy loading on floors | Implement loading plans | 6-months |

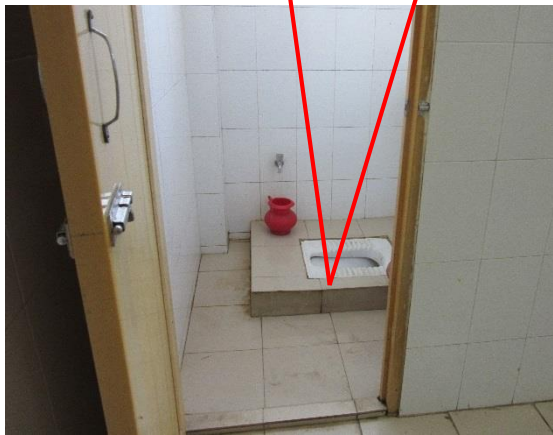
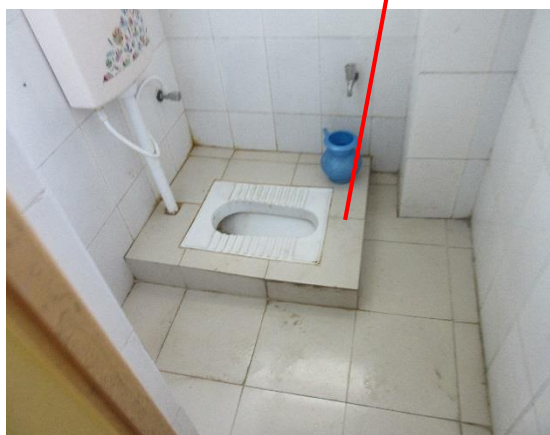
High toilet build-ups (avg. 100 mm)

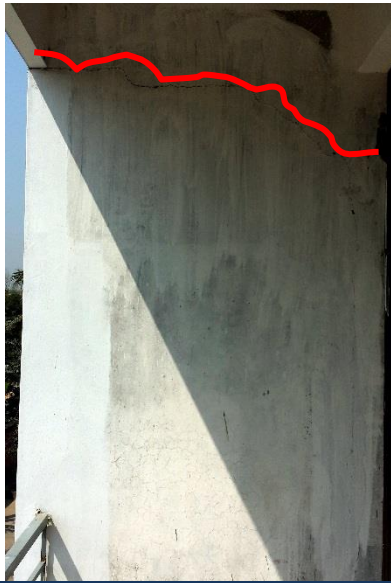
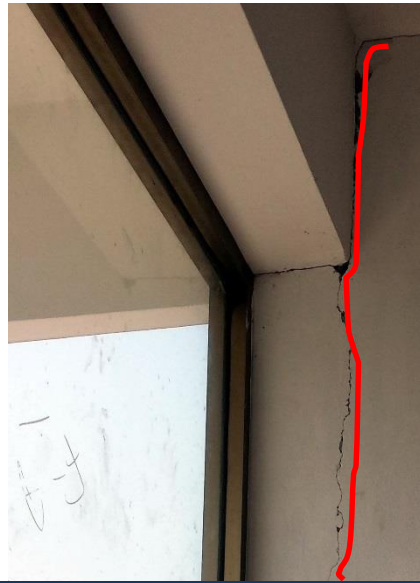
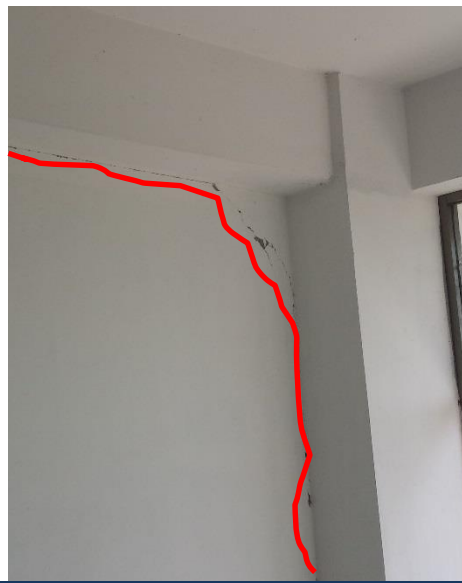
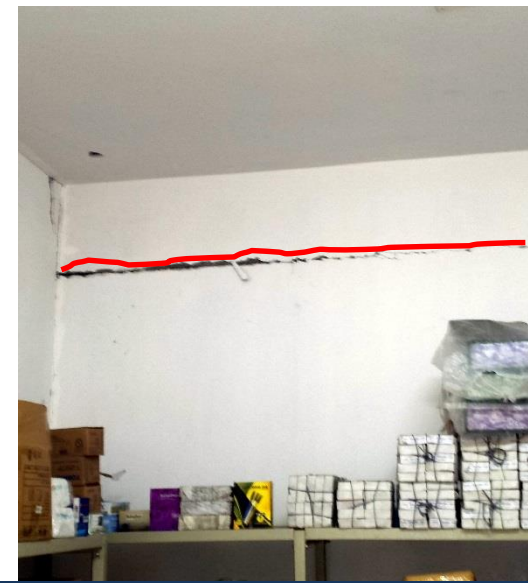
Cracks on the wall in the cantilevers. The cracks width reflects deformations, smaller in bottom , larger at top

| Item No. | Observation | Recommended Action Plan | Recommended Timeline |
|---|---|---|---|
| 5 | Cracking in brick walls | Engage Building Engineer to investigate the cause of cracking in brickwork. | 6-months |
| 6 | Cracking in brick walls | Carry out repairs as directed by Building Engineer. | 6-months |

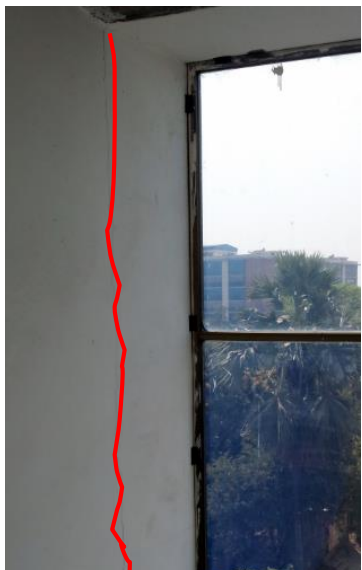
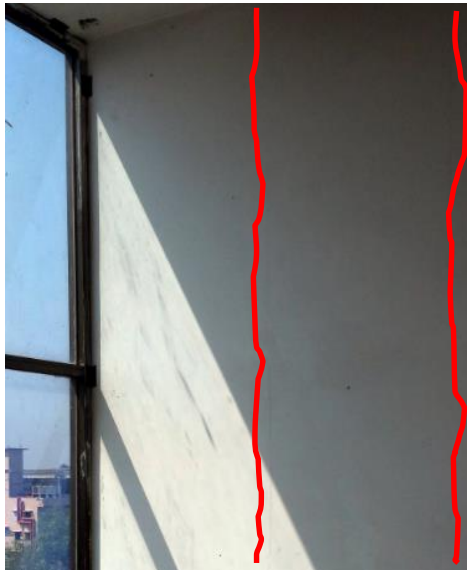
Cracks in the staircase

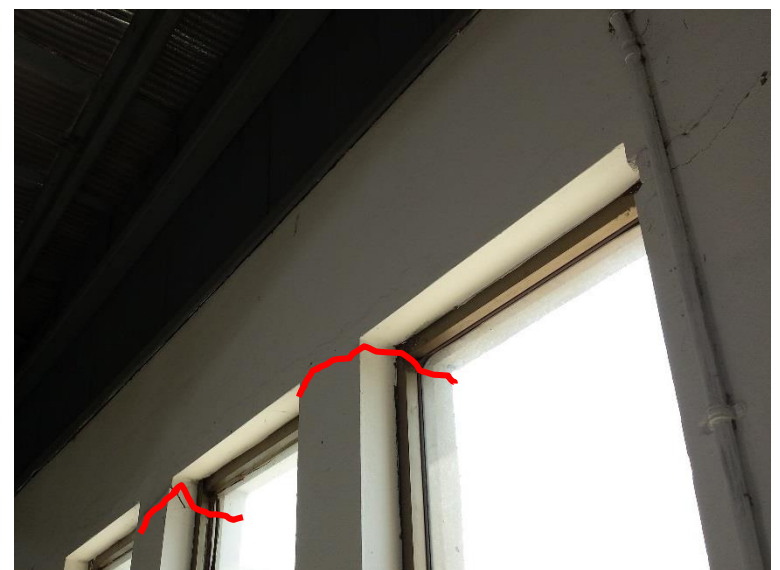
Fully cracked window pillars

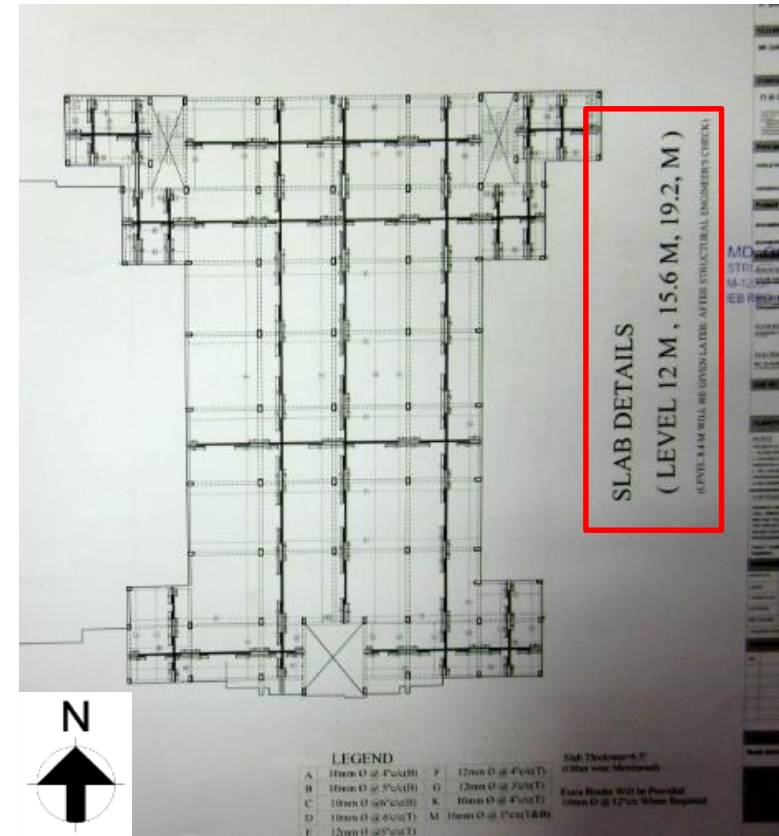
The structural as-built documentation contains details of structural slabs not yet constructed

| Item No. | Observation | Recommended Action Plan | Recommended Timeline |
|---|---|---|---|
| 7 | Discrepancies between drawings and observations on site | Engage a Building Engineer to prepare up-dated as-built documentation | 6-months |

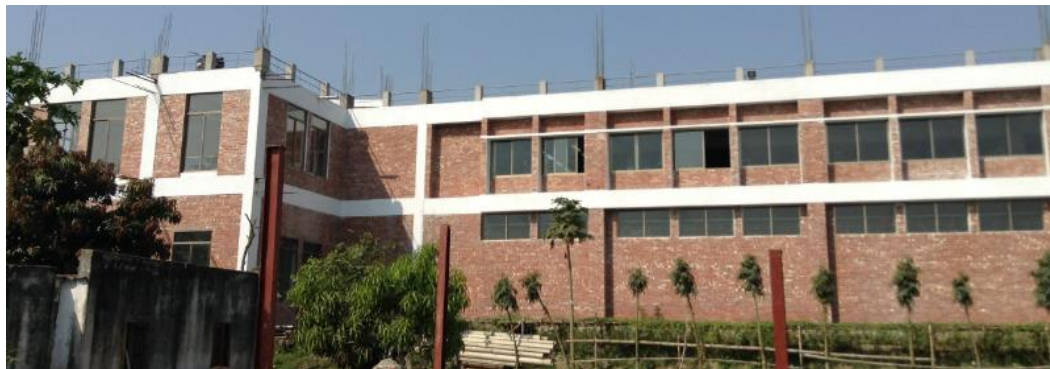
Currently there are 2 storeys built in the concrete part of the factory
