FIRE SAFETY INSPECTION REPORT

Factory Name: Emon Fashion Ltd. (new Unit)

ACCORD ID: 23653

Date: 16th July, 2019

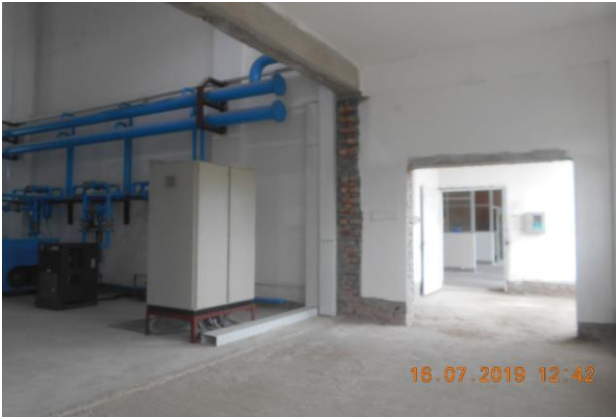
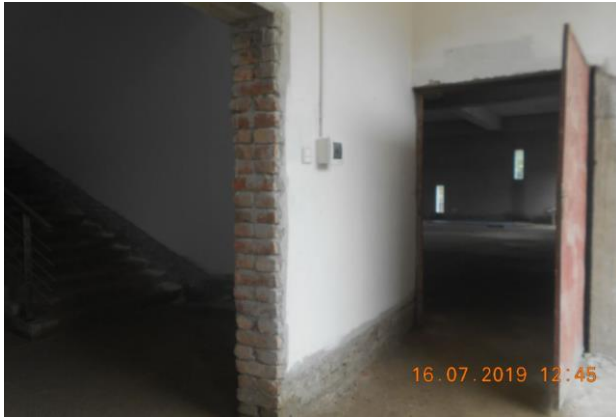
2	Fire Rated Construction	Penetrations through floor/ceiling assemblies are found unsealed.	Seal all penetrations and openings in the wall of exit enclosure walls (full thickness of the wall) by fire rated materials to maintain the fire resistance rating. Provide a minimum 2-hr fire rated shaft to separate the utility risers from each floor if required.	Within 3 months

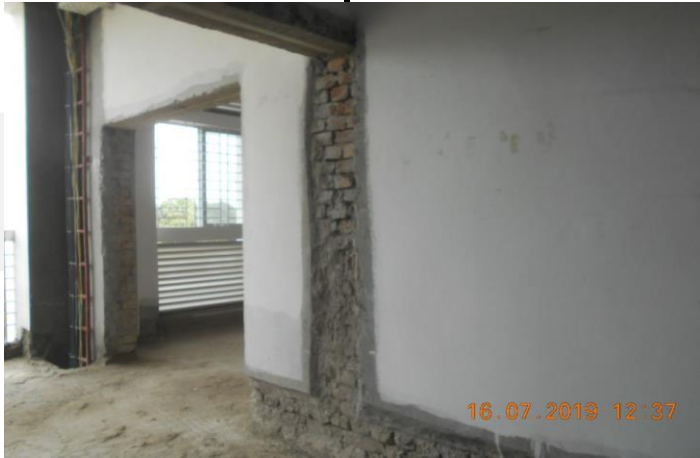
3	Fire Rated Construction	<p>Rooms used for storage of combustible materials are not separated from the surrounding occupancy/areas. Location: 2nd Floor</p>	<p>Rooms used for storage of combustible materials shall be separated from the surrounding occupancy with a minimum 1 hour construction.</p>	Within 3 months

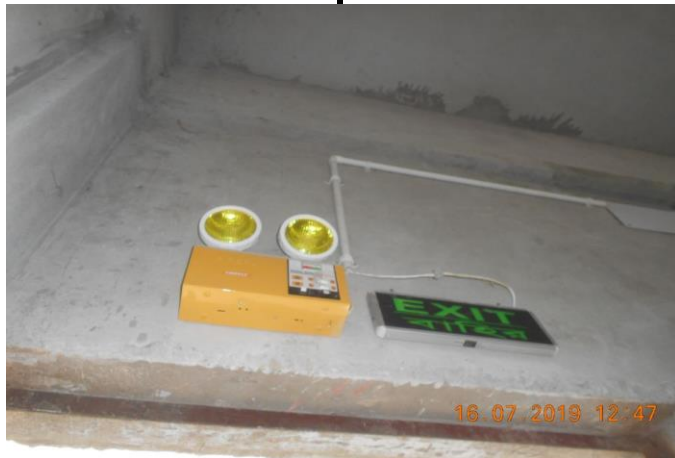
SI No.	Category	Findings	Required Action	Remediation Time Frame
9	Egress Lighting	Exit signage not illuminated (burned out, broken, etc.).	Regularly inspect all exit signage and replace/install lights as needed to illuminate signs.	Within 1 month

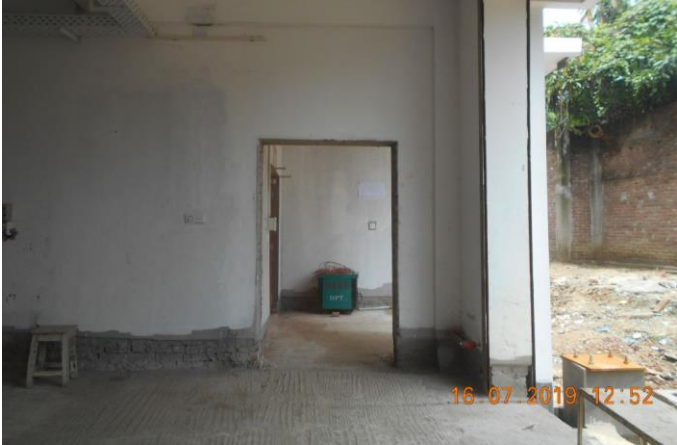
12	Fire Detection & Alarm System	<p>The existing fire alarm system is not a listed system and does not provide automatic alarm and notification features consistent with acceptable standards.</p> <p>Factory has reviewed addressable fire alarm system drawing from Accord with old building.</p>	<p>Replace the fire alarm system with a new, listed addressable fire alarm system in accordance with NFPA 72.</p>	<p>Install within 6 months</p>

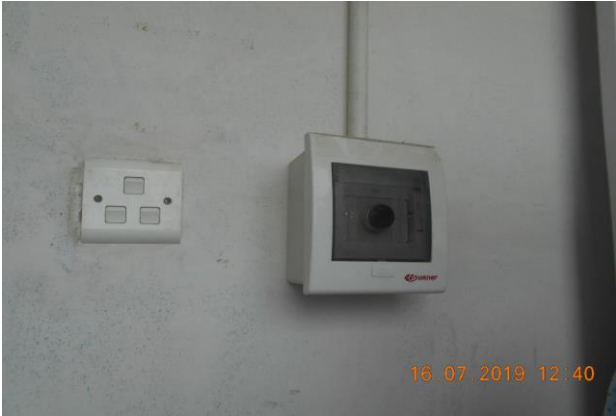
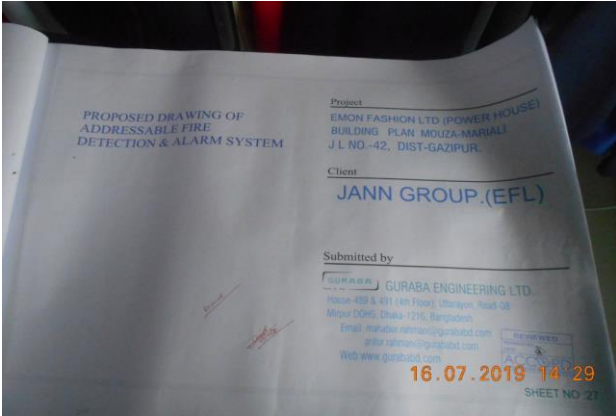
13	Fire Detection & Alarm System (ITM)	Inspection, testing, and maintenance for the fire alarm system is not in accordance with NFPA 72 or as per Accord standard.	Inspect, test and maintain the fire alarm system, and keep written records on-site, in accordance with NFPA 72 or as per Accord standard.	Within 3 months (After installation)
