# **FIRE SAFETY INSPECTION REPORT**

## **EHSAN GARMENTS LTD**

**K.B. BAZAR, TARGACH,GAZIPUR, BANGLADESH**

March 23, 2014

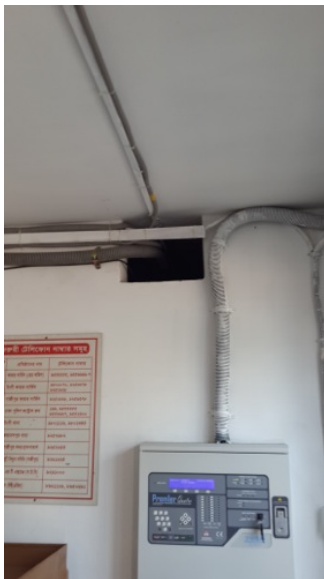
| No. | Category | Finding | Recommendation | Remediation Timeframe |
|---|---|---|---|---|
| F-1 | Fire Rated Construction | Unsealed ceiling penetrations located in the fire command room above the fire alarm control panel.<br>Penetration leads to storage room. | Provide a minimum 2-hr fire-rated shaft to separate the utility risers from each floor level.<br><br>Seal all penetrations and openings in floor/ceiling assemblies to maintain the fire separation. | Within 1 month |

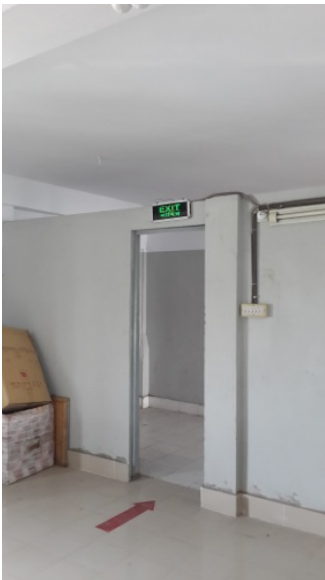
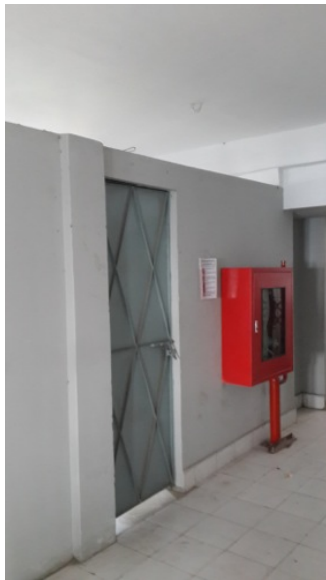
| F-2 | Fire Rated Construction | Unsealed penetrations and openings are located in exit stair enclosures. Storage rooms were located in the exit stairwells Specifically in the east stairwell sixth floor. Storage rooms were not fully sealed and compromises the stairwell exiting system. | Seal all penetrations and openings in exit stair enclosure walls to maintain the fire separation. | Within 3 months |

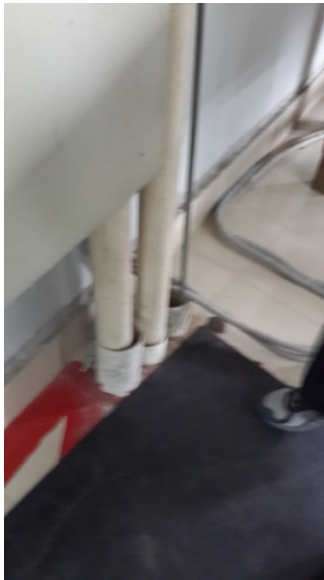
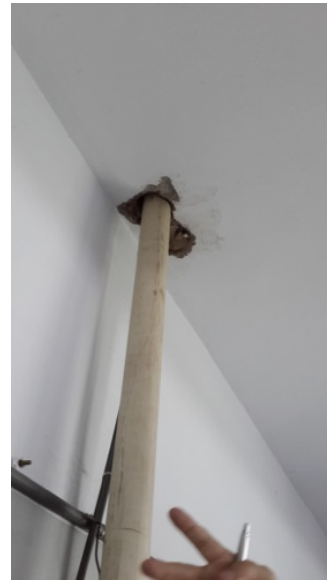
| F-3 | Fire Rated Construction | Unsealed penetrations and openings are located in the fire-rated floor/ceiling assemblies. Specifically located at the M/C Bond room and reflected on all floors, penetrations were seen due to electrical wiring. | <p>Provide a minimum 2-hr fire-rated shaft to separate the utility risers from each floor level.</p> <p>Seal all penetrations and openings in floor/ceiling assemblies to maintain the fire separation.</p> | Within 3 months |

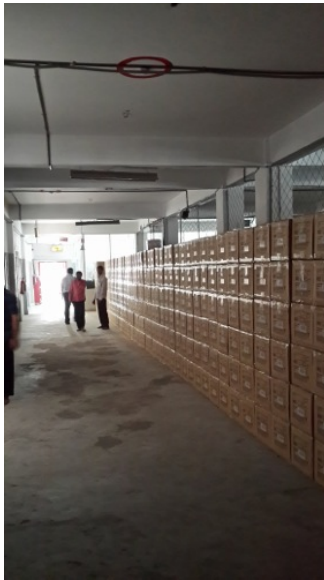
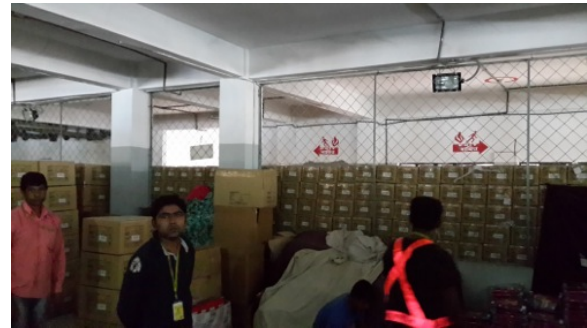
| F-4 | Fire Rated Construction | <p>Areas used for combustible storage are not separated by fire-rated construction.</p> <p>Excess stored boxes were staged outside of storage rooms.</p> <p>However all boxes/storage whether they are rotating storage or not, should be stored inside a proper storage facility/room.</p> | <p>Provide dedicated storage rooms separated by minimum 1-hr fire-rated construction.</p> <p>Where separate storage rooms are not feasible, provide defined storage areas and limit the storage arrangement as follows:</p> <ul style="list-style-type: none"> <li>- Maximum height of 2.4m and maximum area of 23m<sup>2</sup></li> <li>- If sprinkler protected: maximum height of 3.66m and maximum area of 93m<sup>2</sup></li> </ul> <p>Separate areas of unenclosed combustible storage by a minimum clear distance of 3m.</p> | Within 3 months |

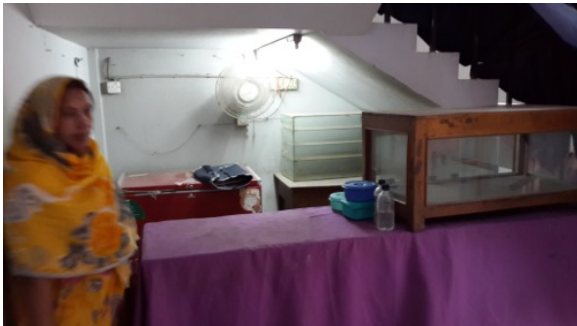
| F-6 | Egress | Located in the south stairwell on ground floor, a snack/drink shop was placed at the bottom of the stairwell. | Remove all storage from exit stairs and egress paths. | Immediate |

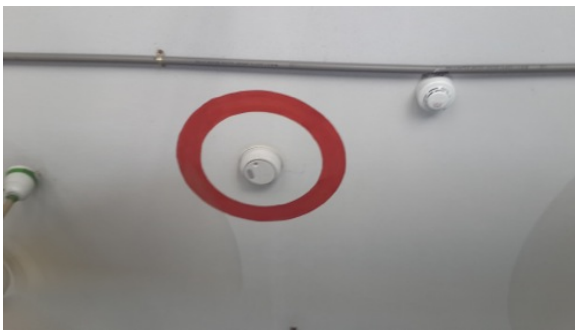
| F-7 | Fire Protection | In addition to having addressable smoke detectors tied into the fire alarm system, the building is also equipped with single-station smoke alarms. Smoke alarm activation sounds only a local alarm and does not provide automatic fire alarm notification of occupants. | Remove the single-station smoke alarms. | Immediate |

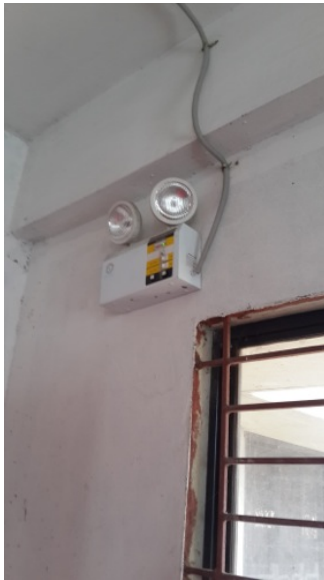
| F-9 | Egress Lighting | Manual on-off switch is provided for emergency lighting units. This was reflected on multiple floors throughout the building. | Remove manual on/off switches from emergency lighting units to prevent them from being switched off. | Within 1 month |
