# Cassiopea Sweaters Ltd.

Borta Para, PO- Pirujali, PS- Joydebpur, Dist-Gazipur, Bangladesh.

27<sup>th</sup> January 2019 and 5<sup>th</sup> February 2019

# Observations

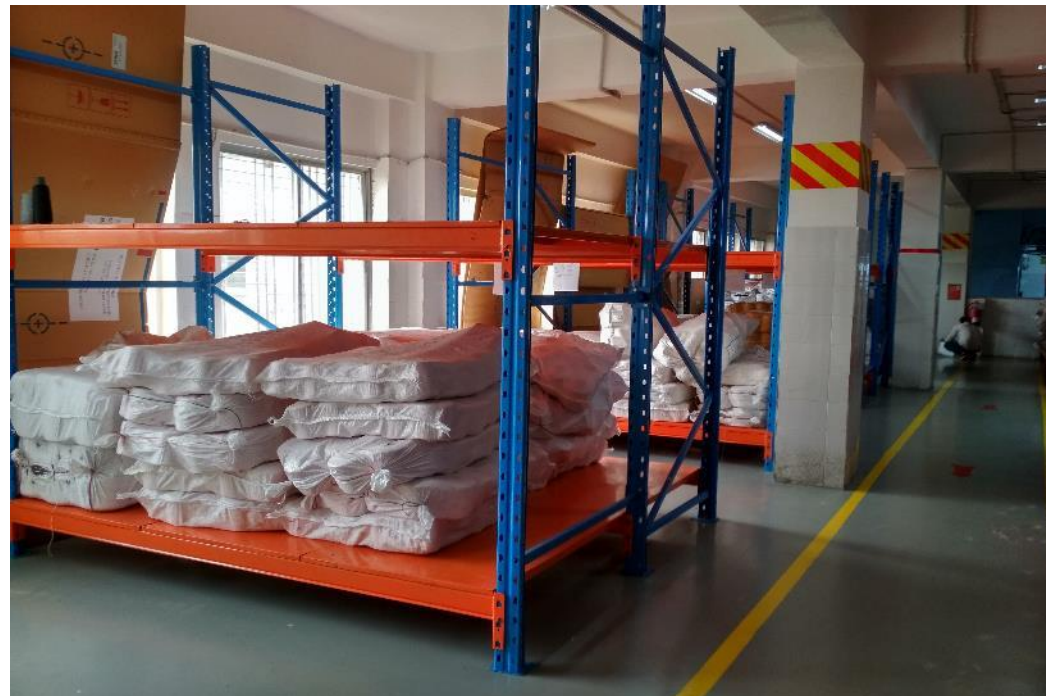
Observed live load 3 kPa

Cursory calculation indicates that column factor of safety is satisfactory considering 3 kPa live load and minimum concrete strength for stone chips aggregate.

Factor of Safety was found below normal design limit considering live load 5 kPa (mentioned in design report/live load plan) and minimum concrete strength for stone chips aggregate.

In design report and analysis model concrete strength of column is considered **33.8 MPa**. Calculation is not provided for the considered value of concrete strength. Also most of the concrete cylinder test report indicate that they were from slab.

| Item No. | Observation | Recommended Action Plan | Recommended Timeline |
|---|---|---|---|
| 2 | Review of design report.(Production Building) | Verify the existing concrete strength by taking minimum 4 nos 100 mm dia. core from columns or by credible concrete cylinder test reports from column. | 6-weeks |

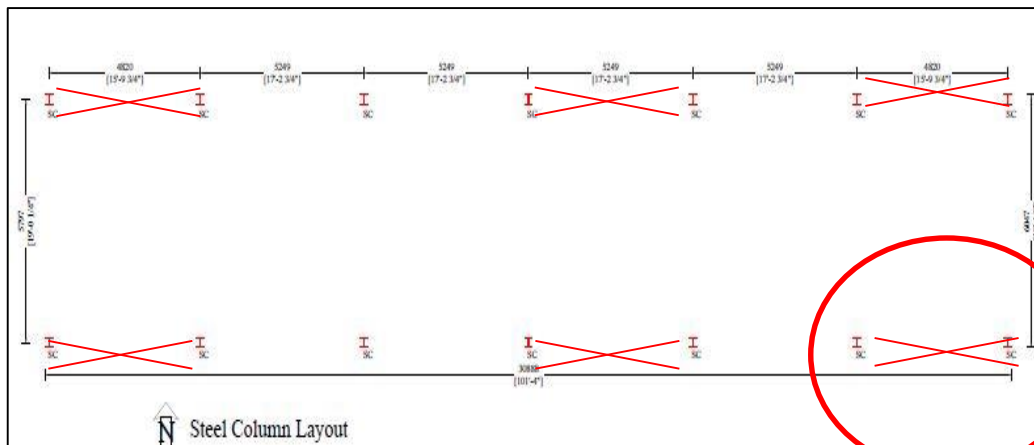
Bracing layout

Missing bracing

| Item No. | Observation | Recommended Action Plan | Recommended Timeline |
|---|---|---|---|
| 4 | Missing bracing & lateral stability of utility shed.(Utility Building) | Building engineer is required to check the lateral stability for the existing bracing system. | 6-weeks |
| 5 | Missing bracing & lateral stability of utility shed.(Utility Building) | Install missing bracing. | 6-weeks |

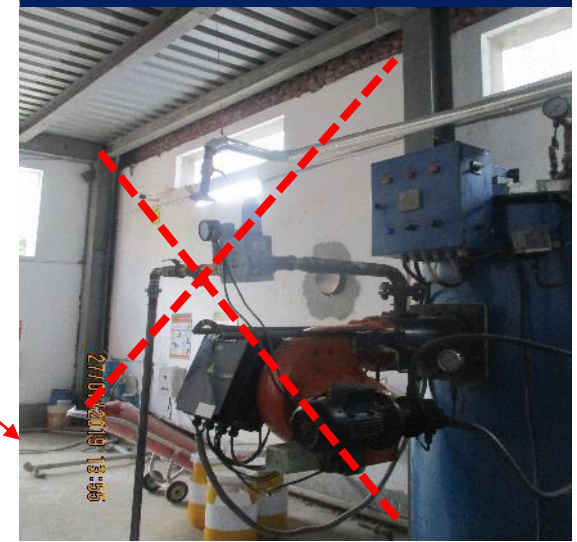
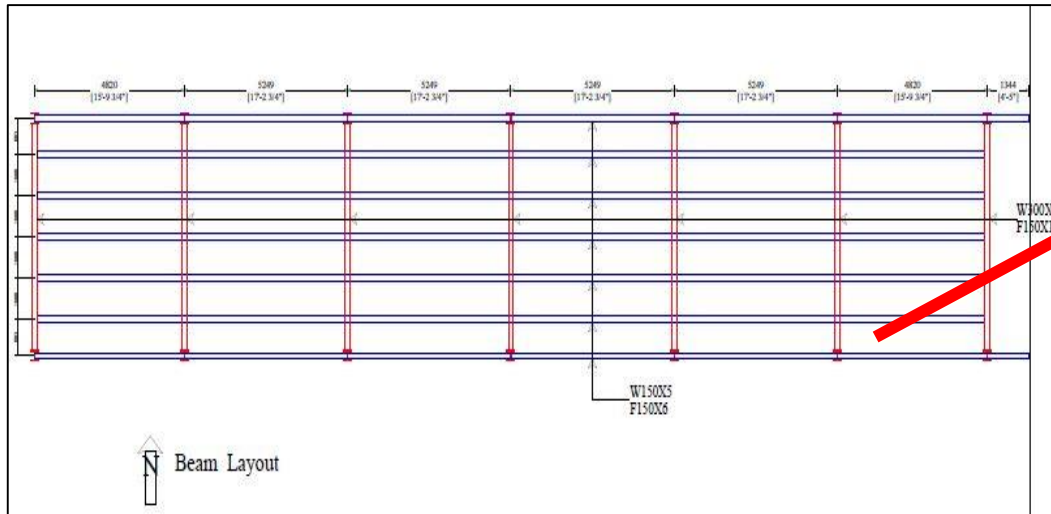
Beam Layout

Number of beams in long direction are not matched. Six beams were observed instead of seven beams.

| Item No. | Observation | Recommended Action Plan | Recommended Timeline |
|---|---|---|---|
| 7 | Inconsistency in as-built drawing. (Utility Building) | Building engineer is required to produce an accurate as-built drawings. | 6-weeks |

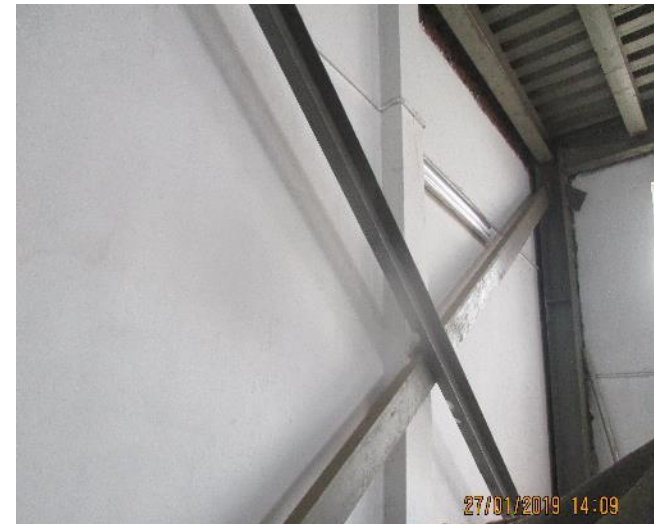
C section( 150 X 75 X 5) instead of  
W section(W:100 X 4 F:100X5)

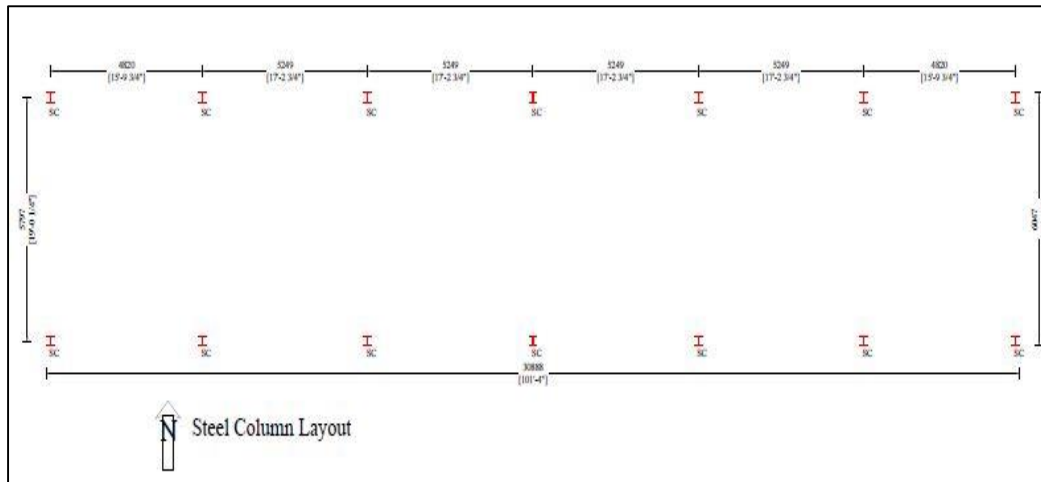
Grid dimension did not match with as-built condition

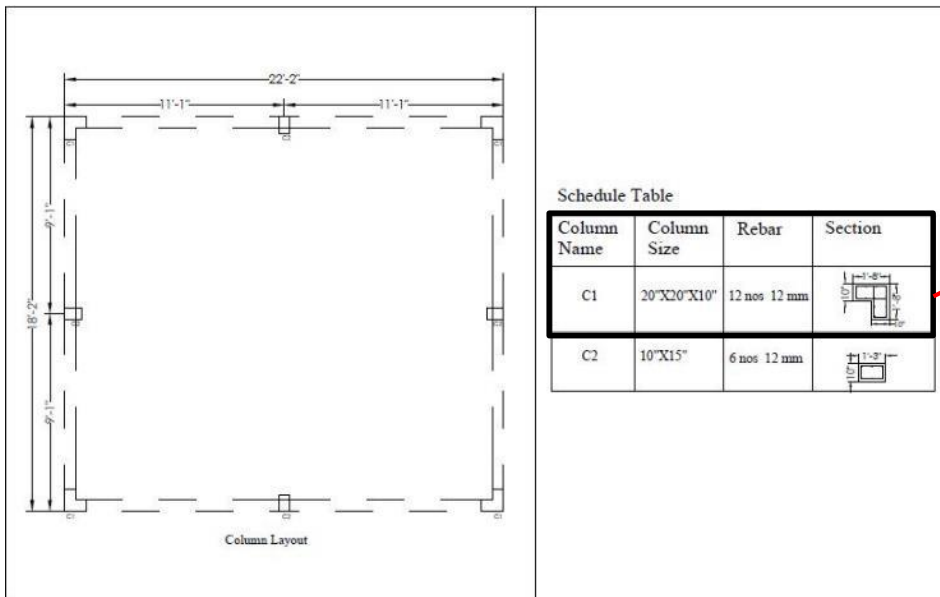
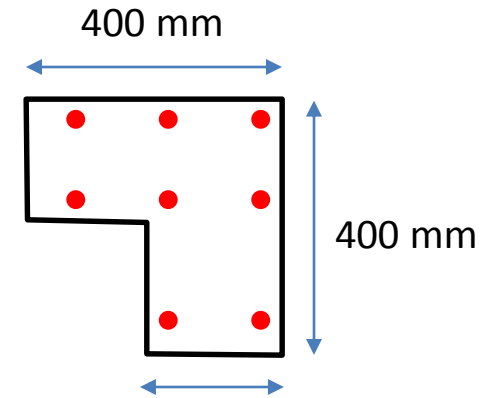
Column size was measured 400mm instead of 450 mm. Also number of rebar counted 10 instead of 12.

| Item No. | Observation | Recommended Action Plan | Recommended Timeline |
|---|---|---|---|
| 8 | Inconsistency in as-built drawing. (Fire pump room) | Building engineer is required to produce an accurate as-built drawings. | 6-weeks |

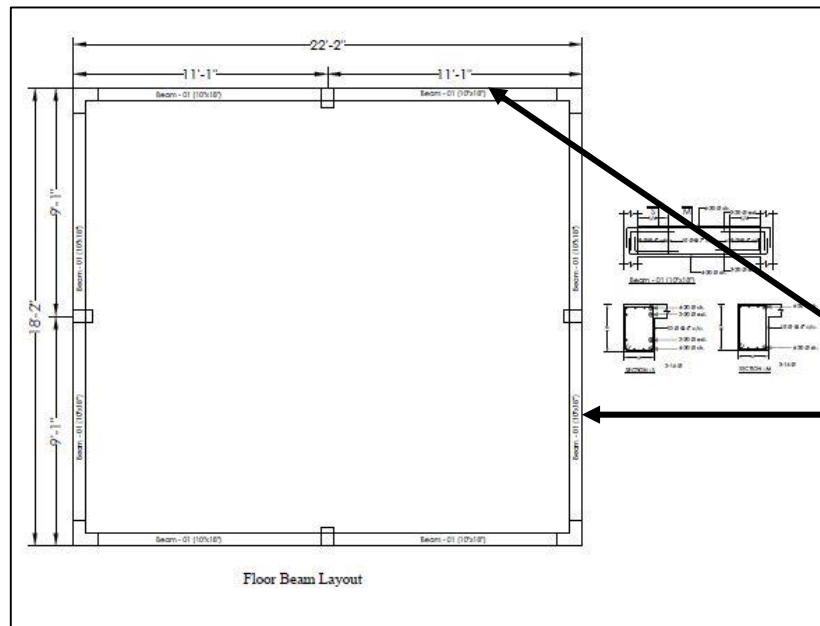
Presence of this beams was not indicative.
