# Bhuyan Warmtex (Pvt) Ltd.

Kadda Nandun, Kadda Bazar, Gazipur, Dhaka.

17<sup>th</sup> June 2014

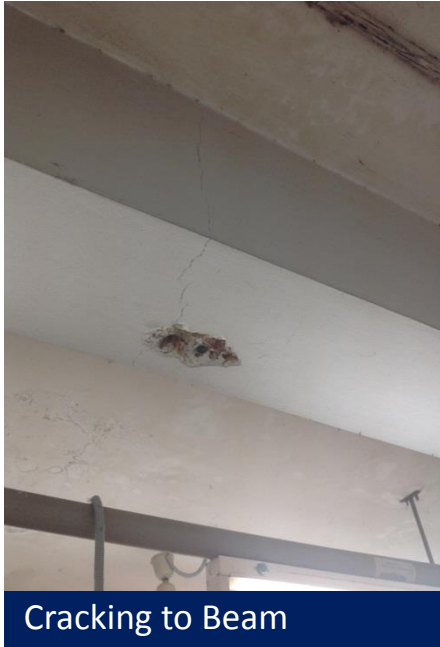
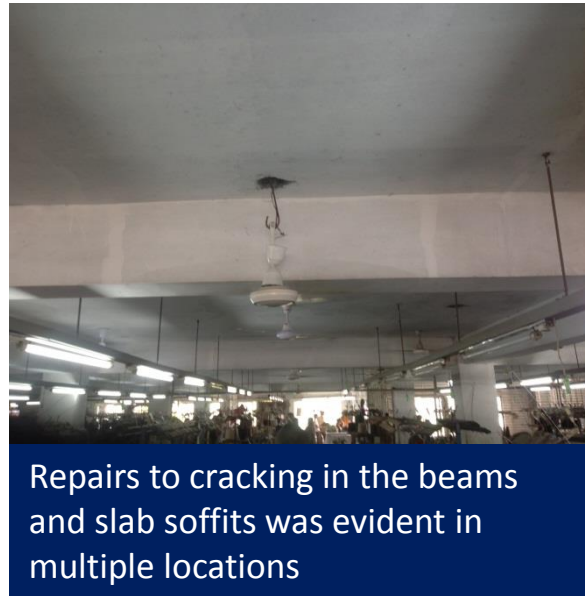
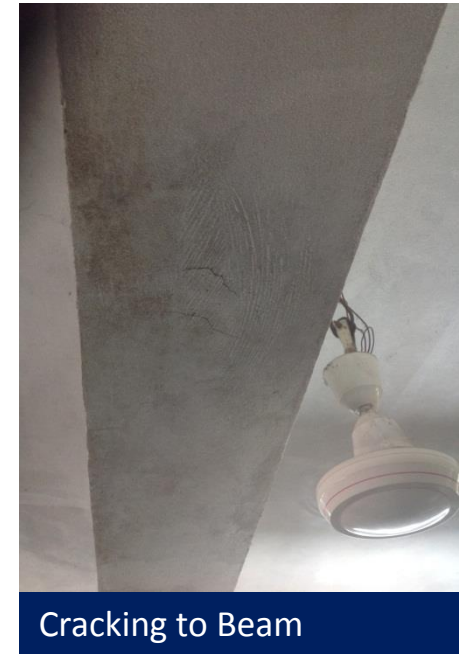
## Building 1 – Cracking observed

Cracking was observed on a number of the structural beams and on the slab soffits of each suspended level.

| Item No. | Observation | Recommended Action Plan | Recommended Timeline |
|---|---|---|---|
| 1 | Cracking to structural elements observed | Sections of render to be removed to investigate if cracks penetrate the building structure. | 6-weeks |
| 2 | Cracking to structural elements observed | Building Engineer to monitor location of all cracks and ensure that, where required, remedial works are carried out. | 6-months |

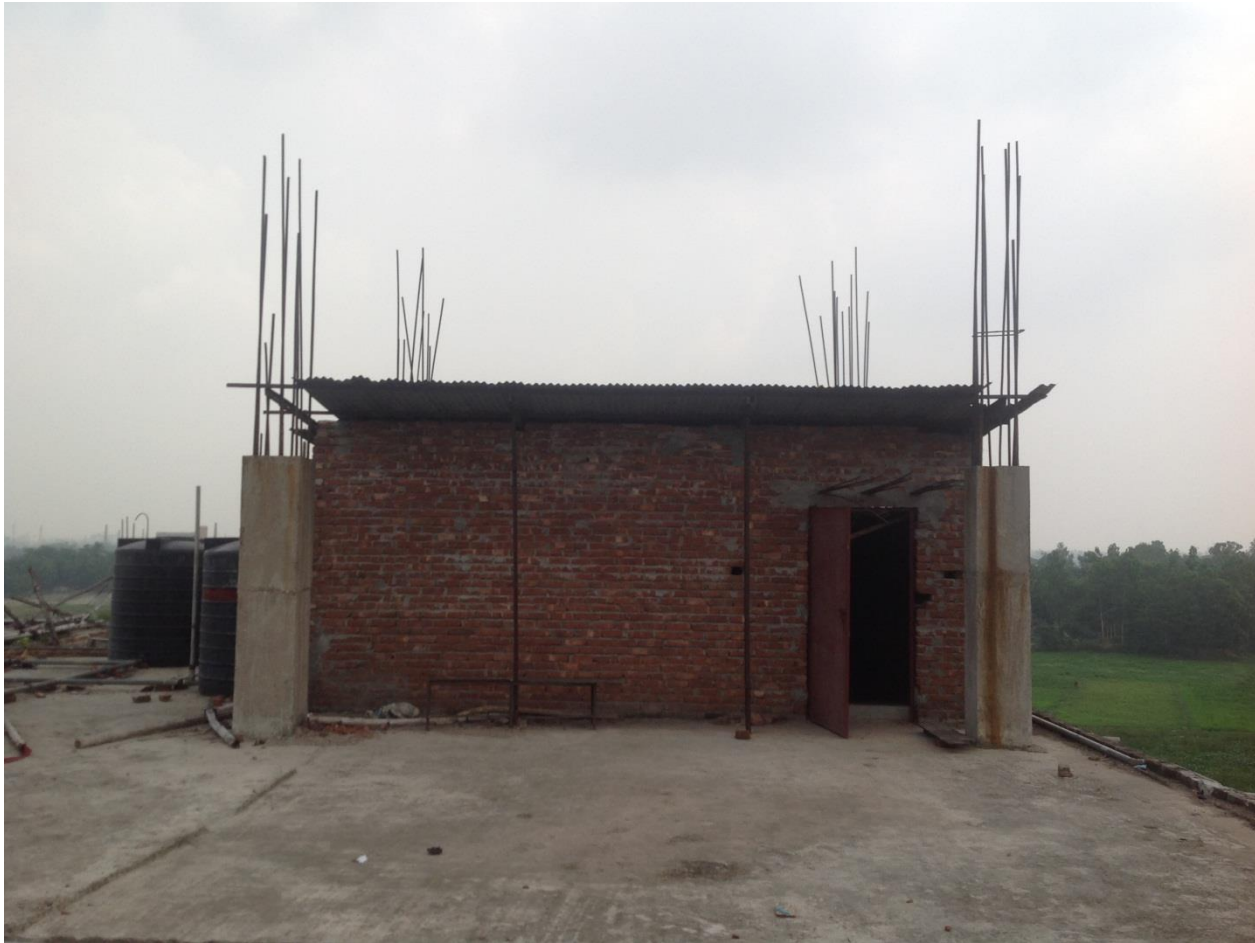
## No Perimeter Protection to Roof

No handrail or edge protection provided at roof level and no access restrictions

| Item No. | Observation | Recommended Action Plan | Recommended Timeline |
|---|---|---|---|
| 3 | Edge protection to roof slab | Handrails to be provided to roof or access to be prohibited to area. | 6-weeks |

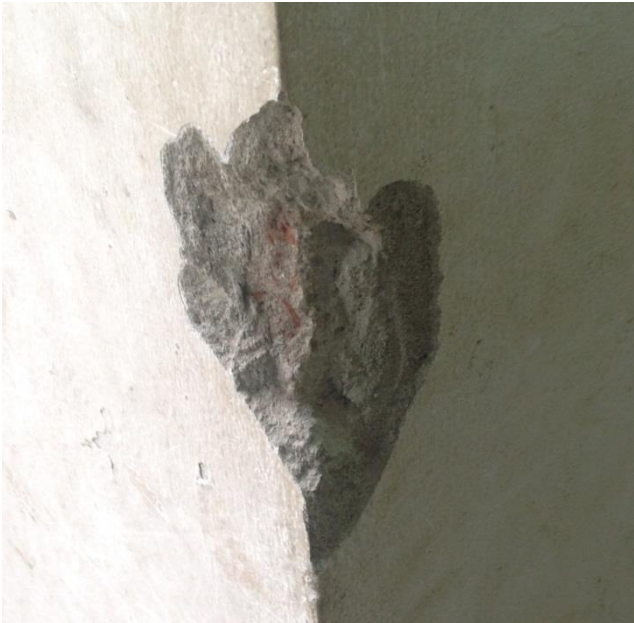
Testing of columns confirmed brick aggregate.

Cursory calculations indicate that working stresses exceed normal acceptable levels in columns. Building Engineer to perform detailed calculations based on “as built” dimensions and loadings. Material data from concrete tests to prove column strength.

| Item No. | Observation | Recommended Action Plan | Recommended Timeline |
|---|---|---|---|
| 5 | Cursory calculations indicate columns to be stressed in excess of normal design limits. | Verify insitu concrete stresses either by 4 no. 100mm dia. Cores or existing cylinder strength data for the columns | 6-months |

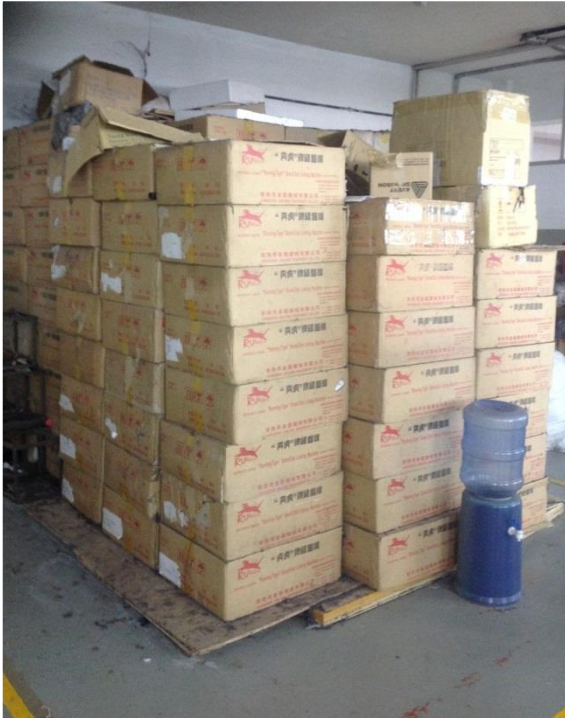
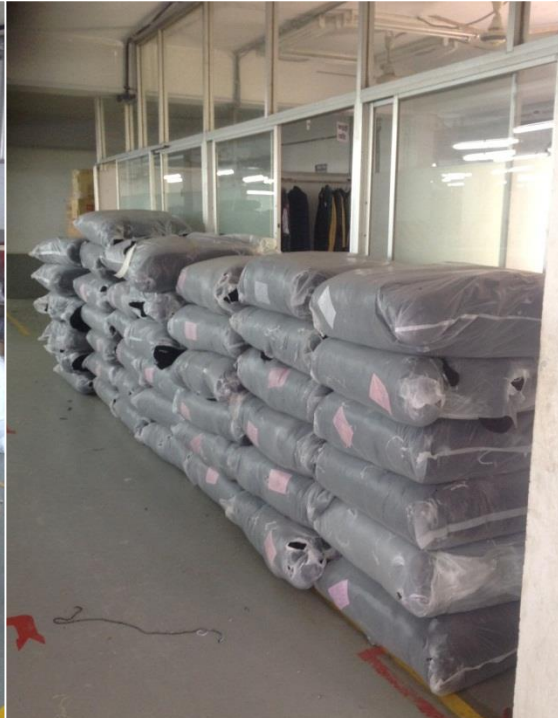
Examples of stacked material on factory floor

High loads were observed in the bonded warehouse on first floor. Controlled stacking of raw material was also observed in areas outside the bonded warehouse on first floor. Building engineer to produce a loading plan for all floors giving consideration to floor and column capacity

| Item No. | Observation | Recommended Action Plan | Recommended Timeline |
|---|---|---|---|
| 7 | Localised areas of high loading | Produce and actively manage a loading plan for all floor plates within the factory giving consideration to floor capacity and column capacity. | 6-months |

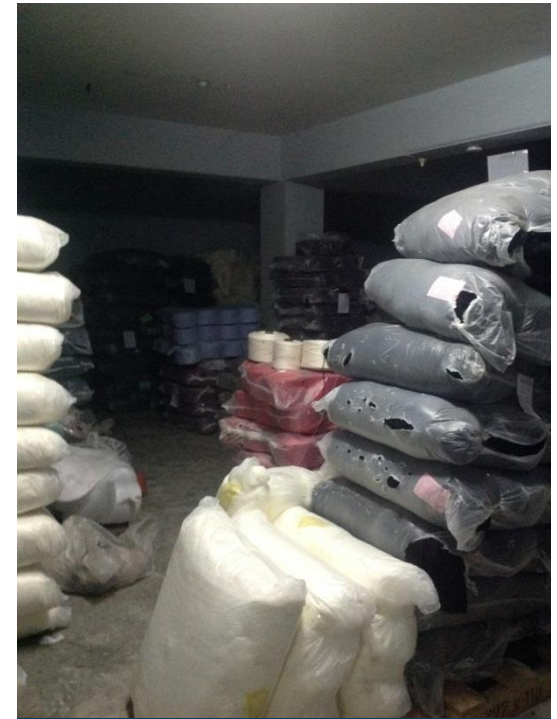
Stored material in bonded warehouse

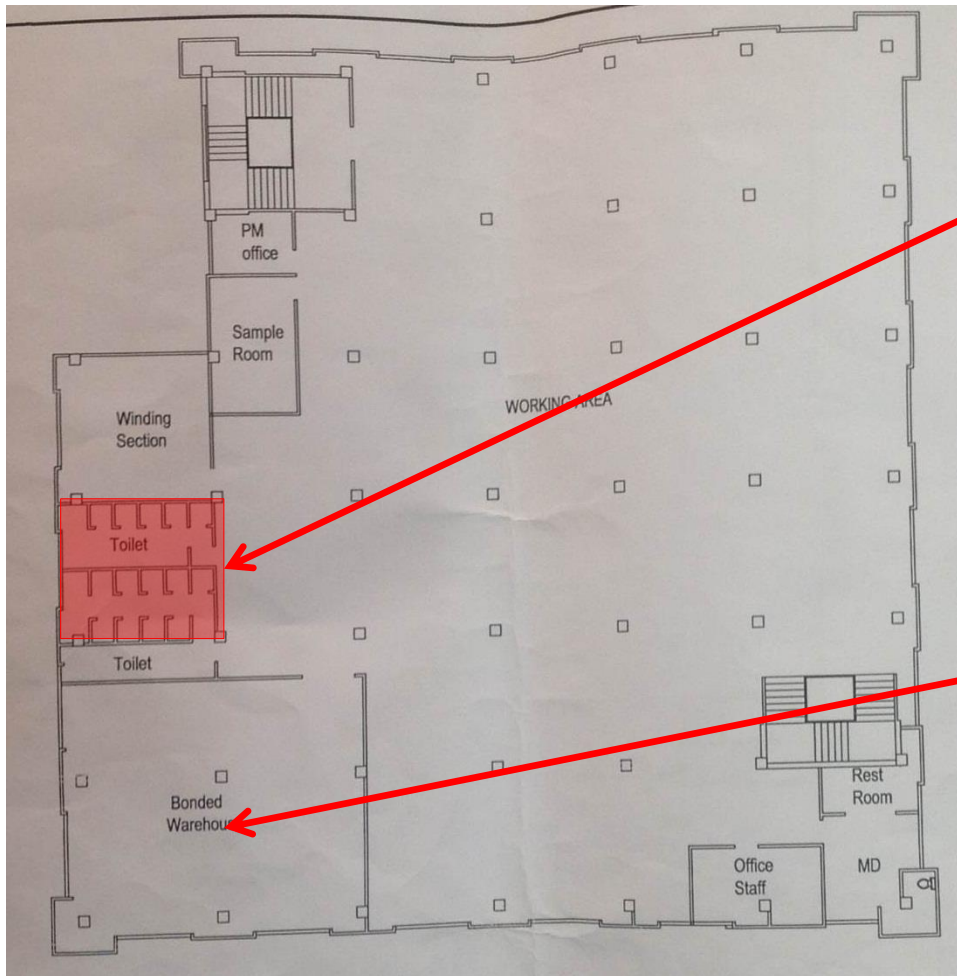
## Drawing Discrepancies

Toilet block location on structural/architectural drawings do not match industrial permit drawings

Internal floor layout and brick partitioning not correctly represented on drawings. Bonded warehouse layout different to that shown on drawings

| Item No. | Observation | Recommended Action Plan | Recommended Timeline |
|---|---|---|---|
| 9 | Inconsistencies noted between drawings and as built construction | Building Engineer to prepare a set of “as built” drawings. | 6-months |

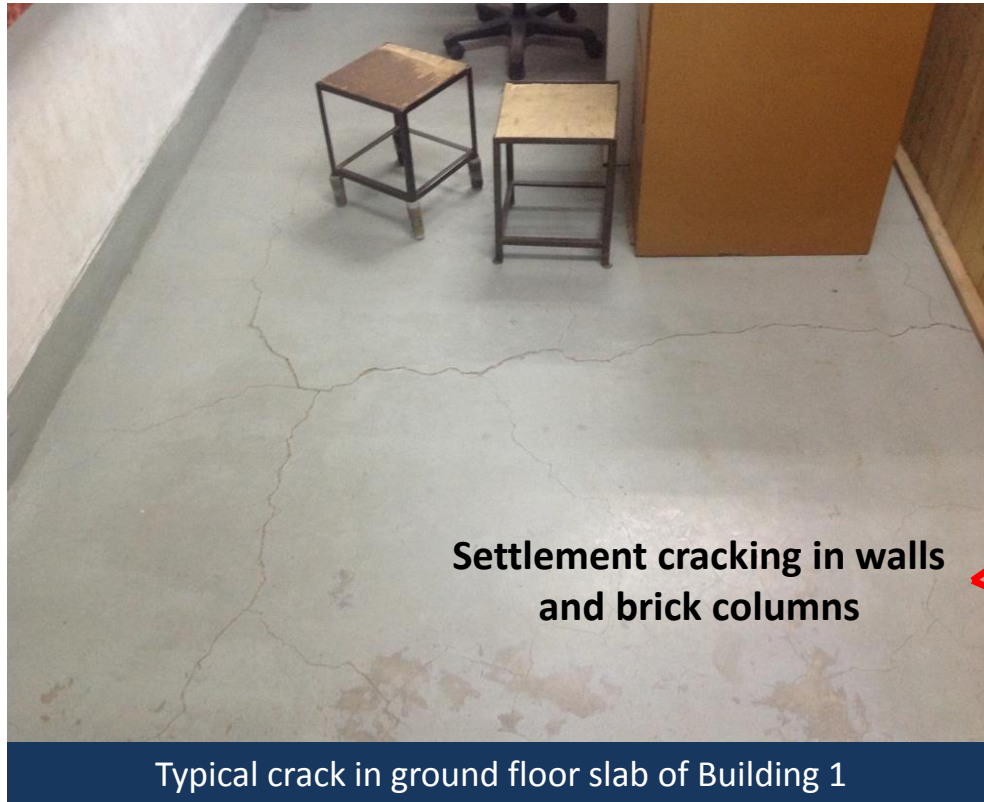
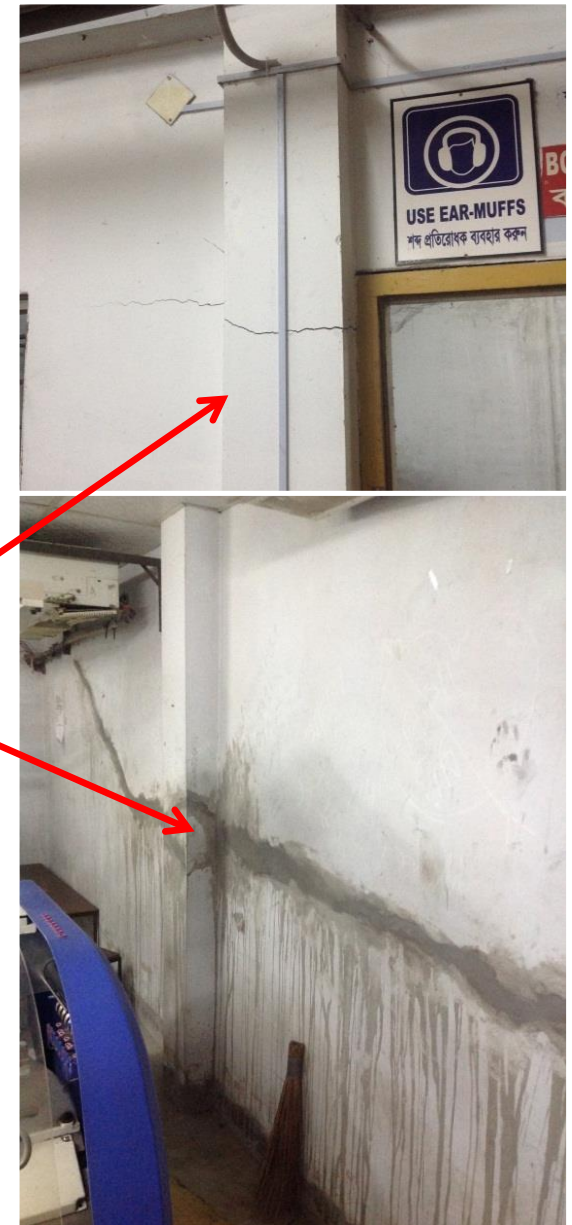
Cracking was observed throughout the ground floor slab of Building 1. This cracking may be due to settlement of the slab. Evidence of settlement cracking was also observed in the internal brick partitions on the ground floor. Masonry above ground floor did not appear to exhibit the same degree of movement.

| Item No. | Observation | Recommended Action Plan | Recommended Timeline |
|---|---|---|---|
| 10 | Cracking in ground floor slab and masonry walls | Cracks to be monitored by factory engineer and repaired as required, should cracking continue building engineer to review and propose remedial works required. | 6-months |

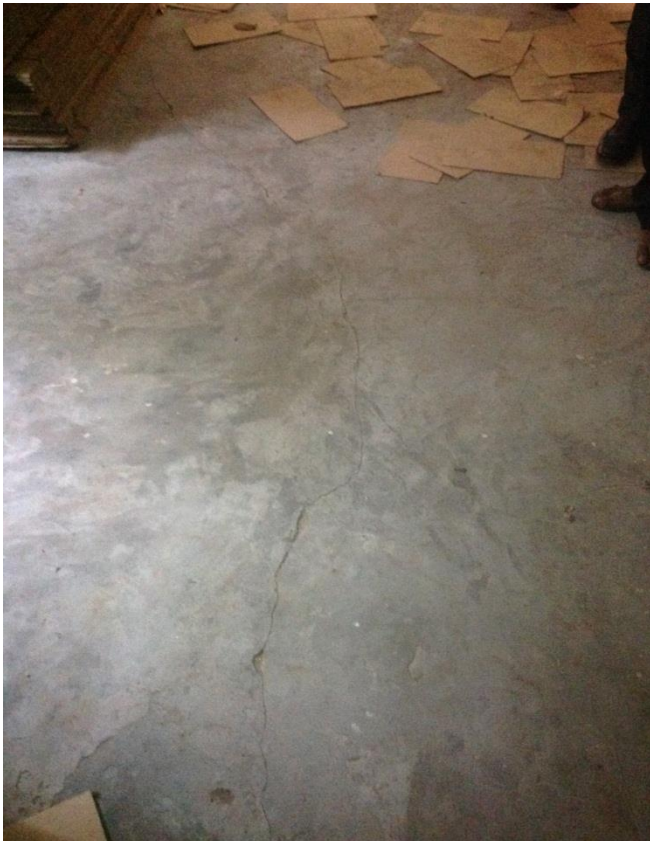
Building 3 cracking to ground floor slab

Cracking was observed in the ground floor slabs of the support buildings, cracking may be due to settlement. Evidence of settlement cracking was also observed in the masonry walls.

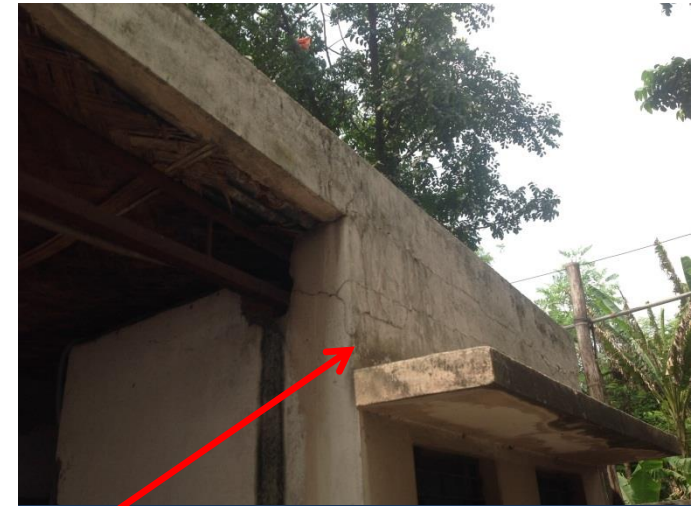
Cracking to walls of Building 2

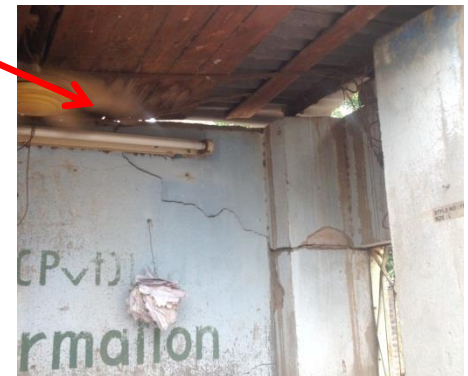
Cracking to wall and brick  
column in Guard House

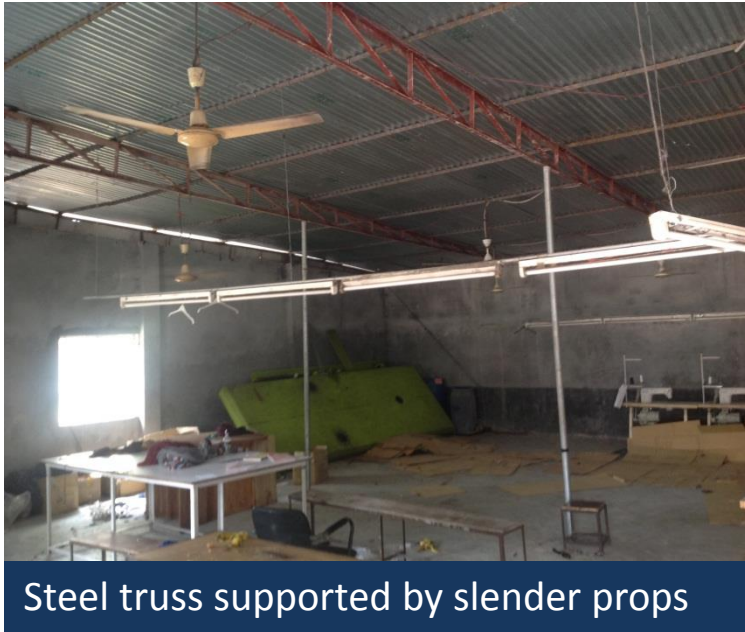
Steel truss supported by slender props

- Overall stability of the roof structures does not appear to have been considered
- Connection details between roof trusses and walls/columns appear inadequate in some locations
- Section sizes used appear to be slender
- Internal props appear slender and not adequately connected at both ends.

Building Engineer to review stability of these structures and propose strengthening works.

| Item No. | Observation | Recommended Action Plan | Recommended Timeline |
|---|---|---|---|
| 11 | Apparently non-engineered lightweight structures | Building engineer to check the capacity of non-engineered structures under horizontal and vertical loading and make any necessary alterations. | 6-months |

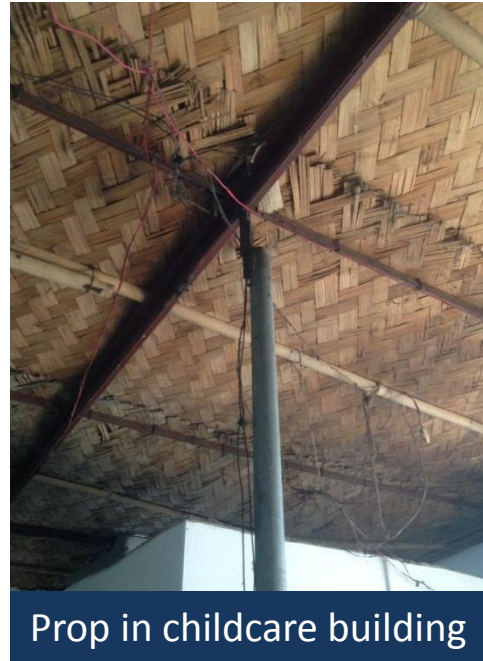
Prop in childcare building

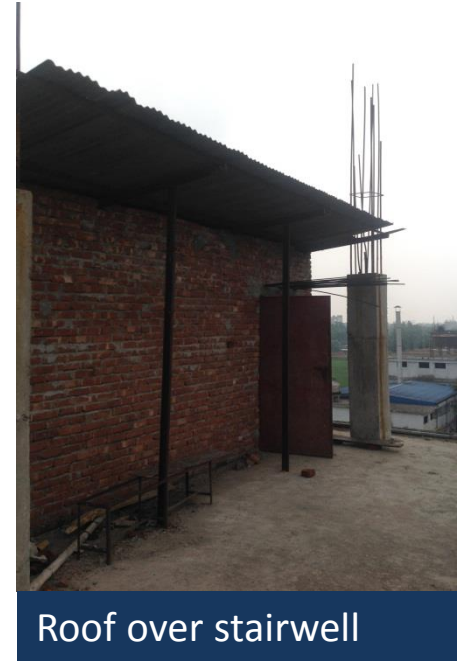
Roof over stairwell
