FIRE SAFETY INSPECTION REPORT

PACIFIC CASUALS LTD.

ACCORD ID: 23763

Date: 05 August, 2019

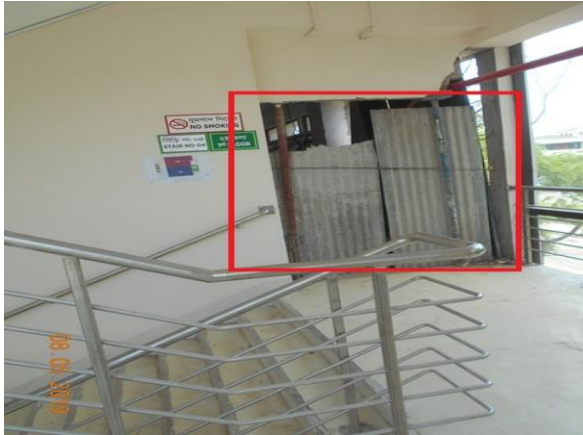
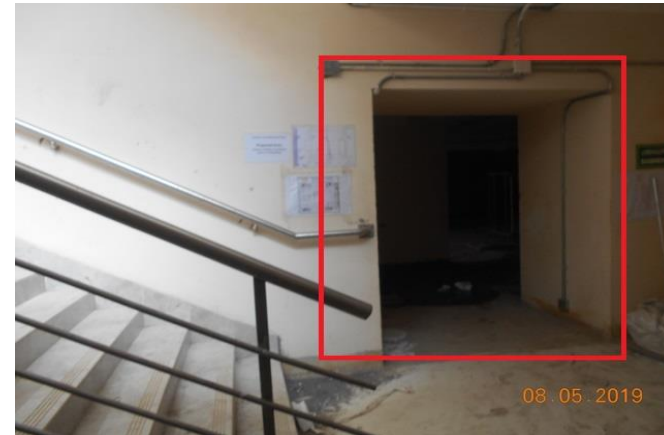
SI No.	Category	Findings	Required Action	Remediation Time Frame
F-1	Fire Rated Construction	Exit stairs are not separated from work areas & other spaces by fire-rated construction due to unprotected openings and penetrations. Location: basement & stair-4 on 1st & 2nd floors.	Provide minimum 1.5-hr fire rated doors and seal all unprotected openings to separate the exit stairs from work areas and other building spaces on all floor levels. Ensure that the fire rated doors are self-closing and positive latching and that they are provided with fire exit (panic) hardware where serving production floors. If fire rated doors are required to be held open for functional reasons, provide automatic closing devices tied to the fire alarm system. Once fire doors are installed, every door in a stair enclosure serving more than 5 stories shall be provided with re-entry unless it meets ACCORD standard 6.8.3.1	Within 6 months

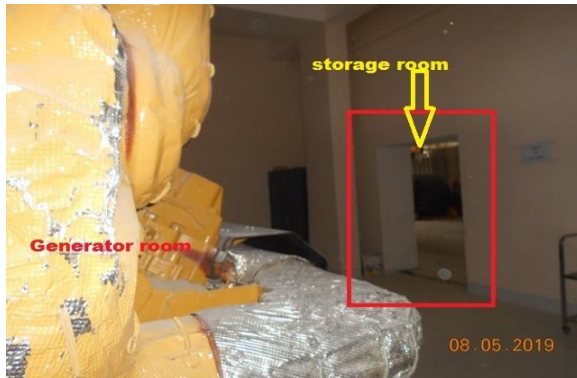
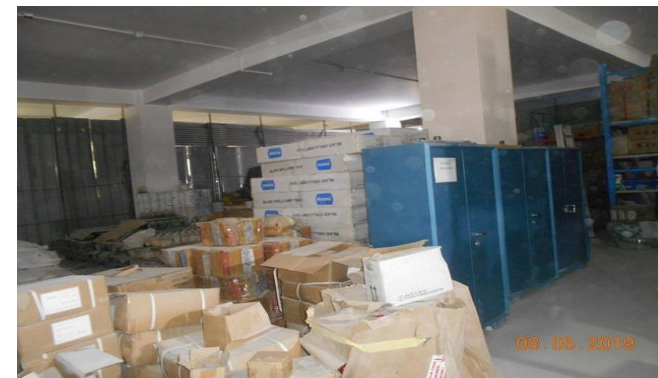
F-2	Fire Rated Construction	<p>Room used for combustible storage is not separated by fire rated construction(opening) on ground floor.</p> <p>Location: between storage room & utility (generator room)</p>	Provide dedicated storage room separated by minimum 1-hr fire-rated construction.	Within 3 months
-----	-------------------------	--	---	-----------------

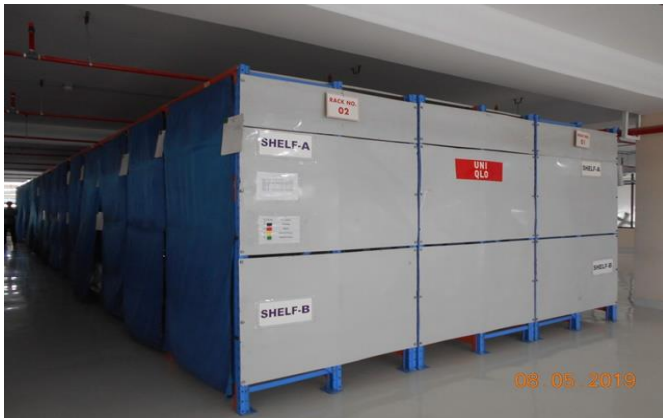
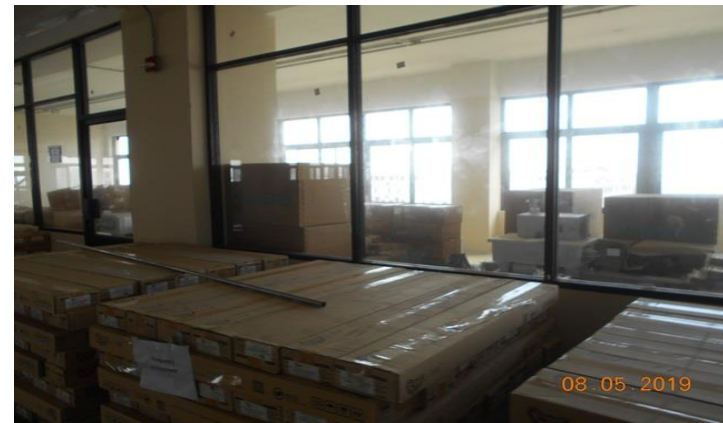
F-3	Fire Rated Construction	<p>Areas used for combustible storage are not separated by fire rated construction. Location: 2nd floor.</p>	<p>Provide dedicated storage rooms separated by minimum 1-hr fire-rated construction. Where separate storage rooms are not feasible, provide defined storage areas and limit the storage arrangement as follows: - Maximum height of 2.4m and maximum area of 23m² - If sprinkler protected: maximum height of 3.66m and maximum area of 93m² Separate areas of unenclosed combustible storage by a minimum clear distance of 3m.</p>	Within 3 months
-----	-------------------------	--	---	-----------------

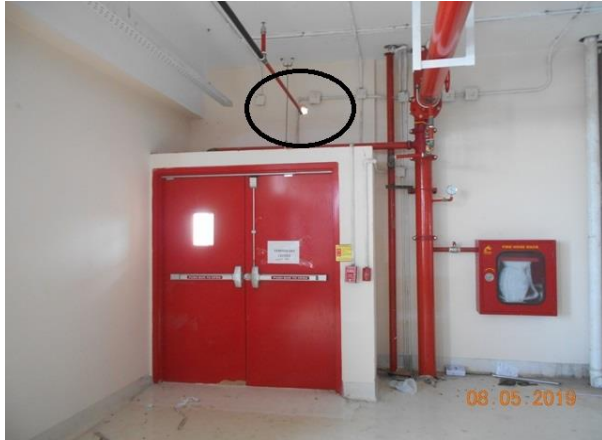
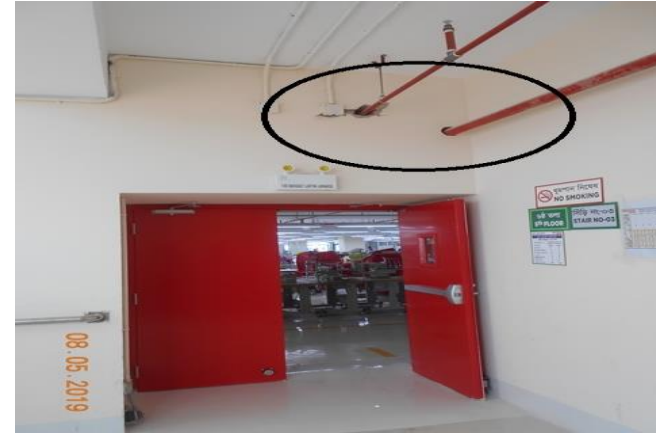
F-4	Fire Rated Construction	<p>Unsealed penetrations and openings are located in the exit stair enclosures.</p>	<p>Seal all penetrations and openings in exit stair enclosure walls to maintain the fire separations.</p>	Within 3 months
-----	-------------------------	---	---	-----------------

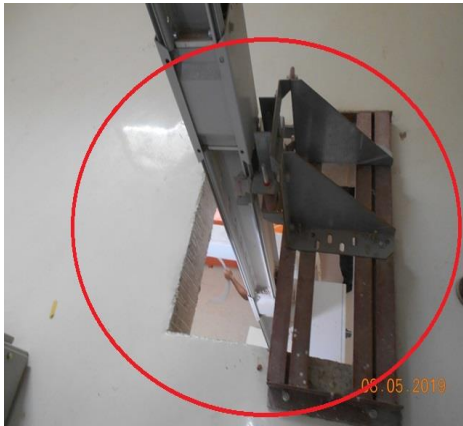
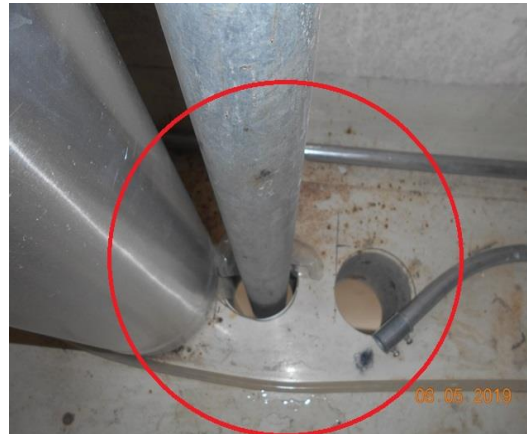
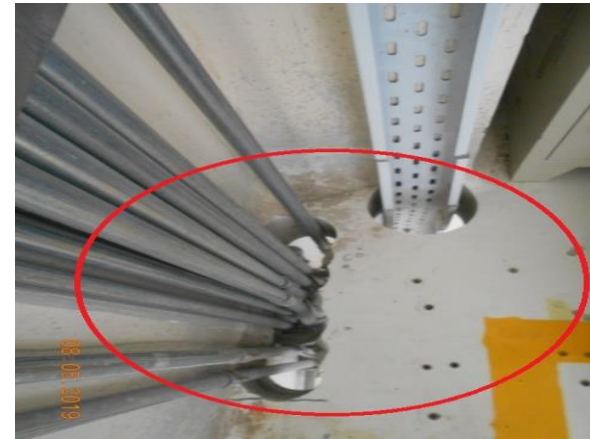
F-5	Fire Rated Construction	Unsealed penetrations and openings are located in the fire rated floor/ceiling assemblies. Location: Electrical & mechanical shafts.	Seal all penetrations and openings in floors/ceiling assemblies to maintain the fire separation.	Within 3 months
-----	-------------------------	--	--	-----------------

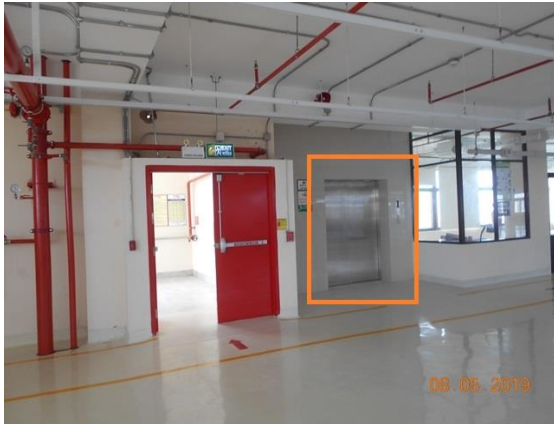
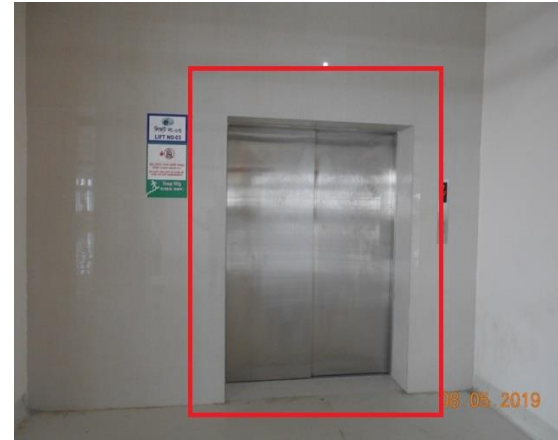
F-6	Fire Rated Construction	The elevator [two no's] discharges inside the production floor.	<p>Provide a minimum 2-hr fire rated construction to separate the elevator shaft from each floor level. Seal all penetrations and openings in floors/ceiling assemblies to maintain the fire separation.</p> <p>Or</p> <p>Submit proper certifications for installed elevator doors to the ACCORD for approval. If not available, or certification is not approved, install new, properly certified fire rated doors in accordance with ACCORD direction.</p>	Within 3 months
-----	-------------------------	---	---	-----------------

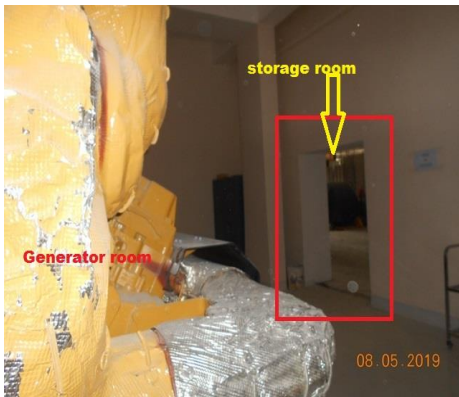
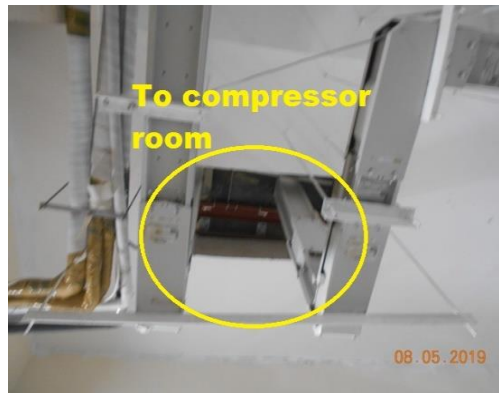
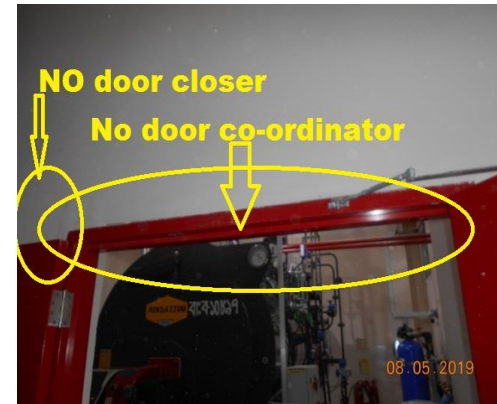
F-7	Fire Rated Construction	<p>The[boiler/generator/transformer/air compressor] room is not separated by fire rated construction (openings & penetrations) Location: On ground floor between sub-station & compressor room (1st floor), generator to storage room, door co-ordinator missing for boiler to generator room.</p>	<p>Specify appropriate upgrade based on conditions: -Separate the boiler room by a minimum 2-hr fire rated construction (for high rise building)/ 1-hr fire rated construction (for low rise building). Seal and/or protected all openings to maintain fire separations. -Separate the [generator/transformer/EMR/gas meter/air compressor] room by a minimum 2-hr fire rated construction. Seal and/or protected all openings to maintain fire separations.</p>	Within 3 months
-----	-------------------------	---	--	-----------------

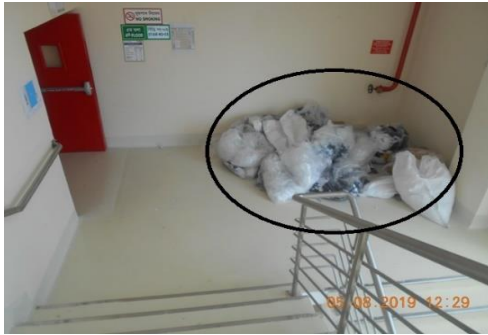
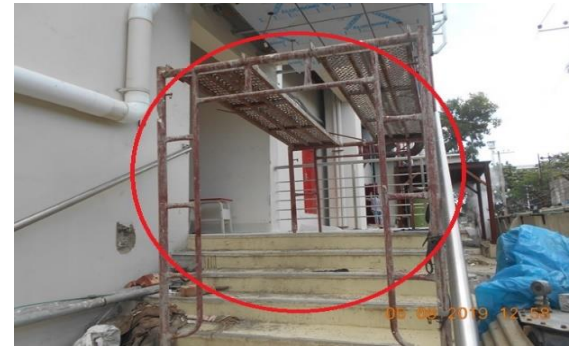
F-8	Egress	<p>Storage was located in the exit stair-3. Location: 4th & ground floors.</p>	Remove storage from the exit stairs and egress path	Immediate
-----	--------	--	---	-----------

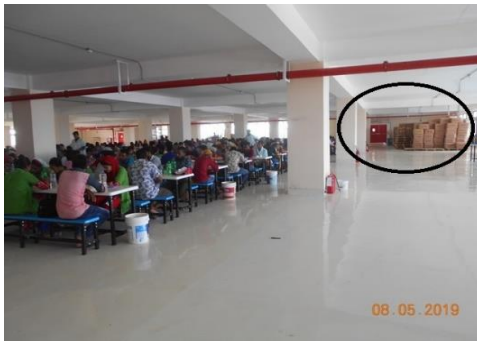
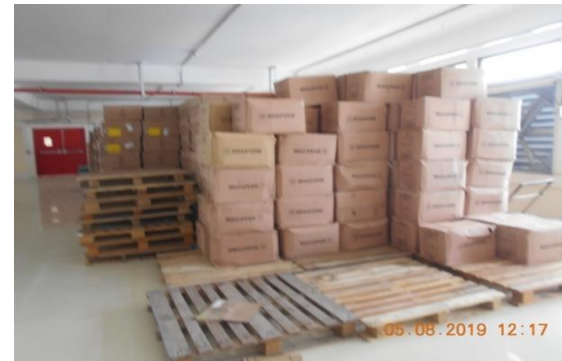
F-9	Egress	Storage located in the dining area. Location: 7th floor.	Remove storage from the dining area.	Immediate
-----	--------	--	--------------------------------------	-----------

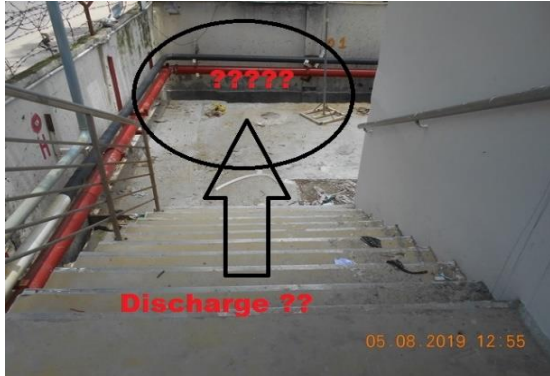
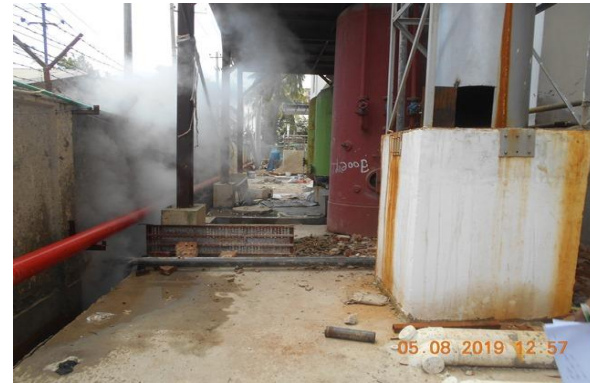
F-10	Egress	Exit stairs do not discharge directly to the outside. Location: East side stairs 3 &4.	Specify appropriate upgrade based on conditions: -Modify stair to discharge directly outside. -Provide 2-hr fire rated exit passageway leading directly outside (vestibules to separate any storage area).	Within 6 months
------	--------	--	---	-----------------

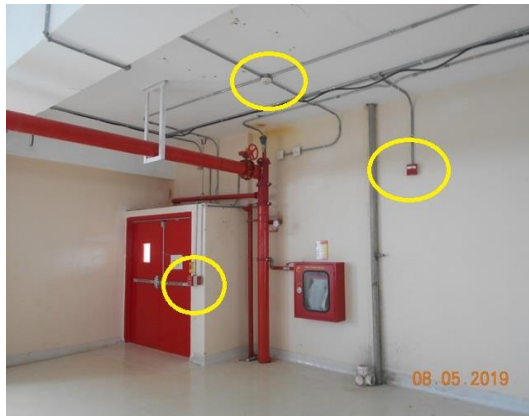
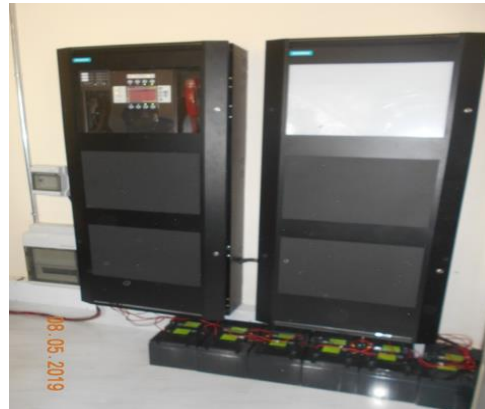
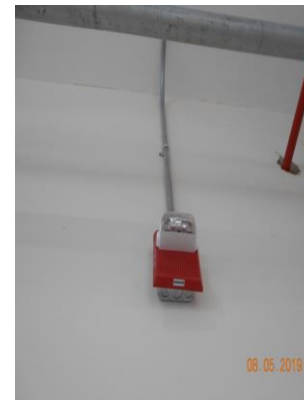
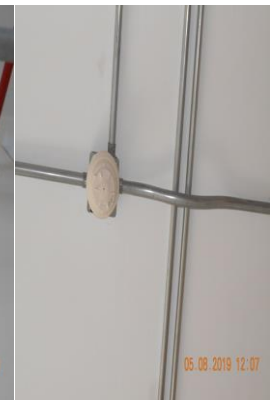
F-11	Fire Detection and Alarm System	Automatic fire alarm & detection system installation requires detailed review to confirm compliance with NFPA 72 and ACCORD standards.	Submit the as-built design of fire alarm system to Accord in accordance with NFPA 72. Installation shall be as per the reviewed design with a listed Addressable Fire Alarm System.	Within 3 months
------	---------------------------------	--	--	-----------------

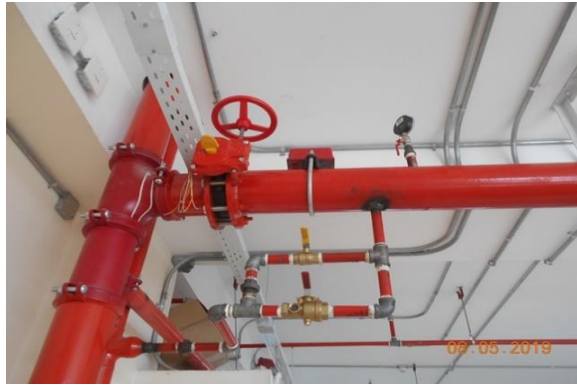
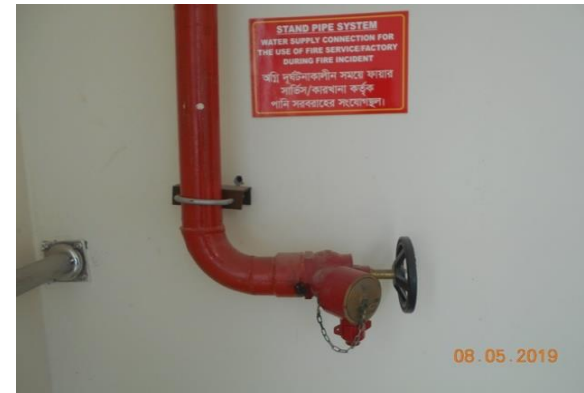
F-12	Fire Protection System	The high-rise building has an occupied floor greater than 23 meter (75 feet). Combined sprinkler system installation is going on (basement, ground, 1st & 7th floors)& it requires detailed review to confirm compliance with NFPA 13 & 14 and ACCORD standards.	Submit the as-built design of combined sprinkler system to Accord in accordance with NFPA 13&14. Installation shall be as per the reviewed design with a listed equipment's.	Within 6 months
------	------------------------	---	--	-----------------

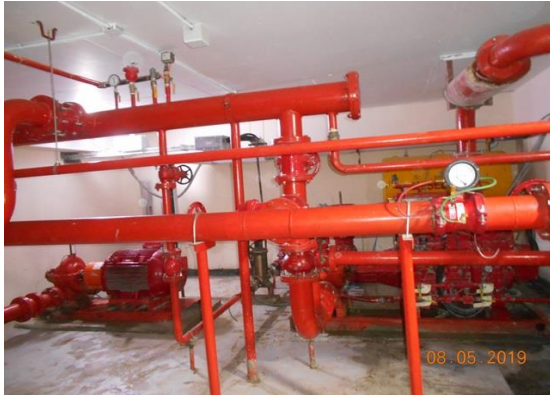
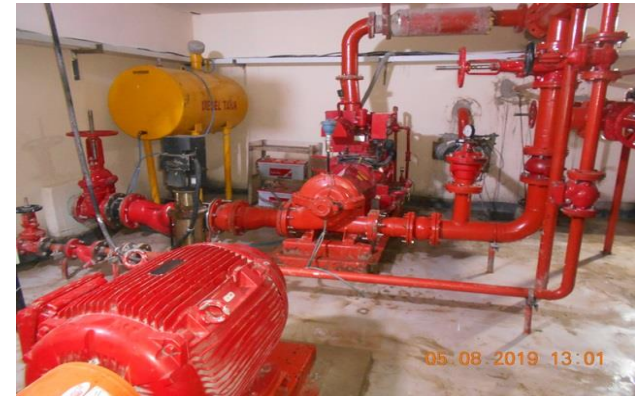
F-13	Fire Protection System	Fire pump installation requires detailed review to confirm compliance with NFPA 20 and ACCORD standards.	Submit the as-built design of fire pump system to Accord in accordance with NFPA 20. Installation shall be as per the reviewed design with a listed equipment's.	Within 3 months
------	------------------------	--	--	-----------------

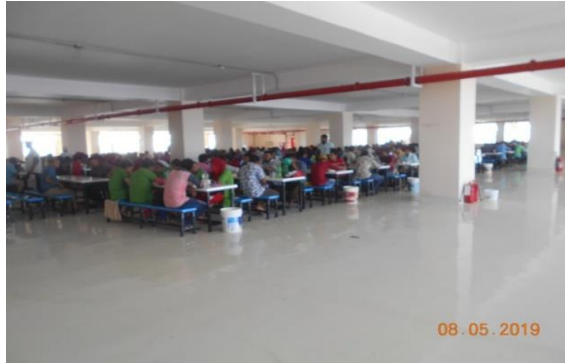
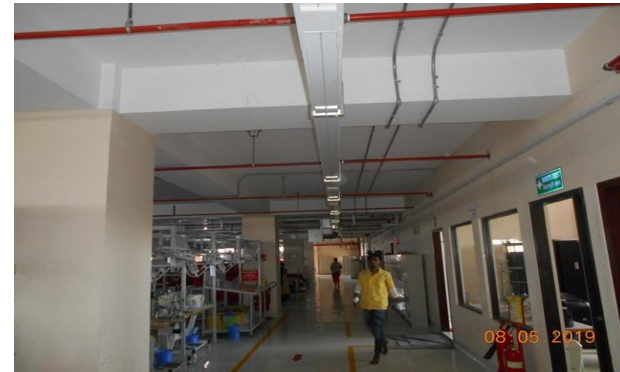
F-18	Egress exit sign	Exit sign not provided at exit. Location: 7th floor & utility area.	Provide exit signs above all exits to the exterior and all doors to the exit stair.	Within 1 month
------	------------------	---	---	----------------

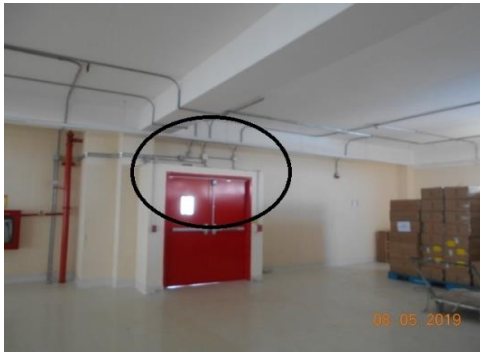
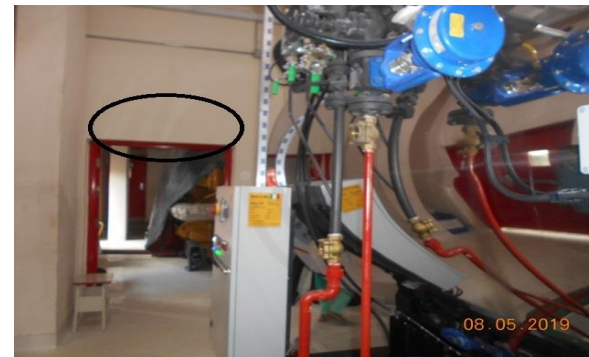
F-19	Directional Exit Sign	The directional signs are not provided where there is a change in direction and where the continuation of the egress path is not obvious. Location: All floors.	Install illuminated directional signs shall be provided where there is a change in the direction for the path of travel and the direction to an exit is not obvious.	Within 1 month
------	-----------------------	---	--	----------------

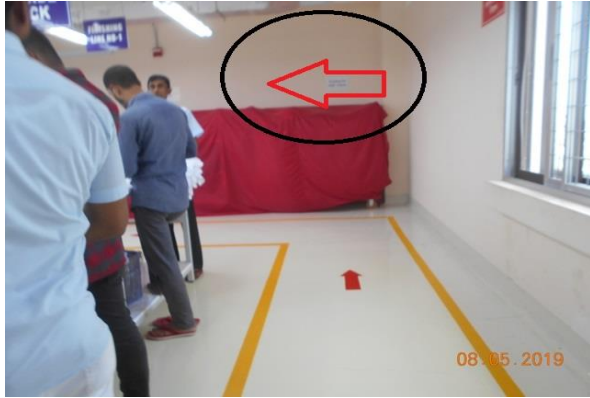
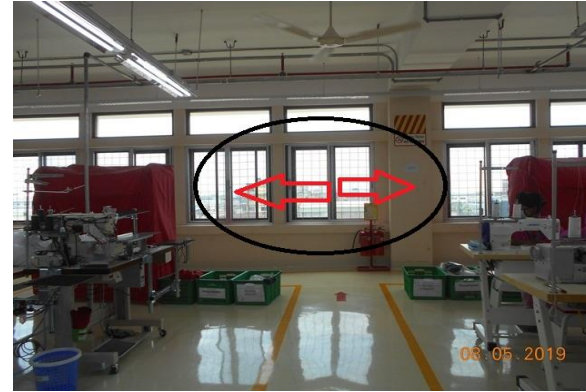
F-20	Non-Working Exit Signs	Exit signage not illuminated (burned out, broken, etc.). Location: stair-1 on 3rd floor.	Regularly inspect all exit signage and replace/install lights as needed to illuminate signs	Within 1 month
------	------------------------	---	---	----------------
