# **FIRE SAFETY INSPECTION REPORT**

**GRAPHICS TEXTILES LTD.  
SREERAMPUR, KALAMPUR, DHAMRAI**

**ACCORD**  
on Fire and Building Safety in Bangladesh

May 20, 2014

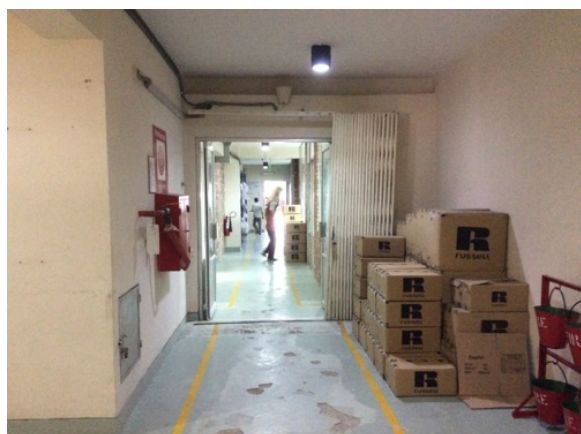
| No. | Category | Finding | Recommendation | Remediation Timeframe |
|---|---|---|---|---|
| F-1 | Fire Rated Construction | The exit stairs are not separated from work areas, and other spaces on each floor by fire-rated construction. This was reflected throughout the building on all floors. | <p>Provide minimum 1.5-hr fire rated doors and seal all unprotected openings to separate the exit stairs from work areas and other building spaces on all floor levels. Ensure that the fire doors are self-closing and positive latching and that they are provided with fire exit (panic) hardware where serving production floors.</p> <p>If fire doors are required to be held open for functional reasons, provide automatic-closing devices tied to the fire alarm system.</p> | Within 3 months |

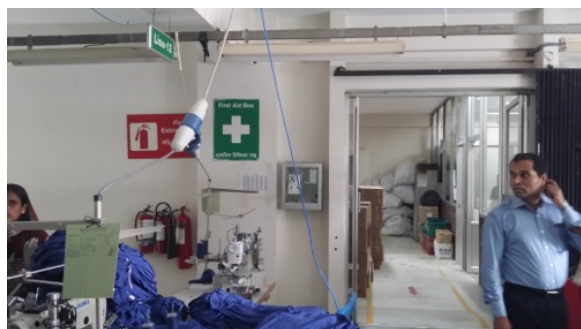
| F-2 | Fire Rated Construction | Areas used for combustible storage are not separated by fire-rated construction. This was reflected throughout the building on various floors. | <p>Provide dedicated storage rooms separated by minimum 1-hr fire-rated construction.</p> <p>Where separate storage rooms are not feasible, provide defined storage areas and limit the storage arrangement as follows:</p> <ul style="list-style-type: none"> <li>- Maximum height of 2.4m and maximum area of 23m<sup>2</sup></li> <li>- If sprinkler protected: maximum height of 3.66m and maximum area of 93m<sup>2</sup></li> </ul> <p>Separate areas of unenclosed combustible storage by a minimum clear distance of 3m.</p> | Within 3 months |

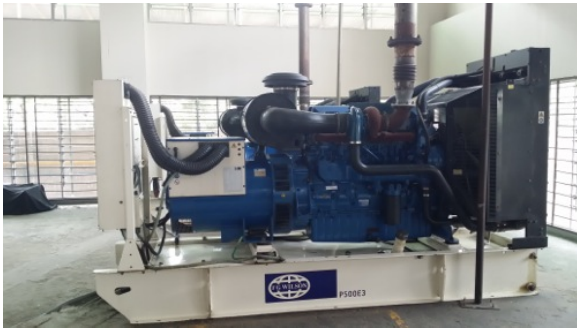
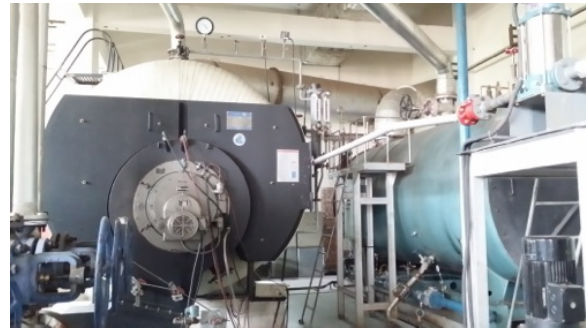
| F-3 | Fire Rated Construction | The boiler, and generator room located on the ground floor, is not separated by fire-rated construction, openings, non-rated doors, and penetrations. | <p>Separate the boiler, and generator room by a minimum 2-hr fire-rated construction. Seal and/or protected all openings to maintain the required fire separations</p> | Within 3 months |

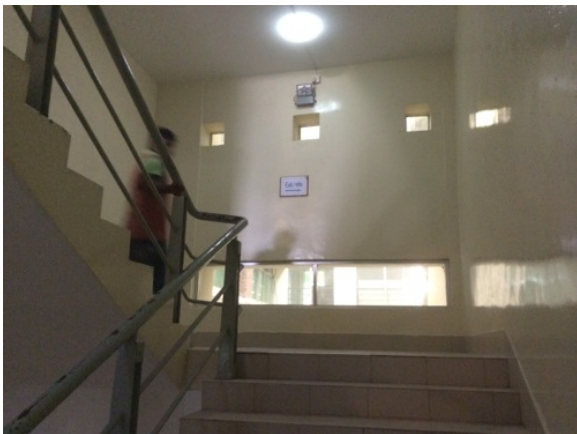
| F-4 | Fire Rated Construction | Unsealed penetrations and openings are located in exit stair enclosures. This was found in all stairwells on various floors. | Seal all penetrations and openings in exit stair enclosure walls to maintain the fire separation. | Within 3 months |

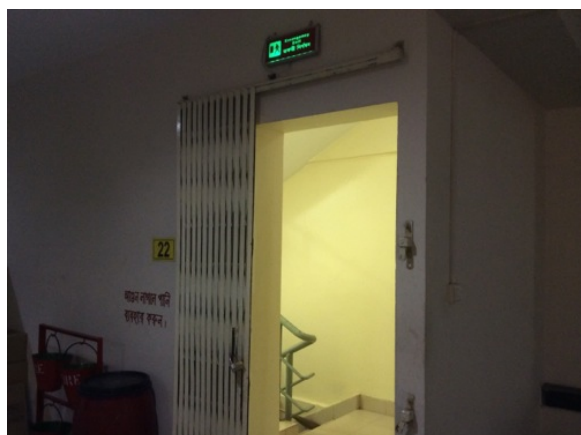
| F-6 | Egress | Egress doors / gates with locking features are provided at building exits, exit stairs, along egress routes, and exit discharge. This was reflected throughout the building on all floors. | Remove locking features from all egress doors / gates.<br><br>If locks are required for security reasons, utilize special door locking features complying with NFPA 101. | Immediate |

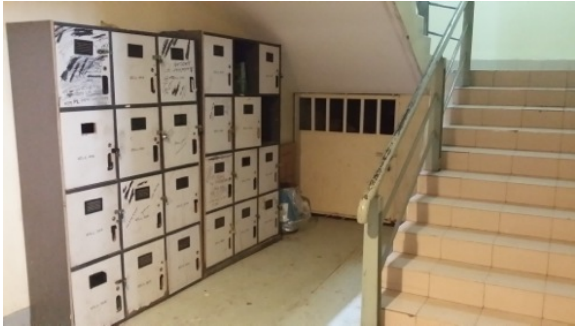
| F-7 | Egress | Storage areas were located in all exit stairwells on the ground floor, underneath the stairs. | Remove all storage from exit stairs and egress paths. | Immediate |

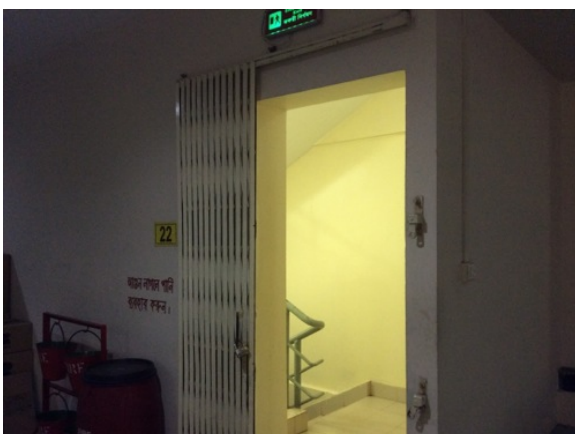
| F-8 | Egress | Collapsible gates / sliding doors are provided at building exits, exit stairs, along egress routes, and exit discharge. This was reflected throughout the building on all floors. | Replace all gates / sliding doors along the means of egress with side-hinged, swinging egress doors.<br><br>If locks are required for security reasons, utilize special door locking features complying with NFPA 101. | Within 1 month |

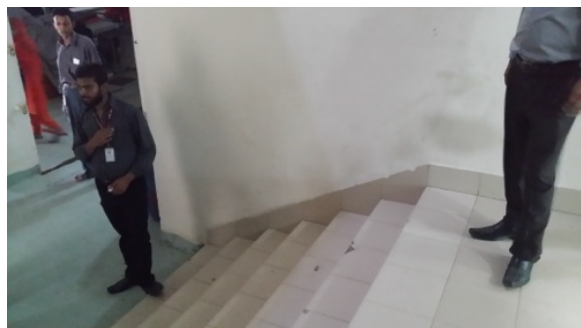
| F-9 | Egress | Handrails on both sides were not provided in each exit stairwell. | Provide handrails on both sides of exit stair. | Within 3 months |

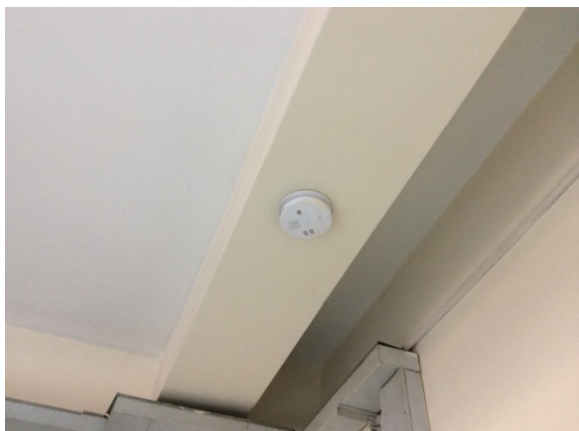
| F-12 | Fire Protection | The building is equipped with single-station smoke alarms. Smoke alarm activation sounds only a local alarm and does not provide automatic fire alarm notification of occupants. | Replace the single-station smoke alarms. Provide automatic smoke detection throughout the building in accordance with NFPA 72. | Within 6 months |

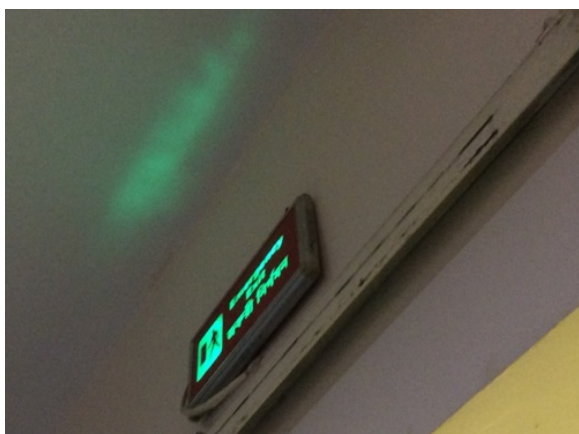
| F-13 | Egress Lighting | Manual on-off switch is provided for emergency lighting units. This was reflected throughout the building in various locations. | Remove manual on/off switches from emergency lighting units to prevent them from being switched off. | Within 1 month |

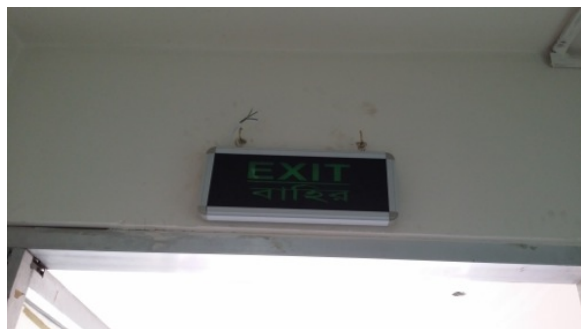
| F-14 | Egress Lighting | Exit signage not illuminated (burned out, broken, etc.). This was reflected throughout the building on various floors. | Regularly inspect all exit signage and replace/install lights as needed to illuminate signs. | Within 1 month |
