# FIRE SAFETY INSPECTION REPORT

## Maxcom International (BD) Ltd. (New Building)

ACCORD ID: 23747

Date: 25 August 2019

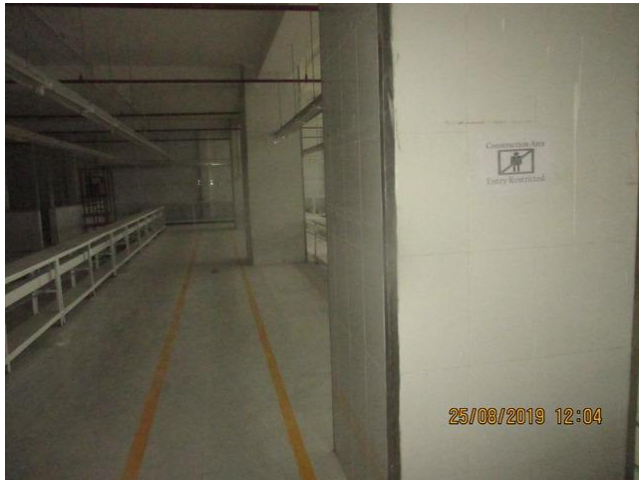
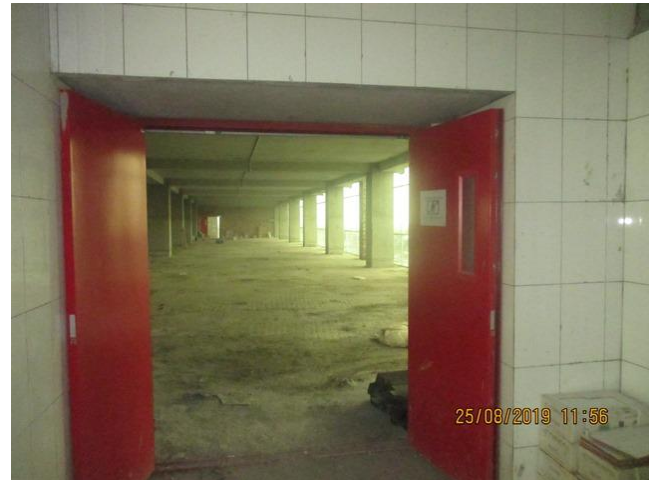
| No. | Category | Finding | Recommendation | Remediation<br>Timeframe |
|---|---|---|---|---|
| F-1 | Fire Rated Construction | Exit stair separation from work areas & other spaces on each floor by fire-rated construction is not completed. | <p>Separate the exit stairs from work areas and other building spaces on all floor levels by minimum 2- hr fire-rated construction. Provide minimum 1.5- hr fire rated doors and seal all unprotected openings and penetrations to maintain the fire separation.</p> <p>Ensure that all fire doors are self-closing and positive latching, and are provided with fire exit (panic) hardware where serving production floors or assembly occupancies.</p> <p>If fire doors are required to be held open for functional reasons, provide automatic-closing devices tied to the fire alarm system.</p> <p>Once fire doors are installed, every door in a stair enclosure serving more than 5 stories shall be provided with re-entry unless it meets ACCORD standard 6.8.3.1.</p> | Within 2 months |

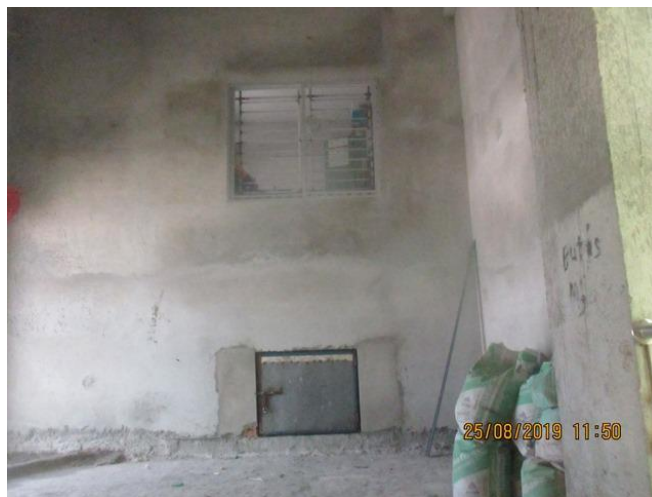
| F-2 | Fire Rated | Lift machine rooms not separated from exit stair enclosures. | Separate lift machine rooms by minimum 2-hr fire rated construction. | Within 2 months |

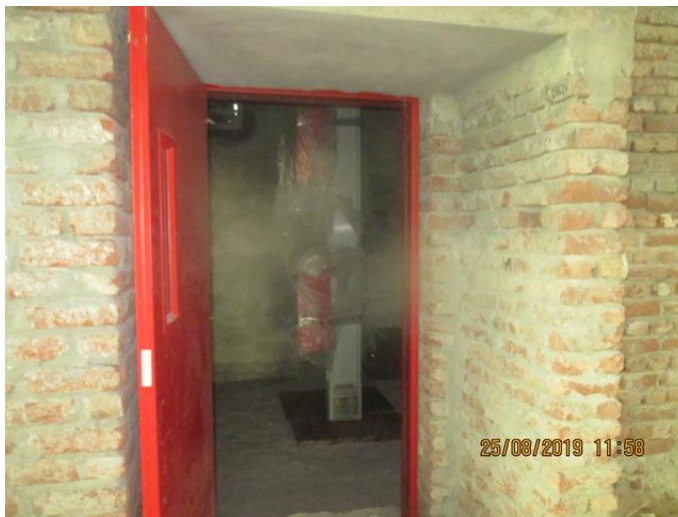
| F-3 | Fire Rated Construction | Electrical riser shaft separation work by fire rated door is not completed. | Complete the fire door installation to separate the utility risers from each floor level and seal all penetrations in floor/ceiling assemblies to maintain the required 2-hr fire separation. | Within 2 months |

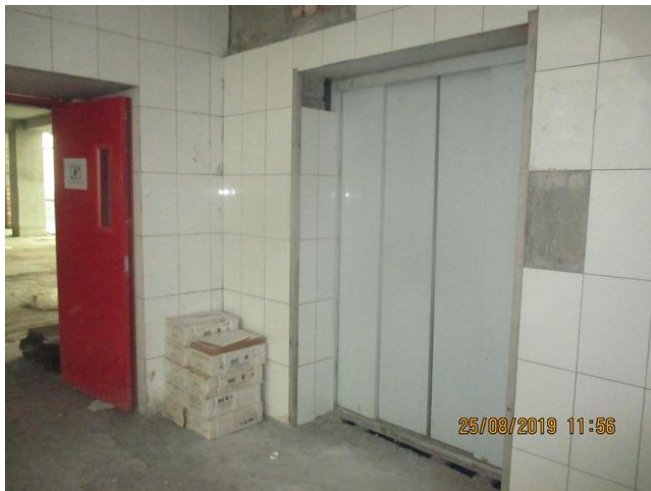
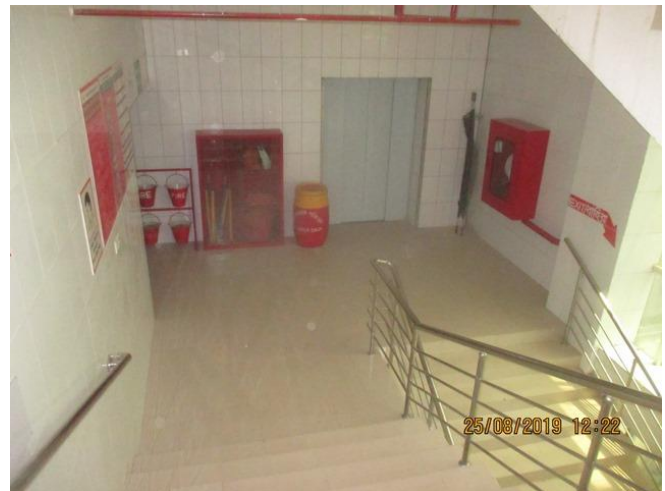
| F-4 | Egress | Elevator shafts provided in exit stair enclosures. | Modify the elevator and stair enclosure arrangement in a way to satisfy Accord standard 6.14.3. Elevator shall not open into an exit enclosure. Elevator landing door shall be of 1.5-hr fire rated. | Within 4 months |

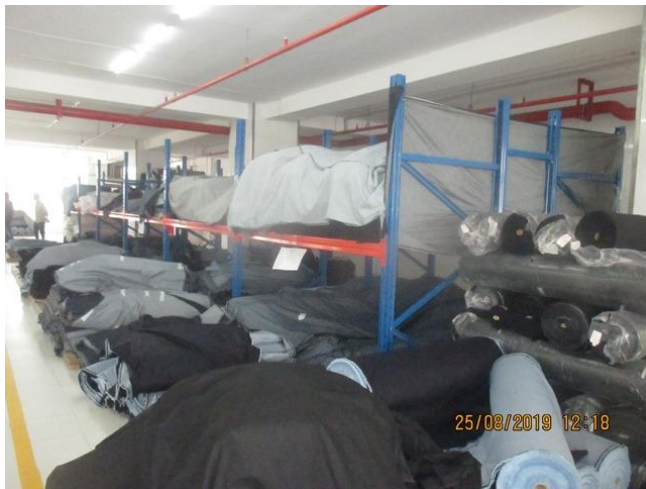
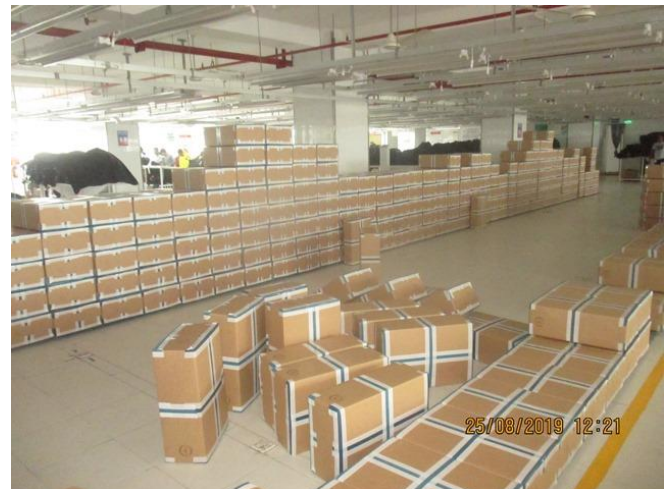
| F-5 | Fire Rated Construction | Areas on the 2nd, 3rd and 4th floor used for combustible storage open to the factory are not properly defined and/or not within limits. | <p>Provide defined storage areas and limit the storage arrangement as follows:</p> <p>Maximum height of 2.45m (8 ft) and maximum area of 23 m<sup>2</sup> (250 ft<sup>2</sup>).</p> <p>If sprinkler protected: maximum height of 3.66m (12 ft) and maximum area of 93m<sup>2</sup> (1000 ft<sup>2</sup>).</p> <p>Separate the areas of unenclosed combustible storage by a minimum clear distance of 3 m (10 ft).</p> | Within 3 months |

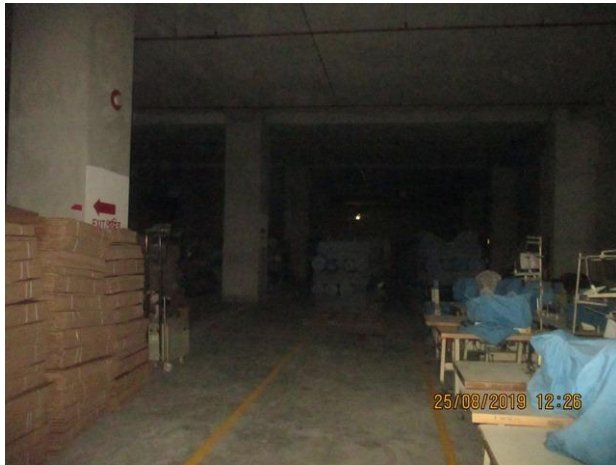
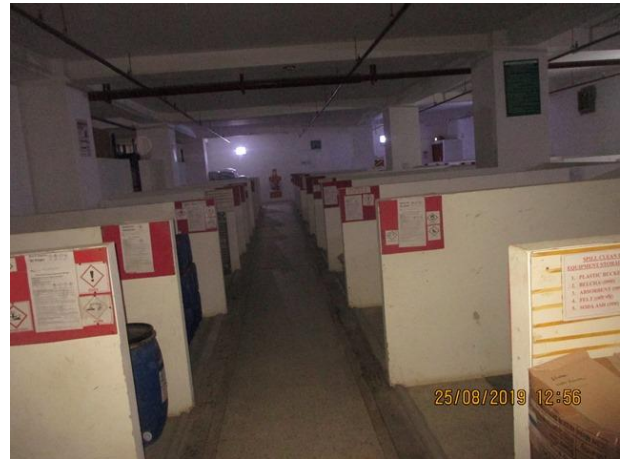
| F-6 | Fire Rated Construction | Storage rooms (bonded warehouse, finished carton and chemical) discharges directly into the exit stair enclosures. | Openings from exit enclosure to storage room, generator and transformer spaces shall be provided with a vestibule with fire rated construction and openings.<br><br>Provide a 1.5 hr. fire rated door on the exit stair side and a 1-hr. fire rated door on the Store, generator, sub-station room side. Ensure that the fire rating of the vestibule construction matches that of the exit stair enclosure. | Within 3 months |

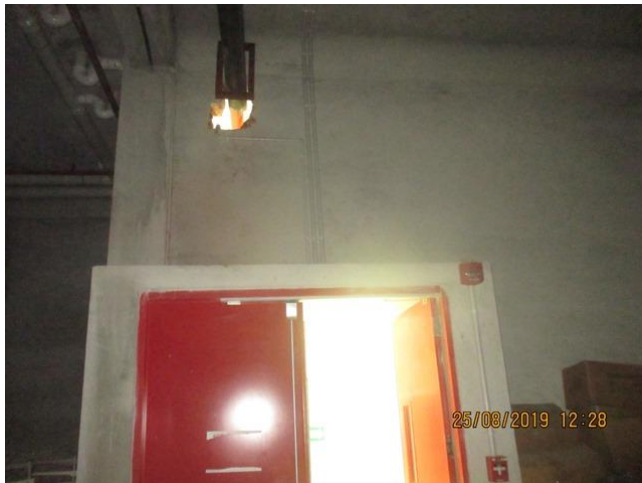
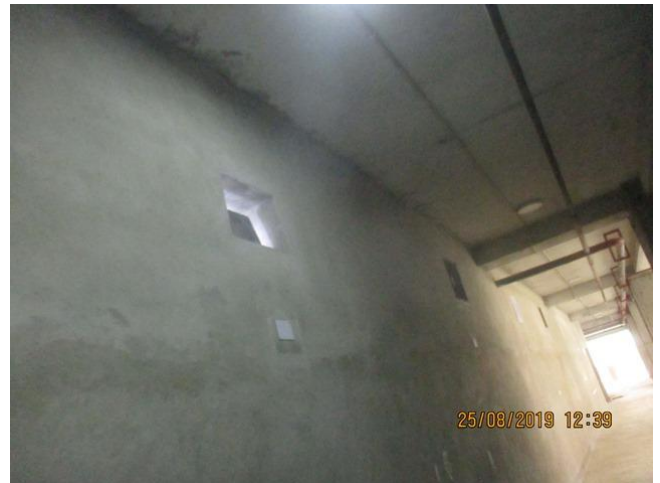
| F-7 | Fire Rated Construction | Unsealed penetrations and openings are located in exit stair enclosures and separation walls. | Seal all penetrations and openings in exit stair enclosure and separation walls to maintain the required fire separation. | Within 2 months |

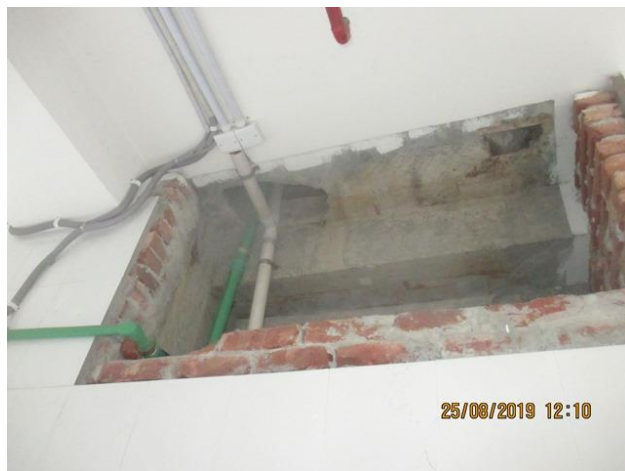
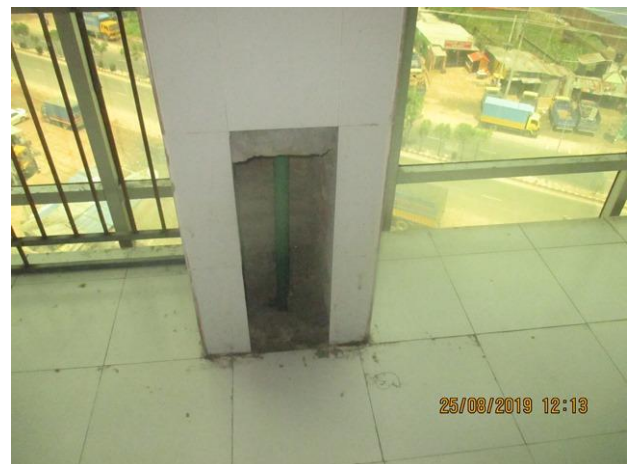
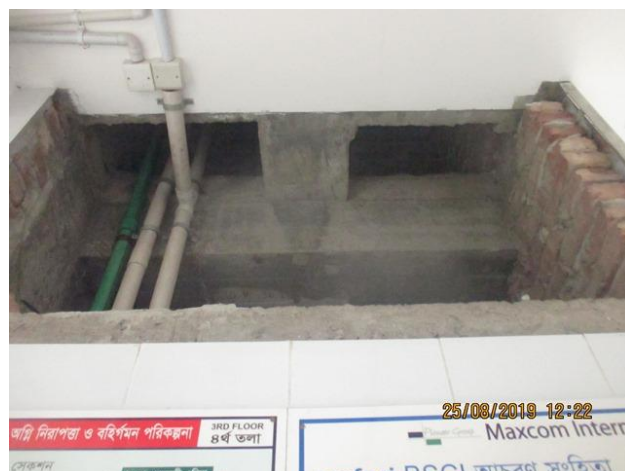
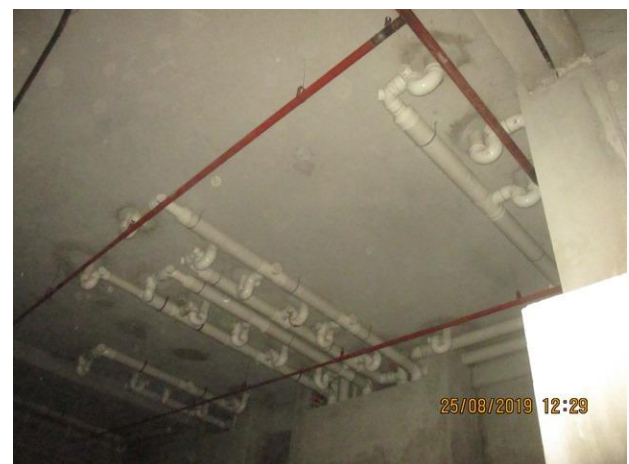
| F-8 | Fire Rated Construction | Unsealed utility pipe shaft/penetration is located in the fire-rated floor/ceiling assemblies | Provide a minimum 2-hr fire-rated shaft to separate the utility risers from each floor level and seal all penetrations in floor/ceiling assemblies to maintain the fire separation. | Within 2 months |

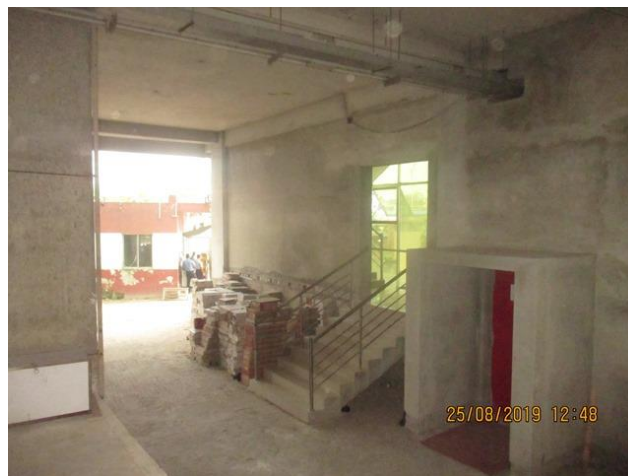
| F-9 | Egress | Exit stairs do not discharge directly to the outside.<br>(N-E stair) | Modify stair to discharge directly outside.<br>Or Provide 2-hr fire-rated exit passageway leading directly outside (vestibules to separate any storage areas).<br>Or Provide sprinkler protection for discharge floor in accordance with NFPA 13 meeting Accord 6.17.3. | Within 4 months |

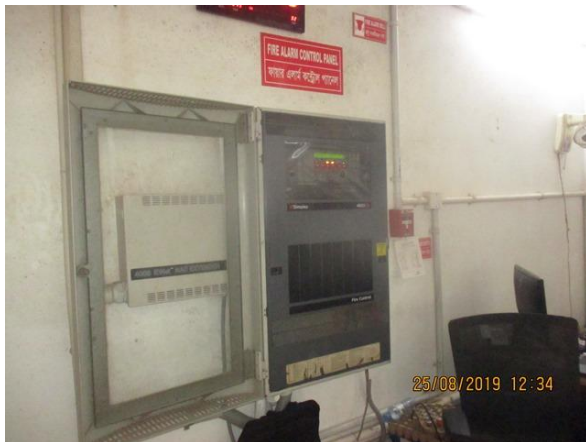
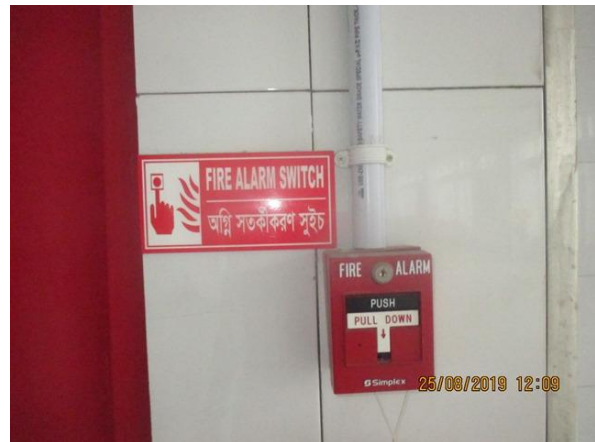
| F-10 | Fire Protection | The fire alarm system installation requires detailed review to confirm compliance with NFPA 72 and ACCORD standard. | Submit as-built drawings, testing records, equipment certification and other relevant documentation to the ACCORD for review and approval/acceptance test. | Within 2 months |

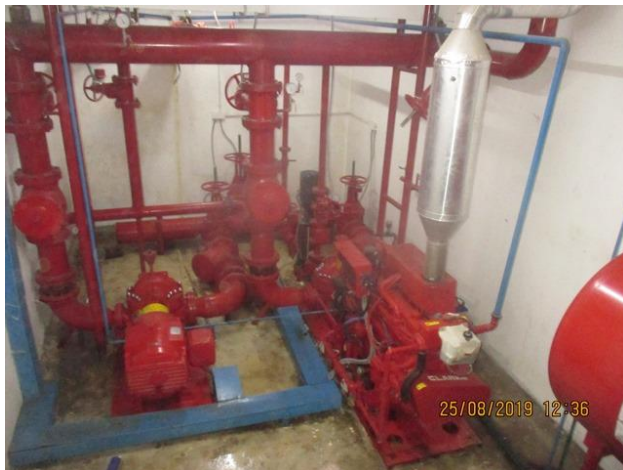
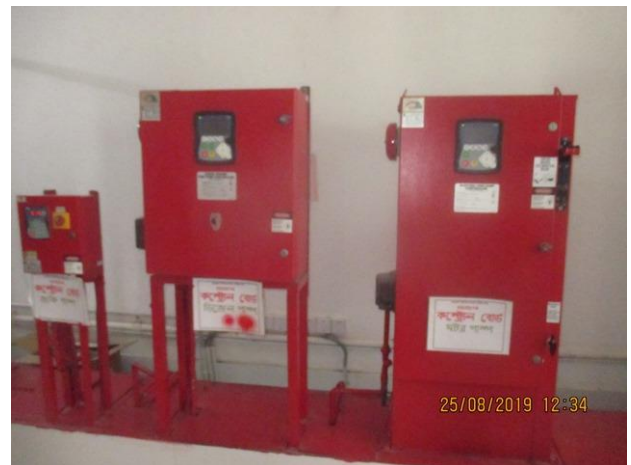
| F-11 Fire Protection | The fire pump set installation requires detailed review to confirm compliance with NFPA 20 and ACCORD standard. | Submit as-built drawings, testing records, equipment certification and other relevant documentation to the ACCORD for review and approval/acceptance test. | Within 2 months |

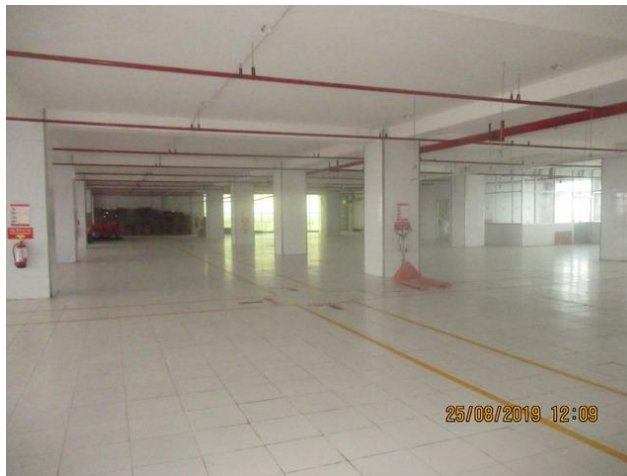
| F-12 | Fire Protection | The high-rise building has an occupied floor greater than 23m (75 ft) and required sprinkler system installation not completed. | Provide automatic sprinkler protection throughout the building in accordance with NFPA 13 and ACCORD standards. | Design within 2 months<br>Install within 4 months |

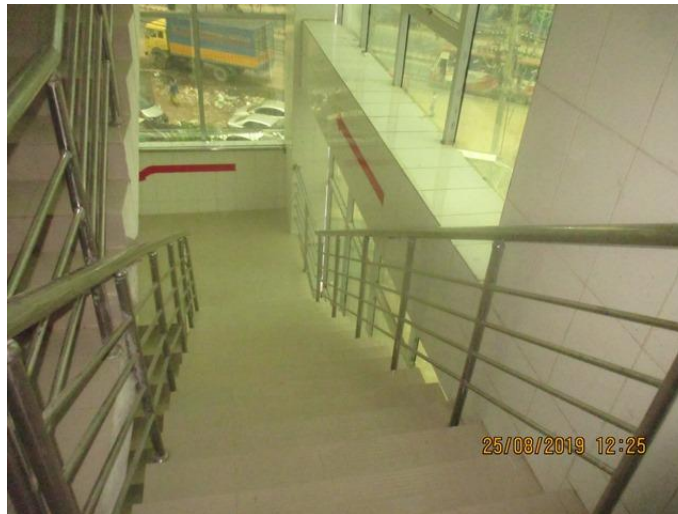
| F-15 | Egress | Width of exit stairs is less than 1.5 m (60 in.) (S-W and N-E stairs). | Provide exit stair minimum clear and unobstructed width of 1.5 m (60 in.) in accordance with Accord standard 6.5.6.2.1. | Within 4 months |

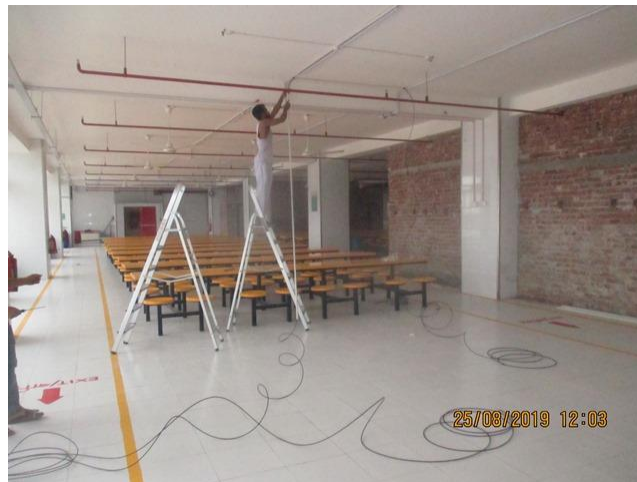
| F-16 | Fire Rated Construction | Dining at 8th floor and separation is not fully completed. | Separate the dining from other occupancies by 3-hr fire rated construction having two direct access to exit stair/outside of the building. Seal and/or protected all openings maintain the required fire separations. | Within 2 months |

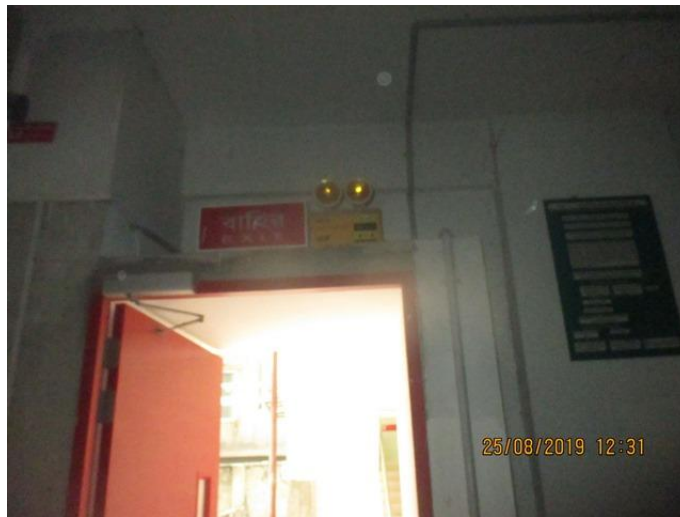
| F-18 | Egress Lighting | Exit signage not illuminated (burned out, broken, etc.). | Regularly inspect all exit signage and replace/install lights as needed to illuminate signs. The source of illumination shall provide not less than 50 lux at the illuminated surface with a contrast of not less than 0.5. Approved self-luminous signs which provide evenly illuminated letters having a minimum luminance of 0.2 cd/m2 may also be used. | Within 1 month |

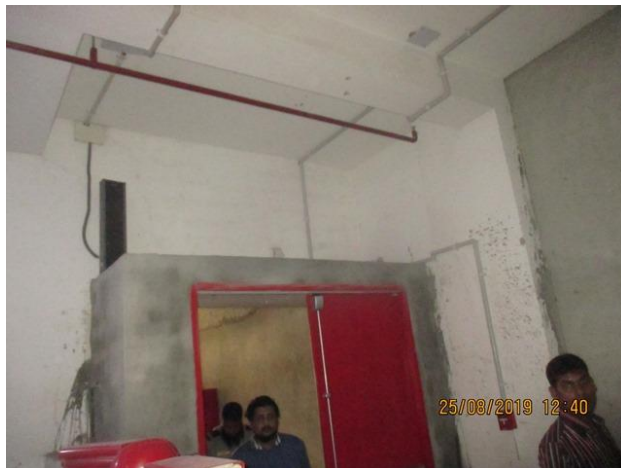
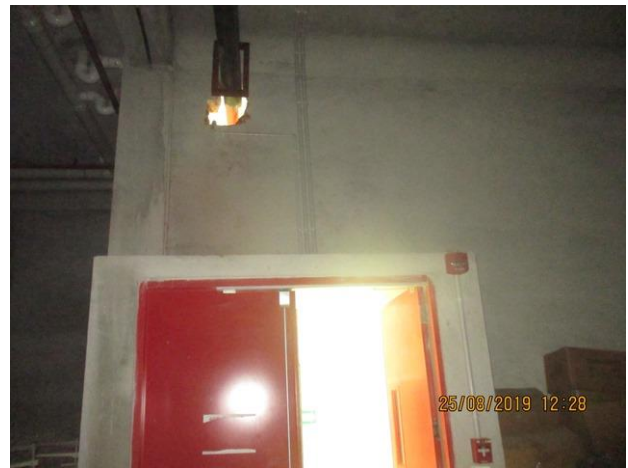
| F-19 | Egress Lighting | Exit signage was not provided at several exits / along the path of egress / in a readily visible location. | Provide exit signs above all building exits to the exterior, all doors to the exit stairs and along all paths of travel where a change of direction is not obvious. | Within 1 month |
