NHT Fashions Ltd.

Plot# 20-22, Sector#05, CEPZ, Chittagong.

Survey Date: 8th March 2015

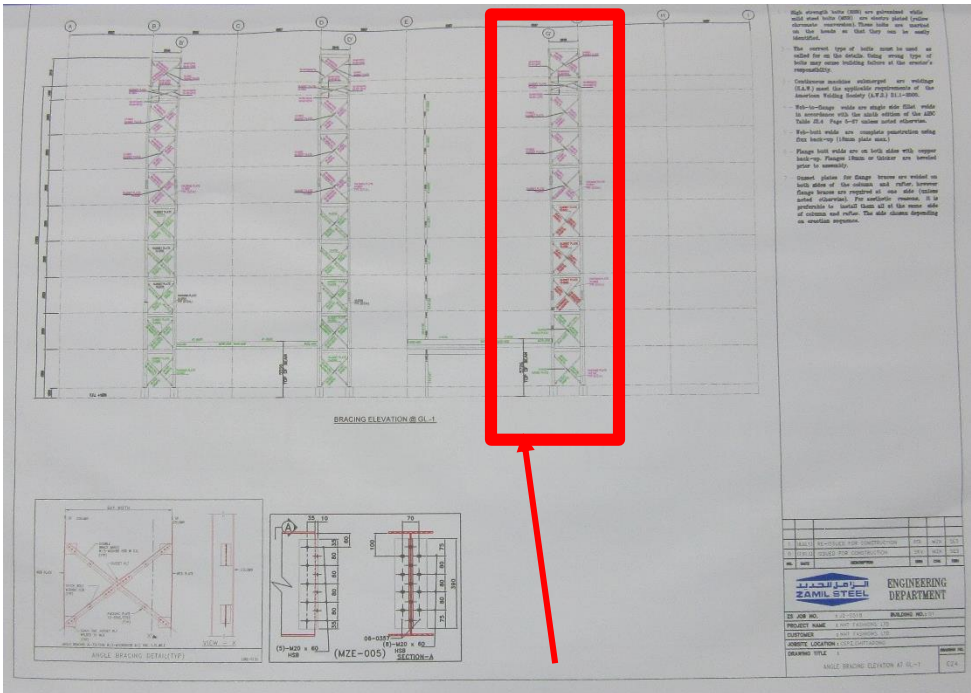
Elevation on grid 1 shows bracing grid G'-G (Zamil Steel Construction Drawing E25 Rev 1)

- Construction drawings show a bay of bracing at grid 1/G'-G. This did not appear to be present in the completed building.
- The braced bays and RC walls on their own may not be sufficient to stabilize a building of this size. Therefore we assume that stability is also provided by moment frame action of the beams and columns. The stability system of the building should be reviewed by the Building Engineer.

Item No.	Observation	Recommended Action Plan	Recommended Timeline
1	Missing bay of bracing and confirmation of stability system	Building Engineer to review design to determine if the apparent lack of bracing on grid 1/G-G' compromises the overall stability of the building.	6-weeks
2	Missing bay of bracing and confirmation of stability system	Install bracing if required.	6-weeks
3	Missing bay of bracing and confirmation of stability system	If the structure has not been designed as a moment frame, then building engineer to review the stability system.	6-weeks
4	Roof not waterproofed and subject to large temperature variations	Investigate options to ensure that the structure is not subject to deterioration arising from possible thermal cracking in concrete roof and consequent water penetration.	6-months
5	Roof not waterproofed and subject to large temperature variations	Consideration should be given to waterproofing the roof.	6-months

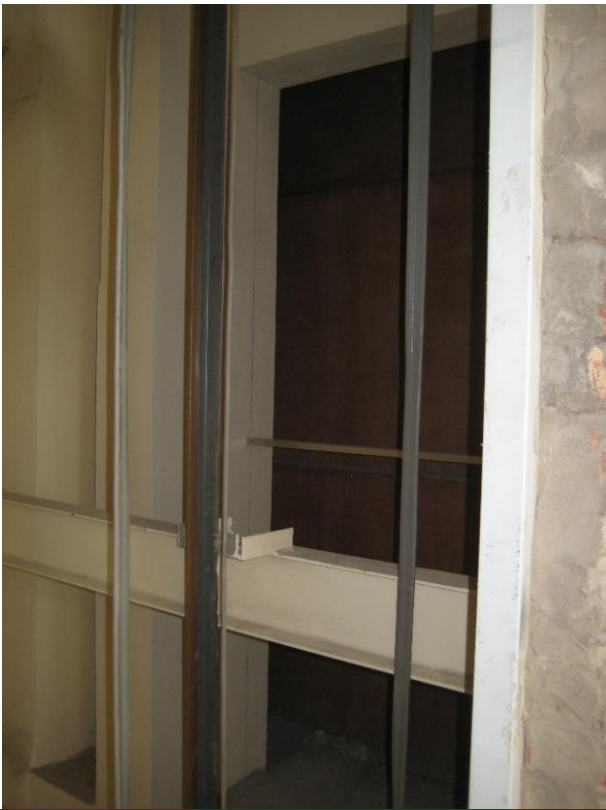
View towards grid 1 from lift shaft G'-G'. Bracing not present

Missing bay of bracing

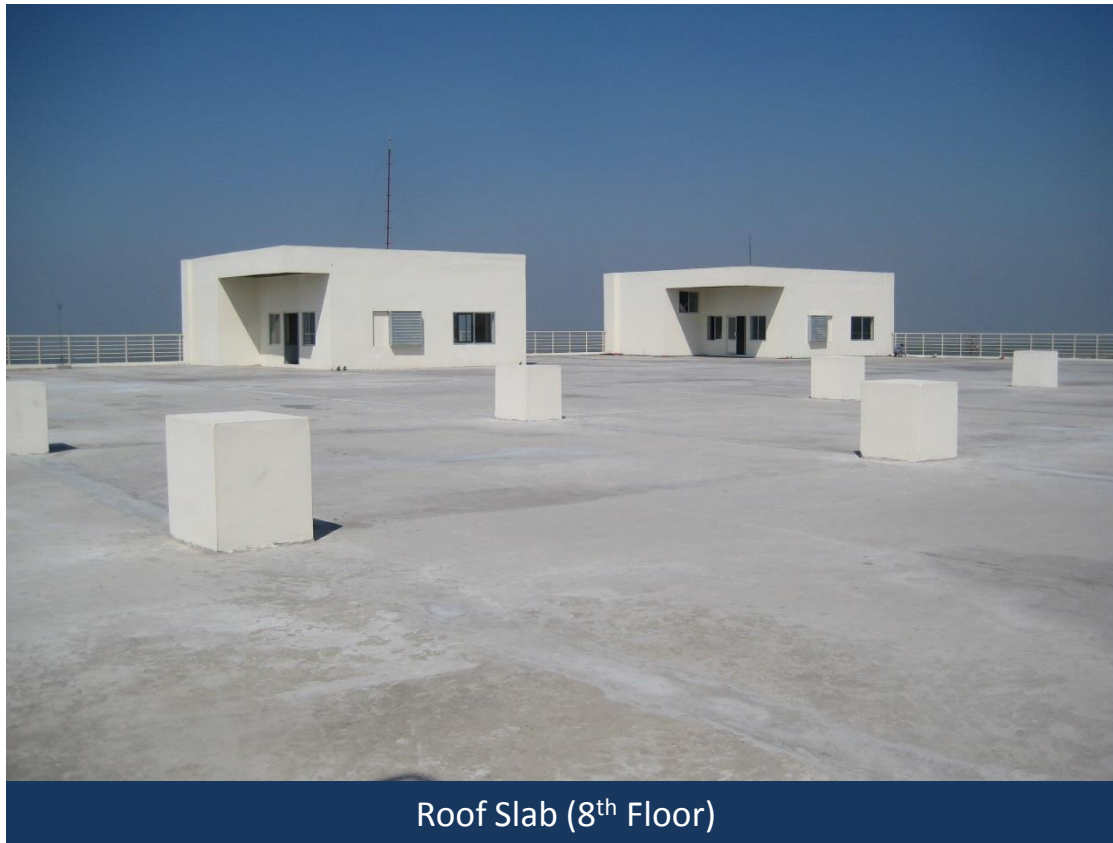
Roof Slab (8th Floor)

Waterproofing of roof

- There did not appear to be any waterproofing to the concrete roof at 8th floor.
- The concrete of the roof will be subject to large temperature changes as it heats up in the sun and cools. This will induce stresses in the structure and could lead to cracking of the concrete slab.
- In the long term the cracking and lack of waterproofing could cause leaks and durability issues for the structure.

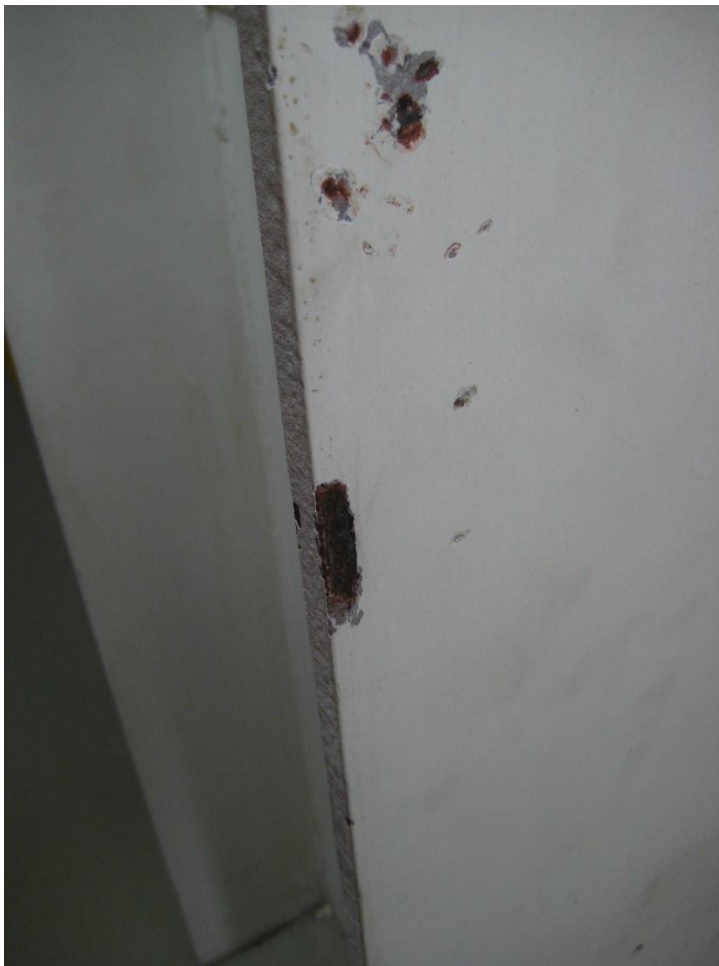
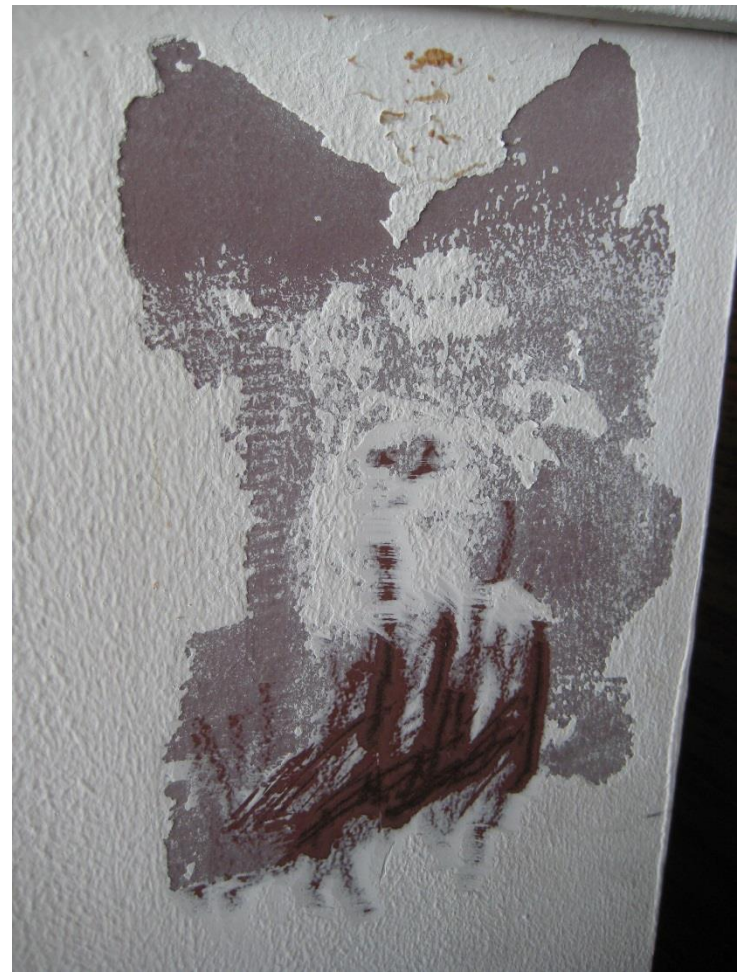
Fire protection to steelwork (Non structural item)

- The paint work to the structural steel appeared to be very thinly applied.
- Intumescent fire protection paint is usually a relatively thick coating.
- Fire protection to steelwork should be investigated.

6	Determine if intumescent paint has been applied to steelwork	Determine if intumescent paint has been applied to steelwork.	6-weeks
7	Determine if intumescent paint has been applied to steelwork	To be reviewed as part of the fire engineering assessment.	6-weeks
