FIRE SAFETY INSPECTION REPORT

LIBAS TEXTILES LTD. New building

ACCORD ID: 23646

Date: 10 July 2019 & 05 August 2019

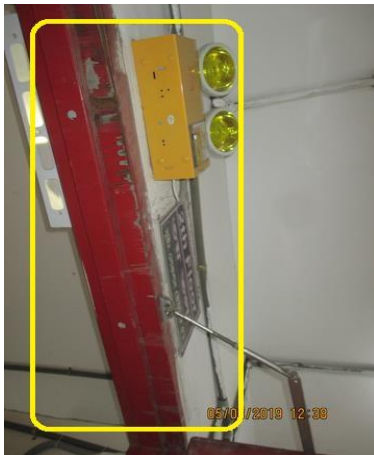
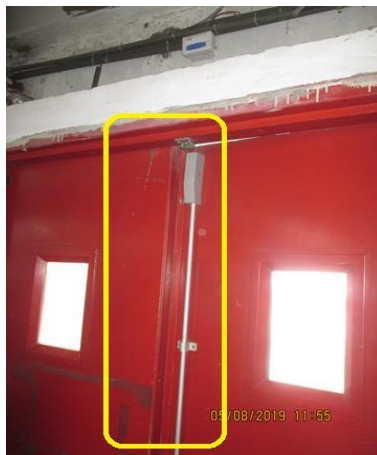
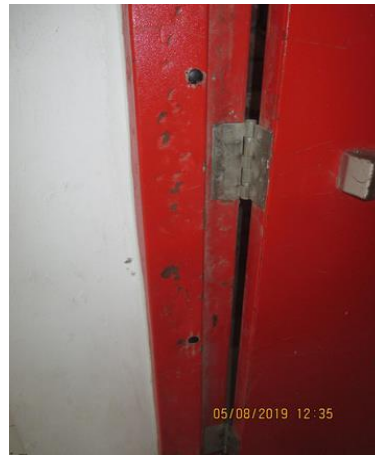
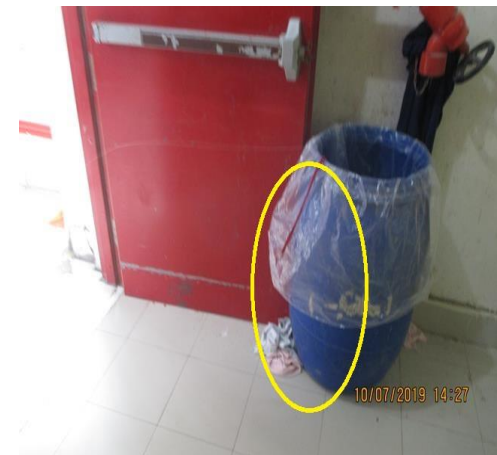
SI No.	Category	Findings	Required Action	Remediation Time Frame
1	Fire-Rated Construction	<p>The exit stairs are not separated from [work areas, other spaces] on each floor by fire-rated construction.</p> <p>Fire doors are not properly functional, not properly latched & found open by external means and Unsealed penetrations and openings are located in exit stair enclosures.</p>	<p>Provide 2-hr rated exit stair enclosure. If fire door is required, provide minimum 1.5-hr listed fire-rated doors and seal all unprotected openings to separate the exit stairs from work areas and other building spaces on all floor levels. Ensure that the fire doors are self-closing and positive & properly latching and that they are provided with fire exit (panic) hardware where serving production floors.</p> <p>If fire doors are required to be held open for functional reasons, provide automatic closing devices tied to the fire alarm system.</p>	Within 3 months

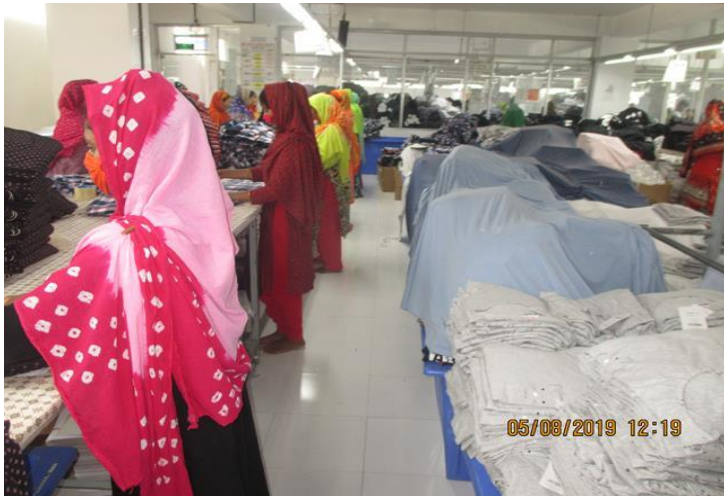
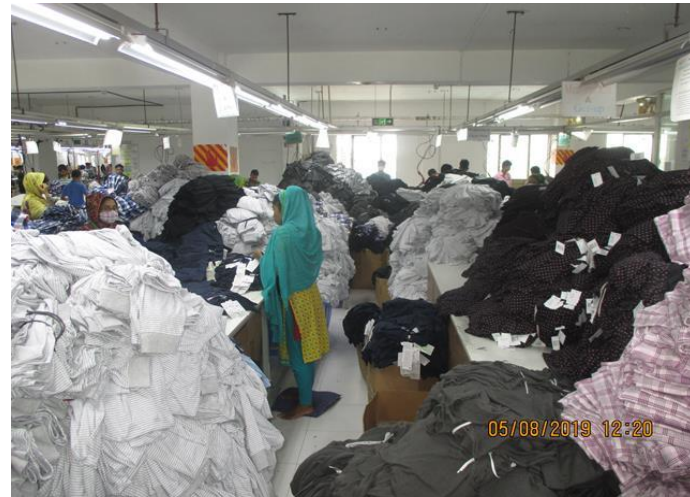
2	Fire-Rated Construction	Areas used for in-process storage of combustible materials are observed in an unplanned manner. Location: building#3: 3rd floor	Provide defined storage areas and limit the storage arrangement as follows:- 1. General Condition: Maximum height of 2.4m and maximum area of 23m ² . Separate areas of unenclosed combustible storage by a minimum clear distance of 3m. 2. If sprinkler protected: maximum height of 3.66m and maximum area of 93m ² . Separate areas of unenclosed combustible storage by a minimum clear distance of 3m. or 3. Enclose the storage area from the surrounding occupancy with a minimum 1 hour construction.	Within 3 months
---	-------------------------	---	--	-----------------

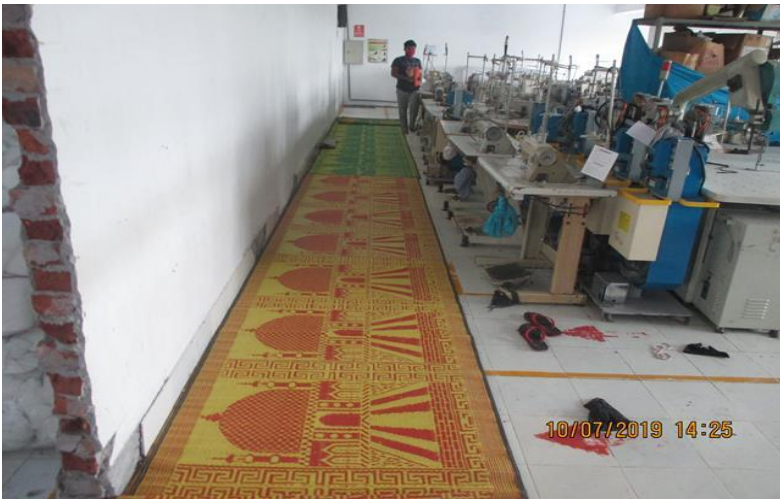
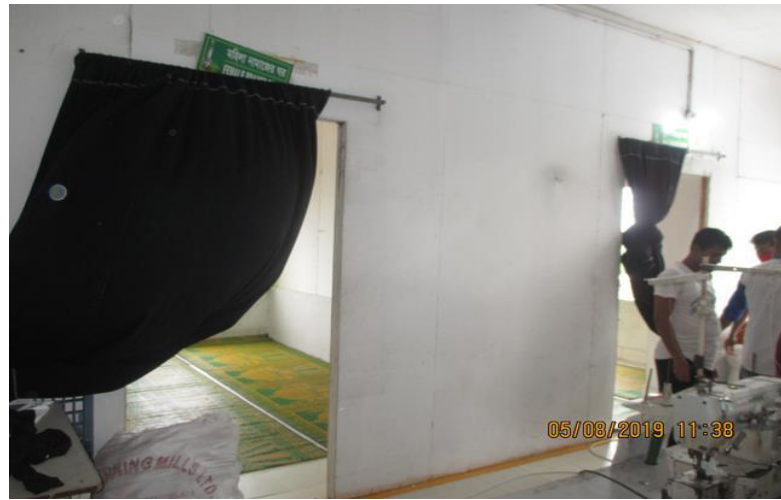
<p>3</p>	<p>Fire-Rated Construction</p>	<p>Prayer area is not separated from other occupancies with fire rated assemblies. Location: Building#4: 3rd floor, 4th floor</p>	<p>Re-locate the prayer area or separate the prayer area from other occupancies with 2-hr fire rated construction & Provide required exits that lead directly to the street or exit stairwell or leading to a separated corridor or open space.</p>	<p>Within 3 months</p>
----------	--------------------------------	---	--	------------------------

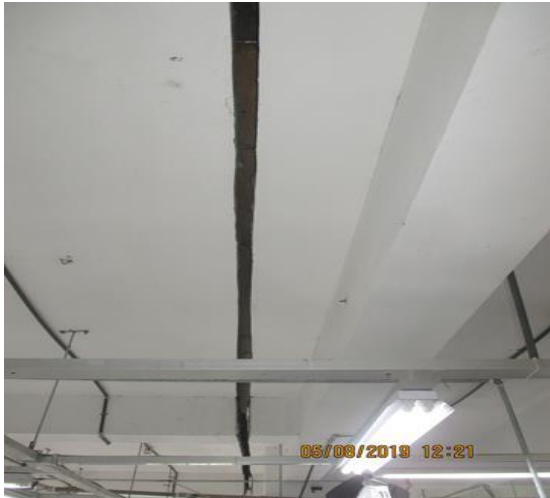
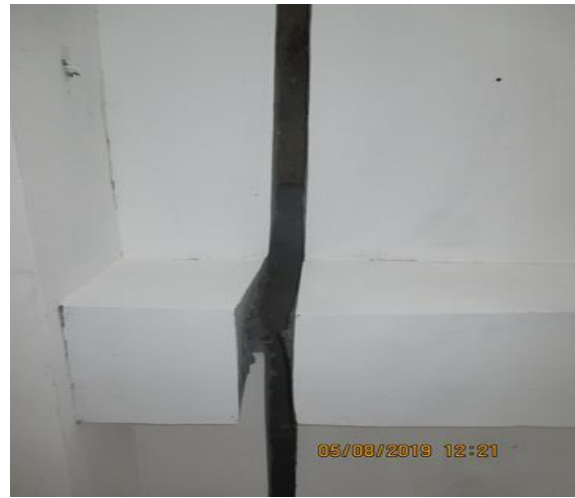
4	Fire-Rated Construction	Penetrations through floor/ceiling (building expansion joint) are not properly sealed.	Seal all penetrations and openings in floor/ceiling (full thickness of the floor/ceiling) assemblies by third-party certified fire rated materials (installation shall be as per manufacturer & certification body guideline) to maintain the fire resistance rating.	Within 3 months
---	-------------------------	---	--	-----------------

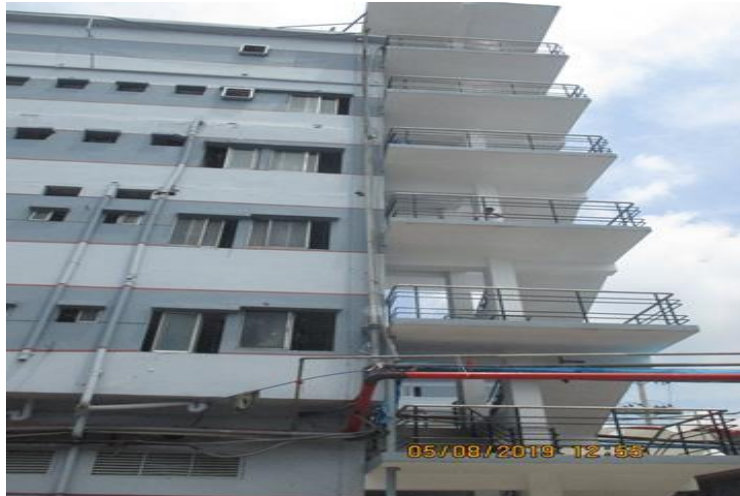
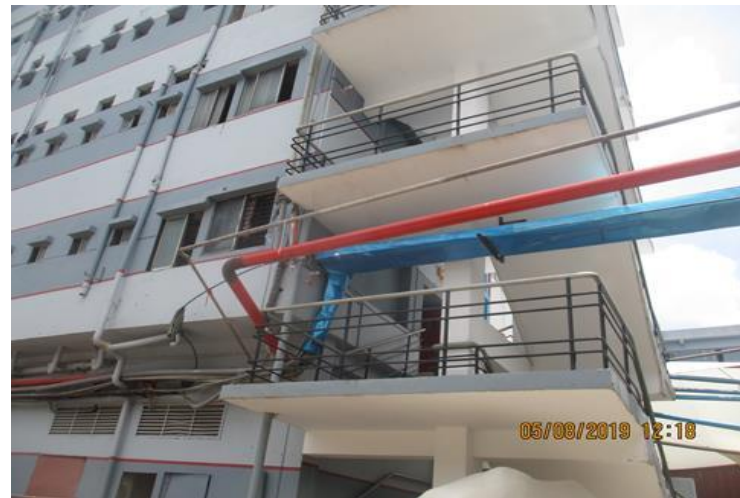
5	Fire-Rated Construction	The exterior exit stair is not properly separated from the building. Location : Building 4	Exterior exit stairs shall be separated from the building with a rating requirement of 1 hr. fire rating for 3 or fewer stories or 2 hr. fire rating for 4 or more stories. The rating of the exterior wall shall extend 3.05 m (10ft) beyond the ends of the stair structure.	Within 3 months
---	-------------------------	--	--	-----------------

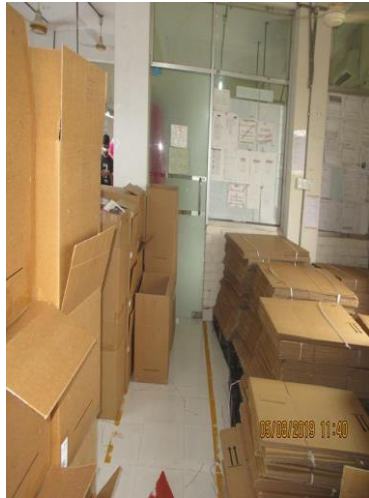
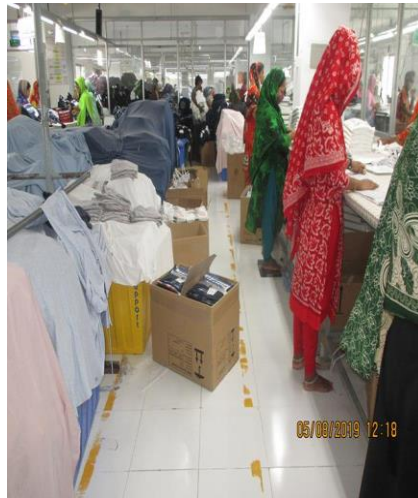
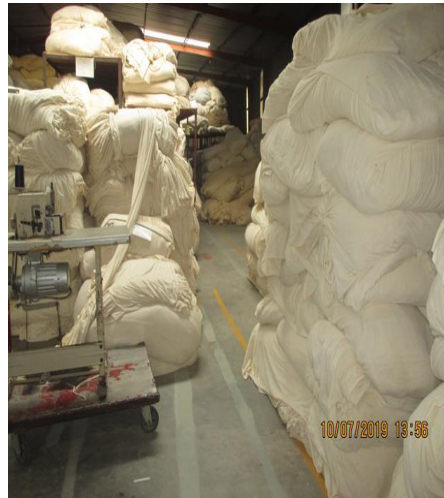
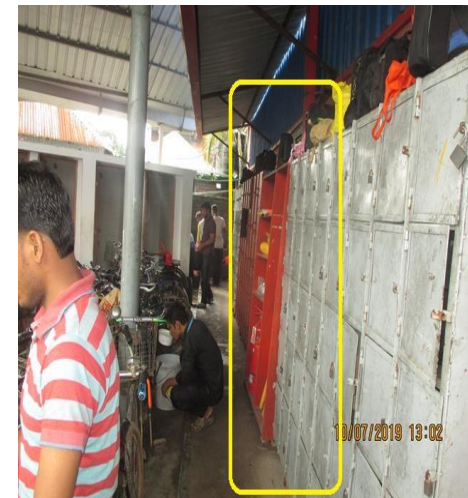
6	Egress	The egress path along means of egress has interrupted by obstruction/storage. Locations: Shed 04, Shed 02, building 03, Batch store shed.	Means of egress shall be maintained continuously free and clear of all obstructions/storage.	Immediately
---	--------	---	--	-------------

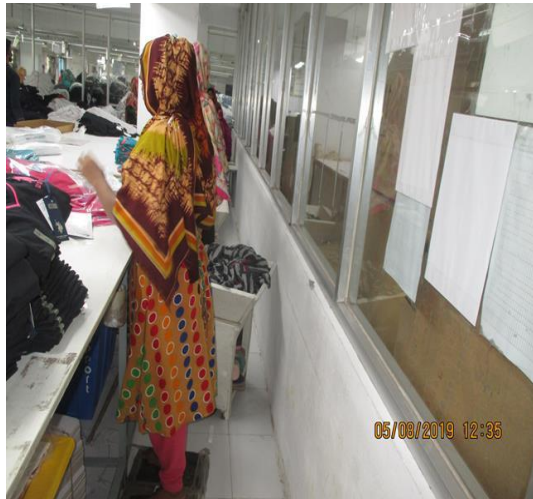
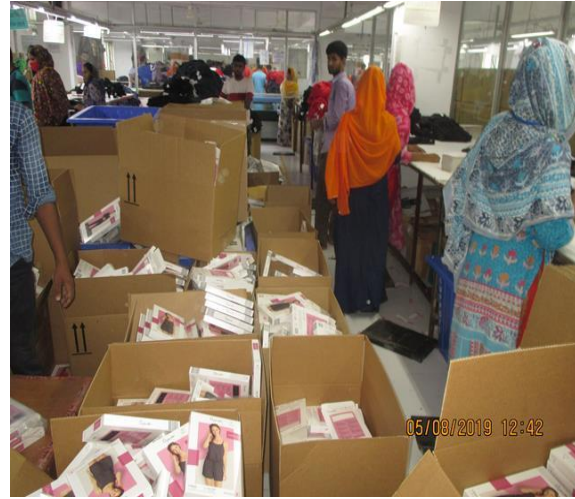
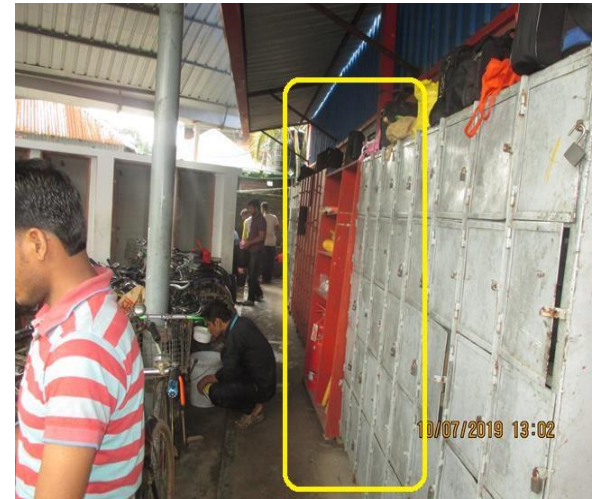
7	Egress	The width of egress aisles is less than 36-in. Location: Shed 02 (Worker Dining), B # 03	Aisles shall be provided with a minimum unobstructed clear-width of 0.9 m (36 in.).	Within 1 month
---	--------	--	---	----------------

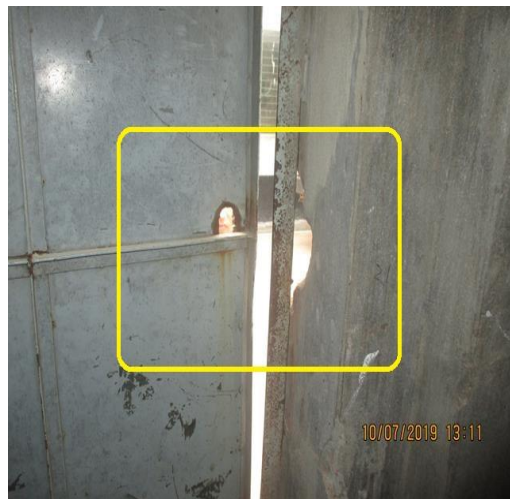
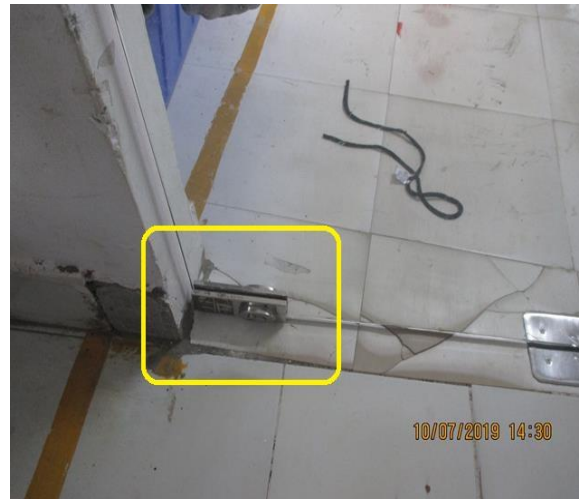
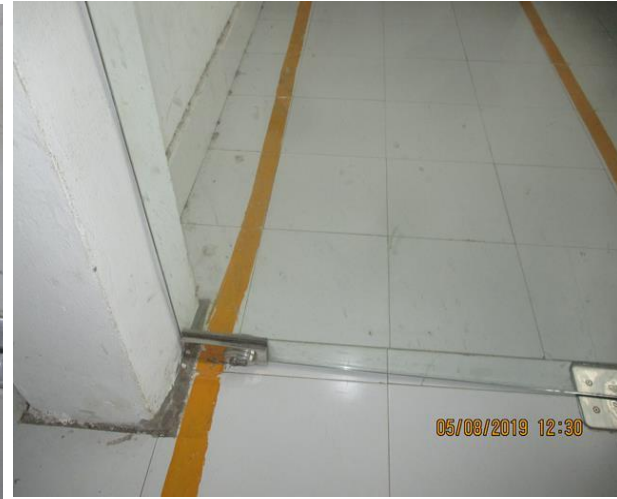
8	Egress	Doors along means of egress are provided with non compliant locking system. Location: Yarn store shed, Finishing accessories store shed, Leftover store shed, building 03, building 04.	Remove non-complaint locking features from all egress gates. If locks are required for security reasons, utilize special door locking features complying with ACCORD standard 6.8.2.	Immediately
---	--------	---	---	-------------

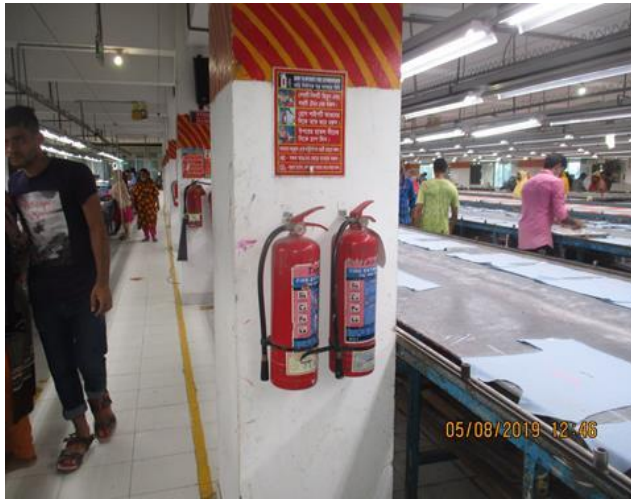
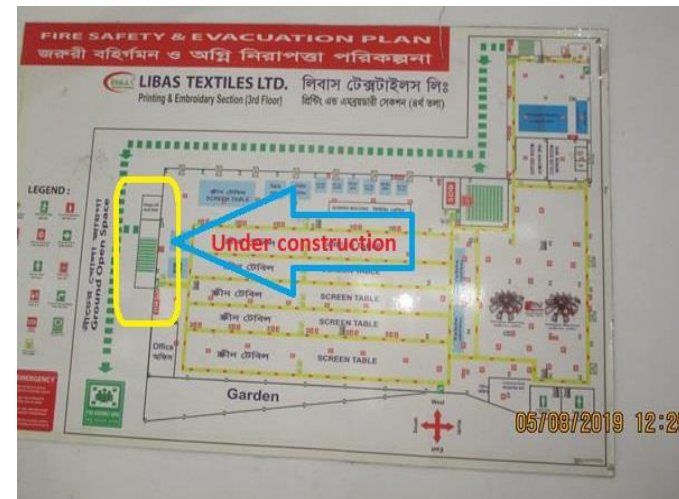
9	Egress	Common path of egress travel exceeds the standard limit. Location: building 03	Reconfigure the egress arrangement to reduce the maximum common path of travel to not more than 23 m (75 ft) or 30 m (100 ft) when complete sprinkler protection is provided.	Within 3 months
---	--------	--	---	-----------------

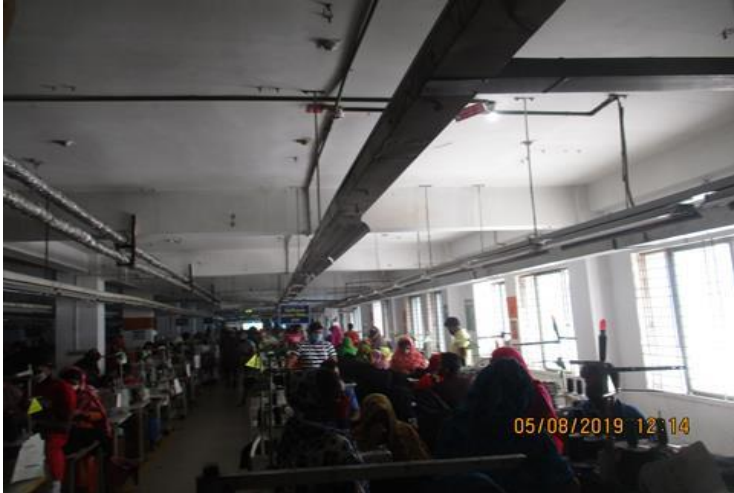
10	Egress lighting	Based on the number and location of emergency lights observed, adequate illumination levels are not anticipated along egress routes. Location: on most of the structures.	Test the emergency lighting system on each floor and provide additional emergency fixtures to provide adequate illumination along the means of egress. Provide a minimum illumination of 10 lux at the floor level within exit stairs and exit discharge paths and minimum 2.5 lux along exit access aisles.	Within 2 months

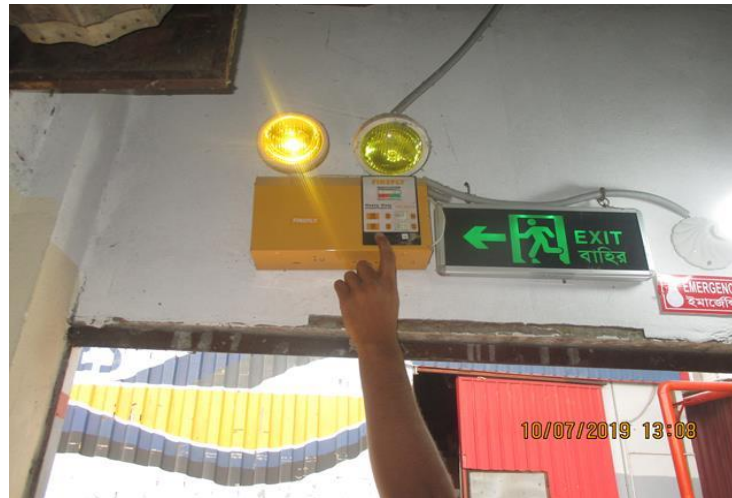
11	Egress lighting	Manual on-off switch is provided for (emergency lighting / exit signage) units.	Remove manual on/off switches from emergency lighting / exit signage units to prevent them from being switched off.	Within 1 month
----	-----------------	---	---	----------------

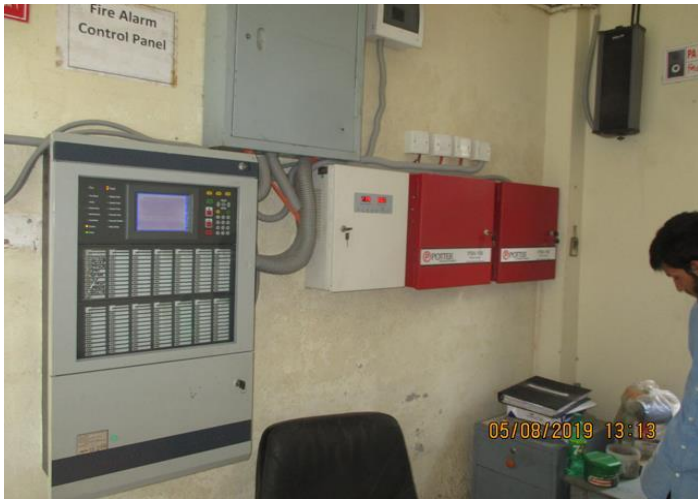
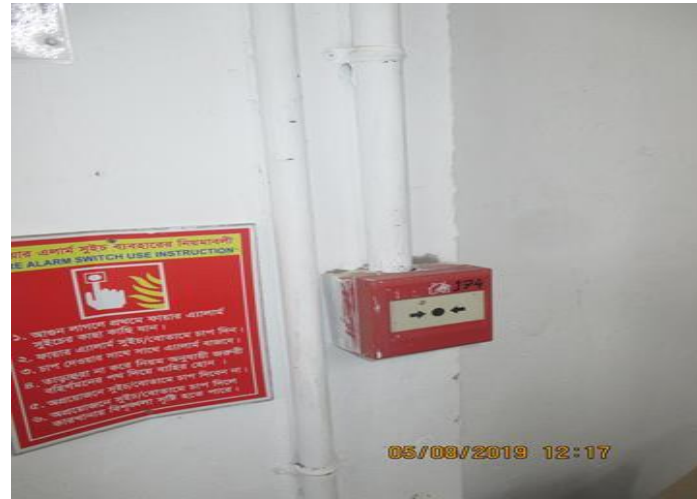
<p>12</p>	<p>Fire Detection and Alarm System</p>	<p>The factory has installed an addressable fire alarm & detection system which is required to be reviewed and verified.</p>	<p>Submit the Addressable Fire Detection and Alarm system design to ACCORD for review and modify the addressable system as per the recommendation. Upon approval & modification (if required) the owner shall verify fire alarm & detection system by ACCORD for final acceptance. The equipment shall be listed and approved 3rd party certified. The installation shall be as per NFPA -72.</p>	<p>Design within 01 Month & Installation/modification Within 03 Months</p>
-----------	--	--	--	--

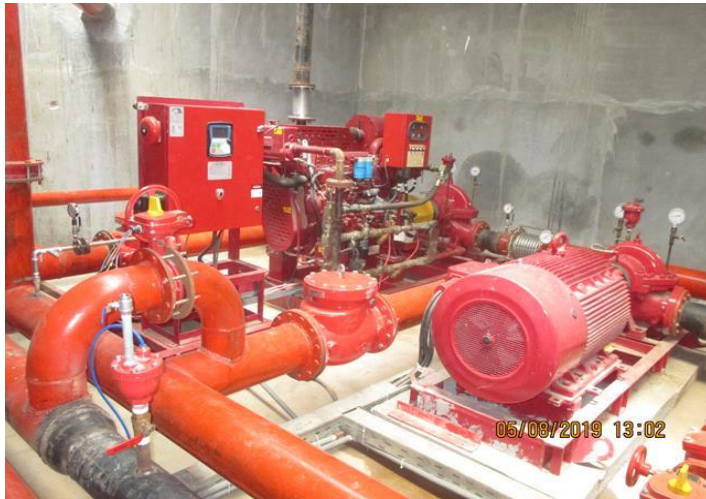
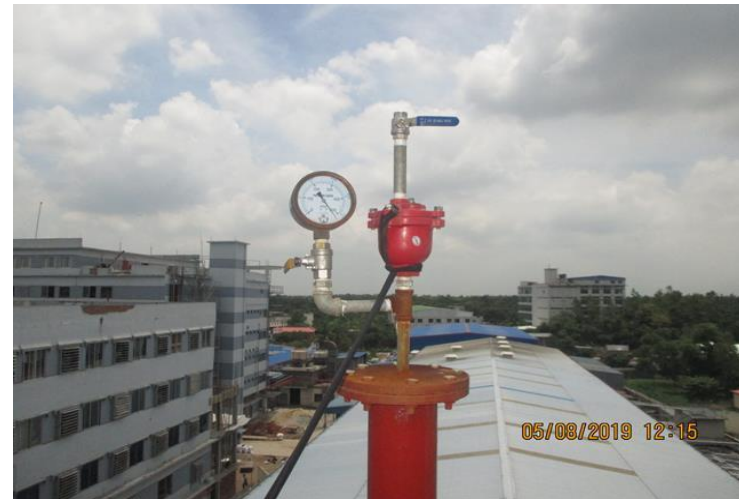
<p>13</p>	<p>Fire Protection</p>	<p>The highest occupied floor of existing building is more than 10 m (33 ft.) above grade where standpipe system is mandatory and factory has installed Class-III standpipe system which is required to be verified.</p>	<p>Submit the standpipe system design to ACCORD for review and modify the standpipe system as per the recommendation. Upon approval & modification (if required) the owner shall verify standpipe system by ACCORD for final acceptance.</p> <p>The equipment shall be listed and approved 3rd party certified. The installation shall be as per NFPA-14, 20, 22 and 24.</p>	<p>Installation/Modification Within 03 Months</p>
-----------	------------------------	--	--	---

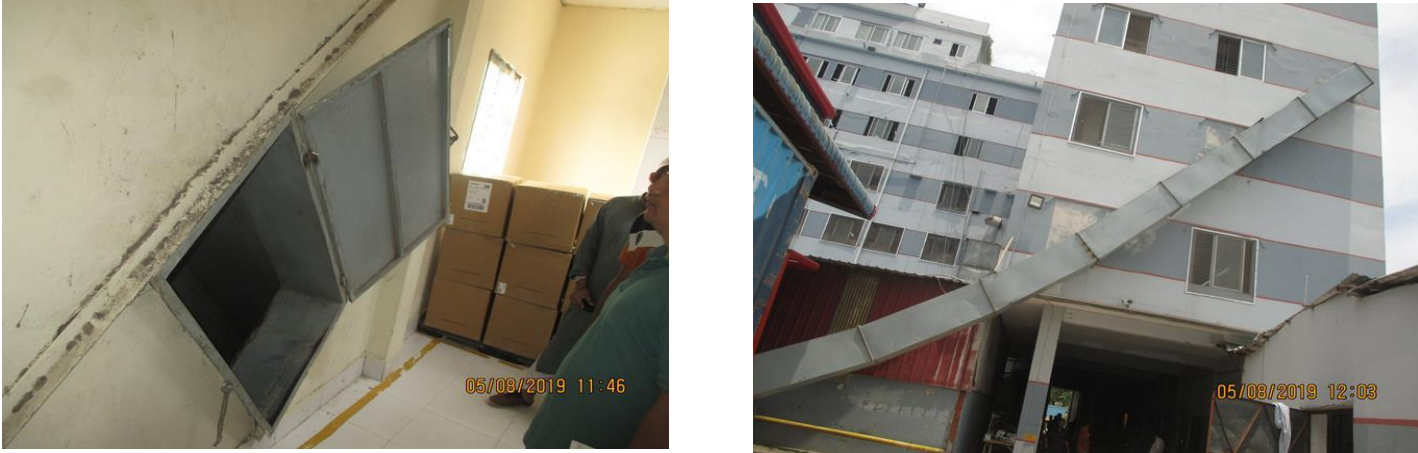
14	Fire-Rated Construction	Duct penetration is observed connecting multiple floors & store shed due to material transportation at building 01 & building 02.	Duct penetration shall be protected with listed fire dampers. Damper shall be 1.5 hr. rated damper when located in 2hr or less fire resistance rated assembly . Damper shall be 3hr rated damper when fire resistance rated assembly is 3hr or more. Or Remove the duct .	Within 3 months

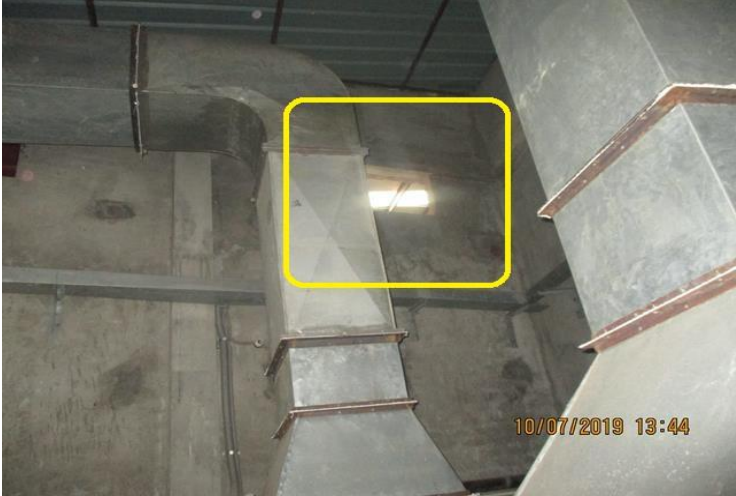
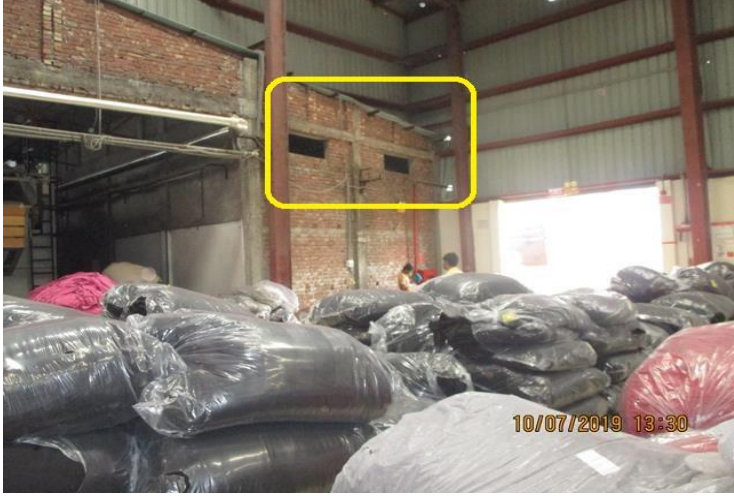
15	Fire-Rated Construction	The air compressor room is not separated by fire rated construction due to penetration with shed 01.	Separate the air compressor room by a minimum 2-hr fire rated construction. Seal and/or protected all openings to maintain fire separations	Within 3 months

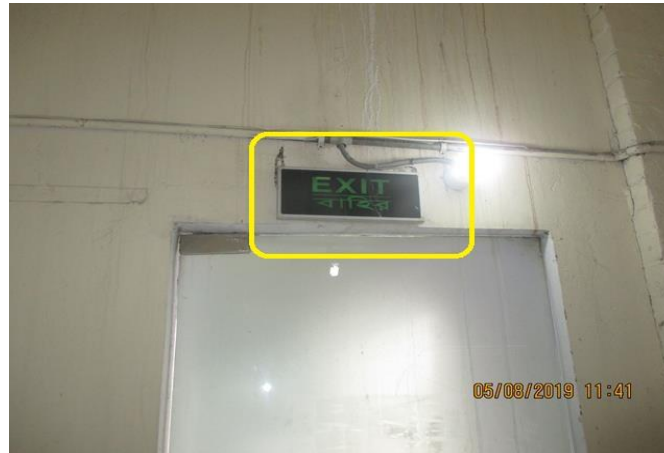
16	Egress Lighting	Building # 04, 3rd floor packing area exit signage not illuminated (burned out, broken, etc.).	Regularly inspect all exit signage and replace/install lights as needed to illuminate signs.	Within 1 month.
----	-----------------	--	--	-----------------

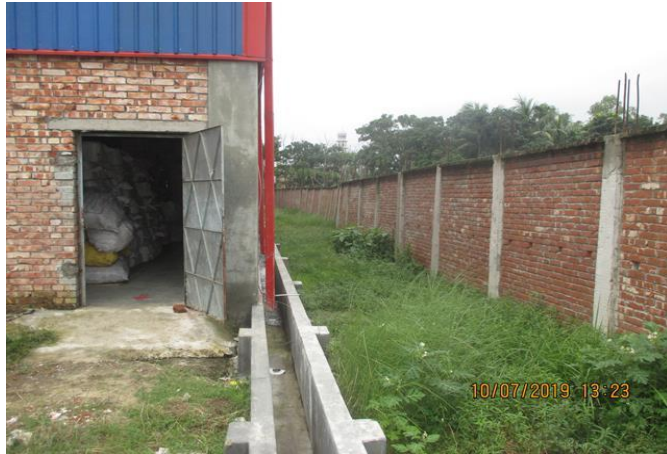
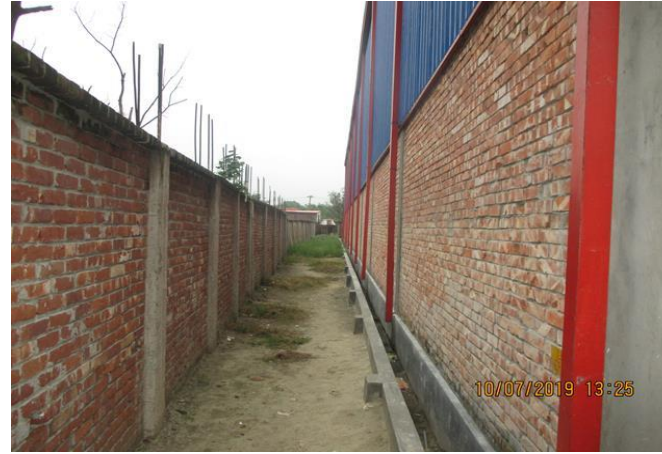
17	Egress	South - east exit discharge path of yarn store shed was found uneven & not usable.	Level exit path to the public way & make it usable by providing slab on drain line.	Within 3 months.
----	--------	--	---	------------------

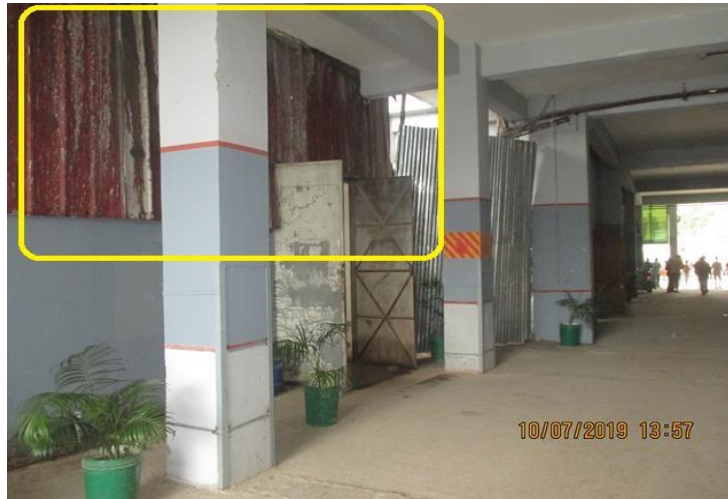
18	Fire rated construction.	Rooms used for storage of combustible materials are not separated from the surrounding occupancy/areas. Location: Batch store shed	Rooms used for storage of combustible materials shall be separated from the surrounding occupancy with a minimum 1 hour construction.	Within 3 months.
----	--------------------------	---	---	------------------
