# LZ Fashion Wear Ltd

Plot # 154, DEPZ (Ext.), Ganakbari, Savar, Dhaka  
(23.943990,90.280182)

14th March 2015

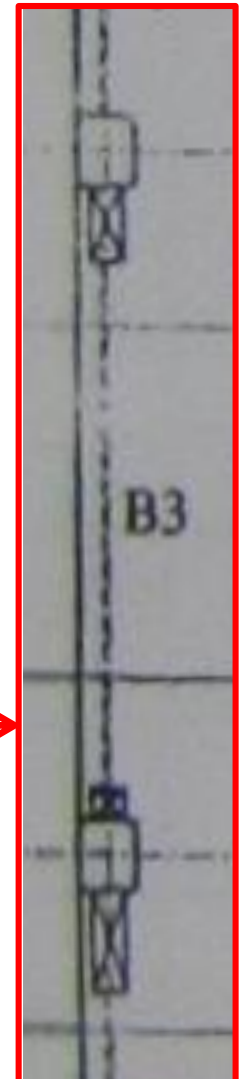
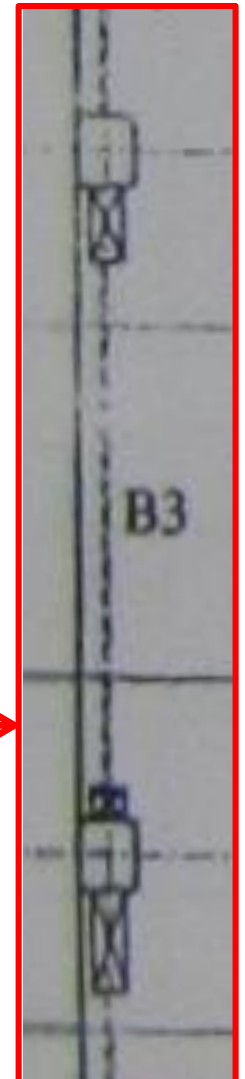
The holes appears to have been relocated into the adjacent slab. If holes did exist in the beams there would be significant questions regarding the strength of the slab and the stability system.

| Item No. | Observation | Recommended Action Plan | Recommended Timeline |
|---|---|---|---|
| 1 | Discrepancy between structural drawings and on-site observations | Update structural drawings to reflect as-built condition | 6-months |

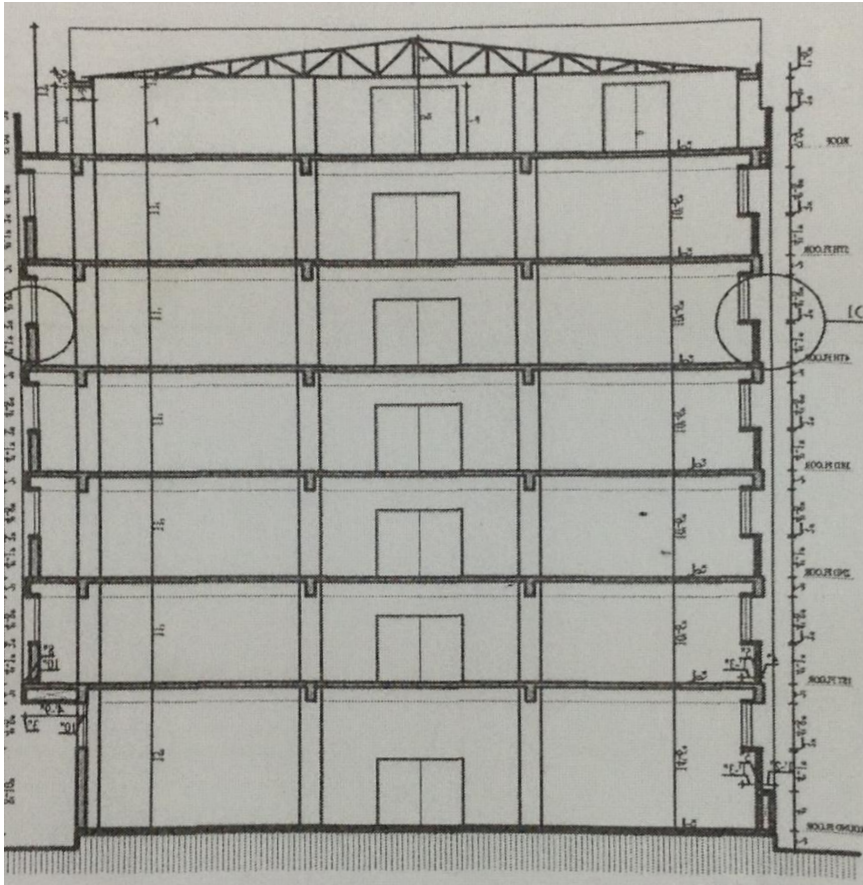
Steel roof structure replaced with concrete

| Item No. | Observation | Recommended Action Plan | Recommended Timeline |
|---|---|---|---|
| 2 | Discrepancies between architectural drawings and on-site observations | Update architectural drawings to reflect as-built condition | 6-months |
