# Blue Planet Fashion Wear Ltd.

Kewa, Sreepur, Gazipur-1740.

13<sup>th</sup> January 2019 & 23<sup>rd</sup> January 2019.

# Discrepancies Between Provided Drawing and On-Site Condition

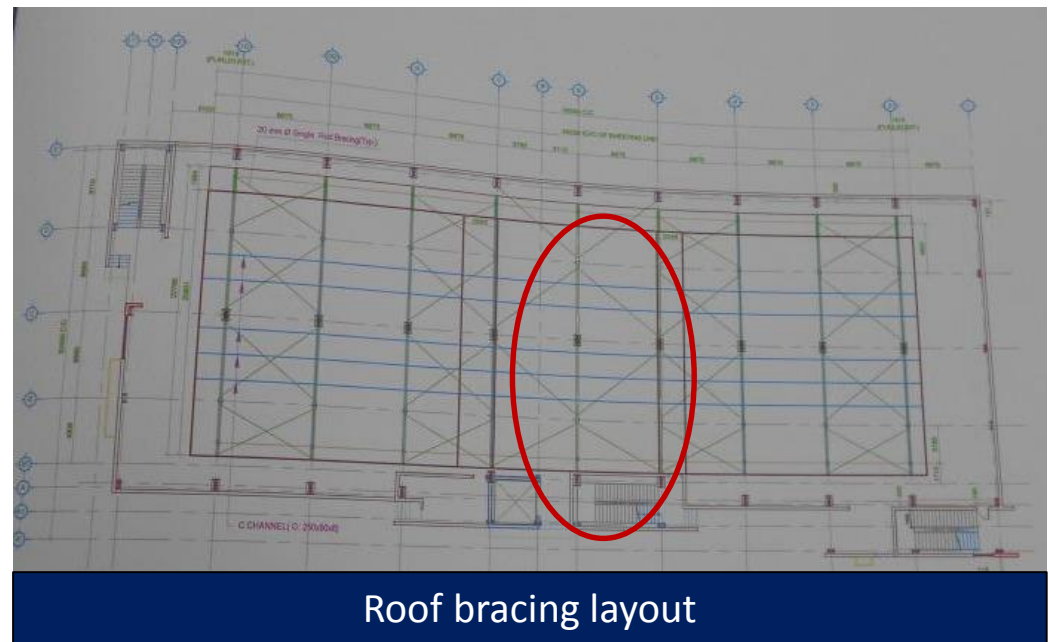
Roof bracing layout

Red marked roof bracing is missing in on site.

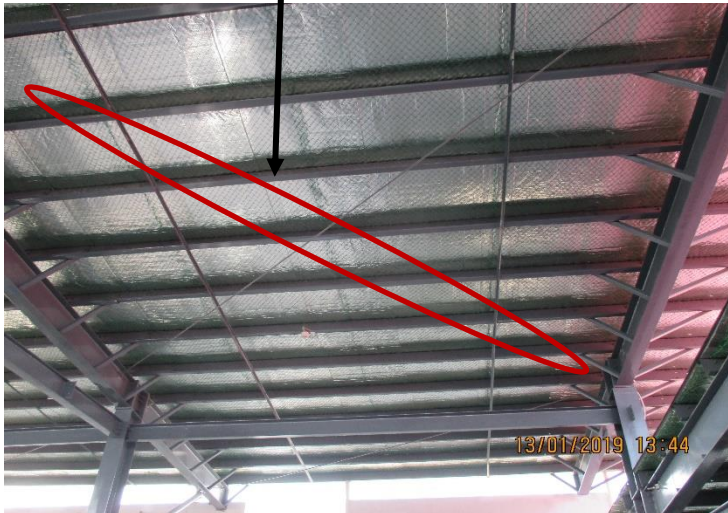
Roof bracing in between grid 5 to 7

On-site roof bracing between 5 to 7 grid was found different than the provided bracing layout drawing. Factory is required to install the roof bracing as per drawing otherwise provide Engineering Assessment for the roof shed.

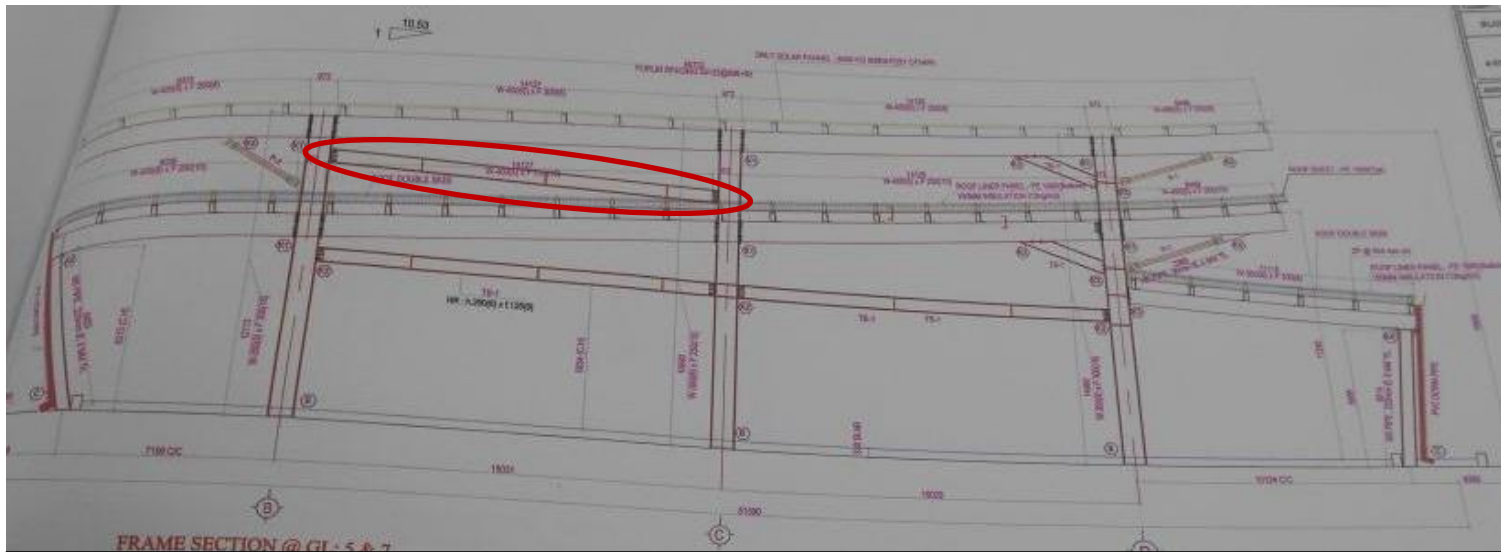
Frame section of grid 5 & 7

Red marked I joist was not installed in the grid of 5 & 7 as per the drawing. Factory engineer is required to install the missing members as per drawing otherwise provide Engineering Assessment for the roof shed.

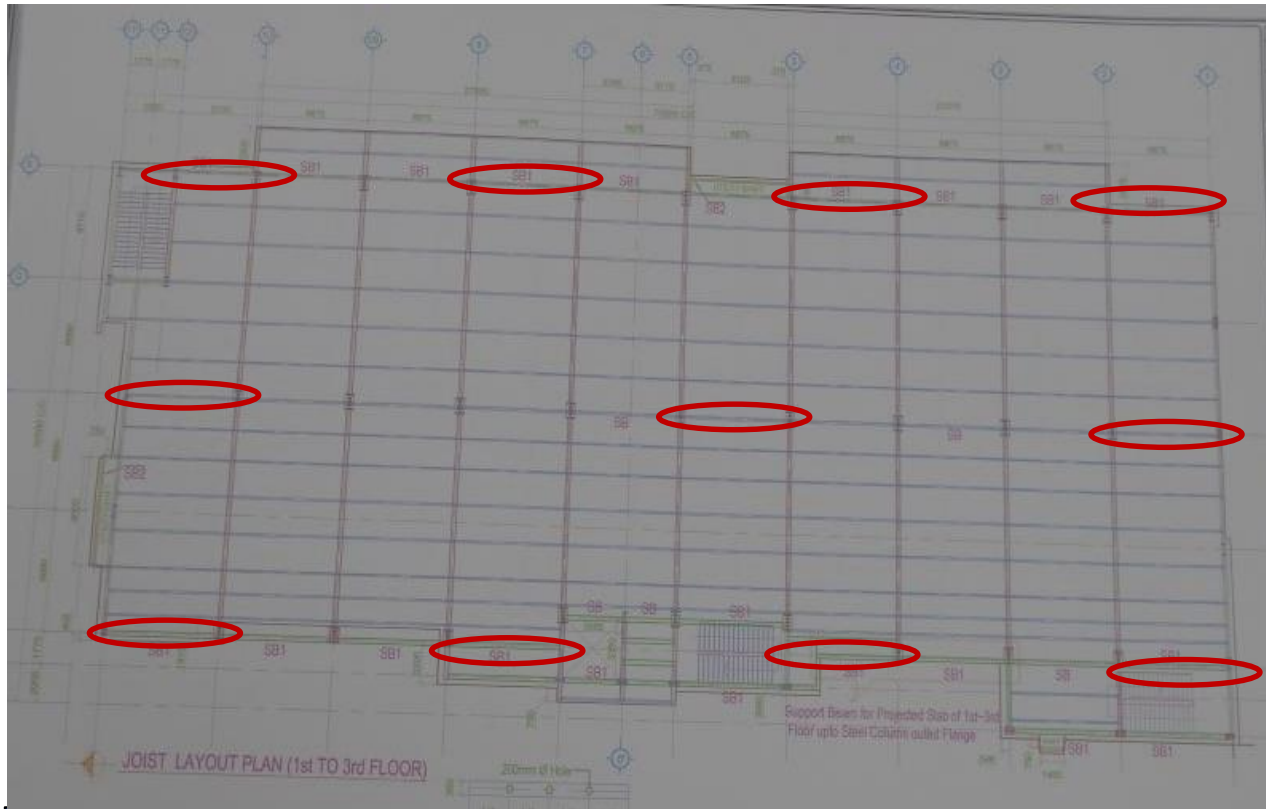
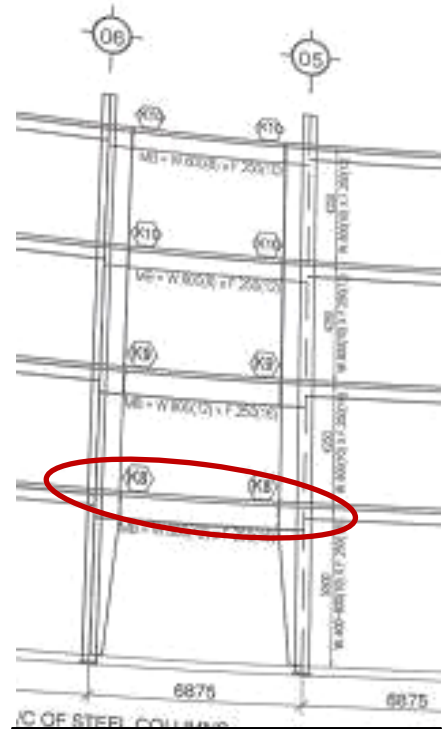
Portal bracing location plan

As per the sub-beam layout, sub-beams are shown in the portal bracing position where no sub-beam exist in on-site condition. Factory is required to provide portal frame layout and cross sectional drawing and revise the sub-beam and joist layout. Factory engineer is require to check the stability of the building.

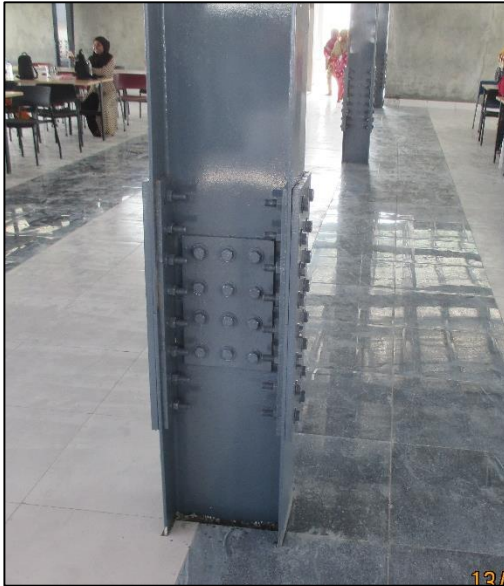
Column Splice in roof

Discrepancies were observed in the column splice connections between as built drawing and on site structure. Factory is required to update the splice connection drawing and provide detail adequacy check of the connections.

| Item No. | Observation | Recommended Action Plan | Recommended Timeline |
|---|---|---|---|
| 4 | (Factory Building)<br>Design adequacy check<br>required for the column<br>splice connections | Factory is required to update the splice connection drawing and provide detail adequacy check of the existing column splice connections. | 6-weeks |

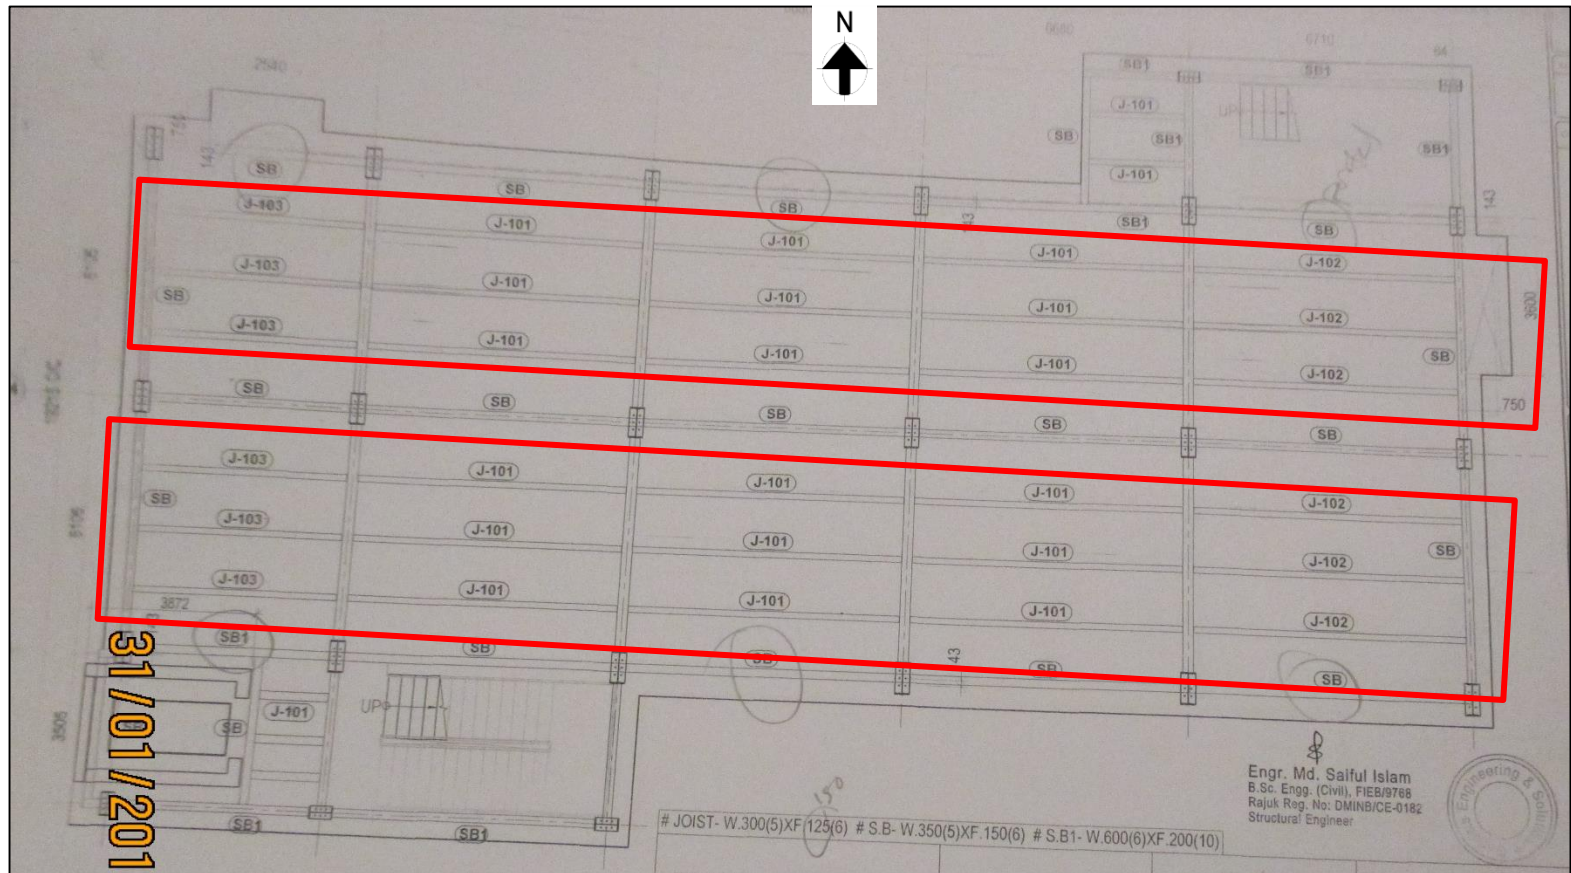
Typical sub-beam layout

As per the sub-beam layout, sub-beam are shown W300x5x125x6 whereas on site condition shows the flange of the sub-beam 150 mm instead of 125 mm. Factory is required update the as built drawing.

| Item No. | Observation | Recommended Action Plan | Recommended Timeline |
|---|---|---|---|
| 6 | (Facility Building)<br>Discrepancies Between<br>Provided Drawing and On-<br>Site Condition | Factory engineer is required to survey and produce accurate as-built drawings which reflect the actual condition. | 6-weeks |

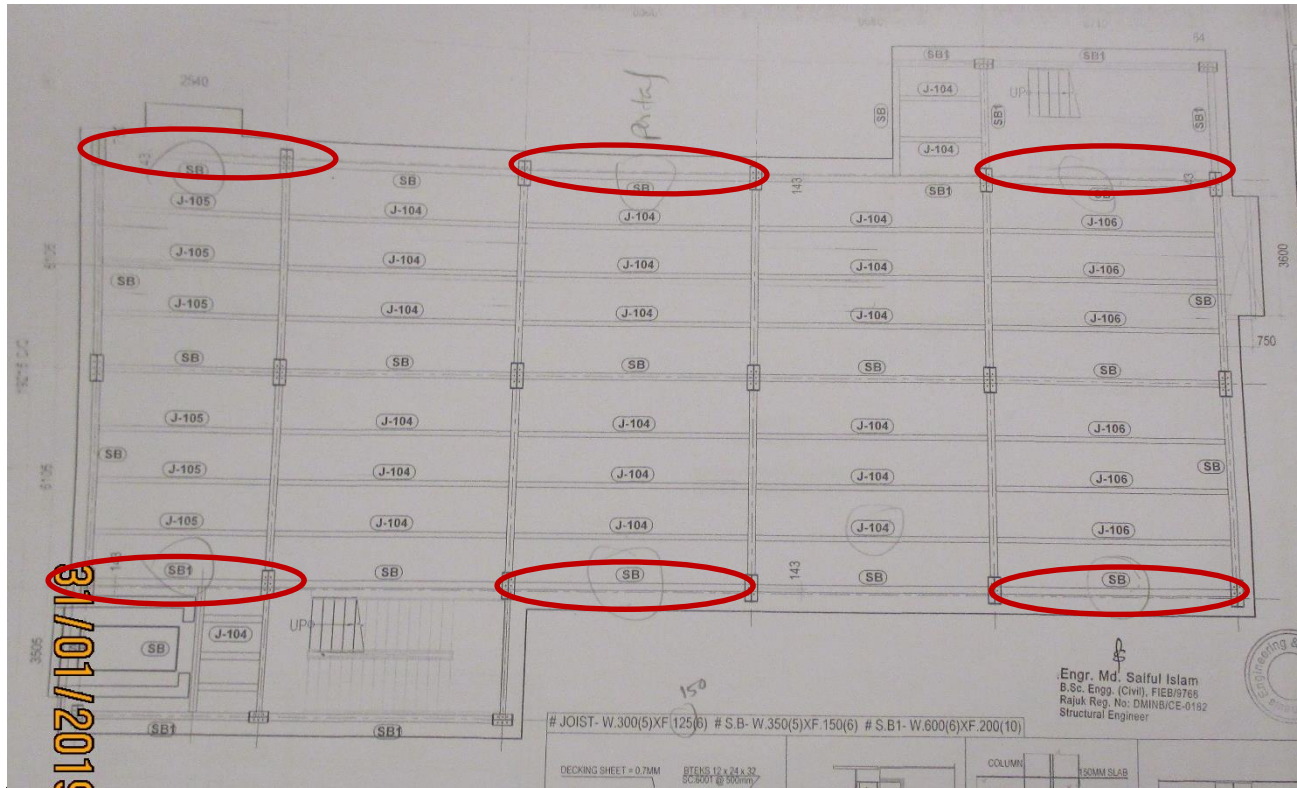
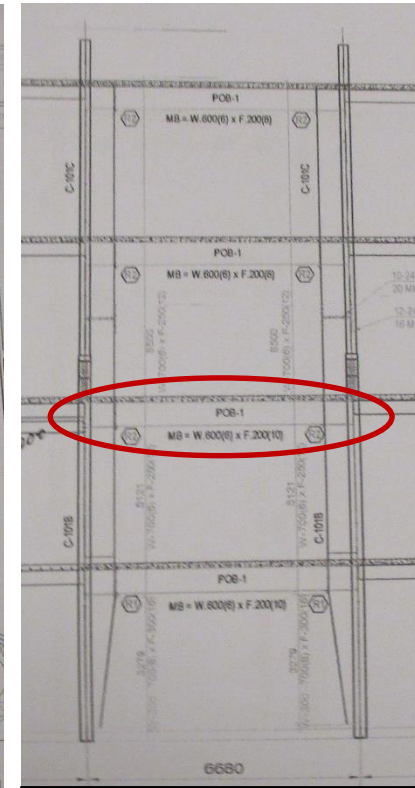
Typical portal layout

As per the sub-beam layout, sub-beam are shown in the portal position where no sub-beam exist in on-site condition. Factory is required to provide portal frame layout and revise the sub-beam and joist layout.
