# FIRE SAFETY INSPECTION REPORT

**Factory Name: Pacific Cotton Ltd.**

**ACCORD ID: 23661**

**Date: 17th July, 2019.**

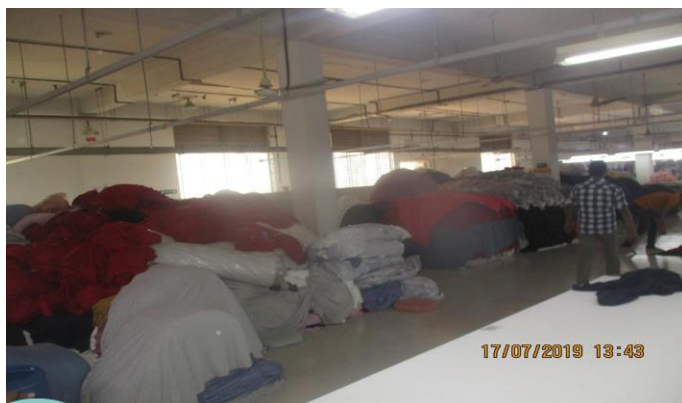
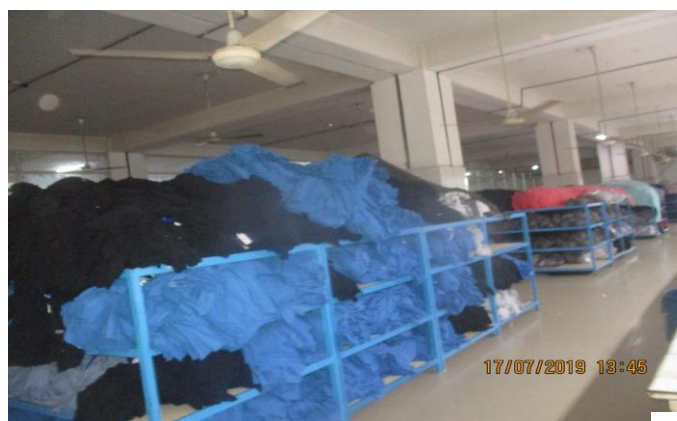
| SI No. | Category | Findings | Required Action | Remediation Time Frame |
|---|---|---|---|---|
| F-01 | Fire Rated Construction | Areas used for in-process storage of combustible materials are open to the surrounding occupancy.<br>Location: Building-01 (Garments Building) | Provide defined storage areas and limit the storage arrangement as follows:-<br>1. <b>General Condition:</b> Maximum height of 2.4m and maximum area of 23m <sup>2</sup> . Separate areas of unenclosed combustible storage by a minimum clear distance of 3m.<br>2. <b>If sprinkler protected:</b> maximum height of 3.66m and maximum area of 93m <sup>2</sup> . Separate areas of unenclosed combustible storage by a minimum clear distance of 3m.<br>or<br>3. Enclose the storage area from the surrounding occupancy with a minimum 1 hour construction. | Within 3 months |

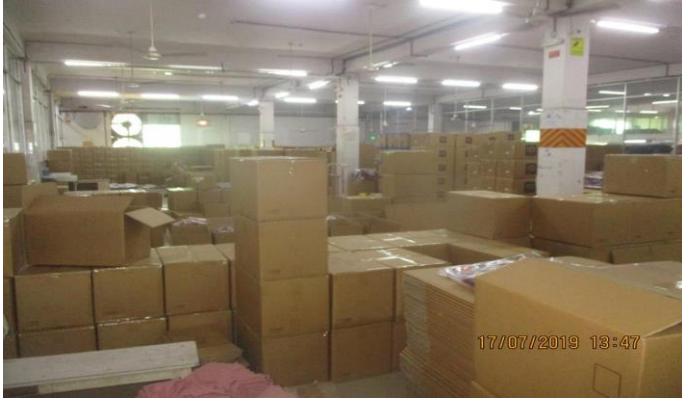
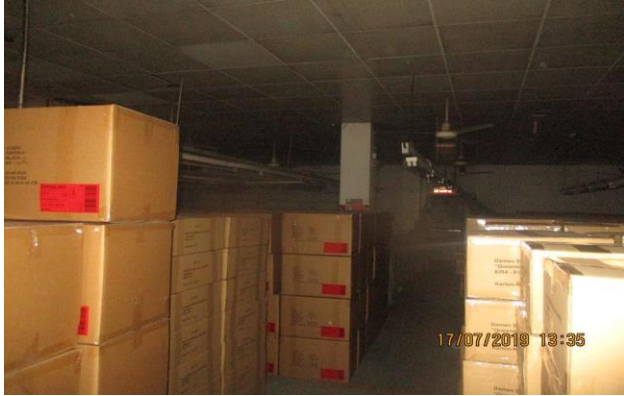
| F-02 | Fire Rated Construction | Rooms used for storage of combustible materials are not separated from the surrounding occupancy/areas.<br>Location: Building-01 (Garments Building) | Rooms used for storage of combustible materials shall be separated from the surrounding occupancy with a minimum 1 hour construction. | Within 3 months |

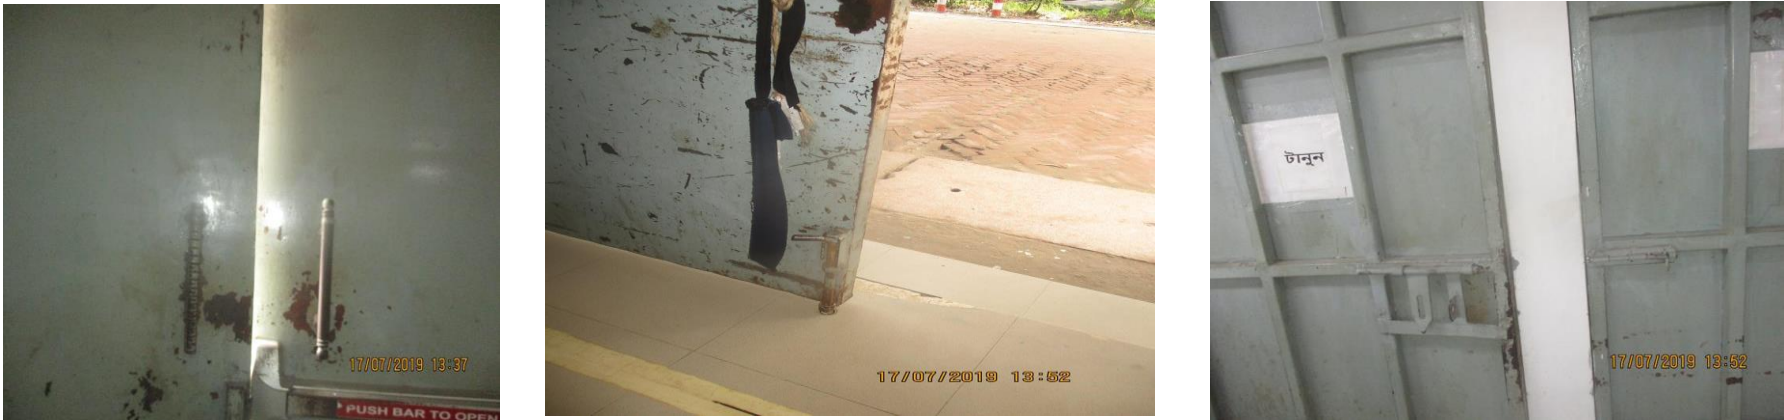
| F-03 | Egress | Doors along means of egress are provided with non compliant locking system.<br>Location: Building-01 (Garments Building) | <ol style="list-style-type: none"> <li>1. Remove all non compliant locking features from egress doors.</li> <li>2. If locks are required for security reasons, utilize special door locking features complying with NFPA 101.</li> <li>3. Doors may be locked where the latch and lock are disengaged with one motion where the occupant load does not exceed 49 persons.</li> <li>4. Doors may be provided with locking hardware from the ingress side provided that a panic bar is installed on any door with an occupant load exceeding 49 persons.</li> </ol> | Immediate |

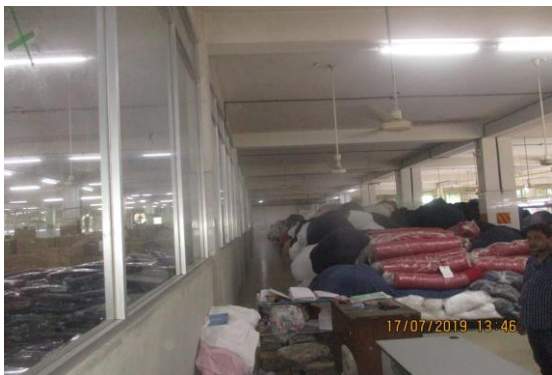
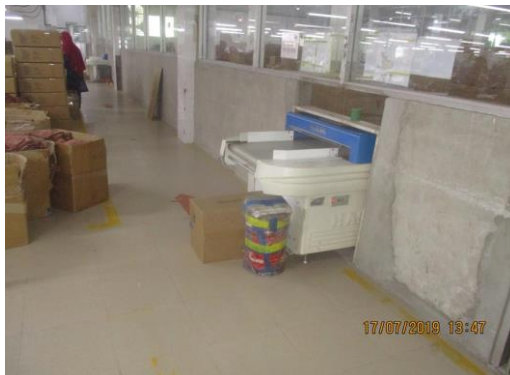
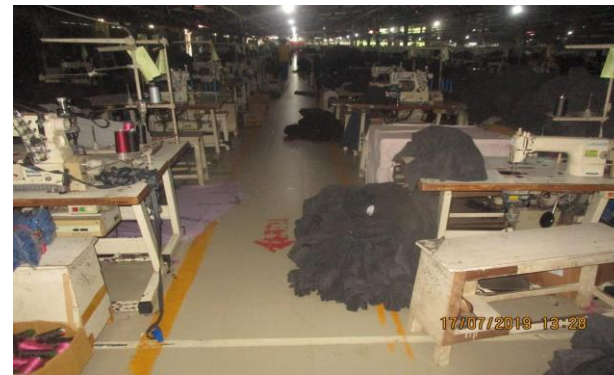
| F-04 | Egress | The egress path along means of egress has interrupted by obstruction/storage.<br>Location: Building-01 (Garments Building) | <p>Means of egress shall be maintained continuously free and clear of all obstructions/storage.</p> <p>Or</p> <p>Keep egress paths and stairs clear of storage.</p> | Immediate |

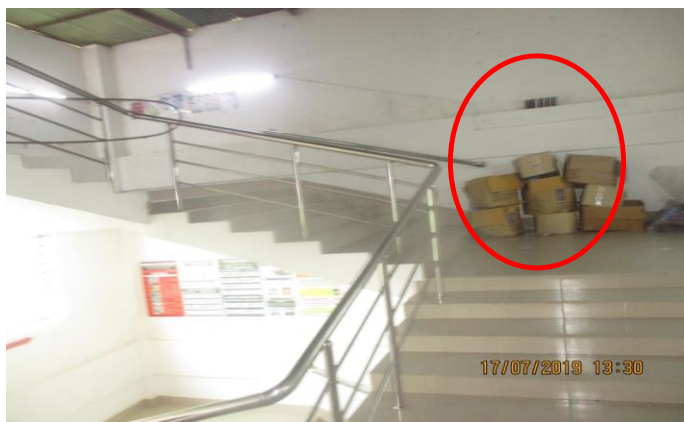
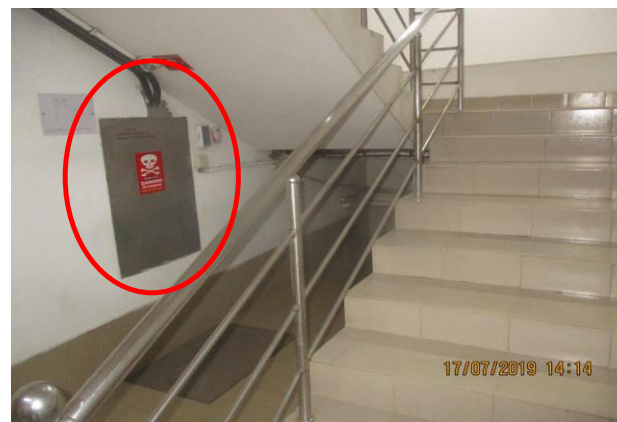
| F-05 | Egress | Storage was located in the exit stairs at exit stair.<br>Location: Building-01 (Garments Building) | Remove all storage from exit stairs. | Immediate |

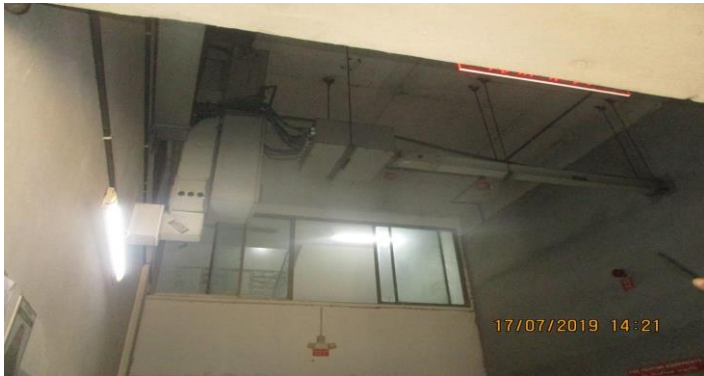
| F-12 | Fire Rated Separation | Unsealed penetrations and openings are located in exit stair enclosures.<br>Location: Building02 (Dyeing Building) | Seal all penetrations and openings in the wall of exit enclosure walls (full thickness of the wall) by fire rated materials to maintain the fire resistance rating. | Within 3 months |

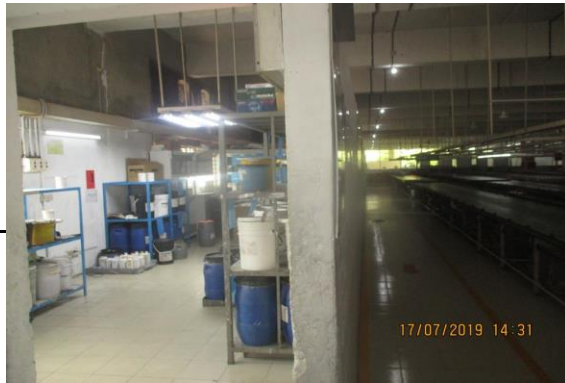
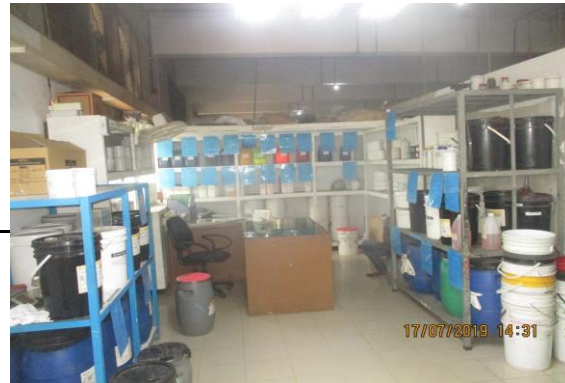
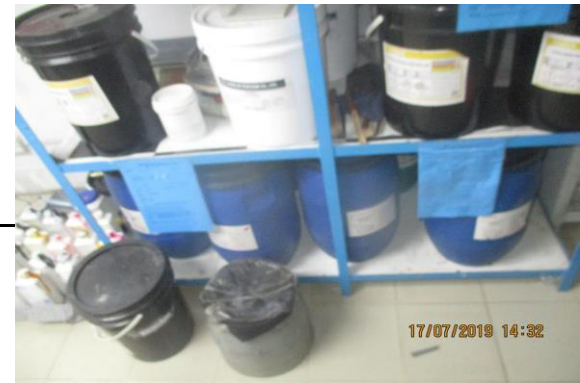
| F-13 | Fire Rated Separation | Rooms used for chemical storage of combustible materials are not separated from the surrounding occupancy/areas.<br>Location: Building02 (Dyeing Building) | Rooms used for chemical storage of combustible materials shall be separated from the surrounding occupancy with a minimum 2 hour construction. | within 3 months |

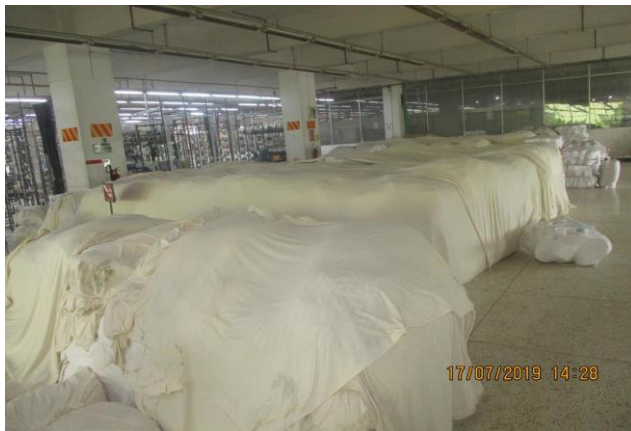
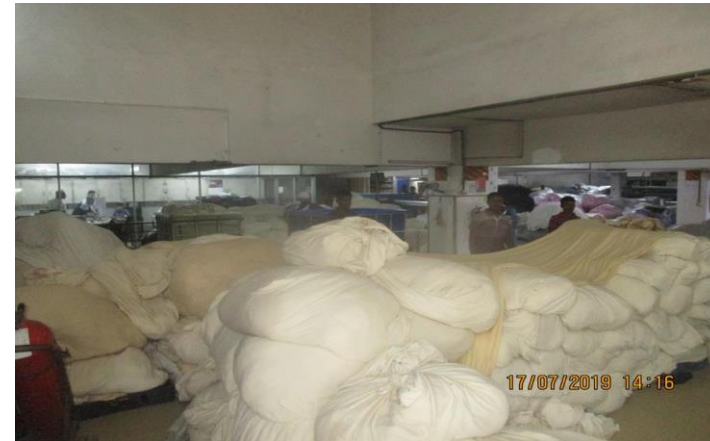
| F-14 | Fire Rated Separation | <p>Areas used for in-process storage of combustible materials are open to the surrounding occupancy and combustible material has been found under marker table at marker shed.</p> <p>Location: Building02 (Dyeing Building)</p> | <p>Provide defined storage areas and limit the storage arrangement as follows:-</p> <ol style="list-style-type: none"> <li><b>1. General Condition:</b> Maximum height of 2.4m and maximum area of 23m<sup>2</sup>. Separate areas of unenclosed combustible storage by a minimum clear distance of 3m.</li> <li><b>2. If sprinkler protected:</b> maximum height of 3.66m and maximum area of 93m<sup>2</sup>. Separate areas of unenclosed combustible storage by a minimum clear distance of 3m.</li> </ol> <p>or</p> <ol style="list-style-type: none"> <li><b>3. Enclose the storage area from the surrounding occupancy with a minimum 1 hour construction.</b></li> </ol> | Within 3 months |

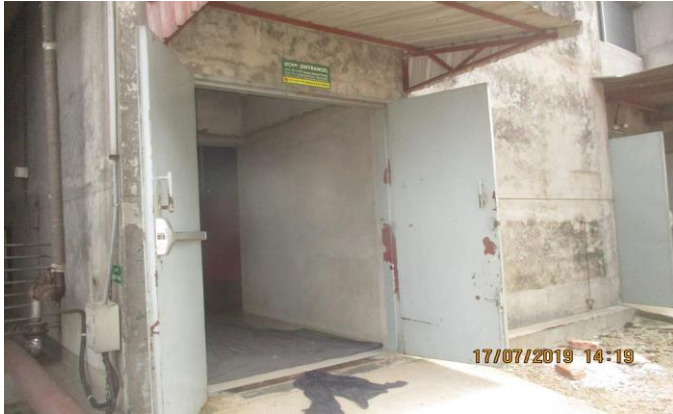
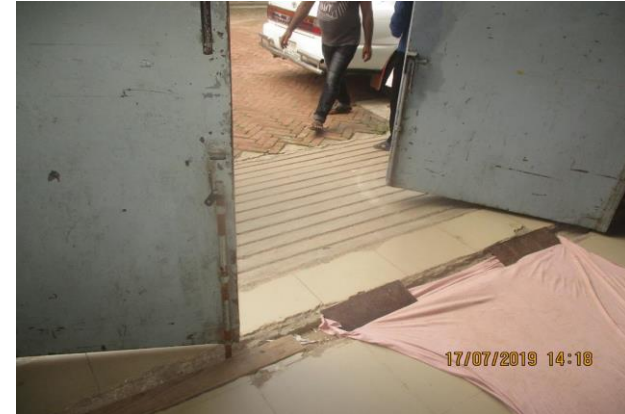
| F-15 | Egress | Doors along means of egress are provided with non compliant locking system.<br>Location: Building02 (Dyeing Building) | <ol style="list-style-type: none"> <li>1. Remove all non compliant locking features from egress doors.</li> <li>2. If locks are required for security reasons, utilize special door locking features complying with NFPA 101.</li> <li>3. Doors may be locked where the latch and lock are disengaged with one motion where the occupant load does not exceed 49 persons.</li> <li>4. Doors may be provided with locking hardware from the ingress side provided that a panic bar is installed on any door with an occupant load exceeding 49 persons.</li> </ol> | Within 3 months |

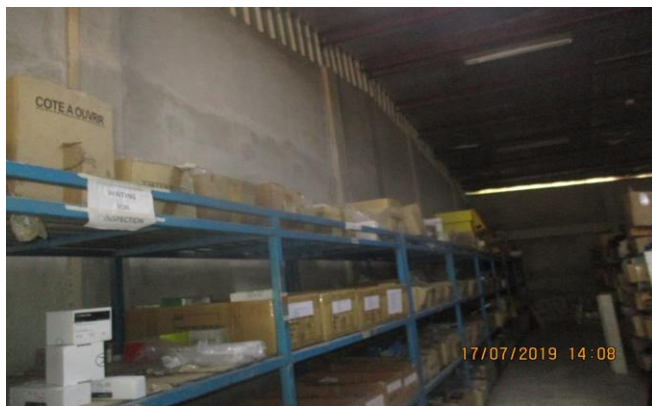
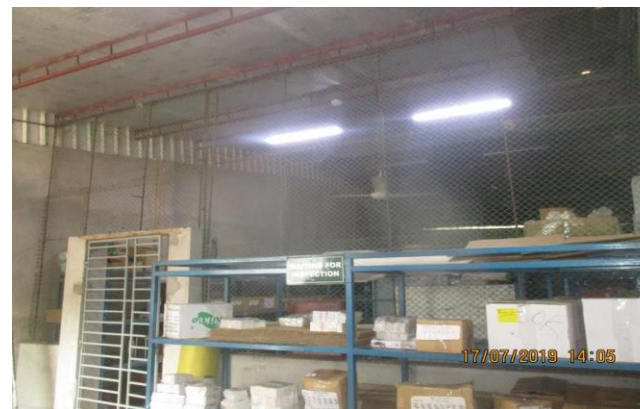
| F-16 | Fire Rated Construction | Dining room is not separated by 2-hr fire rated separation from storage areas.<br>Location: Building 04 (Dining Shed) | Separate the dining area by a minimum 2-hr fire-rated construction having a direct access to exit stair. Seal and/or protected all openings to maintain the required fire separations. | Within 3 months |

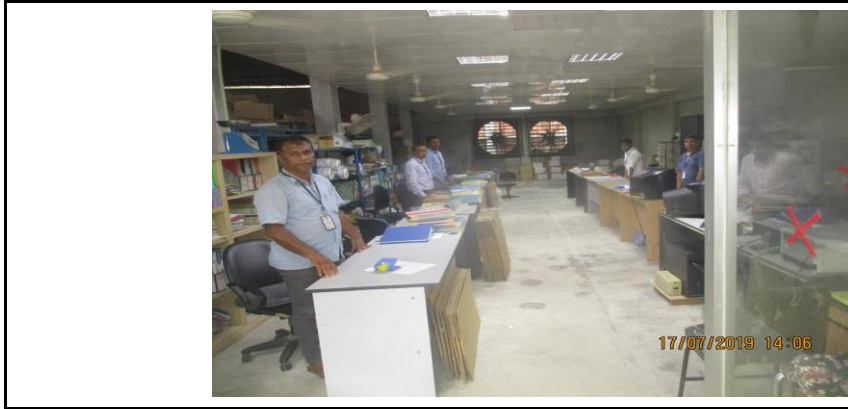
| F-18 | Egress | Office staffs no safe exit.<br>(Pass through store area)<br>Location: Adjacent to the dining shed. | Provide direct exit for the office staffs.<br>Or<br>Provide 2-hr fire rated passage way for the office staffs. | Within 1 month |
