Union Knitwear Ltd. Union Garments ltd.

M.C Bazar, Shishu Palli Plus Road, Mulaid, Tengra, Sreepur, Gazipur (24.24376N, 90.41008E)

15 March 2014

Observations

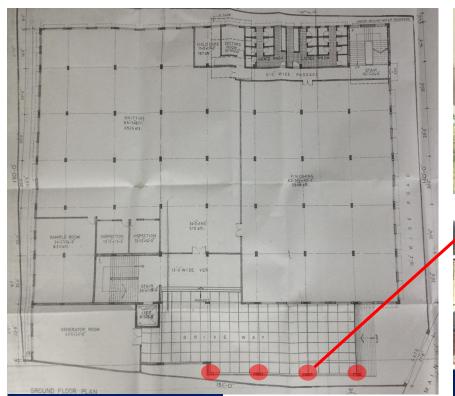
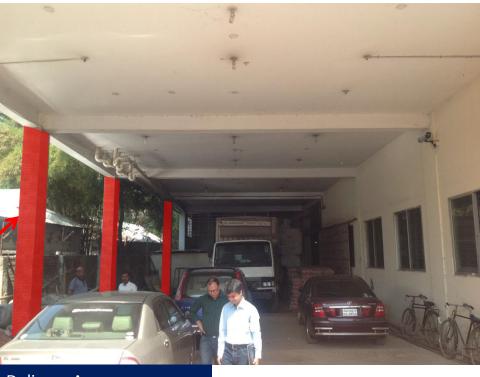
Delivery Area

The columns at the front entrance to the building are at risk of being accidentally struck by a vehicle

4No columns in delivery area at risk of being struck by vehicle.

ITEM 1: The Columns at the front entrance to the Building are at risk of being accidentally struck by a vehicle. Column protection barriers need to be provided.

Building Engineer to check that the columns have been designed for vehicle impact loading or provide adequate protection to the columns at risk of damage due to impact loading.

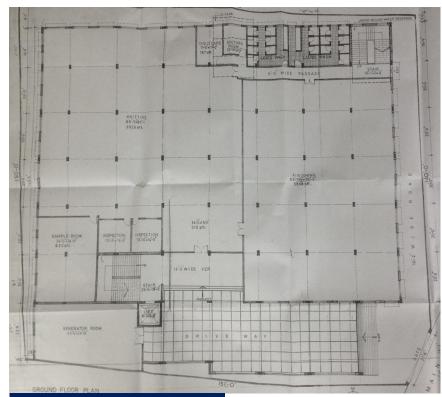
Typical Column Layout

Columns at ground floor appear to be stressed in excess of normal design limits

Cursory calculations indicate that the columns are highly stressed and appear smaller than required by Design Codes for the applied loads.

ITEM 2: Columns appear to be highly stressed – Building Engineer to verify concrete stresses and in-situ concrete strength.

Building Engineer to verify that columns have been designed to support the applied loads.

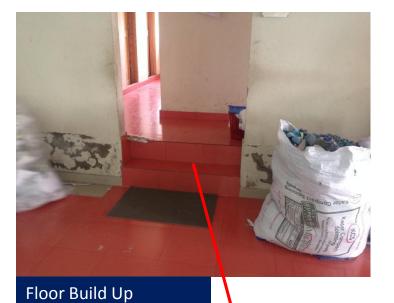
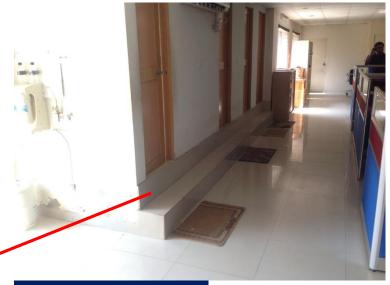
1st Floor Office Toilet Area

Design check required for floor build-ups under water tank and in wash and toilet areas at roof level

450mm (avg) high floor build-up in toilet area supported by concrete slab and beam arrangement.

ITEM 3: Design check required to verify capacity of structure supporting the water tanks and the floor build-ups in the wash and toilet areas at roof level.

Building Engineer to verify that the slab and beams have been adequately designed to carry floor build-up loads

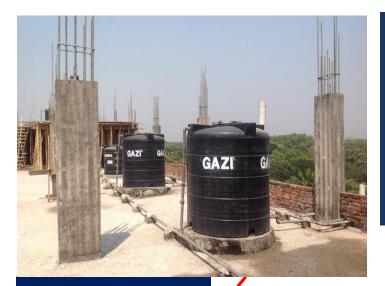
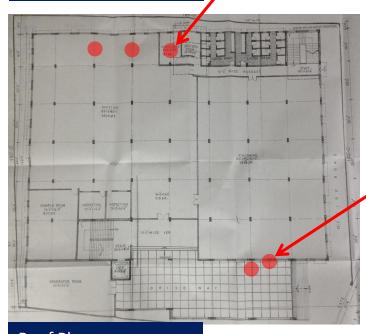
Water Tanks

5No plastic water tanks on 225mm (avg) concrete plinths supported by concrete slab and beam arrangement at roof level.

Building Engineer to verify that the slab and beams have been adequately designed to carry loading due to water tanks

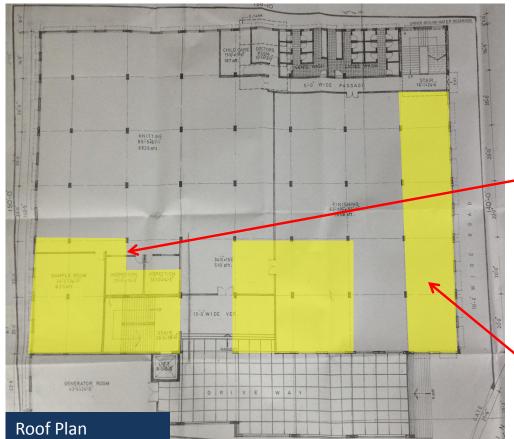
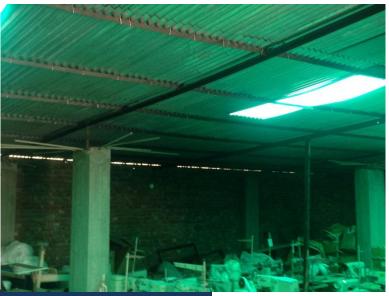
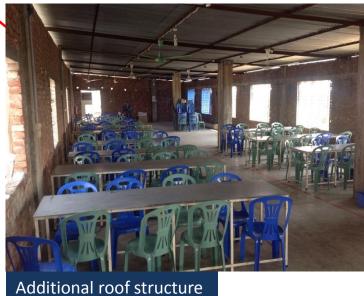
Additional roof structure

Design check required for the temporary steel structures constructed at 4th Floor Level

ITEM 4: Design check required for the temporary steel structures constructed at 4th Floor Level.

Building Engineer to verify design of additional steel structure, including stability, and capacity of RC structure to support additional structure.

9	Design check required for the temporary steel structures constructed at 4th Floor Level	Building Engineer to provide detailed calculations for the temporary roof structures and the associated light steel roof. These should confirm their ability to withstand all design wind loadings - pressure, suctions and uplift forces.	6-weeks

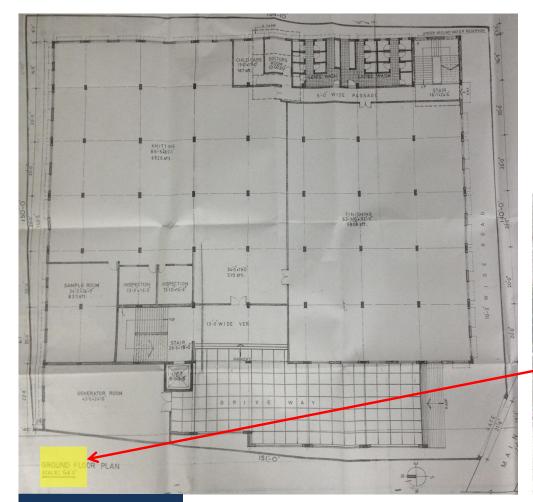
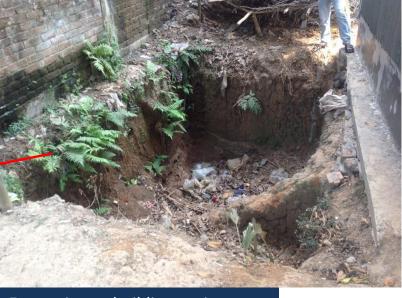
Excavation at building perimeter

Excavation at the North West Corner perimeter of the building should be filled in

ITEM 5: Excavation at the North West Corner perimeter of the building should be filled in.

Excavation at location shown to be filled with compacted engineering fill material to prevent settlement / subsidence of building foundations

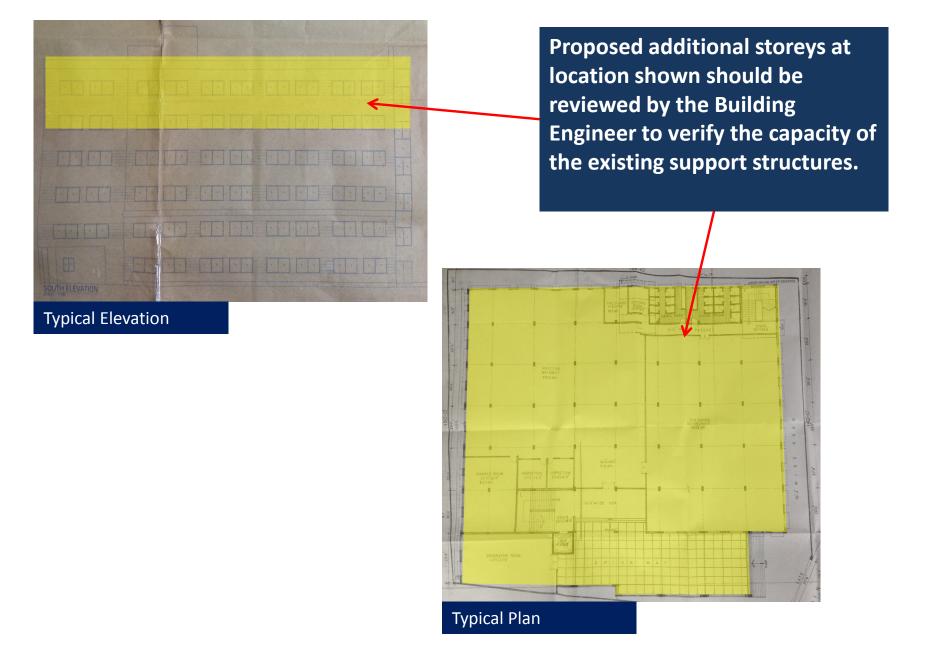
Potential Vertical Extensions to the existing building structure should be reviewed by the Building Engineer

ITEM 6: Any potential vertical extension should be reviewed by the Building Engineer to confirm the structural capacity of the as-built structure regardless of the existing Permit drawings

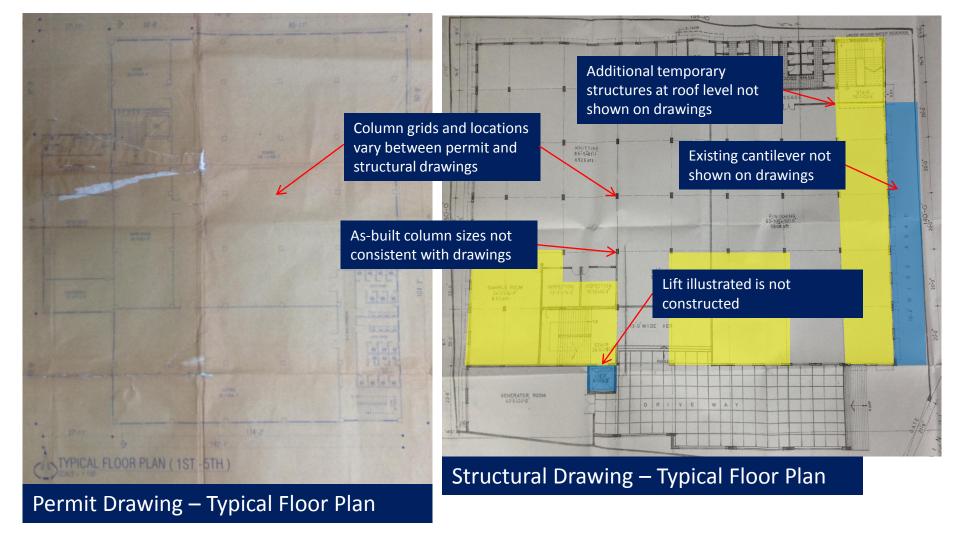
Permit / Structural Drawings

Inconsistencies between permit drawings, structural drawings and as-built structure

Discrepancies between permit drawings, structural engineers' drawings and asbuilt structure.

ITEM 7: Inconsistencies between Permit drawings, structural drawings and what is actually constructed. Accurate Structural Drawings should be produced.
