# Body Link Sweater Ltd. Marigold Accessories Ltd.

Plot No. 371, 342, Noljani, Chandona, Joydevpur, Gazipur  
(23.990786N, 90.389874E)

15<sup>th</sup> March 2015

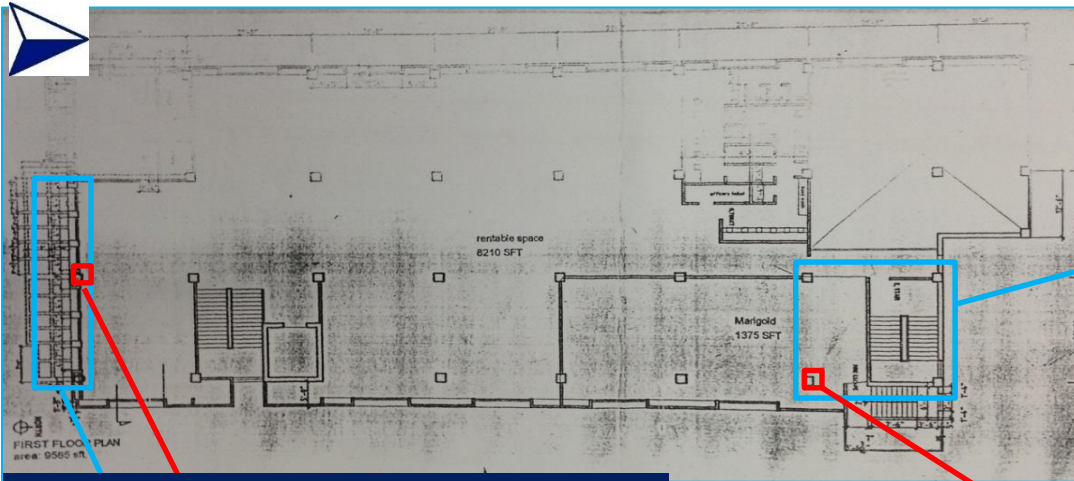
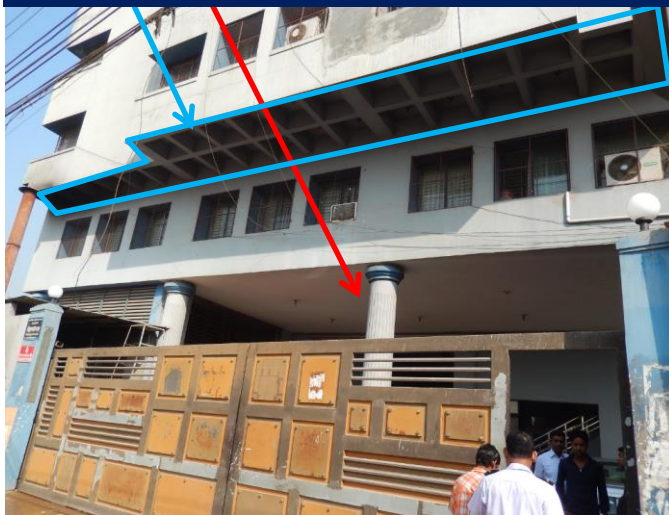
Column supporting cantilever

Cursory calculations indicate high column stress in columns, particularly those supporting cantilever and under water tank

Item No.	Observation	Recommended Action Plan	Recommended Timeline
1	High stress levels in columns	Limit water tank to half its capacity.	Immediate - Now
2	High stress levels in columns	Remove storage and limit live load to max. 2kPa at all levels in the red areas shown.	Immediate - Now
3	High stress levels in columns	Limit live load in all other areas to max. 3kPa at all levels.	Immediate - Now
4	High stress levels in columns	Building Engineer to review design, loads and column stresses in all areas.	Immediate - Now
5	High stress levels in columns	Verify in-situ concrete stresses by 100mm diameter cores from min. 4 columns at ground floor level.	Immediate - Now
6	High stress levels in columns	A Detail Engineering Assessment of Factory to be commenced - see attached Scope.	Immediate - Now
7	High stress levels in columns	Produce and actively manage a loading plan for all floor plates within the factory. giving consideration to floor capacity and column capacity.	6-weeks

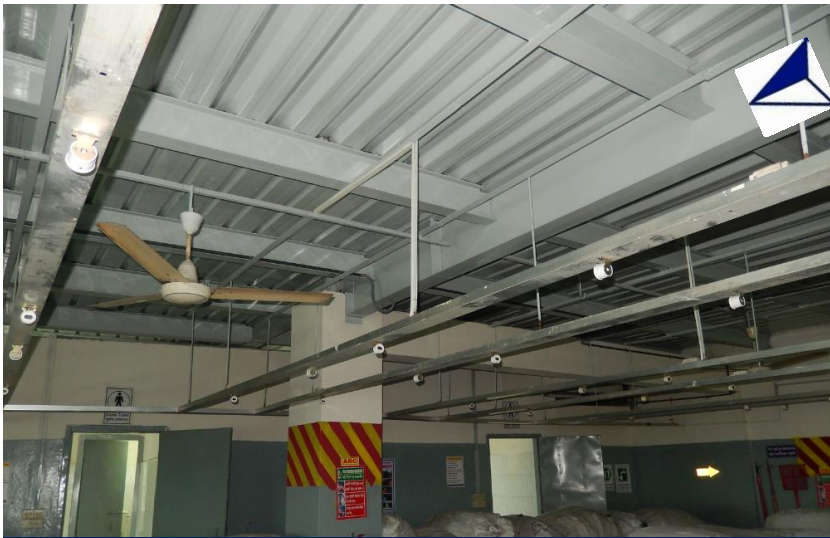
As-built: Primary N-S, purlins E-W direction

Discrepancies between composite roof design and as-built condition

8	High stress levels in columns	Detail Engineering Assessment to be completed.	6-weeks
9	High stress levels in columns	Continue to implement load plan	6-months
10	Discrepancies between composite roof design and as-built condition	As part of the Detail Engineering Assessment (see Item 1), Building Engineer to check the design of the composite roof as constructed for adequacy to resist statutory Code loads (vertical and horizontal).	6-weeks
11	Discrepancies between composite roof design and as-built condition	Carry out any works arising from engineering check.	6-months
12	Discrepancies between composite roof design and as-built condition	As part of the Detail Engineering Assessment (see Item 1), Building Engineer to produce accurate as-built drawings.	6-months

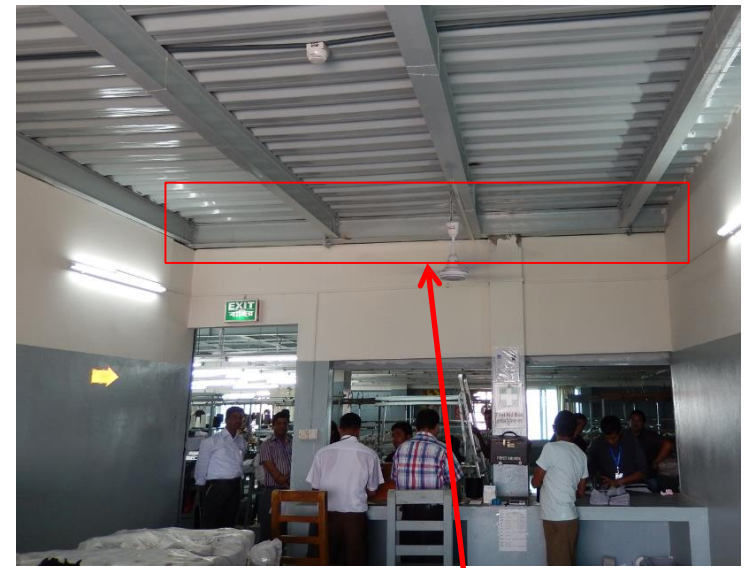
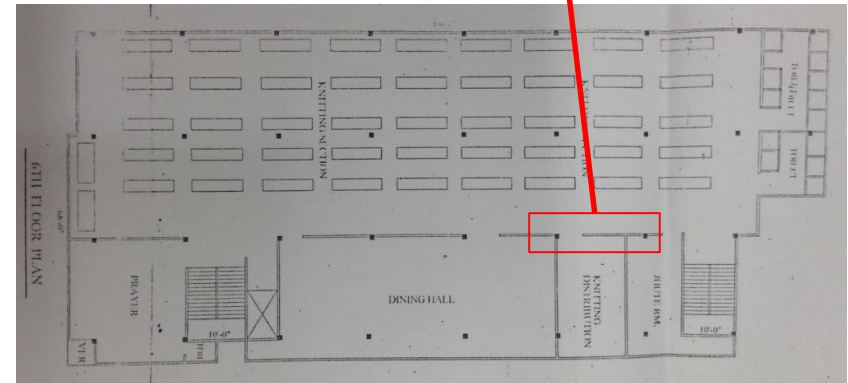
Primary beam missing: brick wall is load bearing

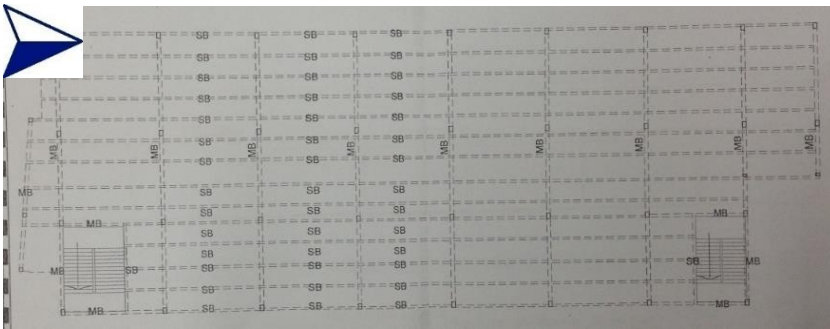
Design: Primary E-W, purlins N-S direction

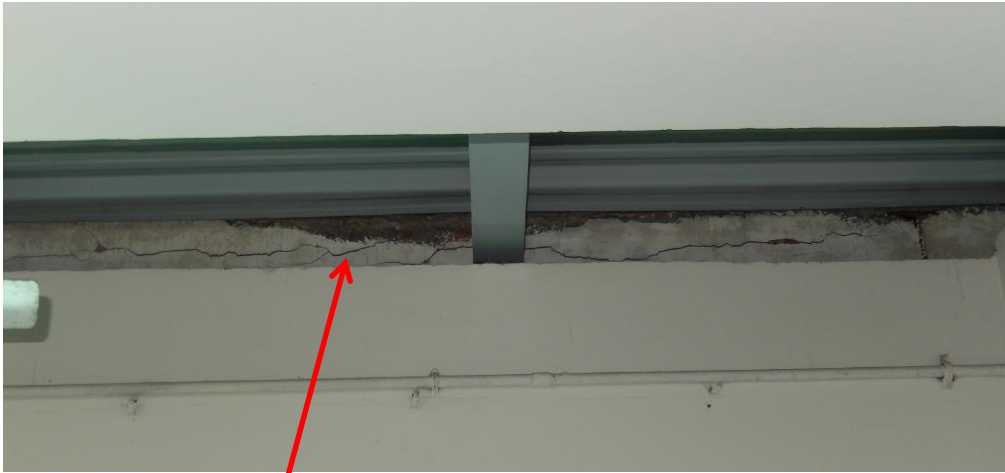
Cracking observed between roof deck and brick wall

Lateral load transfer from composite roof onto concrete frame is unclear

Item No.	Observation	Recommended Action Plan	Recommended Timeline
13	Lateral load transfer from composite roof to perimeter beams	As part of the Detail Engineering Assessment (see Item 1), Building Engineer to check the connection details of the roof to the perimeter structure, in terms of vertical and lateral load transfer.	6-weeks
14	Lateral load transfer from composite roof to perimeter beams	Carry out any works arising from engineering check.	6-months
15	Damage to columns and beams	Building Engineer to assess damaged structural elements and carry out a design check.	6-weeks
16	Damage to columns and beams	Carry out any structural remedial works arising from engineering check.	6-months
17	Non-engineered roof in generator and boiler buildings	Building Engineer to check roof structures in these buildings for adequacy to resist statutory Code loads (vertical and horizontal).	6-weeks
18	Non-engineered roof in generator and boiler buildings	Carry out any structural remedial works arising from engineering check.	6-months

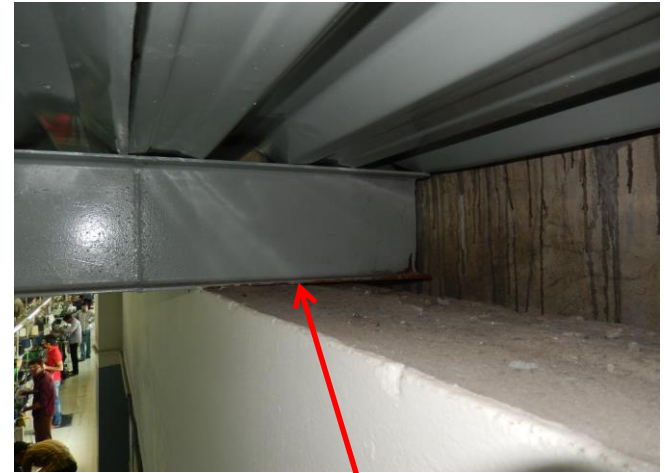
No anchorage detected between roof deck and concrete beams

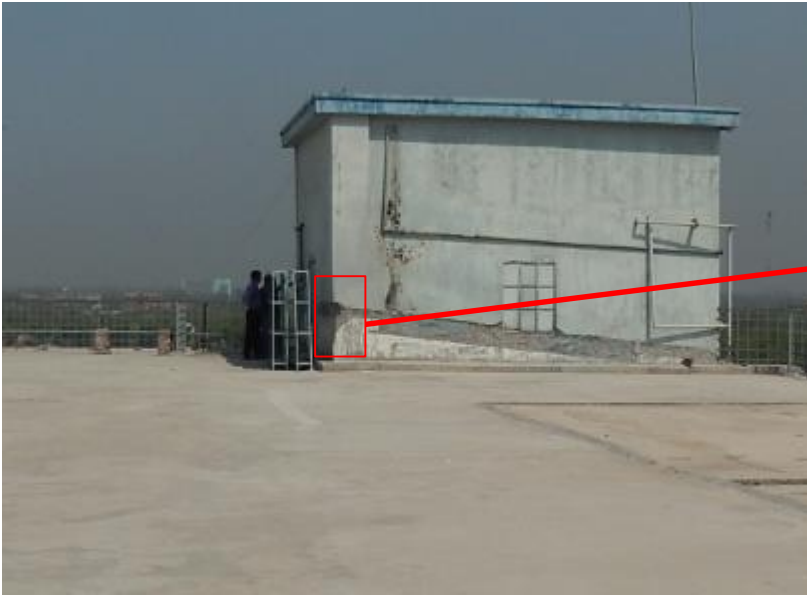
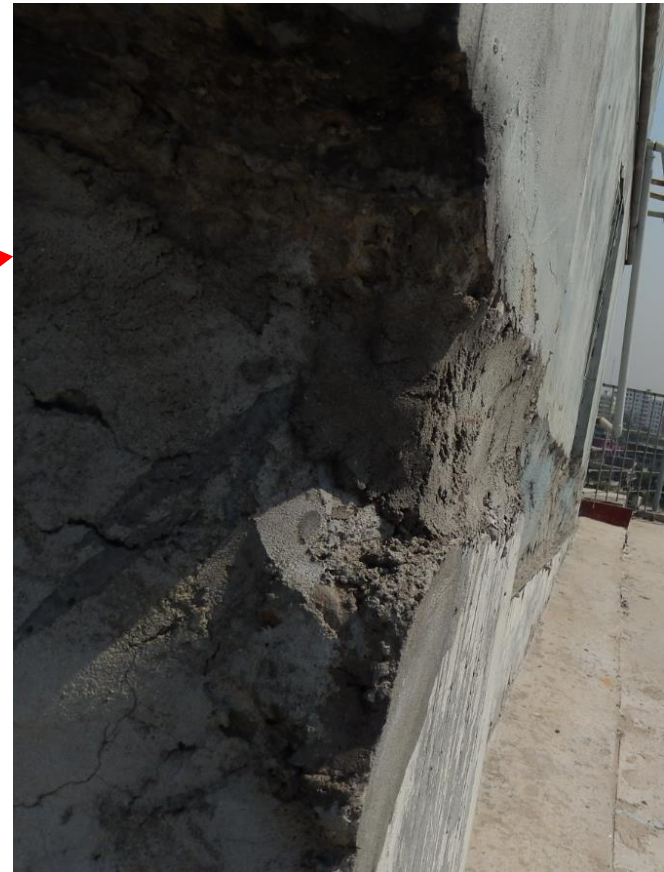
Three or more of the reinforcement bars in the column appear to be cut

Columns under water tank are damaged  
- Review required

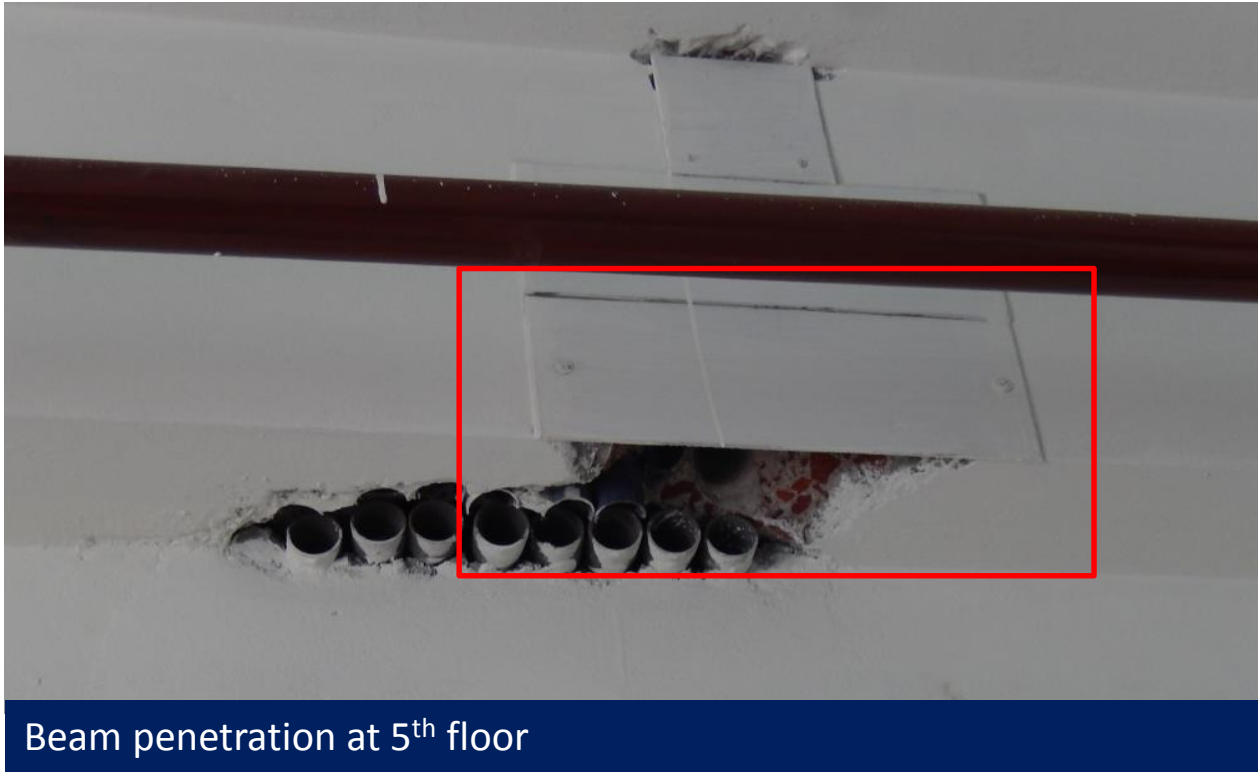
Beam penetration at 5<sup>th</sup> floor

5<sup>th</sup> floor beam is damaged  
- Review required

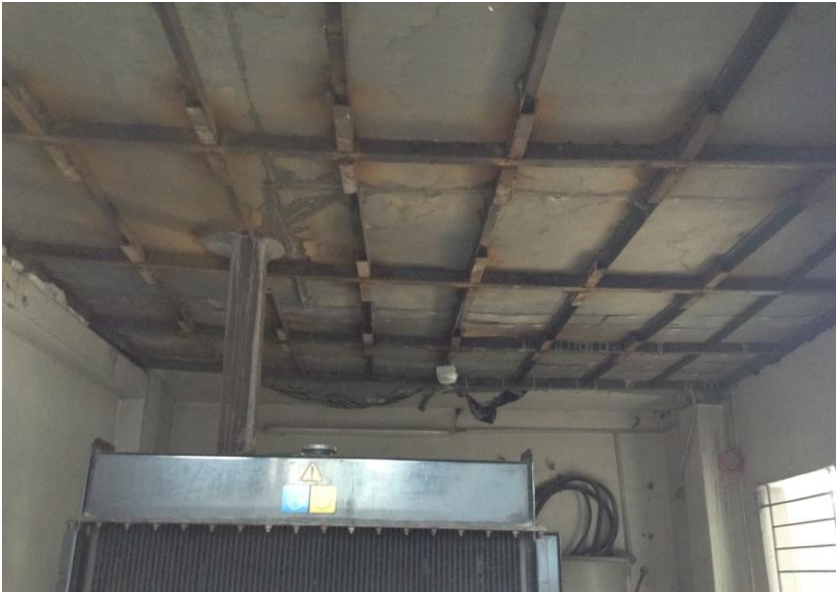
Metal sheet with concrete fill in generator building

Non-engineered roof in generator and boiler buildings

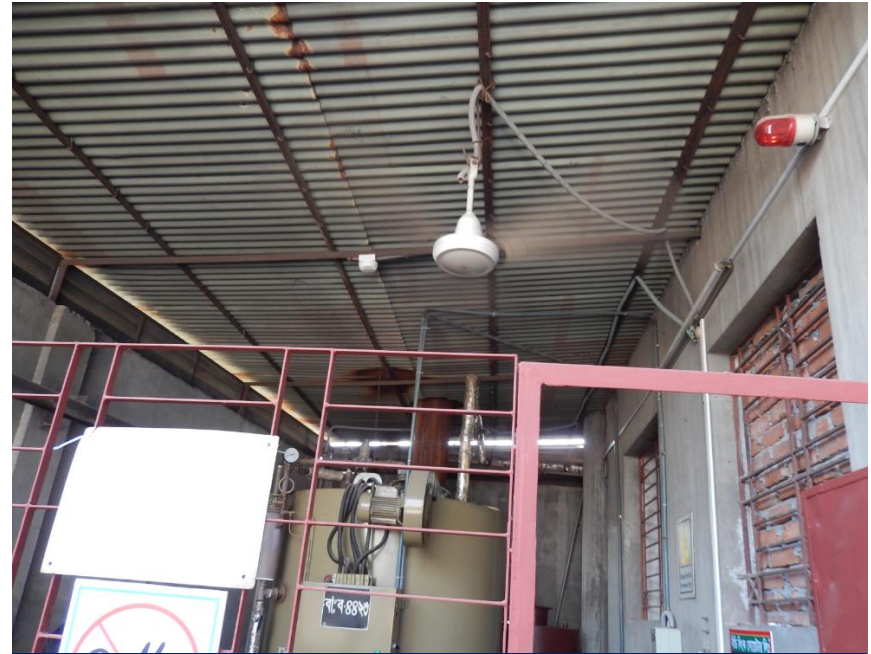
Metal deck in boiler building

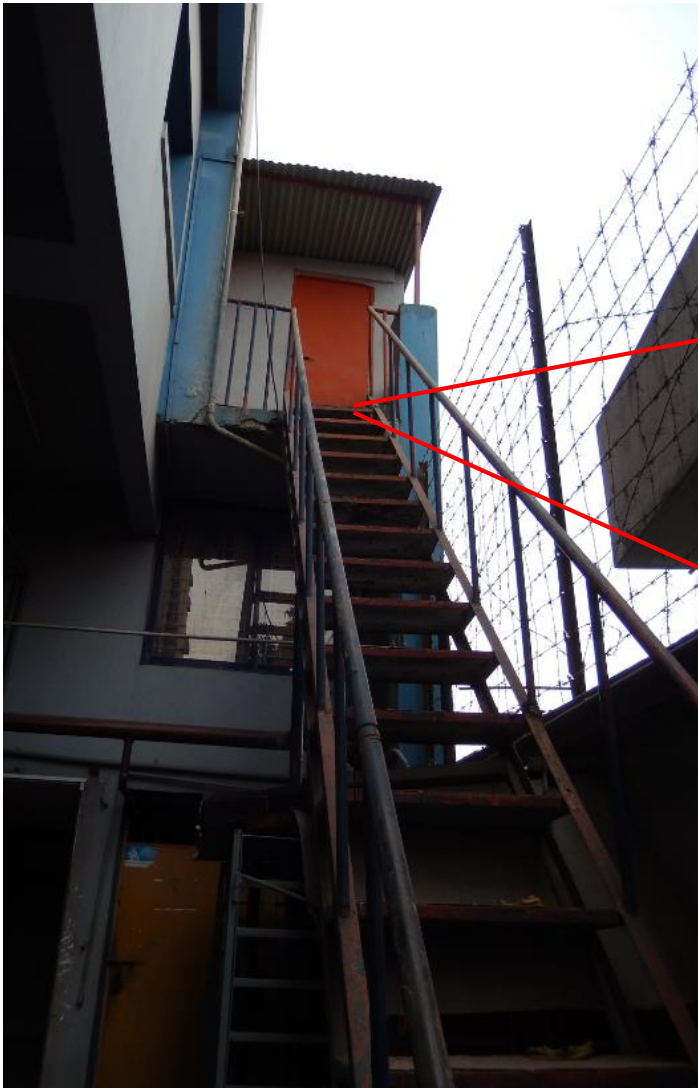
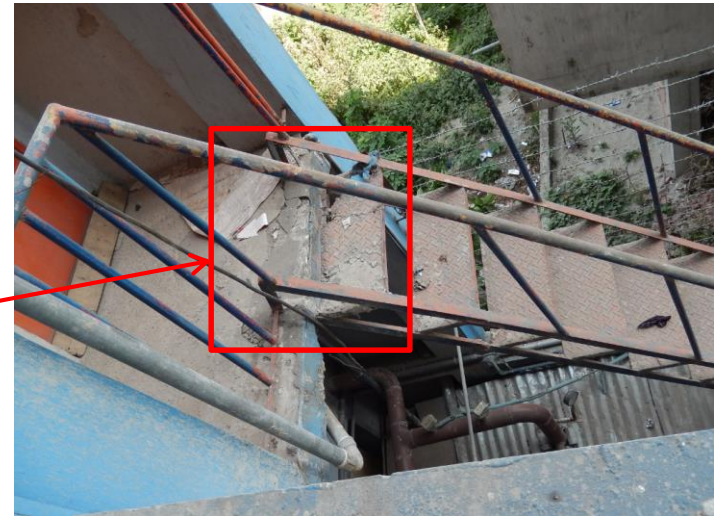
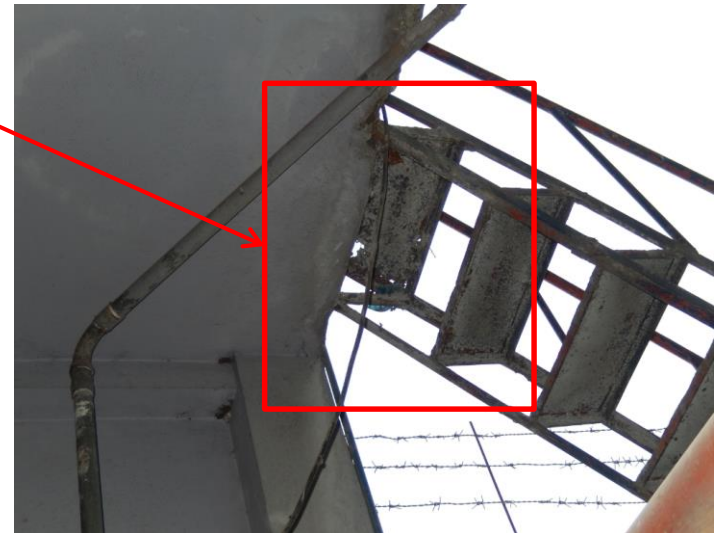
**Non-structural Observation: Unsafe steel access stair requires repair**
