FIRE SAFETY INSPECTION REPORT

Factory Name: Disney Sweater Ltd. (Extension)

ACCORD ID: 23720

Date: 29 July, 2019

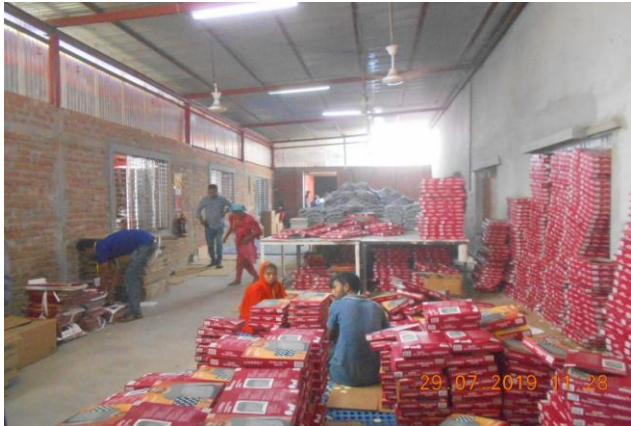
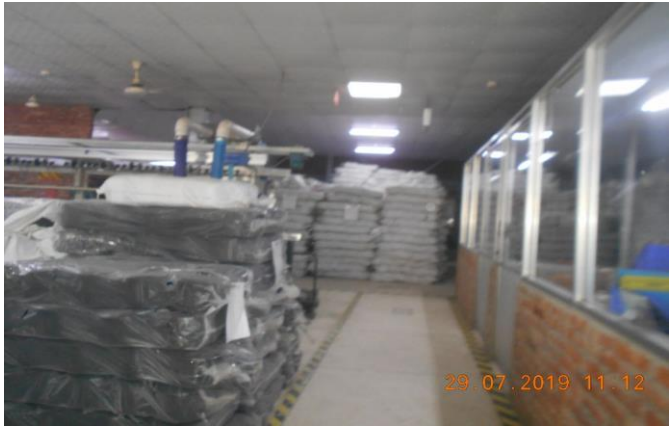
2	Fire rated construction	<p>Rooms used for storage of combustible materials are not separated from the surrounding. Location: Bonded wear house, Yarn store, Finished Goods Store 1 & 2.</p>	<p>Rooms used for storage of combustible materials shall be separated from the surrounding occupancy with a minimum 1 hour construction.</p>	<p>Within 3 months</p>

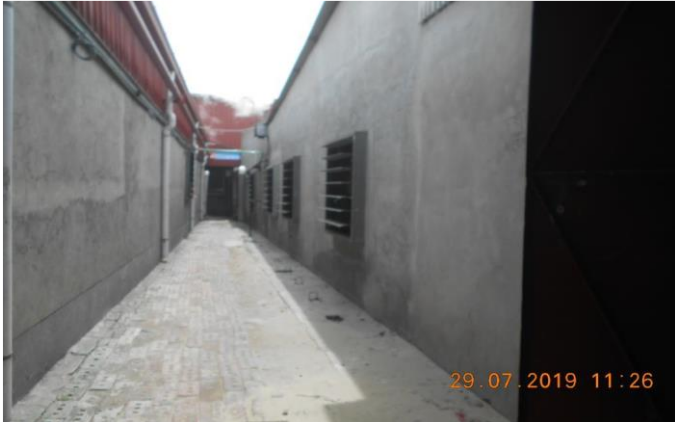
4	Fire rated construction	<p>Corridor serving more than 30 occupants is not separated by fire rated construction. Location: South side Shed-A (Winding, Bonded wear house, Finished Goods Area-1).</p>	<p>1. Separate the corridor by a minimum 1-hr fire rated construction. Or 2. Provide automatic sprinkler system throughout the story as per NFPA 13</p>	Within 3 months

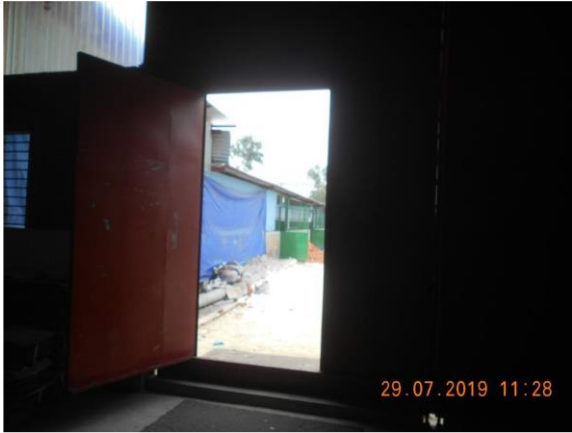
8	Egress	Fire evacuation maps is not posted at the entrance of each exits.	Fire evacuation maps shall be posted at the entrance of each exits.	Within 1 month

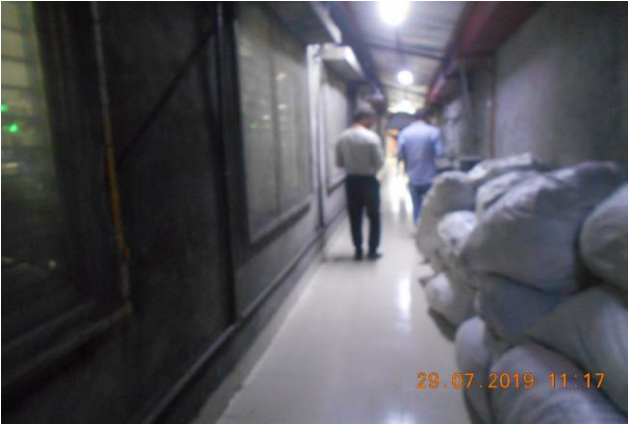
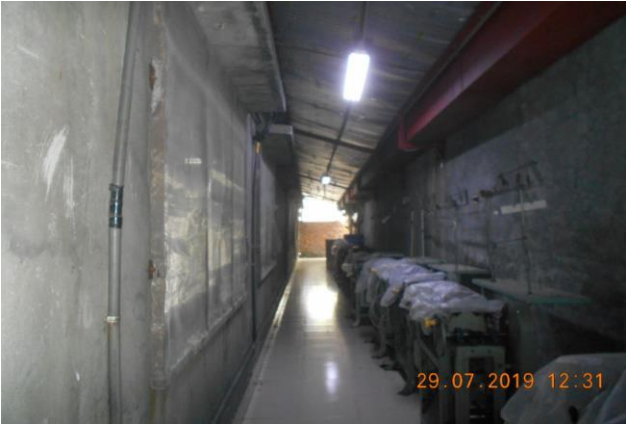
11	Egress	Aisles mark is not provided at floor. Location: Shed-B	Provide clear and unobstructed aisles width (minimum 36 in.) at all required locations.	Within 1 month

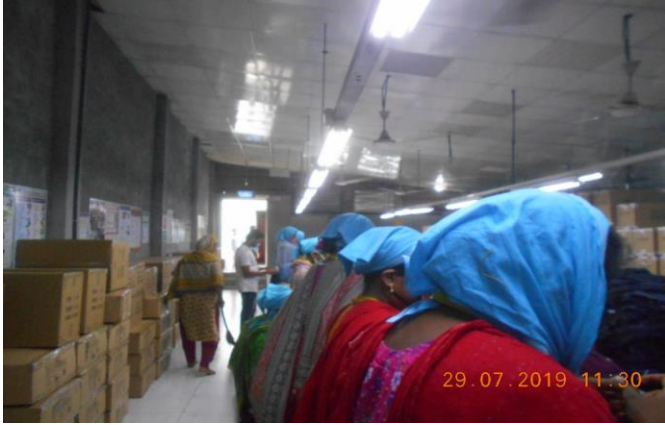
12	Egress Lighting	Exit sign not provided at exit at several locations.	<p>Lighted exit signs shall be placed at entrance to an exit. Additional exit signs shall be placed throughout the facility anywhere the continuation of the egress is not obvious.</p> <p>Lighted exit signs shall be provided with either battery backup or uninterruptable power supply systems and shall be continuously illuminated.</p>	Within 1 month

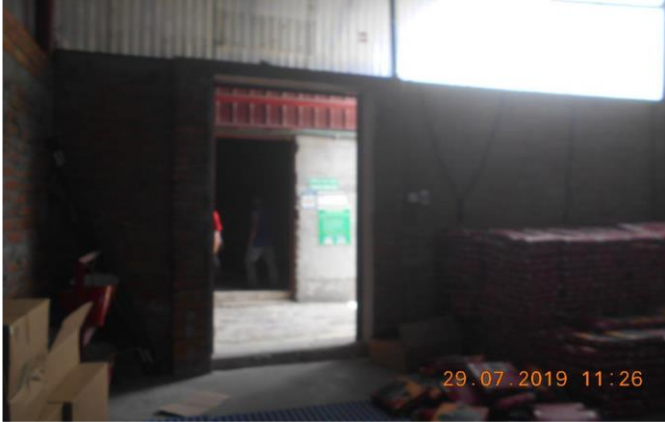
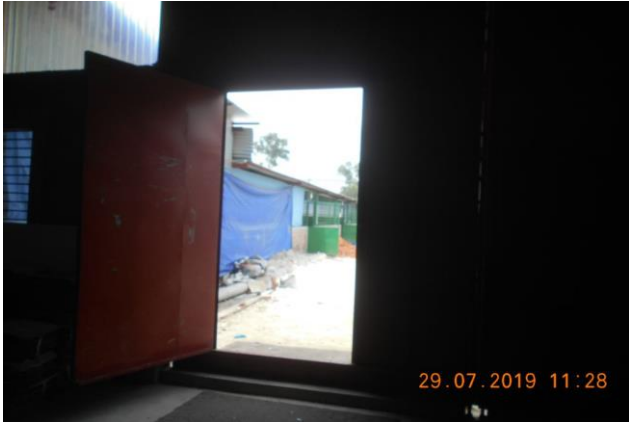
13	Egress Lighting	Based on the number and location of emergency lights observed, adequate illumination levels are not anticipated along egress routes.	Test the emergency lighting system on each floor and provide additional emergency fixtures to provide adequate illumination along the means of egress. Provide a minimum illumination of 10 lux at the floor level within exit stairs and exit discharge paths and minimum 2.5 lux along exit access aisles.	Within 3 Months

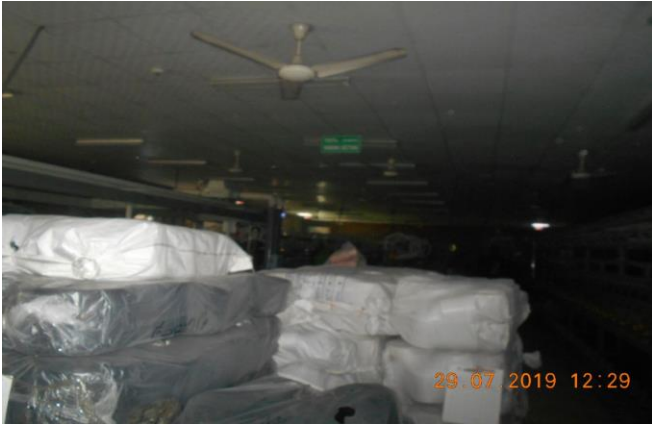
14	Egress Lighting	Inspection, testing, and maintenance for the emergency lighting system was not in accordance with The ACCORD standard.	Inspect, test and maintain the emergency lighting system in the accordance with The ACCORD standard. Keep written records on-site.	Within 1 month

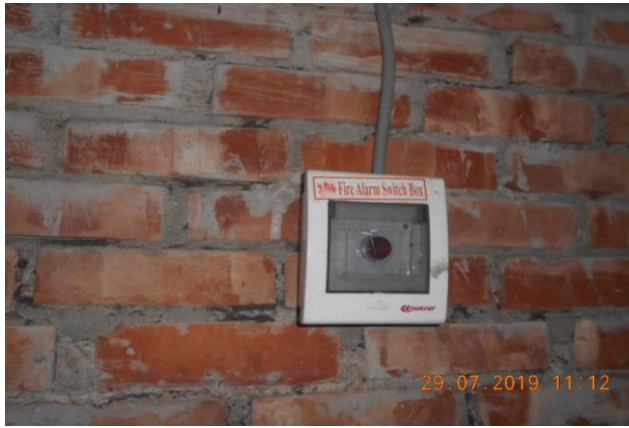
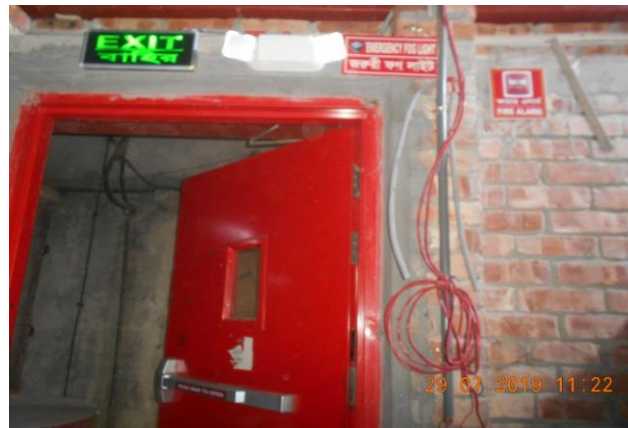
SI No.	Category	Findings	Required Action	Remediation Time Frame
16	Fire Alarm & Detection System (ITM)	Inspection, testing, and maintenance for the fire alarm system is not in accordance with NFPA 72 or as per Accord standard.	Inspect, test and maintain the fire alarm system, and keep written records on-site, in accordance with NFPA 72 or as per Accord standard.	Within 9 months
17	Fire Protection	The required no smoking signs are not present in the factory.	Smoking is prohibited in any garment factory building or separate storage building. Signs shall be posted in Bengali and English at all building entrances. If the factory creates a designated smoking area outside the building, information of these areas will be posted on the signs.	Within 1 month
