# Shafi Knit Ltd.

Natun Para, Baipail (beside DEPZ-2), Ashulia, Savar, Dhaka  
(23.945646N, 90.277794E)

12<sup>th</sup> May 2019

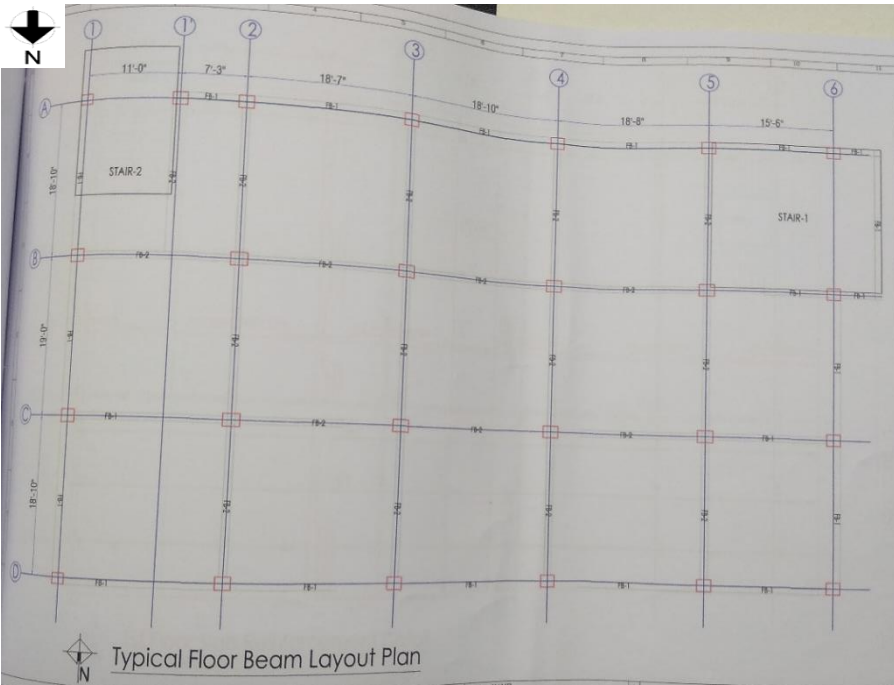
Typical floor beam layout

Cantilever beams were found only at 3<sup>rd</sup> floor roof. A Typical Floor Beam Layout Plan shows cantilever beams. In addition, beam down stand was measured 200 mm instead of 250 mm (as per provided as-built drawing) at 1<sup>st</sup> to 3<sup>rd</sup> floor beams.

| Item No. | Observation | Recommended Action Plan | Recommended Timeline |
|---|---|---|---|
| 1 | Discrepancies between provided drawings and on-site condition | Building Engineer to survey the structure and prepare accurate as-built drawings. | 6-weeks |

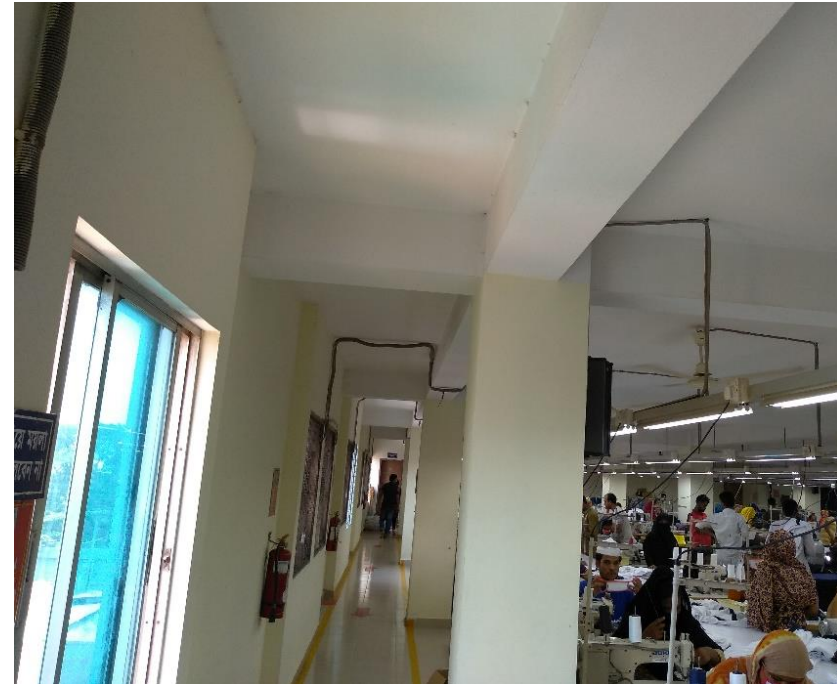
Cantilever beam on roof floor beam

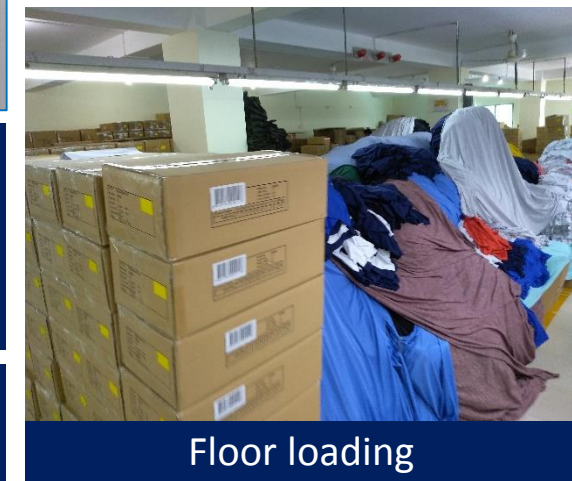
Floor loading

The provided Load Plan shows 2 kPa loading. As the second phase of construction started in July 2015 and ended in March 2016 up to roof top shed the Load Plan must be in accordance with BNBC Standard.

During inspection no over loading was found. FoS calculation for internal & external columns were found satisfactory considering 3 KPa allowable floor live loading for all buildings.

Factory is required to revise the DEA including Load Plan as per actual onsite condition and submit to Accord.

| Item No. | Observation | Recommended Action Plan | Recommended Timeline |
|---|---|---|---|
| 3 | Load plan & design reports required to be revised and submitted to Accord for further review | Produce and actively manage a loading plan for all floor plates within the factory, considering floor, column and foundation capacity as per BNBC provision. | 6-weeks |

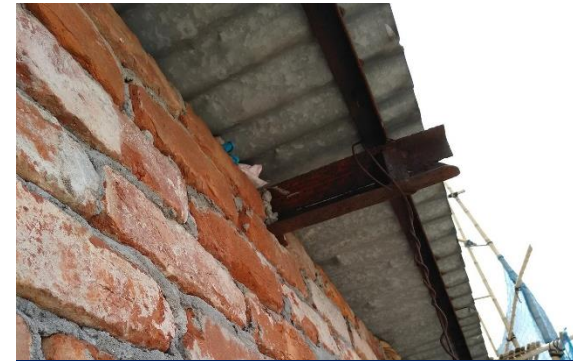
Non-engineered connection

Apparent non-engineered shed was found at roof level. Light weight roof structure supported on 125 mm brick wall. The connections appeared to be non-engineered. No documentation was available onsite.

| Item No. | Observation | Recommended Action Plan | Recommended Timeline |
|---|---|---|---|
| 6 | Apparent non-engineered Shed at roof without as-built documentation | Prepare “as constructed” drawings which reflect the actual site dimensions with complete structural information. | 6-weeks |
| 7 | Apparent non-engineered Shed at roof without as-built documentation | Building engineer to check the capacity of the light weight roof structure against lateral loading. | 6-weeks |
| 8 | Apparent non-engineered Shed at roof without as-built documentation | Carry out remedial works resulting from engineering assessment if necessary. | 6-months |

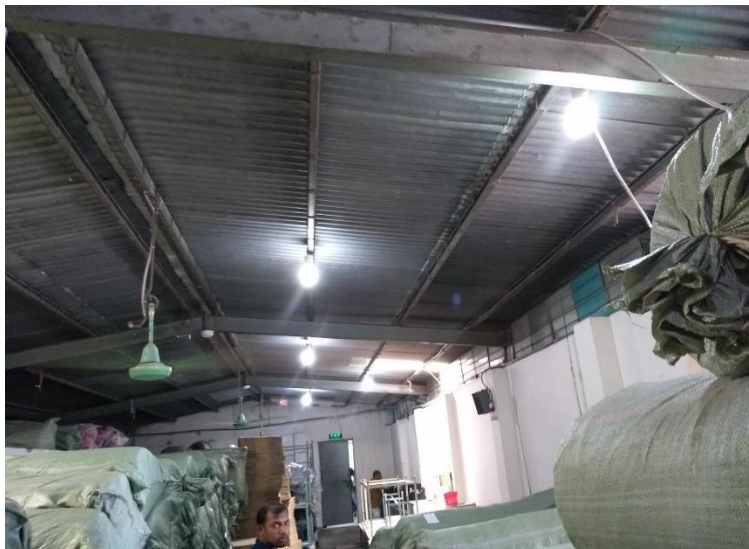
Shed-1

No documents were available for shed 1 & 2.  
Building engineer is required to prepare “as constructed” drawings that includes connection details which reflect the actual site dimensions with complete structural information.

| Item No. | Observation | Recommended Action Plan | Recommended Timeline |
|---|---|---|---|
| 9 | Lack of as-built documents | Prepare “as constructed” drawings which reflect the actual site dimensions with complete structural information. | 6-weeks |

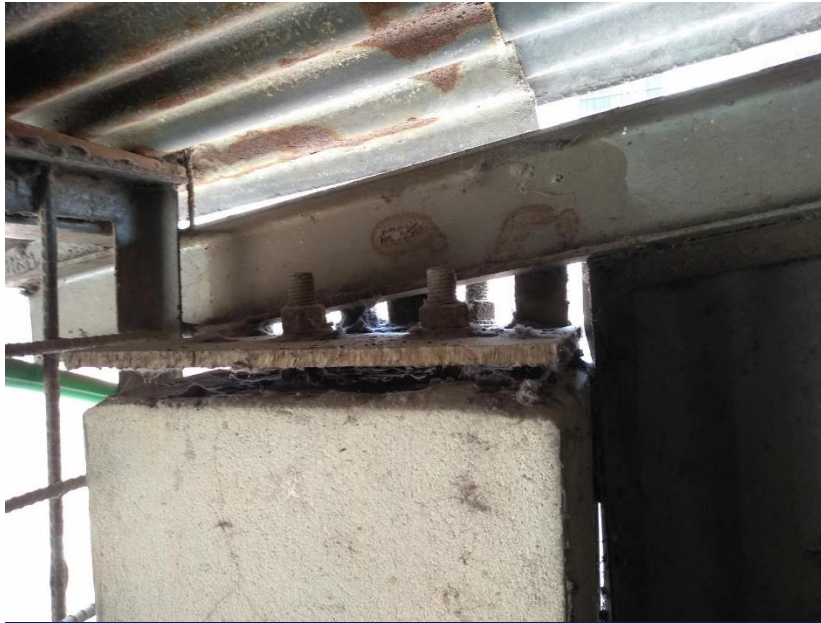
Significant gap observed between steel baseplate and RCC column.

| Item No. | Observation | Recommended Action Plan | Recommended Timeline |
|---|---|---|---|
| 10 | Significant gap between steel baseplate and RCC column of Shed-1 | Check the adequacy of the connections. | 6-weeks |
| 11 | Significant gap between steel baseplate and RCC column of Shed-1 | Carry out suitable remedial works as per suggestion of factory engineer. | 6-weeks |

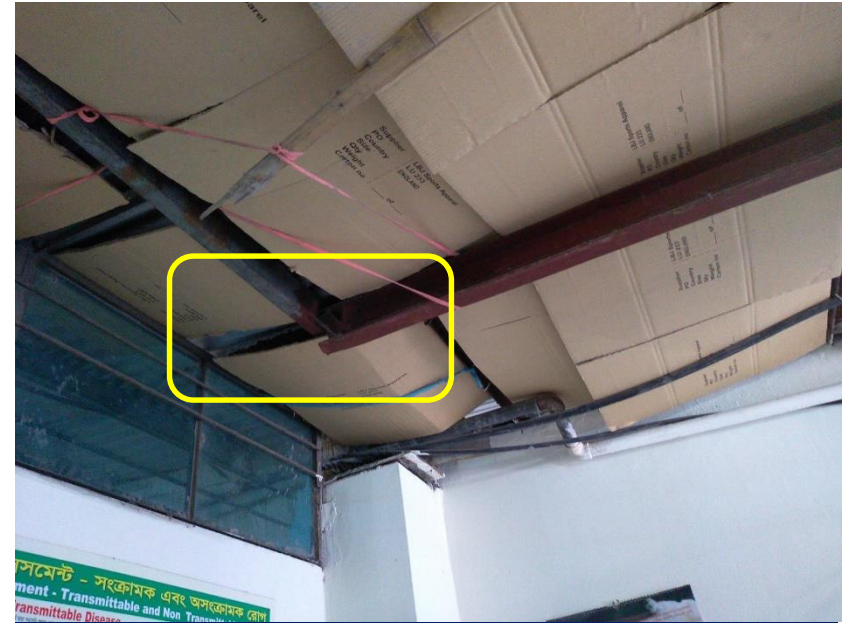
Poor/non-engineered connection was found at extension of shed-1 (doctor's room)
