FIRE SAFETY INSPECTION REPORT

**MEEK SWEATER LIMITED
NOOR COMPLEX, AOCHPARA, SATAISH LINK ROAD,
TONGI**

ACCORD
on Fire and Building Safety in Bangladesh

May 17, 2014

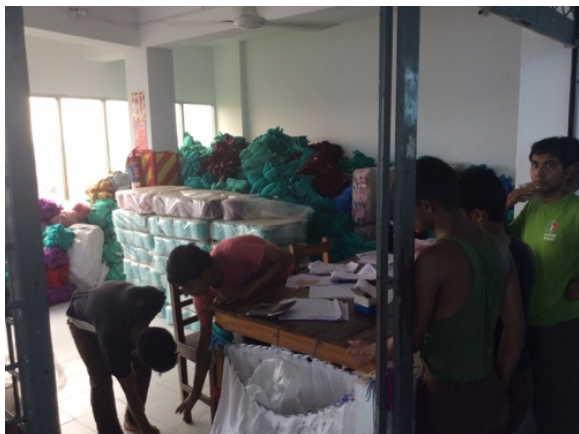
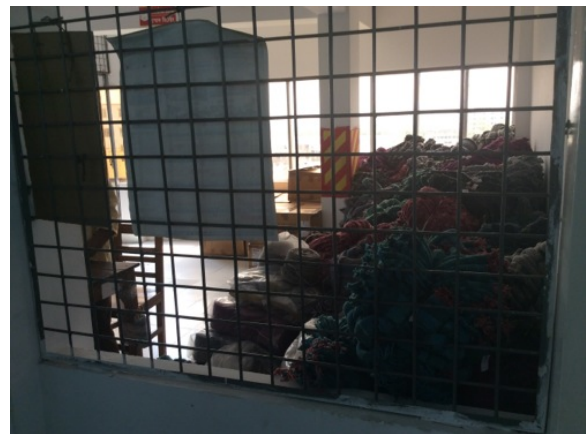
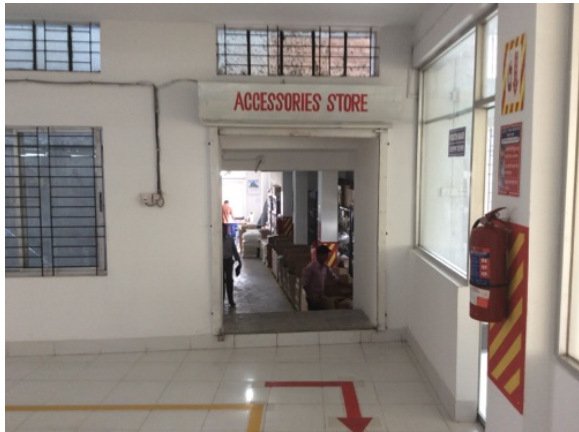
No.	Category	Finding	Recommendation	Remediation Timeframe
F-1	Fire Rated Construction	Storage rooms used for combustible storage are not separated by fire- rated construction on all floors.	Provide dedicated storage rooms separated by minimum 1-hr fire-rated construction.	Within 3 months

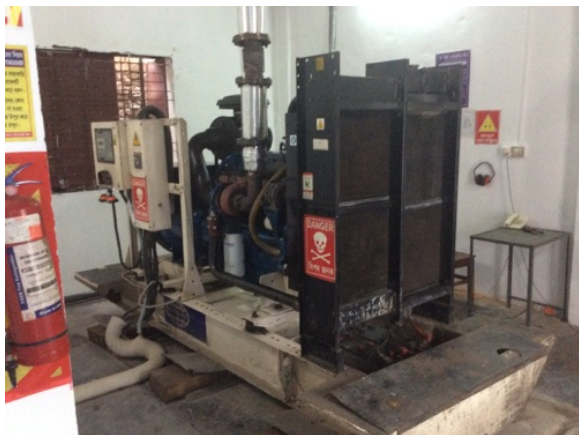
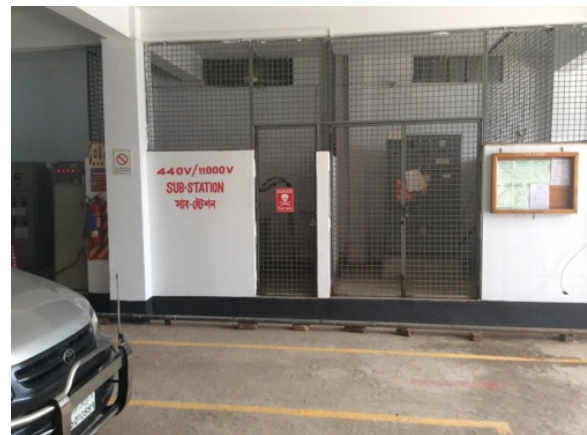
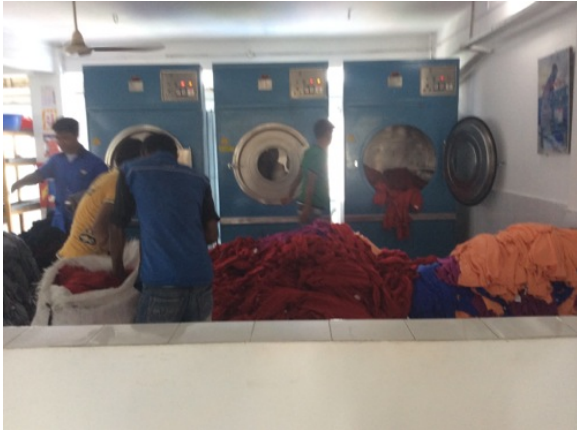
F-2	Fire Rated Construction	The boiler, generator, and transformer on the ground floor and the natural gas dryers on Floor 2 are not separated by fire-rated construction.	Separate the boiler, generator and transformer rooms, as well as the gas dryers by a minimum 2-hr fire-rated construction. Seal and/or protect all openings to maintain the required fire separations	Within 3 months
-----	-------------------------	--	---	-----------------

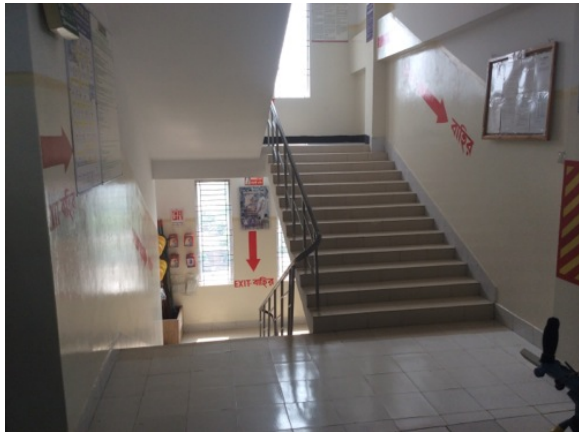
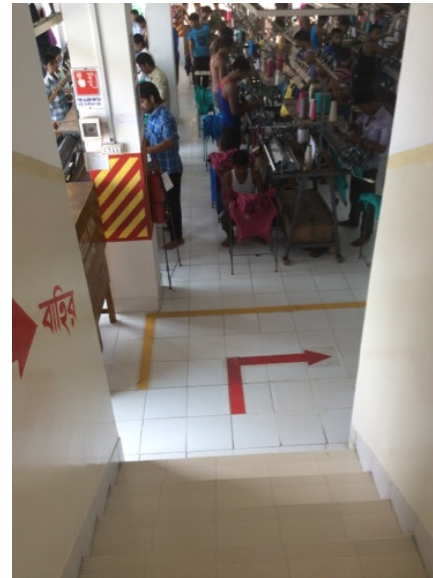
F-3	Fire Rated Construction	The exit stairs are not separated from work or storage areas on each floor by fire-rated construction.	<p>Provide minimum 1.5-hr fire rated doors and seal all unprotected openings to separate the exit stairs from work areas and other building spaces on all floor levels. Provide vestibules to separate storage areas from egress paths. Ensure that the fire doors are self-closing and positive latching and that they are provided with fire exit (panic) hardware where serving production floors.</p> <p>If fire doors are required to be held open for functional reasons, provide automatic-closing devices tied to the fire alarm system.</p>	Within 3 months
-----	-------------------------	--	--	-----------------

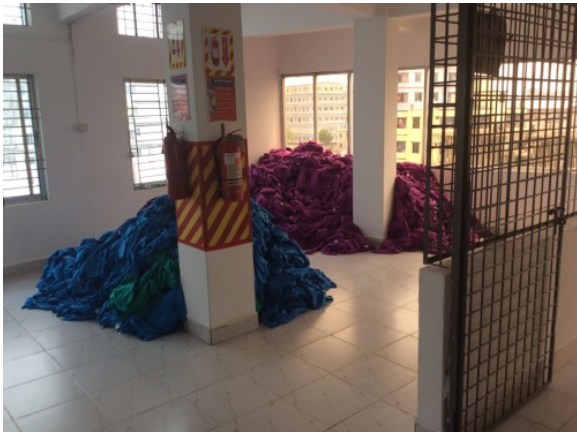
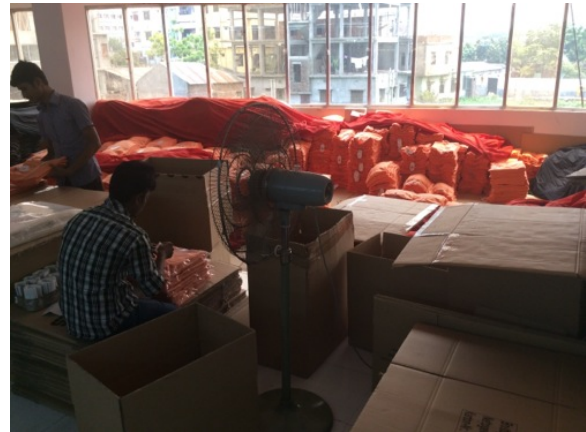
F-4	Fire Rated Construction	Areas used for combustible storage on factory floors are not separated by fire-rated construction on Floors 1-4.	Provide dedicated storage rooms separated by minimum 1-hr fire-rated construction.	Within 3 months
			<p>Where separate storage rooms are not feasible, provide defined storage areas and limit the storage arrangement as follows:</p> <ul style="list-style-type: none"> - Maximum height of 2.4m and maximum area of 23m² - If sprinkler protected: maximum height of 3.66m and maximum area of 93m² 	
			Separate areas of unenclosed combustible storage by a minimum clear distance of 3m.

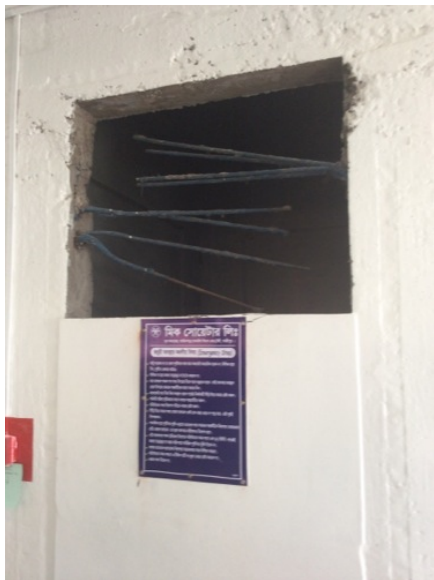
F-5	Fire Rated Construction	Unsealed penetrations and openings are located in the fire-rated elevator shaft.	Seal all penetrations and openings in elevator shaft to maintain the fire separation.	Within 3 months
-----	-------------------------	--	---	-----------------

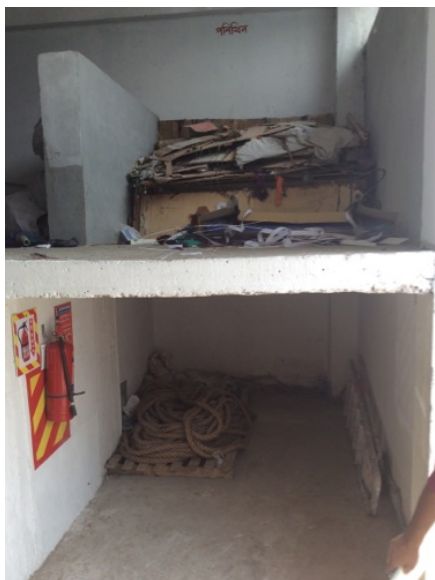
F-6	Egress	Storage was located in the northeast exit stair at the roof.	Remove all storage from exit stairs and egress paths.	Immediate
-----	--------	--	---	-----------

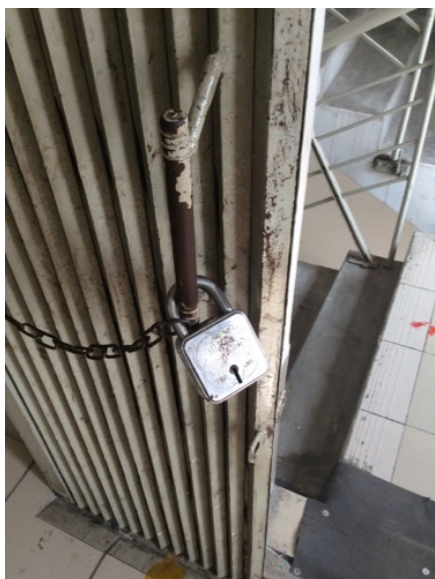
F-7	Egress	Egress doors / gates with locking features are provided at building exits, exit stairs, and exit discharges on the ground floor. Doors / gates were open and unlocked at time of inspection.	Remove locking features from all egress doors / gates. If locks are required for security reasons, utilize special door locking features complying with NFPA 101.	Immediate
-----	--------	--	--	-----------

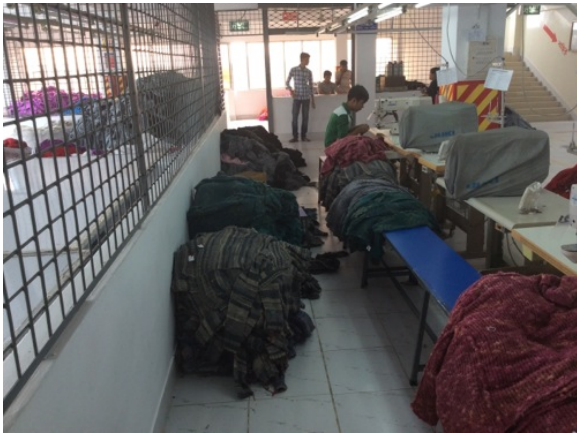
F-8	Egress	Storage was located in the egress path on Floor 4.	Keep egress paths and stairs clear of storage.	Immediate
-----	--------	--	--	-----------

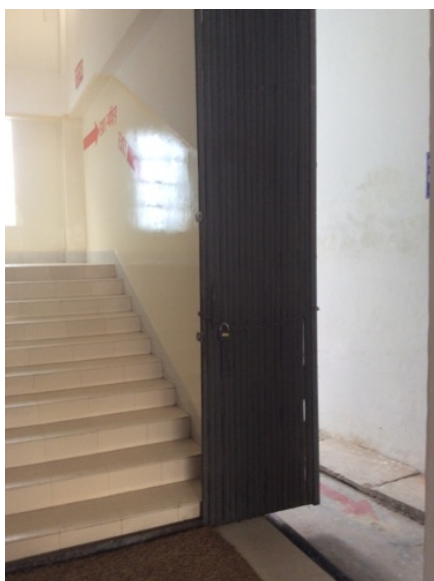
F-9	Egress	Collapsible gates are provided at building exits, exit stairs, and at exit discharge at the ground floor.	Replace all gates / sliding doors along the means of egress with side-hinged, swinging egress doors.	Within 1 month
			If locks are required for security reasons, utilize special door locking features complying with NFPA 101.

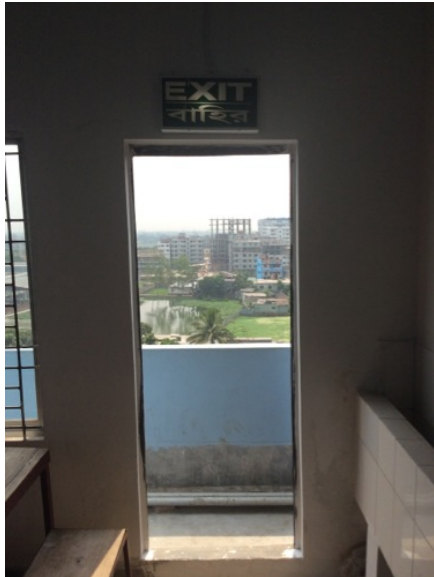
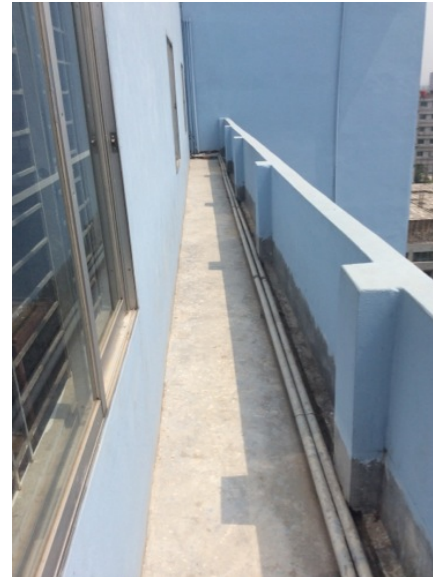
F-10	Egress	Balcony on roof is labeled as emergency exit, however there is no exit from the balcony.	Remove emergency exit sign from balcony doorway.	Within 1 month
------	--------	--	--	----------------

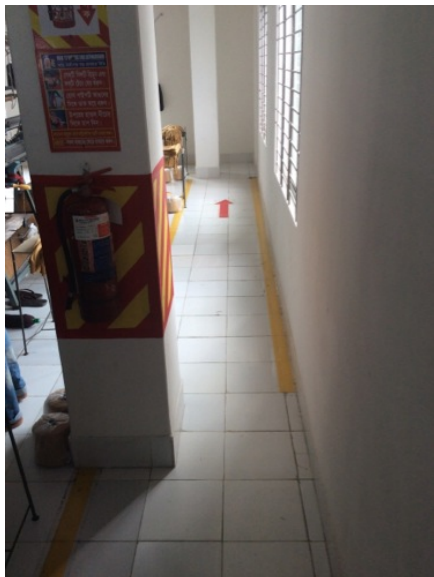
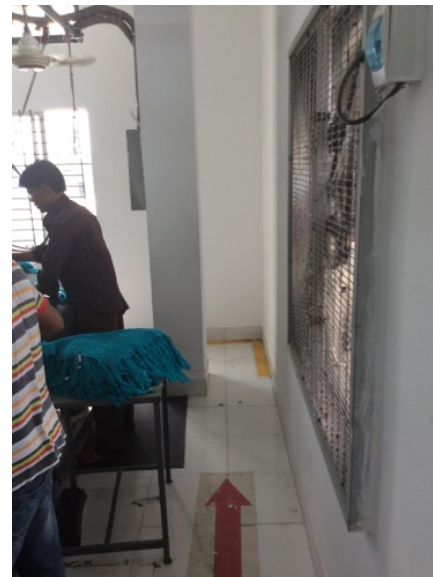
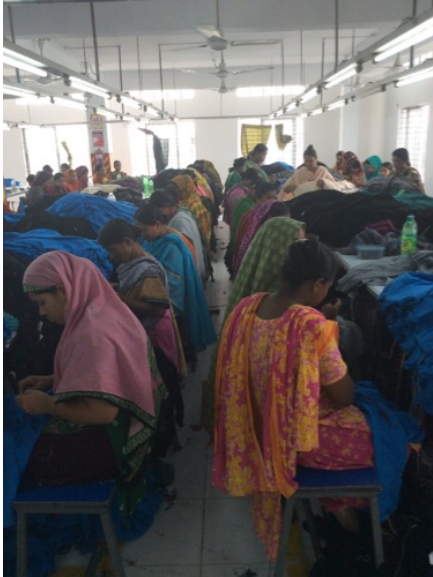
F-11	Egress	The width of egress aisles is less than 36-in on Floors 1-6.	Provide minimum aisle widths of 36-in.	Within 3 months
------	--------	--	--	-----------------

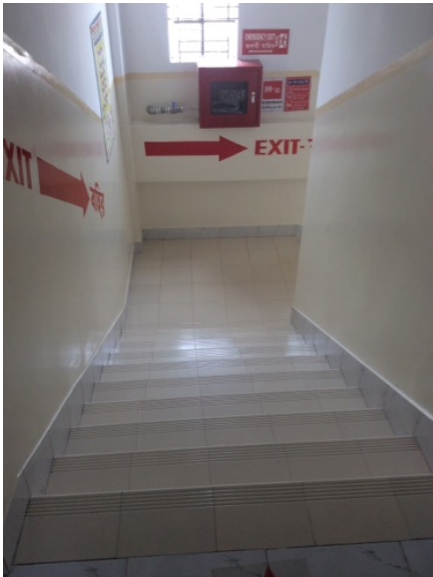
F-12 Egress

Handrails are not provided in the northwest exit stair.

Provide handrails on at least one side of exit stair.

Within 3 months

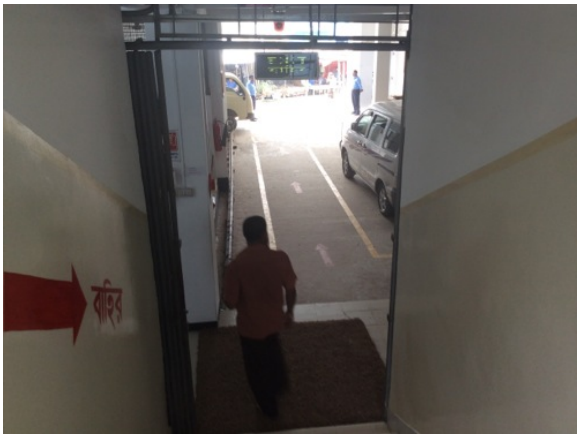
F-13	Egress	All exit stairs discharge inside the building in the parking area.	Provide 2-hr fire-rated exit passageway leading directly outside (vestibules to separate any storage areas). -OR- Provide sprinkler protection for discharge floor in accordance with NFPA 13.	Within 6 months
------	--------	--	--	-----------------

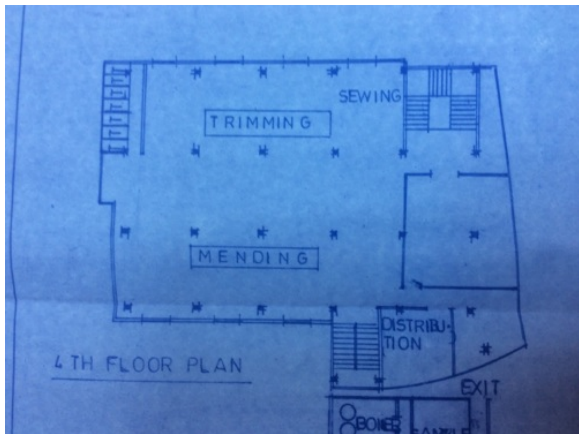
F-14	Egress	The exit stairs are not remotely located from each other such that a single fire event could compromise both exits on all floor.	Provide additional exit(s). -OR- Provide sprinkler protection in accordance with NFPA 13.	Within 6 months
------	--------	--	---	-----------------

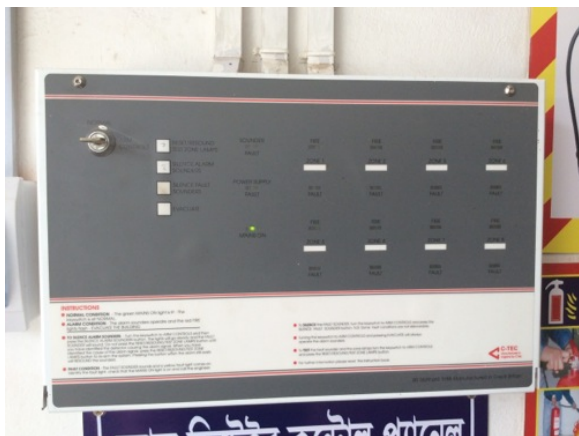
F-15	Fire Protection	Inspection, testing, and maintenance for the fire alarm system was not in accordance with NFPA 72.	Inspect, test and maintain the fire alarm system, and keep written records on-site, in accordance with NFPA 72.	Within 3 months
------	-----------------	--	---	-----------------

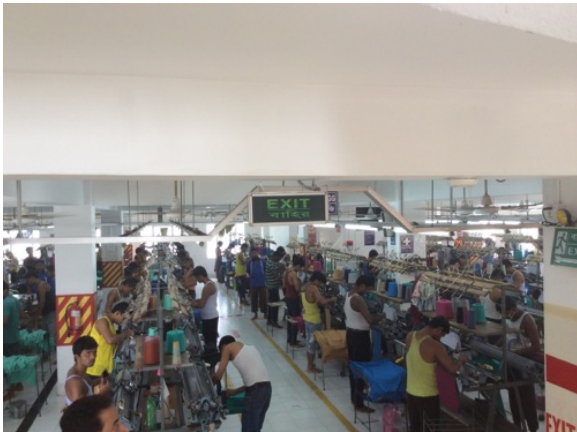
F-16	Egress Lighting	Double-sided exit signs located at exit stairs on some floors.	Change exit signs to one-sided signs that only direct egress into stairwells.	Within 1 month
------	-----------------	--	---	----------------

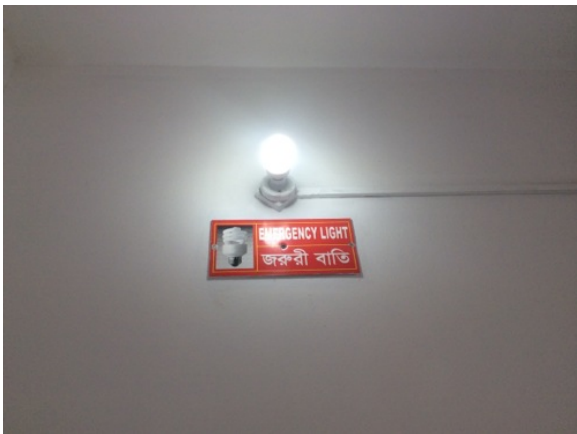
F-17	Egress Lighting	Inspection, testing, and maintenance for the emergency lighting system was not in accordance with The ACCORD Standard.	Inspect, test and maintain the emergency lighting system in accordance with The ACCORD standard. Keep written records on-site.	Within 3 months
------	-----------------	--	--	-----------------

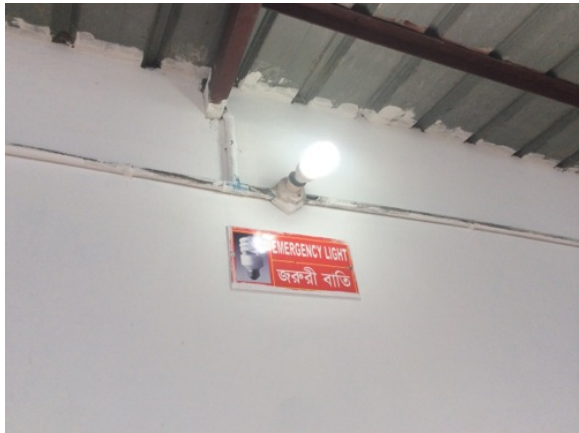
F-18	Egress Lighting	Based on the number and location of emergency lights observed, adequate illumination levels are not anticipated along egress routes on all floors.	Test the emergency lighting system on each floor and provide additional emergency fixtures to provide adequate illumination along the means of egress. Provide a minimum illumination of 10 lux at the floor level within exit stairs and exit discharge paths and minimum 2.5 lux along exit access aisles.	Within 3 months
------	-----------------	--	--	-----------------
